**Inspection Report**

Permit Number:	C0410002
Inspection Type:	PARTIAL
Inspection Date:	Tuesday, November 19, 2019
Start Date/Time:	11/19/2019 9:00:00 AM
End Date/Time:	11/19/2019 1:00:00 PM
Last Inspection:	Tuesday, November 5, 2019

Permitee: **CANYON FUEL COMPANY**  
 Operator: **CANYON FUEL COMPANY**  
 Site: **SUFKO MINE**  
 Address: **597 SOUTH SR24, SALINA UT 84654**  
 County: **SEVIER**  
 Permit Type: **PERMANENT COAL PROGRAM**  
 Permit Status: **ACTIVE**

An inspection was conducted as part of the Sufco midterm review on November 19, 2019. The main mine surface facilities were visited as well as the waste rock site. Link Canyon facilities were discussed, but not visited.

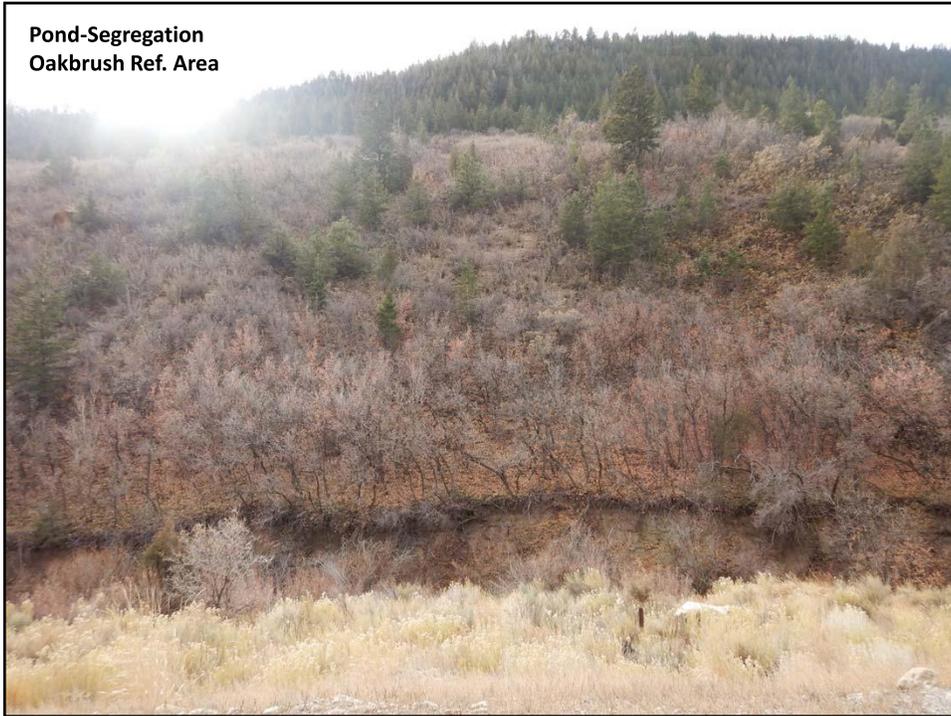
**Pond-Segregation  
Oakbrush Ref. Area**

Five reference areas were observed during the inspection. At the Pond/Segregation location the Pinyon Juniper and Oakbrush reference areas were observed to be in good condition with no offsite impacts noted. At the Waste Rock Site the Sagebrush/Grass, Rabbitbrush/Sagebrush, and Mountain Brush reference areas were all observed to be in good condition with no offsite impacts noted.

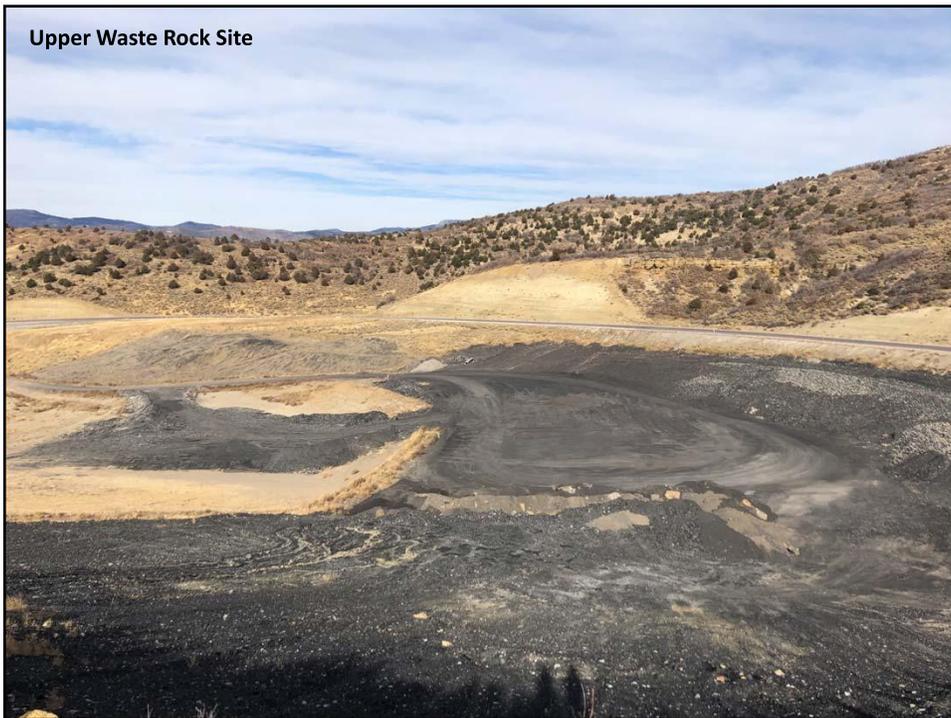
**Upper Waste Rock Site**

Topsoil and subsoil had been stripped from Phases 1 - 4 of the waste rock site. The volume of waste rock in Phase 1 was significantly less than anticipated because a sizeable amount had been recently removed. According to operator representative Bryant Bunnell, a large volume of coal mine waste was recently deemed profitable after blending with high grade product, leaving approximately 15% capacity in Phase 1.

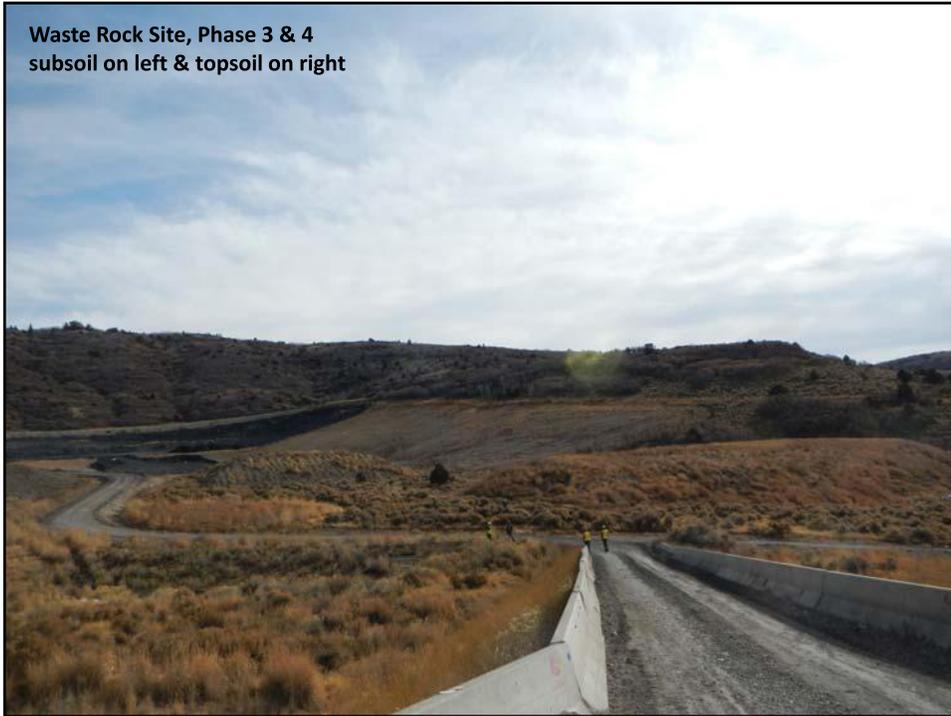
The two stockpiles from Phase 3 & 4 construction were constructed, bermed and signed in December 2018. They are not shown on the Phase 4 Map 4D, because they were not originally contemplated. The 2018 stockpiles were seeded and mulched in November 2019. The seed tag from the seeding is attached. The 2018 stockpiles were photographed from a distance.

**Waste Rock Site, Phase 3 & 4  
subsoil on left & topsoil on right**

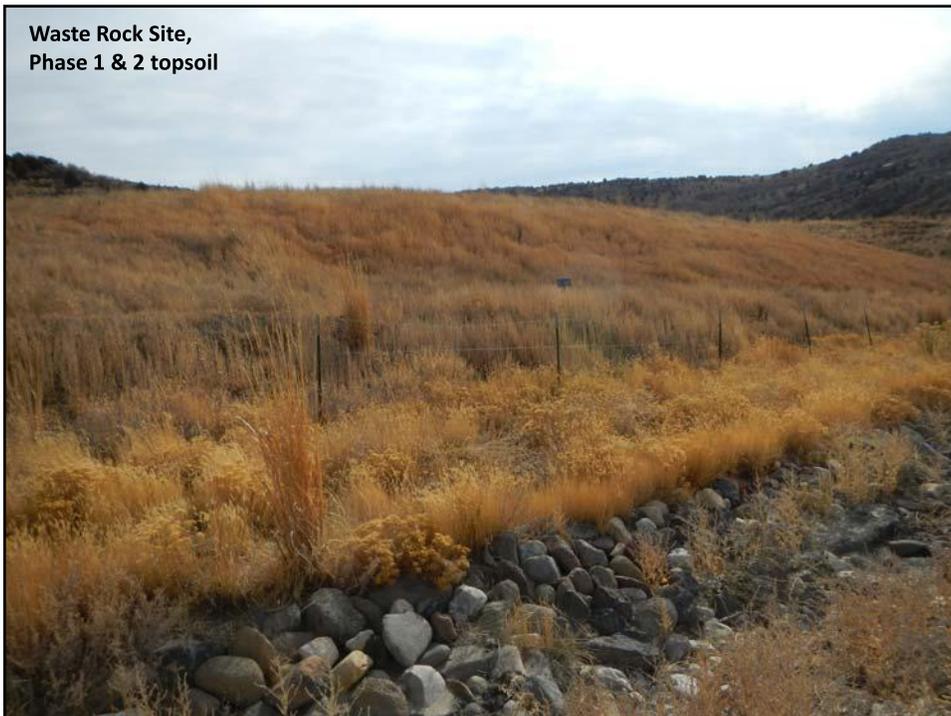
The topsoil and subsoil stockpiles shown on Map 4D were constructed during the initial expansion (Phases 1 & 2). They are bermed, vegetated, and signed. These stockpiles were seeded in 2016. Interestingly, desirable vegetation appears more vigorous on the subsoil than the topsoil stockpile. Stockpile photographs are attached.

**Waste Rock Site,  
Phase 1 & 2 topsoil**

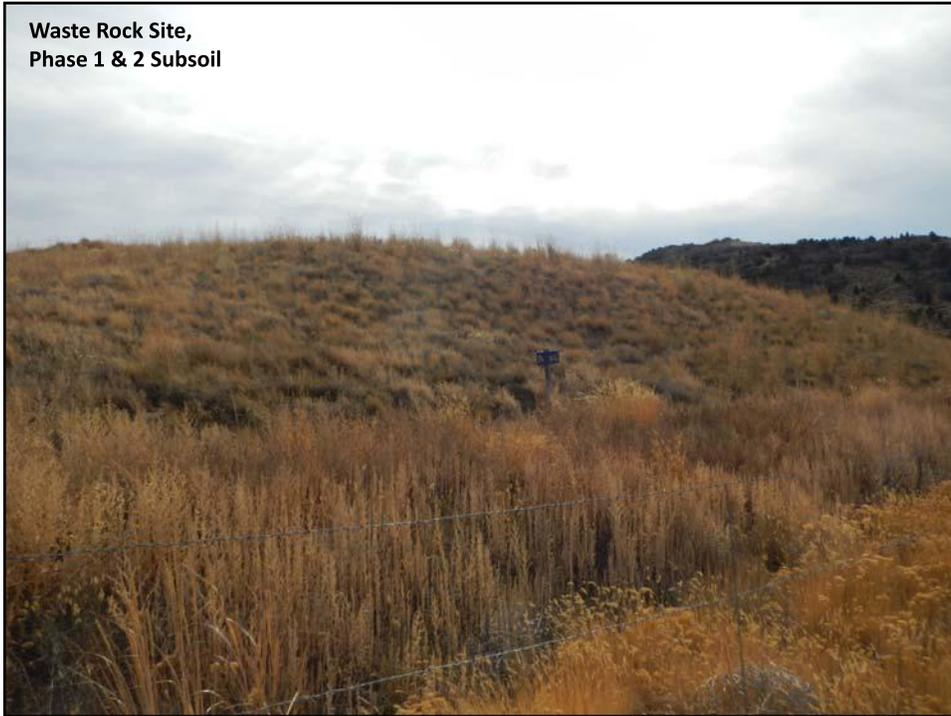
**Waste Rock Site,  
Phase 1 & 2 Subsoil**

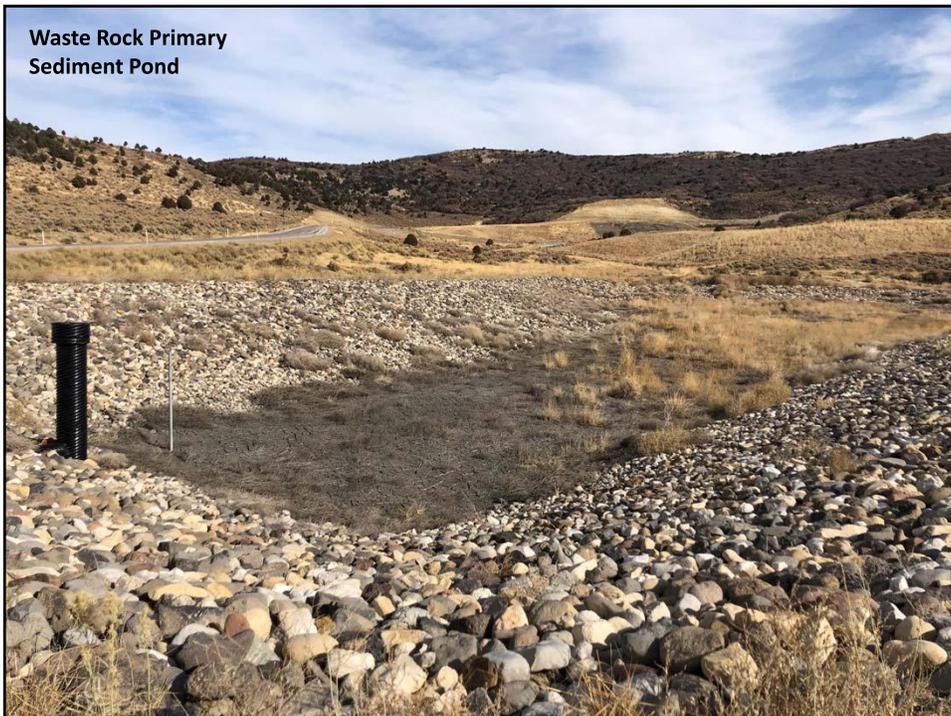
**Waste Rock Primary  
Sediment Pond**

The sediment ponds at the waste rock site were also inspected. Both ponds at the waste rock facility were dry and appeared to be in good condition. The sediment marker at the main pond was clearly marked and the primary and secondary outlets were found to be in good condition.
