Minerals Inspection Report

Mine Name: PR Springs	Permit Number: M/47/0090	Mine Status: Inactive
Operator Name: US Oil Sands, Inc.	Inspection Date: 6/19/2018	Permit Fees: Paid
Inspector(s): A. Abate	Inspection Time: 10:00 AM	Bond Amount: \$732,000
Attendee(s): Lyle Gardner, Operator Representative	Weather: Sunny, Clear	Bond Escalation: 01/01/2019
Inspection Purpose: Spring 2018 inspection for idle mine		Prior Inspection: 11/2/2017

Conclusions and Recommendations
Erosion areas were inspected and determined to be minor and do not appear causing any off site impacts. Oil and solvent tanks were not drained. Partial water sampling was conducted by operator at the end of May 2018 for 2nd quarter 2018 to meet requirements. Please provide that data to the Division when it becomes available from the lab. Operator has done some noxious weed spraying on the topsoil stockpiles. Discussed the operator applying for final bond release on exploration permit E/19/0053.

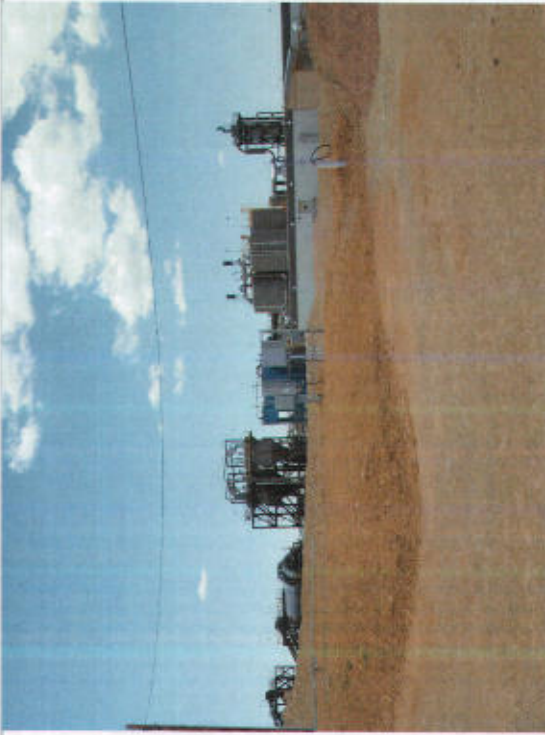
4. <i>Deleterious Material</i> A small area of 55-gallon drums were noted on the property. Some of the drums were empty, some were covered. Drums with open bungholes were covered. Solvent and hot oil tanks were noted in the facility area. Recommend the operator to either place in secondary containment, or drain the tanks of their contents.	<input checked="" type="checkbox"/>	<input type="checkbox"/>

View of the plant facility

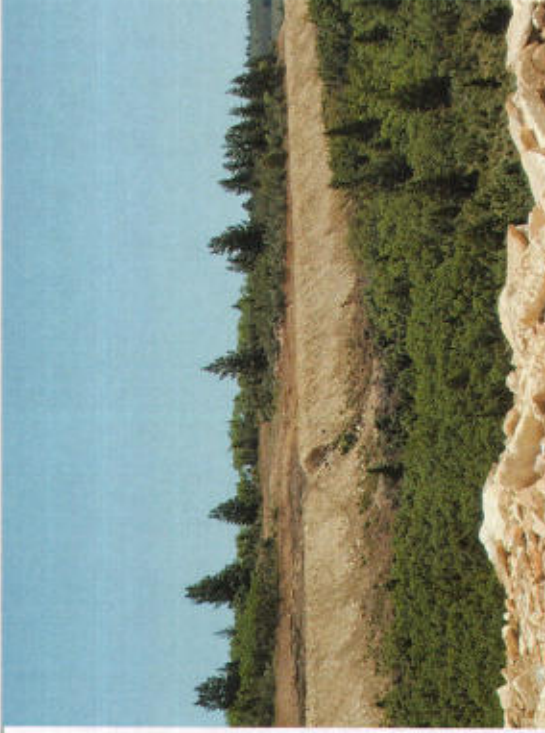
3. <i>Protection of Drainages/Erosion Control</i> The original test pit and the main mine pit were both inspected for erosion. The small area of rilling identified in the fall did not appear to have gotten any worse. The drainage break alongside the haul road was observed. This berm break directs flow to a sediment pond located in between the canyons. The pond was inspected and was observed to be dry. Based on these observations, it appears that the region did not receive much moisture over the winter. US Oil Sands remains bound to the sampling obligations of the October 2015-approved water monitoring plan of the on-site wells and nearby springs. Phase I of the monitoring plan required tri-annual sampling. Phase I sampling was complete as of Fall 2017. Phase II sampling requires bi-annual sampling 2 quarters per year and begins in Spring 2019. Reporting of all water monitoring data will be required as part of the annual report, which will be sent to the operator prior to the end of the 2018 and due on January 31, 2019.	<input checked="" type="checkbox"/>	<input type="checkbox"/>

Breach in the haul road for drainage.

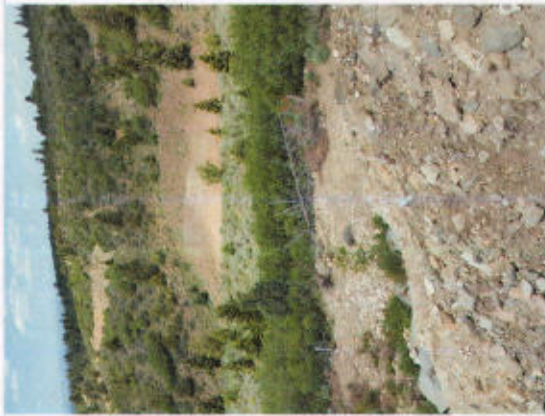
Sediment pond was dry

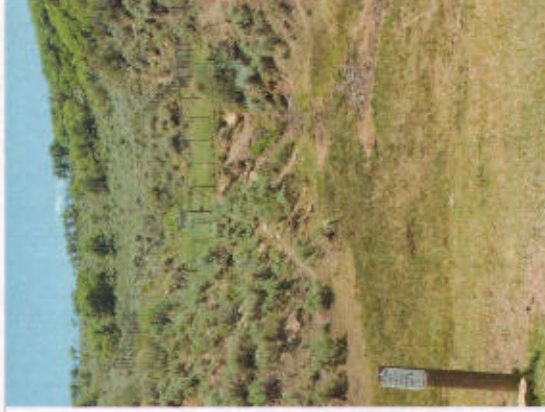
10. <i>Other</i>	<input checked="" type="checkbox"/>	<input type="checkbox"/>
Samples were collected from the springs only. The water wells were taken off-line as a result of the plant shut down protocol making it impossible to collect a sample. This should be noted and explained in the USOS water sampling report to the Division.

Visited the PR Spring. It was flowing at approximately 1 - 3 gallons per minute.
