# WATER QUALITY MEMORANDUM

## Utah Coal Regulatory Program

RE: 2009 First Quarter Water Monitoring, Canyon Fuel Company, LLC, Skyline Mine, C/007/0005, Task ID #3226

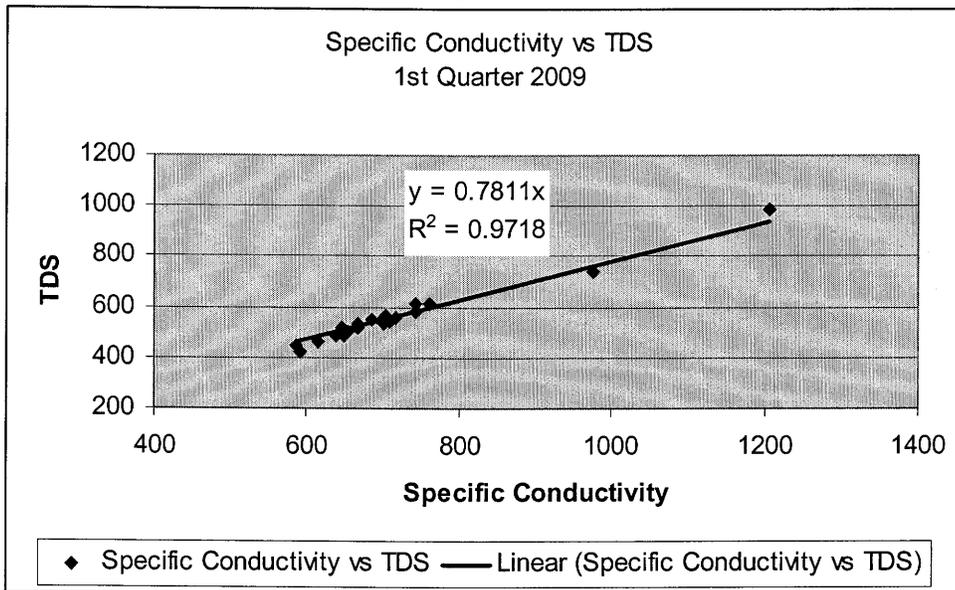
- TDS/Conductivity
  - Out of 22 samples for which both field specific conductivity and TDS were determined, only 4 have TDS/Conductivity ratios  $< 0.76$ , and 4 have a ratio  $> 0.8$ .
    - The linear trendline has a slope of 0.78 (see chart).
    - This ratio is typically between 0.55 and 0.76.
    - UPDES discharges account for 15 of these samples.

These two Reliability Checks may be indicating that the meter used to measure field specific conductivity is reading low and that the Permittee needs to calibrate it more frequently, or possibly replace it.
- For CS-6, CS-12, CS-13, CS-14, VC-6, and VC-9 the Division calculated Reliability Checks that involve dissolved Ca, Mg, K, Na, Cl, and SO<sub>4</sub>. There were not data on dissolved ions at other sites.
  - Ideally the  $Mg/(Ca + Mg)$  ratio is  $< 40\%$ .
    - Of the 6 samples, 5 have a ratio  $< 40\%$
    - The CS-12 ratio is right at 40%.
    - CS-12 consistently has a high ratio and frequently has the highest ratio.
  - All 6 have a  $Ca/(Ca + SO_4)$  ratio  $< 50\%$ .
    - Ideally the ratio is  $> 50\%$ .
    - Because  $Mg/(Ca + Mg)$  values are within the expected range, SO<sub>4</sub> values may bear watching.
