Plateau Mine

Meeting Concerning UDOG M Stipulation #7
- Impoundments 1, 3, 5

SUBJECT: Supplementary Embankment Slope Stability Study, Sedimentation Ponds
No. 1, 3 & 5, Star Point Mine

SUPPLEMENTARY STUDY ON
EMBANKMENT SLOPE STABILITY
FOR
SEDIMENTATION PONDS NO. 1, 3 and 5
STAR POINT MINE, CARBON COUNTY, UTAH

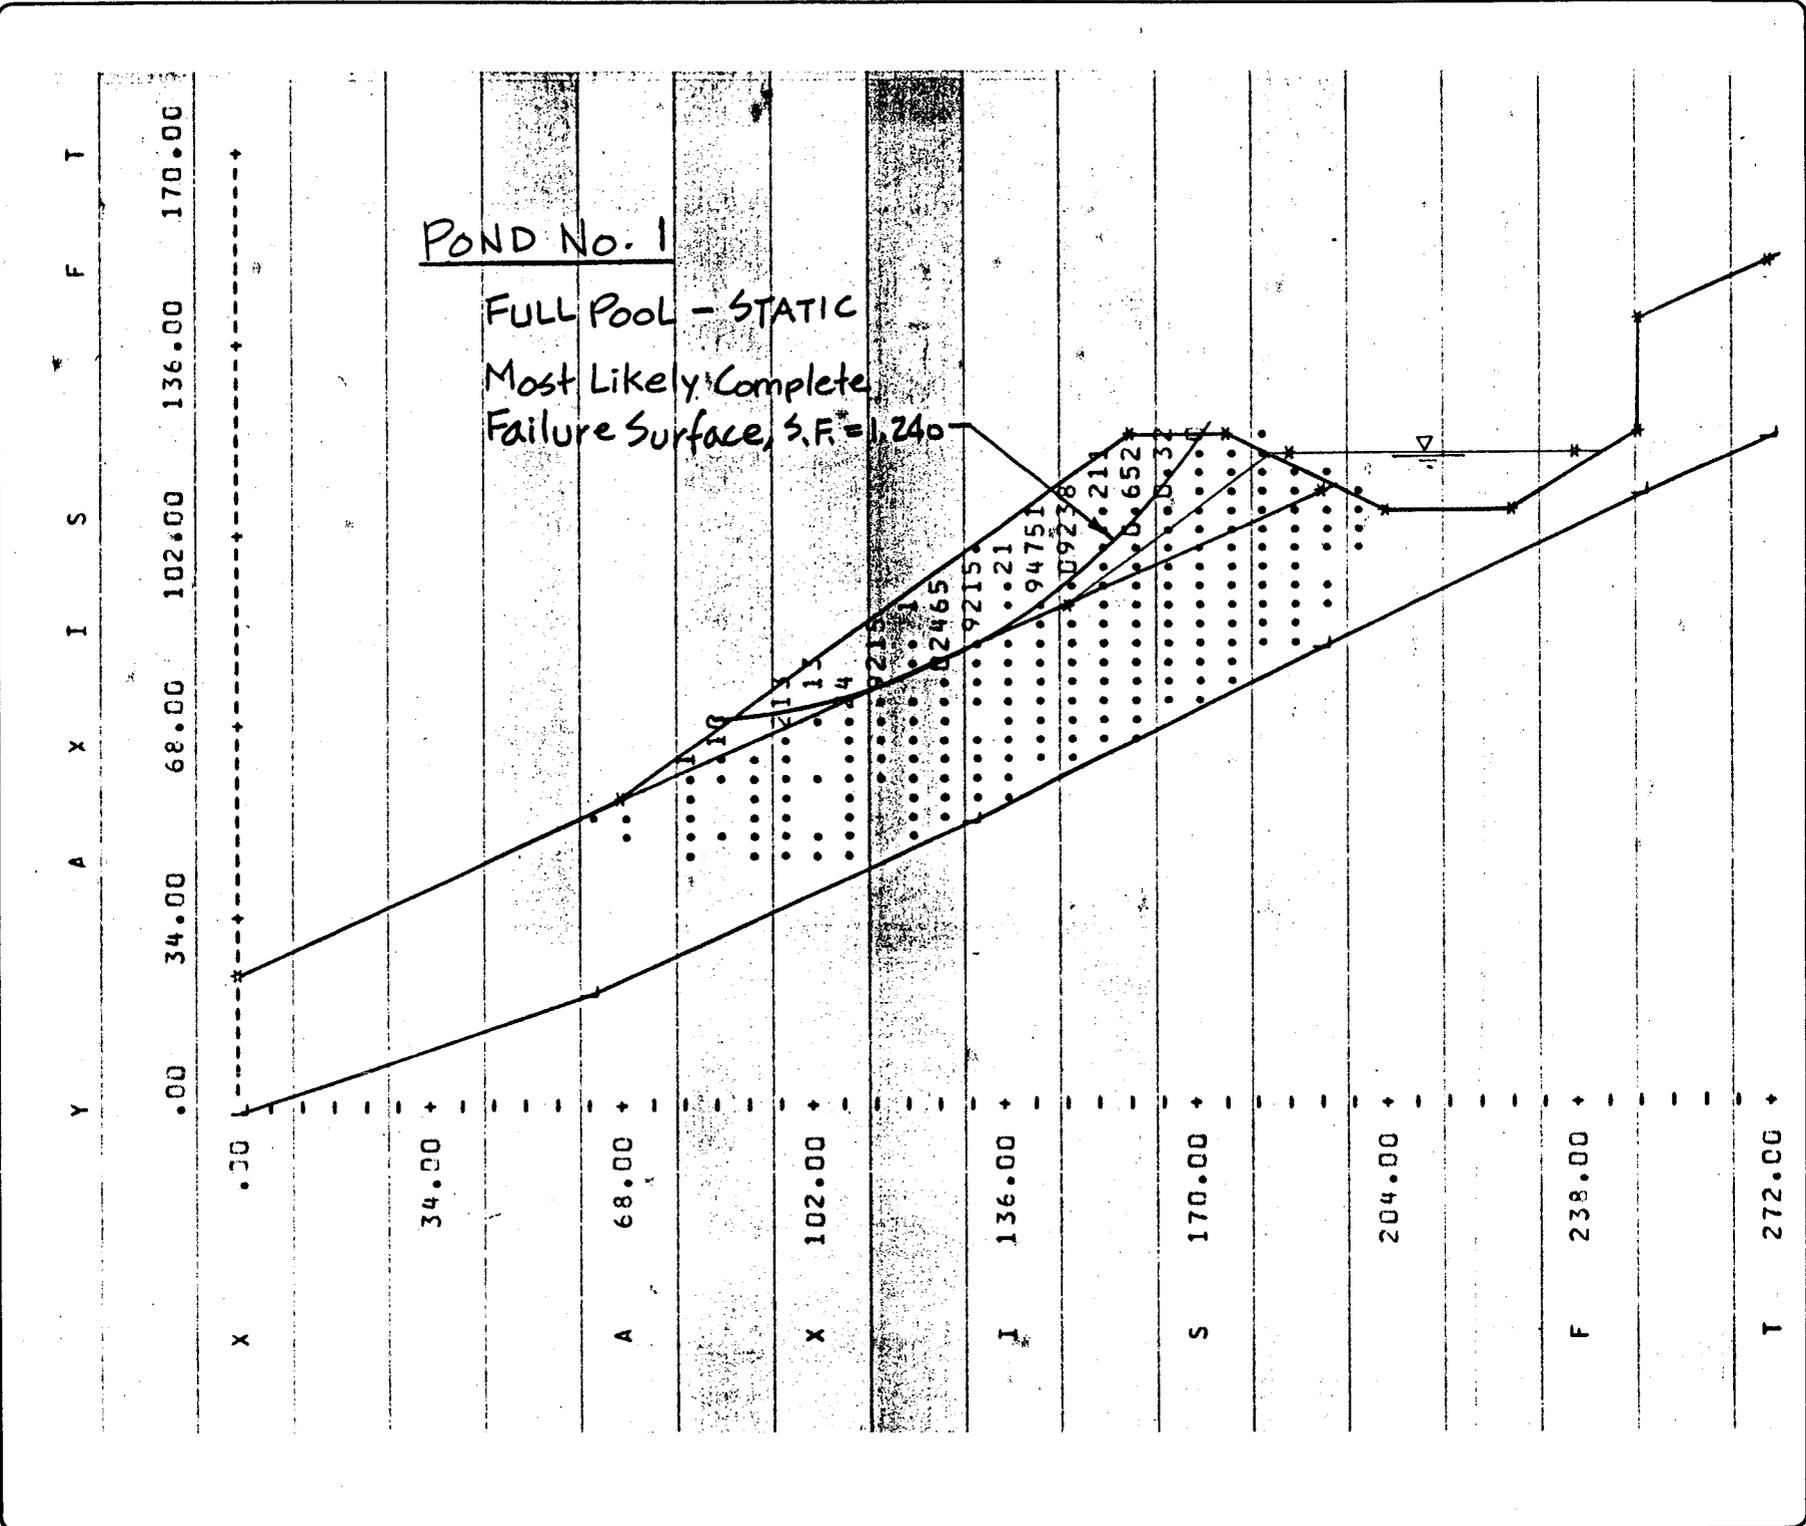
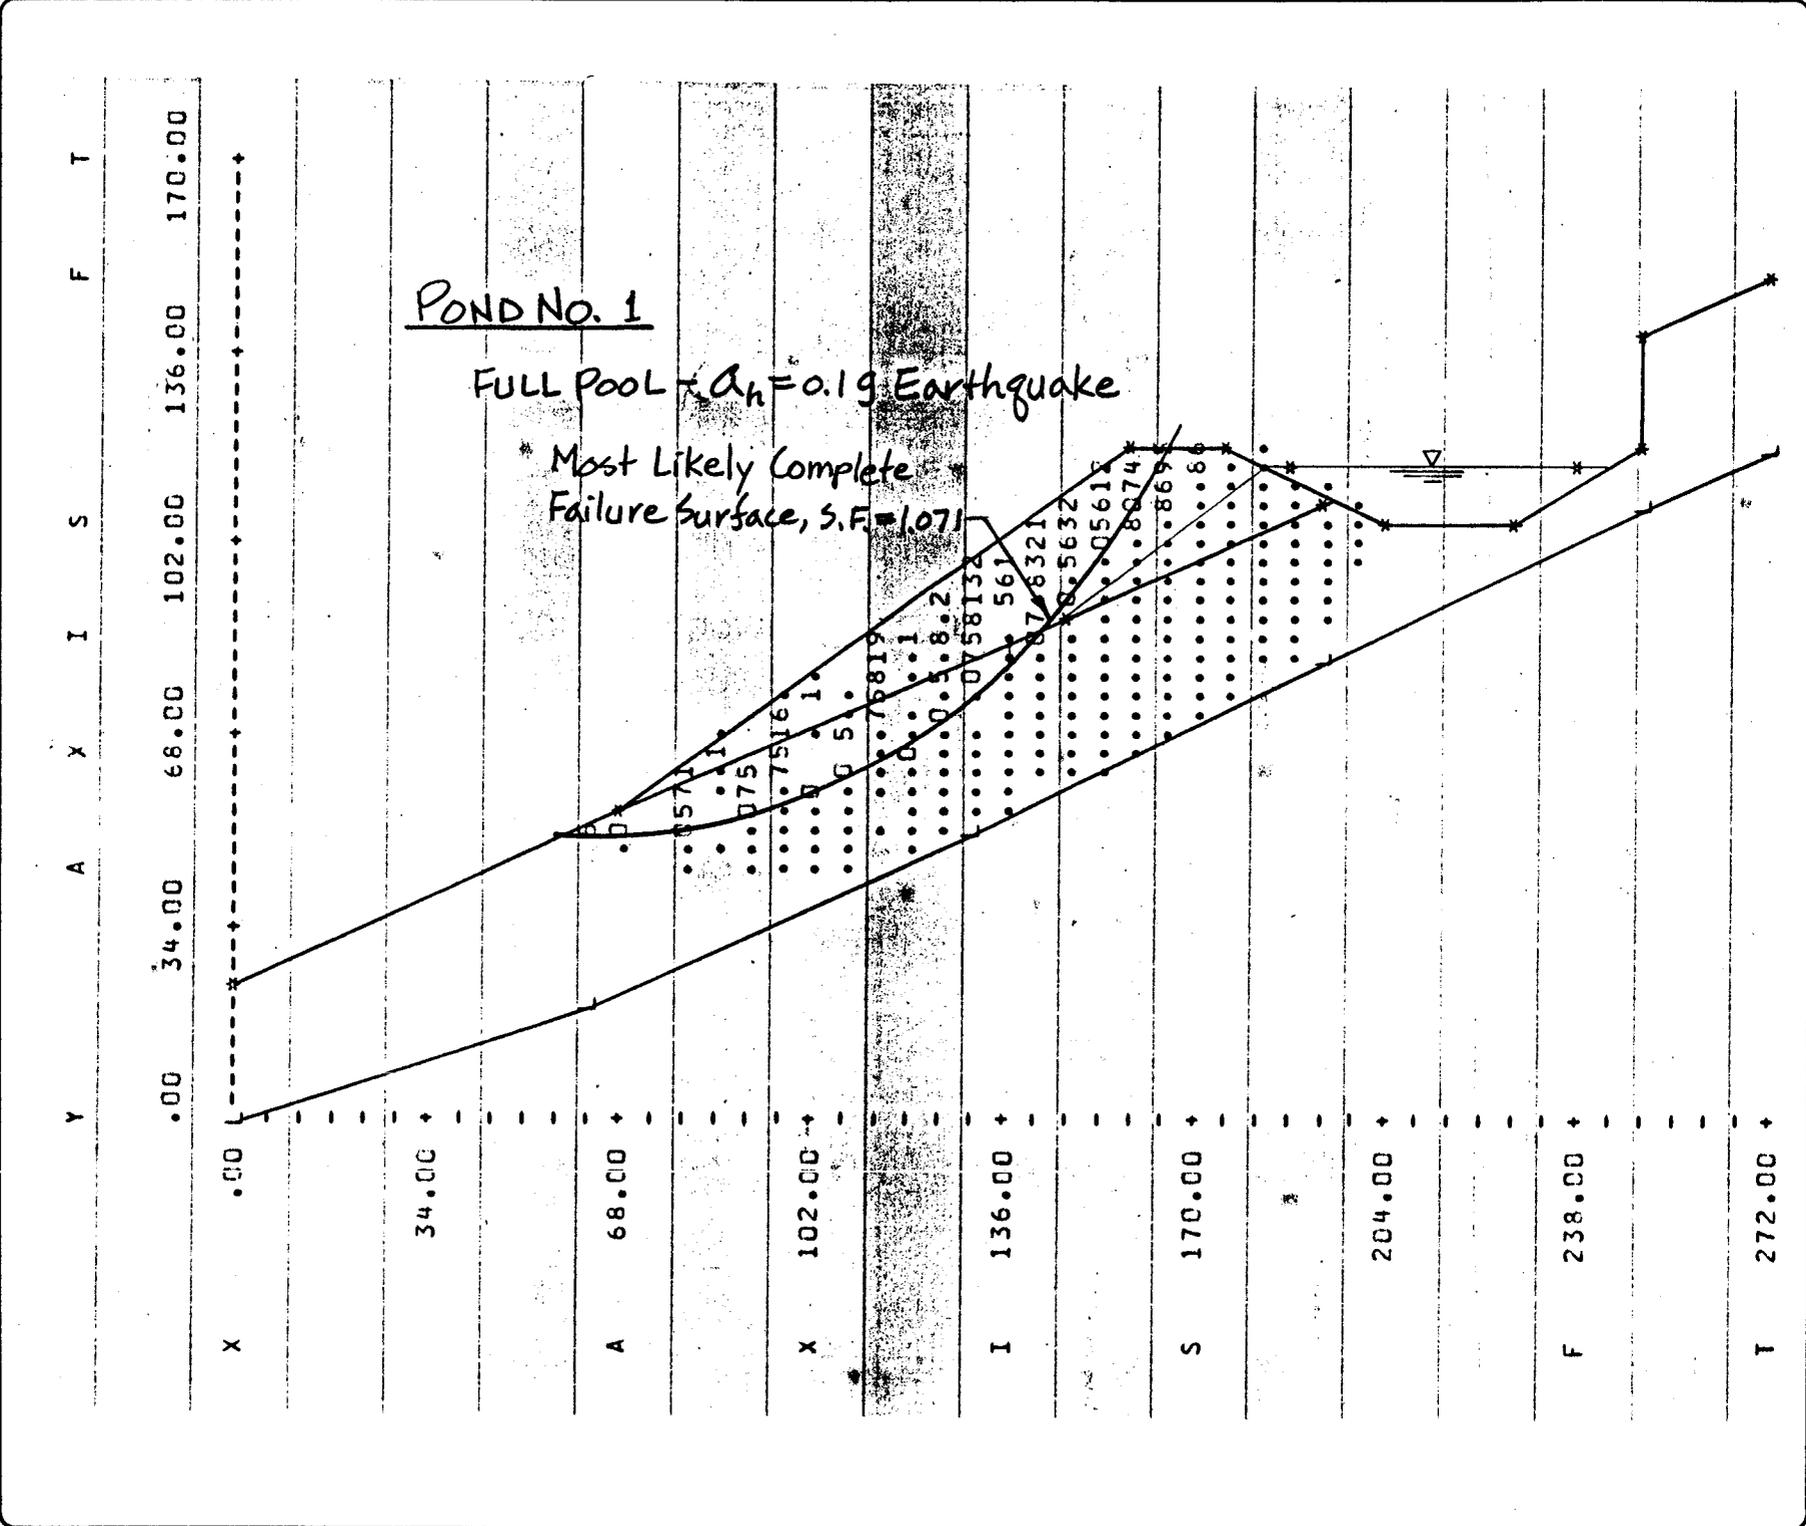
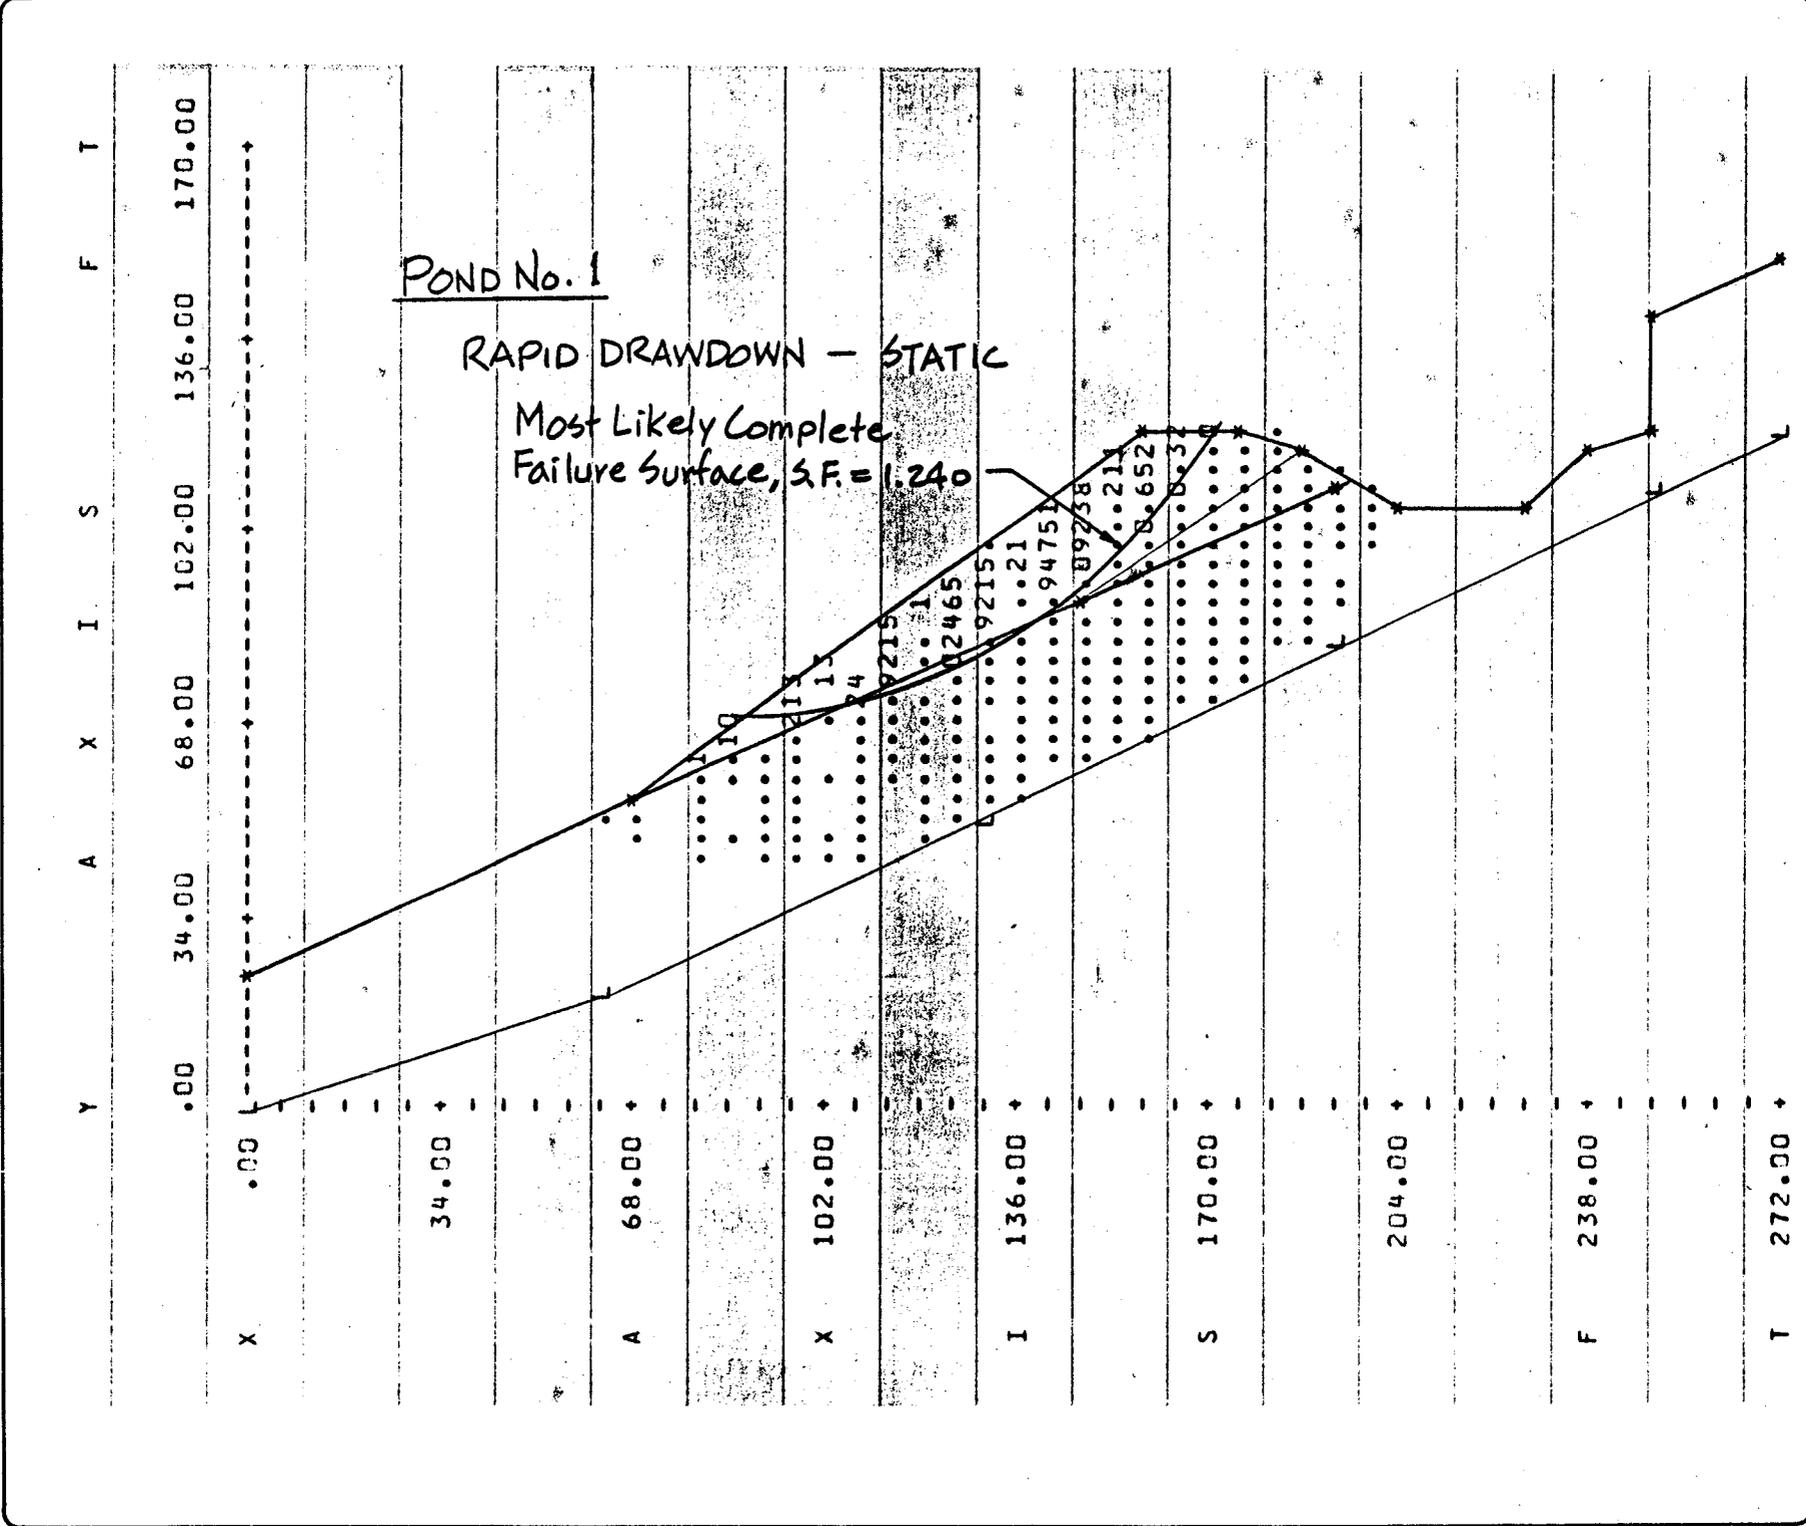
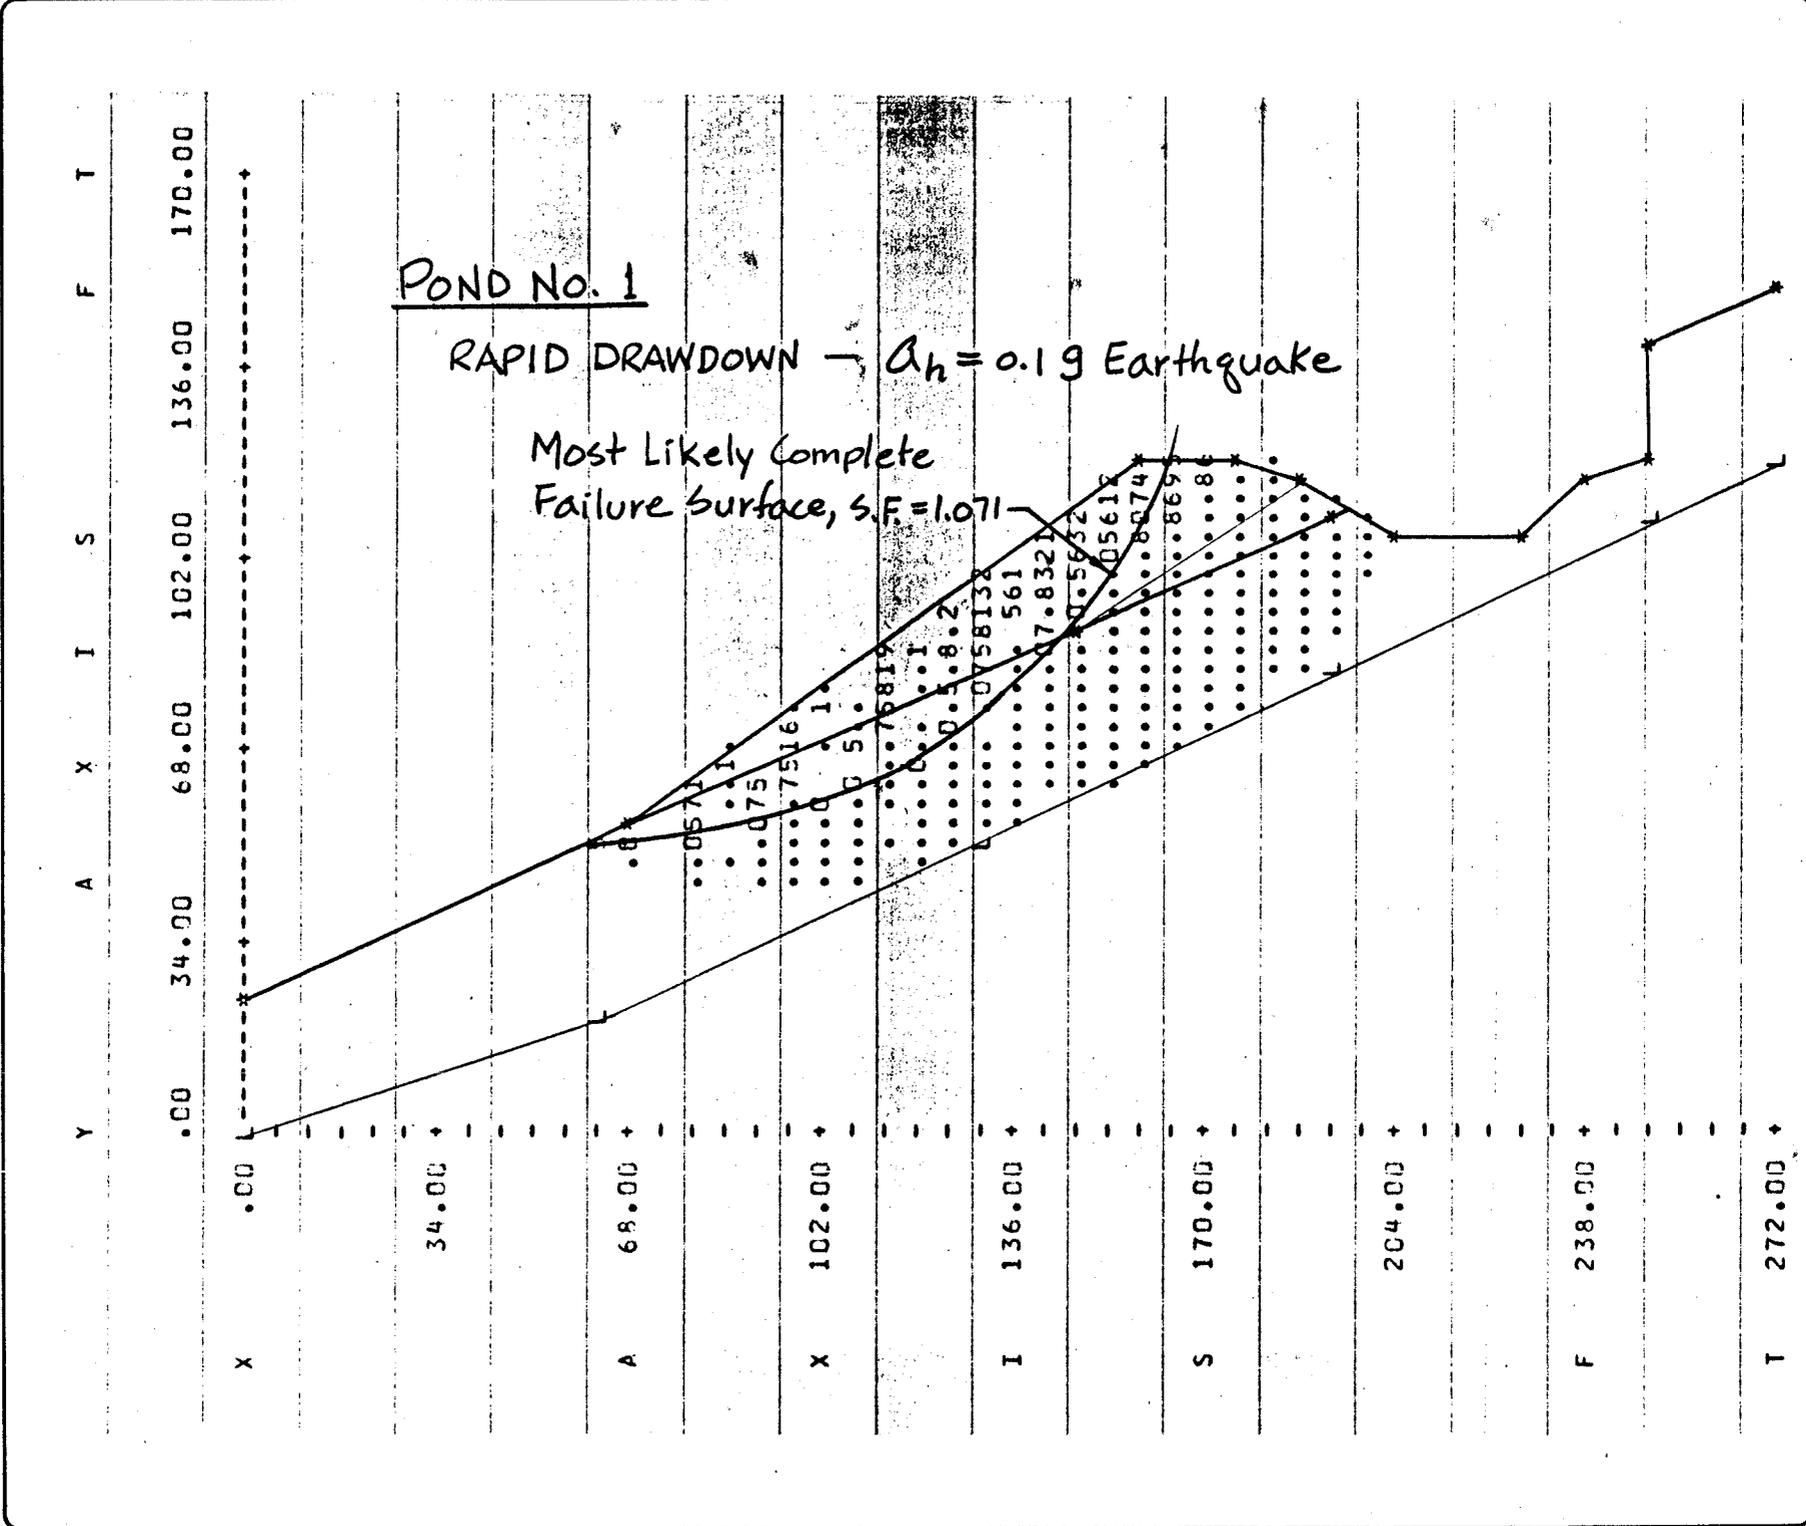
A further evaluation of the critical failure surfaces associated with the minimum factors of safety against slope failure for the embankment of Pond No. 1 presented in Table 1 of the previous report shows that these failure surfaces appear to be surficial and localized with little possibility of causing a total embankment

failure. The potential failure surfaces most likely to bring about a total embankment failure would be deep-seated and are delineated on plots generated by the STABL2 Computer Program used for performing the slope stability analysis as shown in Figs. 1 through 4.

For each case, based on the number of failure surfaces specified to be analyzed, the STABL2 analysis computes and prints out the ten lowest factors of safety. The corresponding failure surfaces of these factors of safety are then plotted on computer printout as loci represented by digits 1 through 9 and 0, with 1 for the failure surface of the lowest factor of safety, up to 9 for the 9th lowest factor of safety, and 0 of the 10th lowest factor of safety. The factors of safety against total embankment failure for the sedimentation pond embankments are tabulated as follows:

A single row of piles installed along the crest of the pond embankment may not be very effective in improving the stability of the embankment since the piles can hardly intercept the full original critical failure surfaces, such as those shown on Figs. 1 through 4. Instead, multi-rows of piles, installed at suitable spacings
