TO: Technical Memo

RE: Plateau's Graben Crossing Resubmittal Star Point Mine,
ACT/007/006, Carbon County, Utah

Plateau Graben Crossing

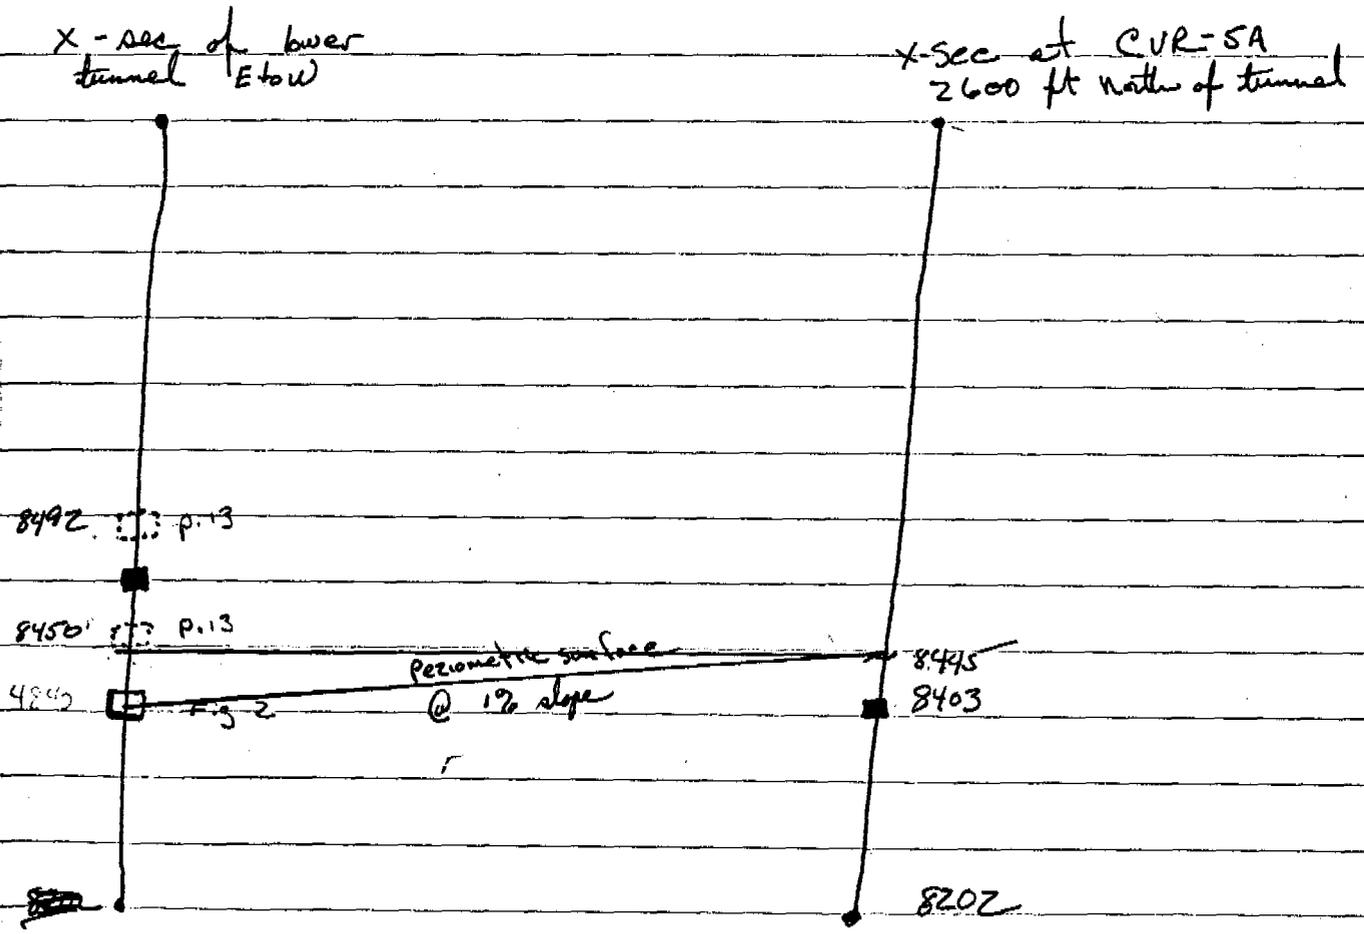
Cross-section from Drill Hole CUR-5A to
Proposed Tunnel Location - Showing Constant
Water Table Gradient

The use of drill hole CUR to establish the regional water table in relationship to the proposed tunnel does not necessarily depict the true nature of the water table near the tunnel's location. First the regional that the applicant refers to may not exist as the applicant portrays it. Just the data presented from one drill hole (CUR-5A) 2600 ft away can not be to the site of the tunnel without adjustments. The gradient of the water table has not been

established or considered. Does it maintain a constant level or does it slope? If the fault systems do block the the transfer of ground water between fault blocks as pointed out on page 9 and Figure 1, then each fault blocks could maintain its separate local aquifer. Thus, the graben would exhibit several local aquifers at various levels.

The data extrapolated from CUR-5A to the tunnel area does not consider the ground water levels on the eastern end of the tunnel. Without knowing the levels or gradient on the aquifers the ^{systems end of the} tunnel could be five feet below the aquifer, according to the following data supplied by the applicant.

If, without knowing ground water levels or gradients, of the regional or local water tables ^{at CUR-5A would then be} the water level ^{extrapolated} across to the west end of the tunnel, it would place the top of the coal seams 5 ft below the regional water table (see Preparation 1).

2. Plateau should gather and submit data from all boreholes located in the area.
3. Plateau should drill test wells south of the proposed tunnel crossing to establish the gradient and water levels for each fault block if no data exists for these areas.
