Re: Noncoal Waste, Star Point Mine Longwall, Cyprus Plateau Mining Corporation, Star Point Mine, ACT/007/006, Carbon County, Utah

RE: Star Point Mine Longwall

RE: Hydrogeologic Issues Related to Longwall Abandonment Within Castle Valley Ridge.

HYDROGEOLOGY ASSOCIATED WITH
 LONGWALL ABANDONMENT

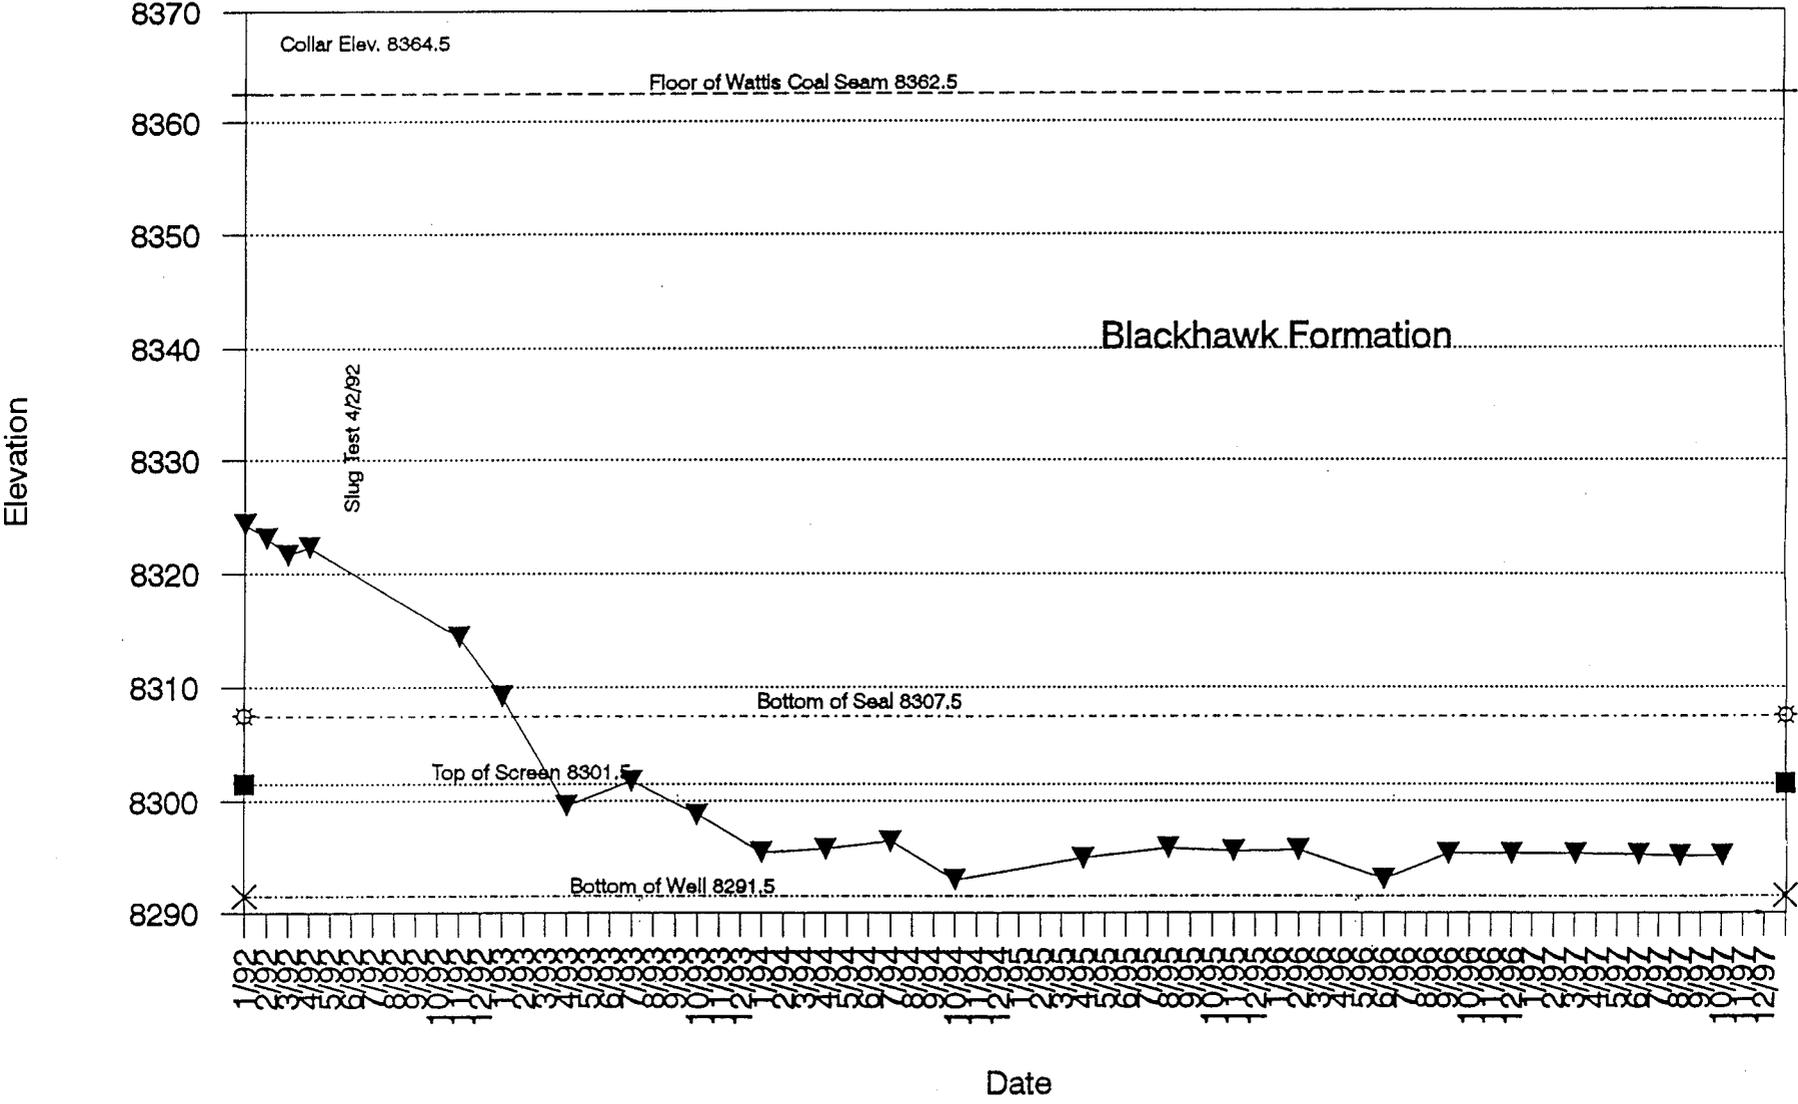
Figure 31
Well P92-01A-WD
Water Level Graph

Attached graphs for in-mine wells P92-01A-WD, P92-01B-WD, P92-01C-WD, P92-02-WD, and P92-04-WD show a consistent decline in water levels as mining advanced southward. The graphs

for wells P92-01C-WD, P92-02-WD, and P92-04-WD also show a partial recovery of water level following termination of mining. Graphs for wells P92-01A-WD and P92-01B-WD show little or no recovery to date.

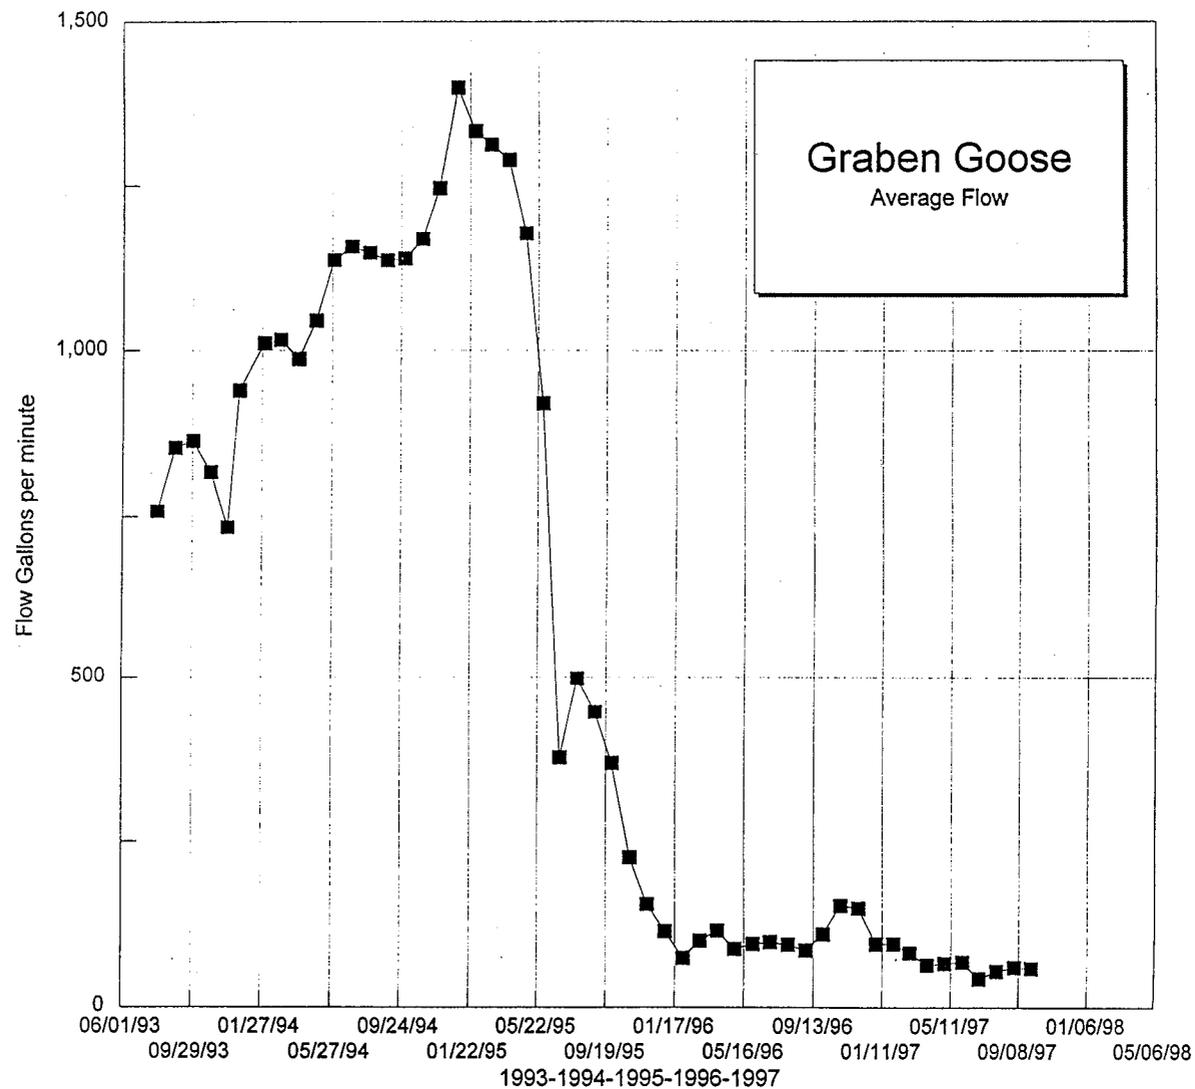
WATER METER READINGS AT GRABEN GOOSE

The overall lack of water entering the mine from northern mine sections is also verified through a review of pumping data collected from the Graben Goose pump. As shown in the attached figure, pumping levels declined substantially during the mid 1990's when mining retreated from the Gentry Ridge area and moved northward into Castle Valley Ridge. As shown in the figure, pumping subsequent to this move reduced from an all time high of 1,398 gpm to a current flow of approximately 50 gpm.

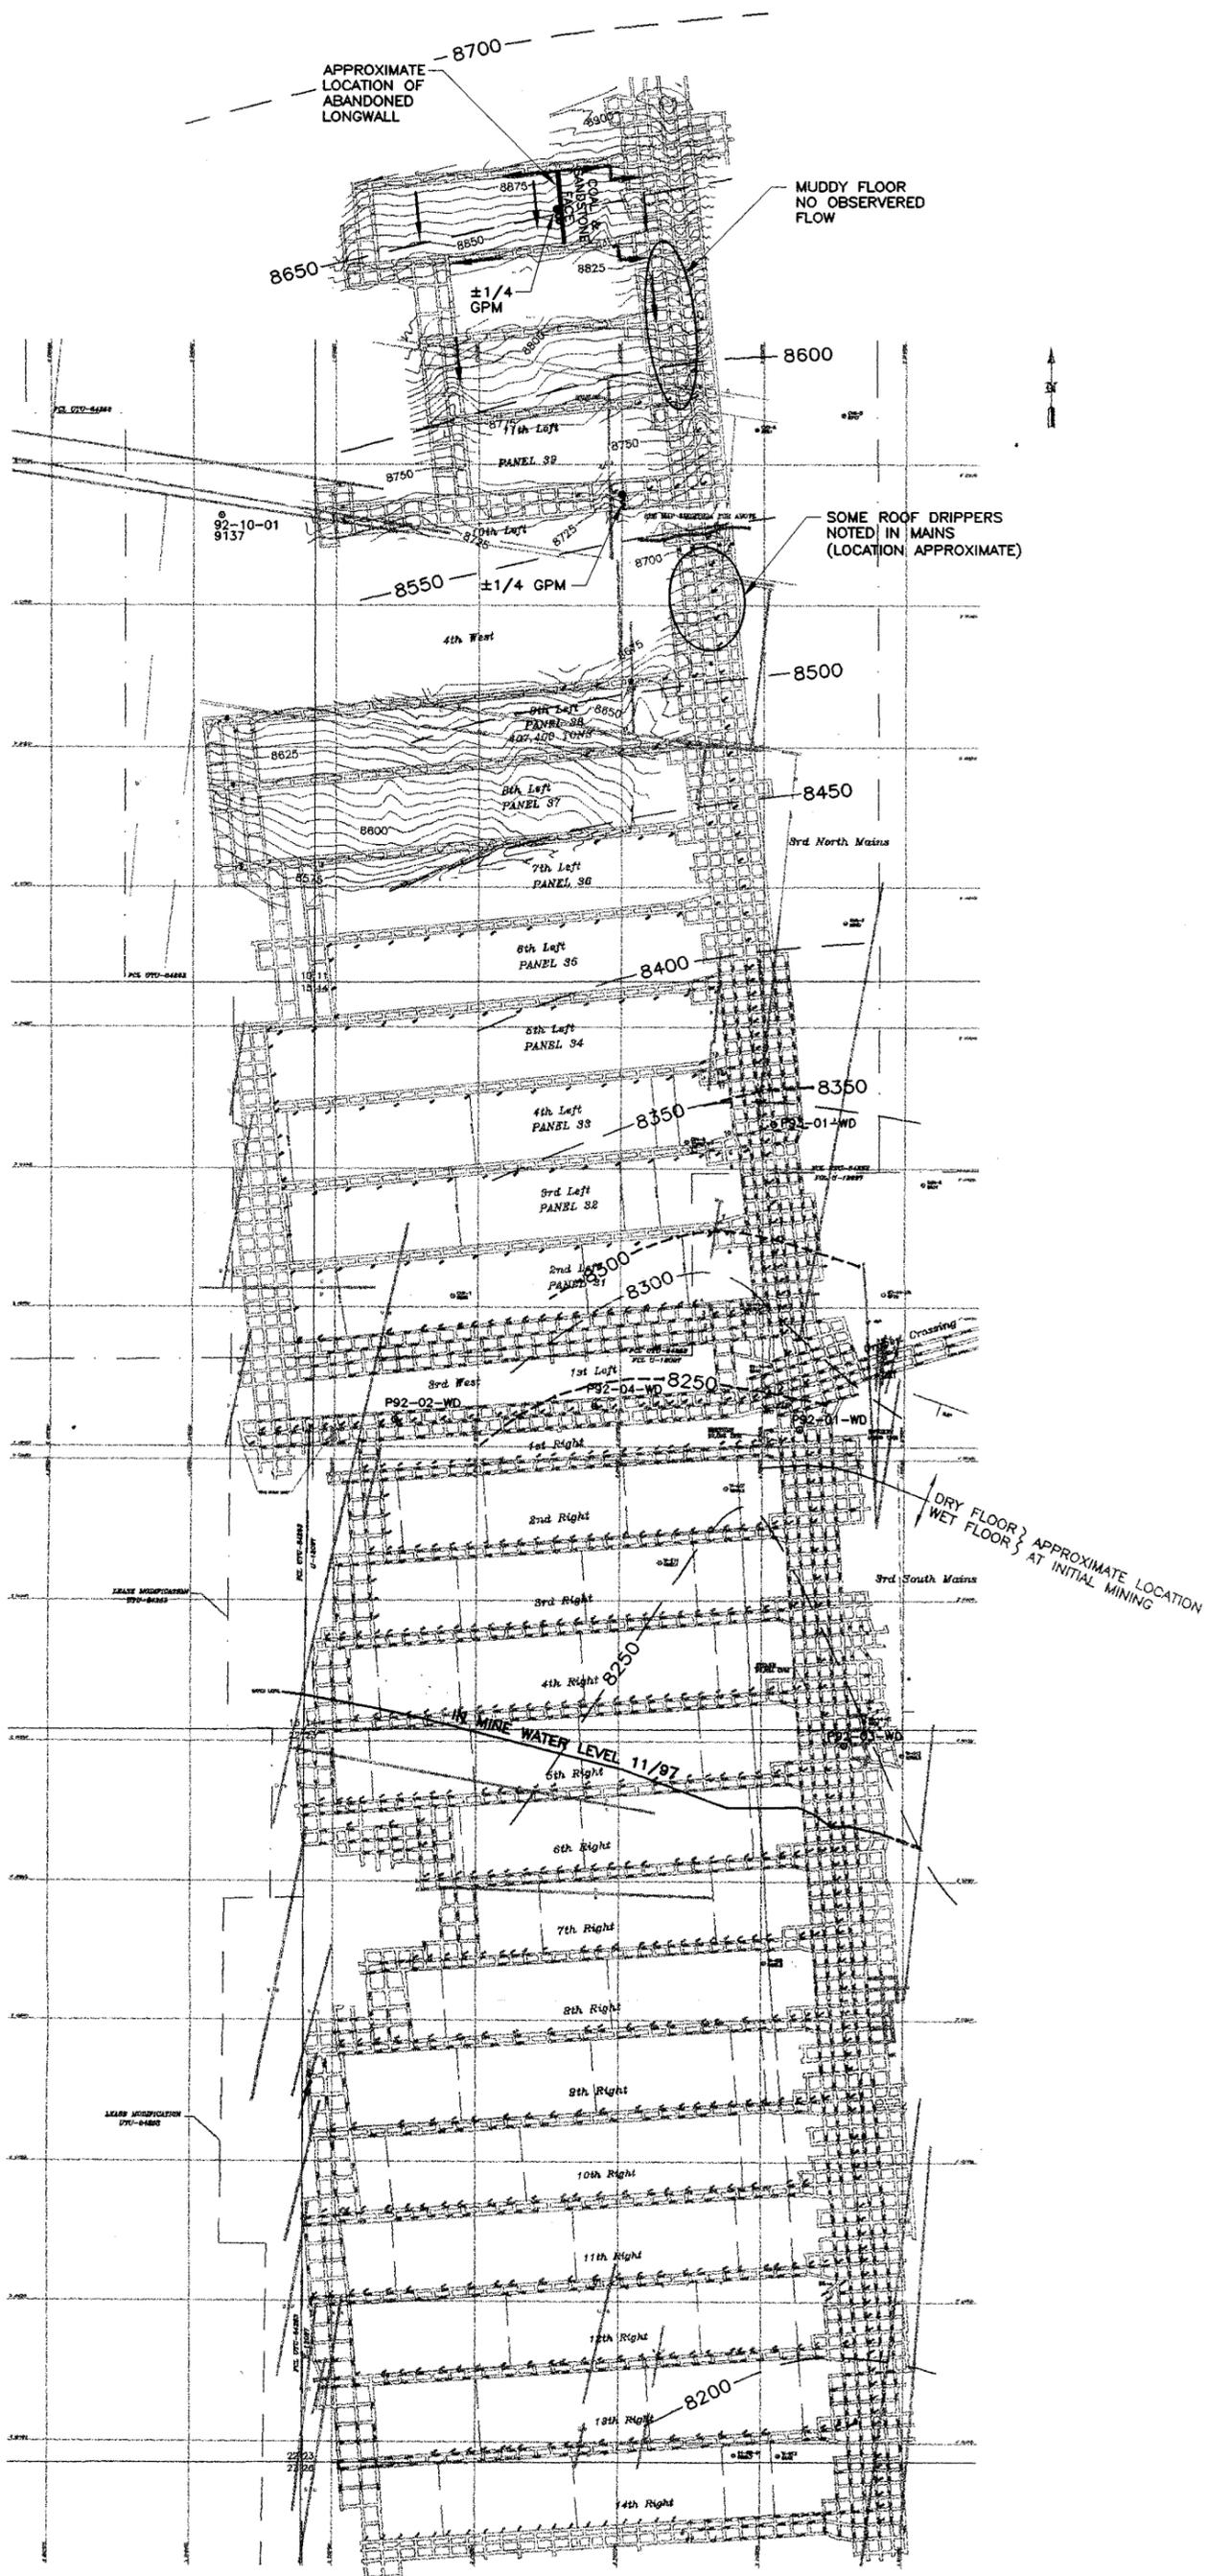
FIGURE NO.
 1
 OF
 1
 002-19-100

Initial hydrogeologic investigations of the Gentry Ridge Coal tract completed in the late 1980's and early 1990's projected a southward trending groundwater gradient which would be intercepted by mining within a short distance south of the Graben Crossing. Further clarification regarding where the water might be encountered during mining was made following the completion of drill holes P92-01-WD, P92-02-WD and P92-04-WD. Water was subsequently encountered within the 3rd South Mains just south of 1st Right (see Figure 1 attached).

The in-mine ponded water level noted on November 4, 1997 was found at the intersection of Cross-Cut 82 with the #3 Entry, and at the intersection of Cross-Cut 83 with the #2 Entry as shown on the attached figure. As shown on Figure 1, the current water level is below (south) of the dry/wet interface noted during mine development. Current data taken from the monitoring wells identified above shows an approximate overall net decline in water level (depending upon well location) to be between 25 and 118 feet. Overlaying 1993 water level data over mine workings containing the abandoned Longwall unit shows that the water level is in excess of 210 feet below the mine workings. Current water levels would be greater than 210 feet deep since local water levels have dropped since 1993 as documented above. Since long term water levels can not rise to the pre-mining levels noted on Figure 1 (due to tunnel diversions), there is no possibility of the mine being flooded with base groundwater.

The Longwall unit is located near the extreme north end of the abandoned mine workings, and is itself located just west of a natural ridge. As shown on Figure 1, any water found within the mains just north and east of the Longwall will move east, then southward. Similarly, any water found north and west of the Longwall, will move within the gob area to the south and west. Any pooling which could occur within the gob area behind the Longwall unit will overtop down gradient tunnel intersections and continue to move southward away from the abandoned section. A small floor seep located approximately midway along the Longwall unit is discussed hereafter.
