Inspection Report

Permit Number:	C0070011
Inspection Type:	TECHNICAL
Inspection Date:	Wednesday, July 15, 2020
Start Date/Time:	7/15/2020 1:00:00 PM
End Date/Time:	7/15/2020 2:00:00 PM
Last Inspection:	Tuesday, June 9, 2020

Permitee:	HIAWATHA CO	AL CO INC			
Operator:	HIAWATHA COAL CO INC				
Site:	HIAWATHA MINE				
Address:	PO BOX 1240,	HUNTINGTON	UT 84528		
County:	CARBON				
Permit Type:	PERMANENT C	OAL PROGRAM	N		
Permit Status:	INACTIVE

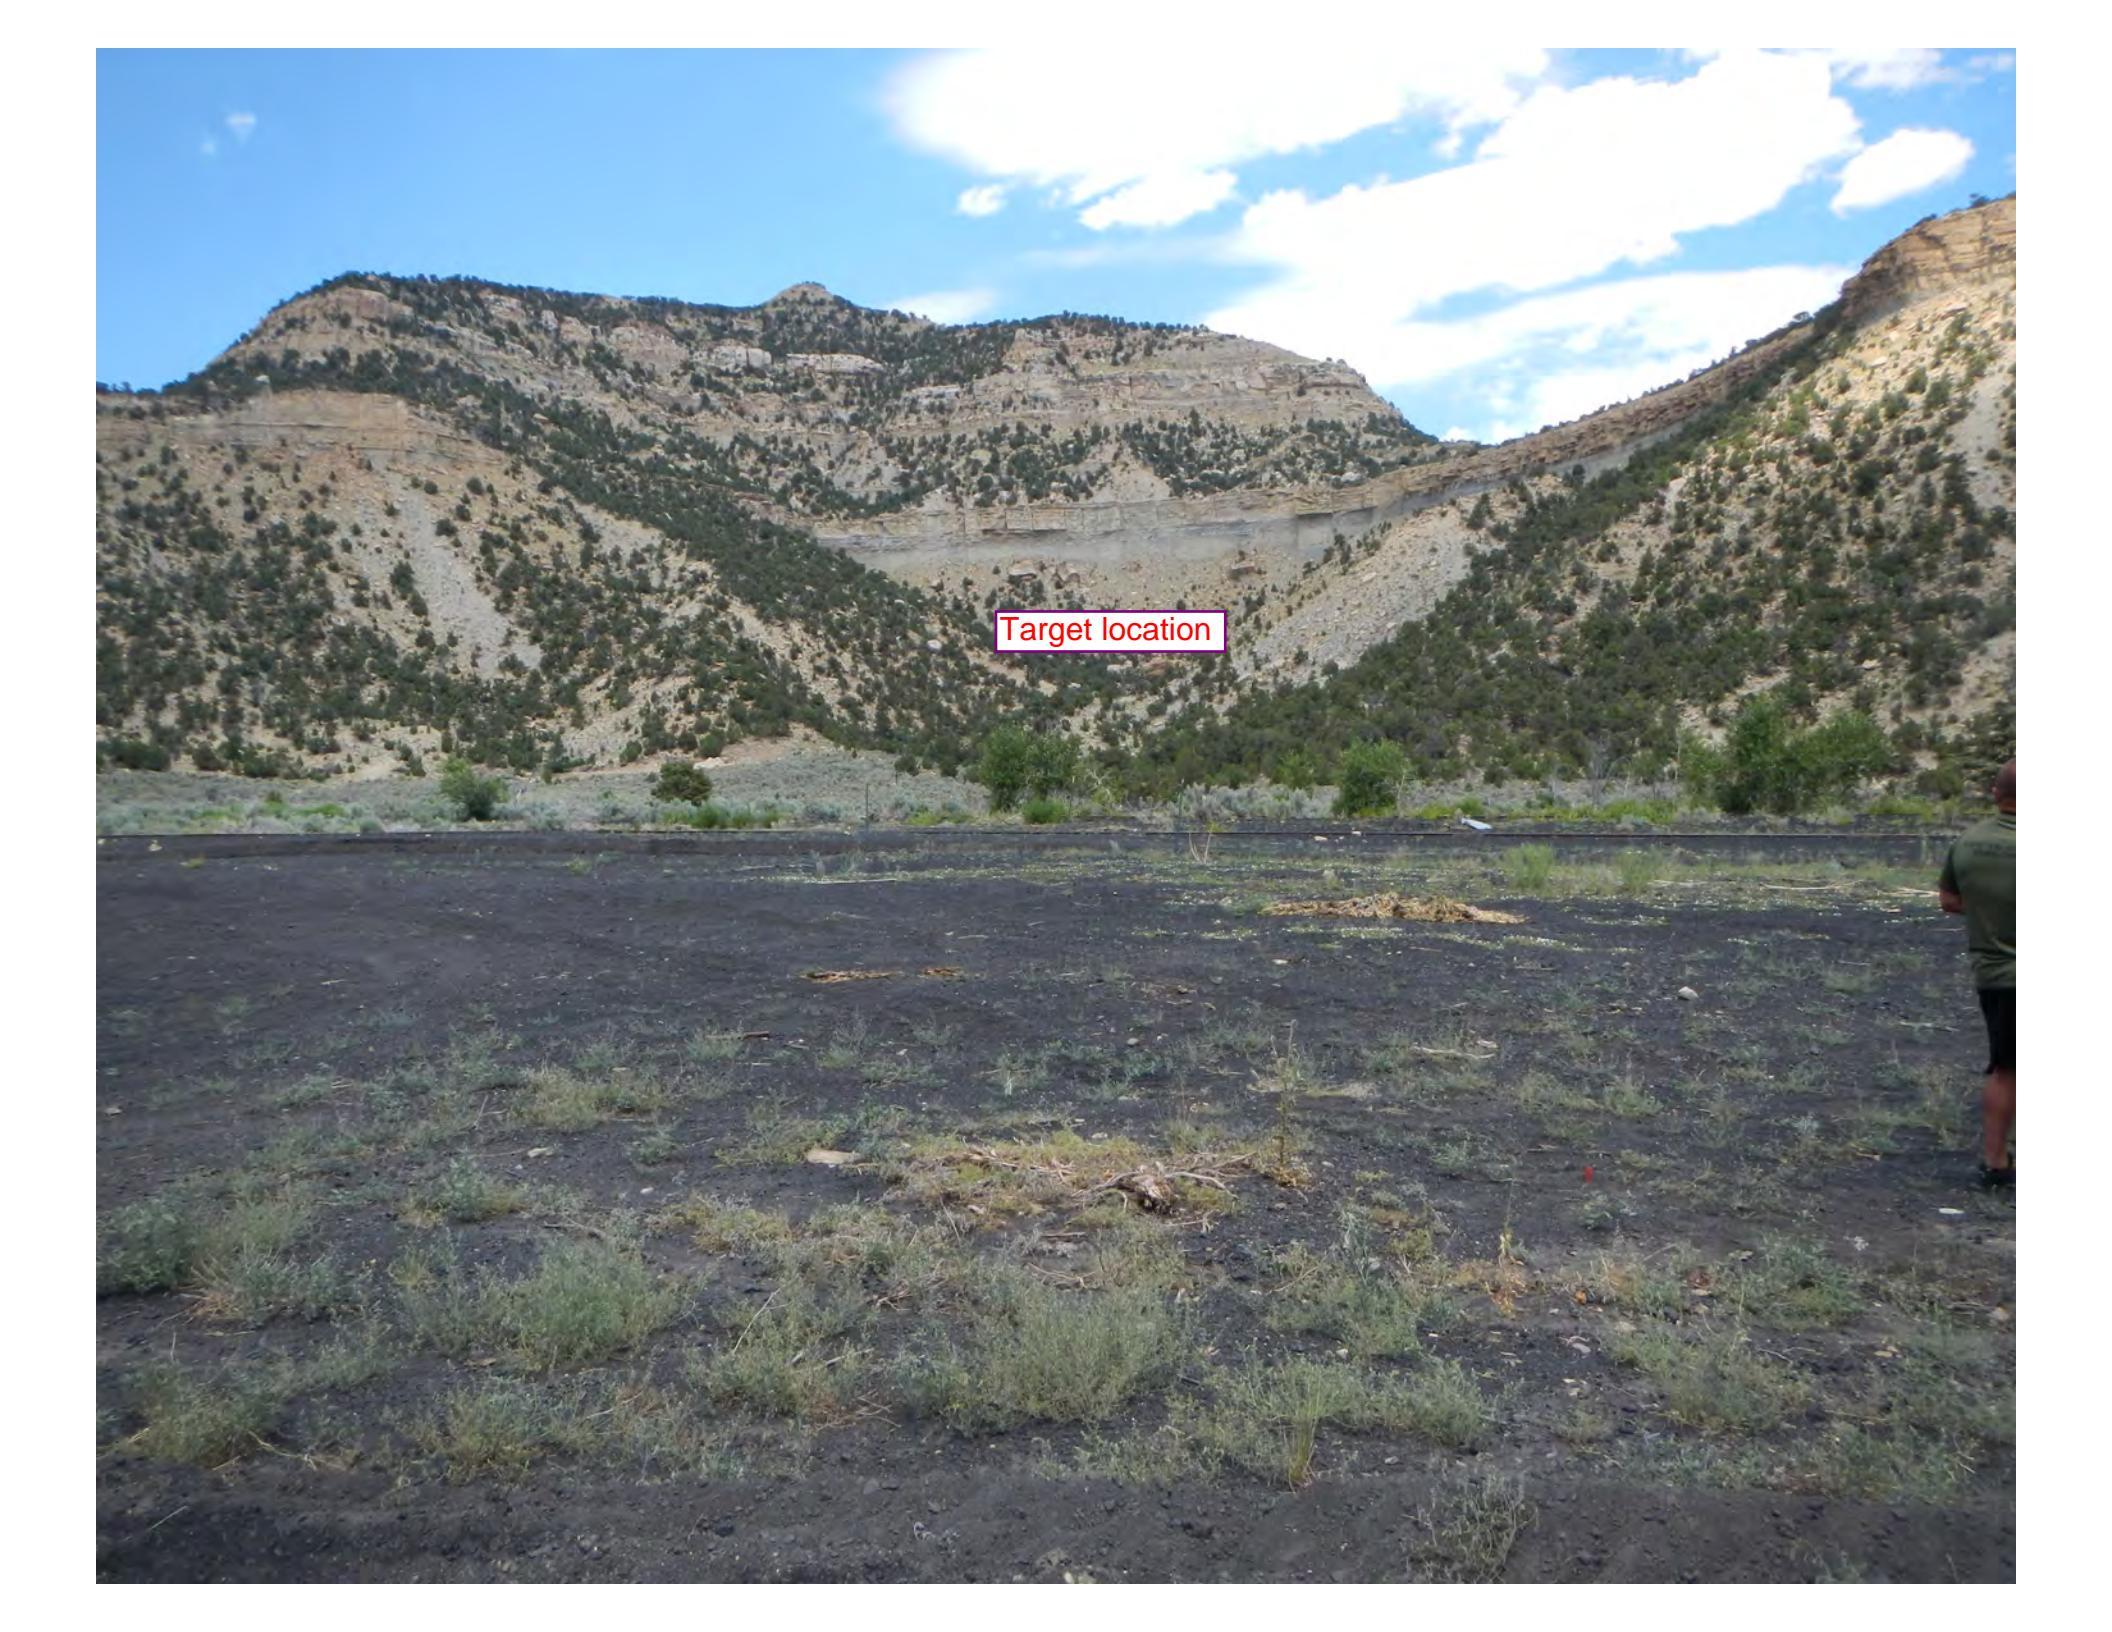
The upper rail yard will be the source of 75,543 CY of borrow soil for reclamation of slurry pond #1 (MRP p. 2-38 and pp. 2-40-2-44) It is Reclamation Area 13 (RA 13). Lead is naturally occurring in all soils, but gun range activity could increase lead content in soil. Lead (PB2+) is not biodegraded and persists in the soil, where it may be taken up by plants*. In high concentrations, lead interferes with photosynthesis and may affect soil organisms.** Consequently, the MRP page 2-5 states that the effect of the gun range would be evaluated in 2020.

During the inspection, many brass and steel casings were seen in the surface layer of soil. Plastic shot gun casings were also seen.

During this inspection, it was agreed that no further sampling was required at this time, but that final reclamation sampling for the upper rail yard should include lead analysis. I will work with Mr. Reynolds to write an amendment to the reclamation plan that describes the required sampling, the additional parameter and analytical procedure, and the acceptable values for total lead in the cover soil.
