BEAVER CREEK Coal Company

Re: Application for Excellence in
Surface Mining Award

Gordon Creek No. 3 & 6 Mines
Final Minesite Reclamation
by
Beaver Creek Coal Company

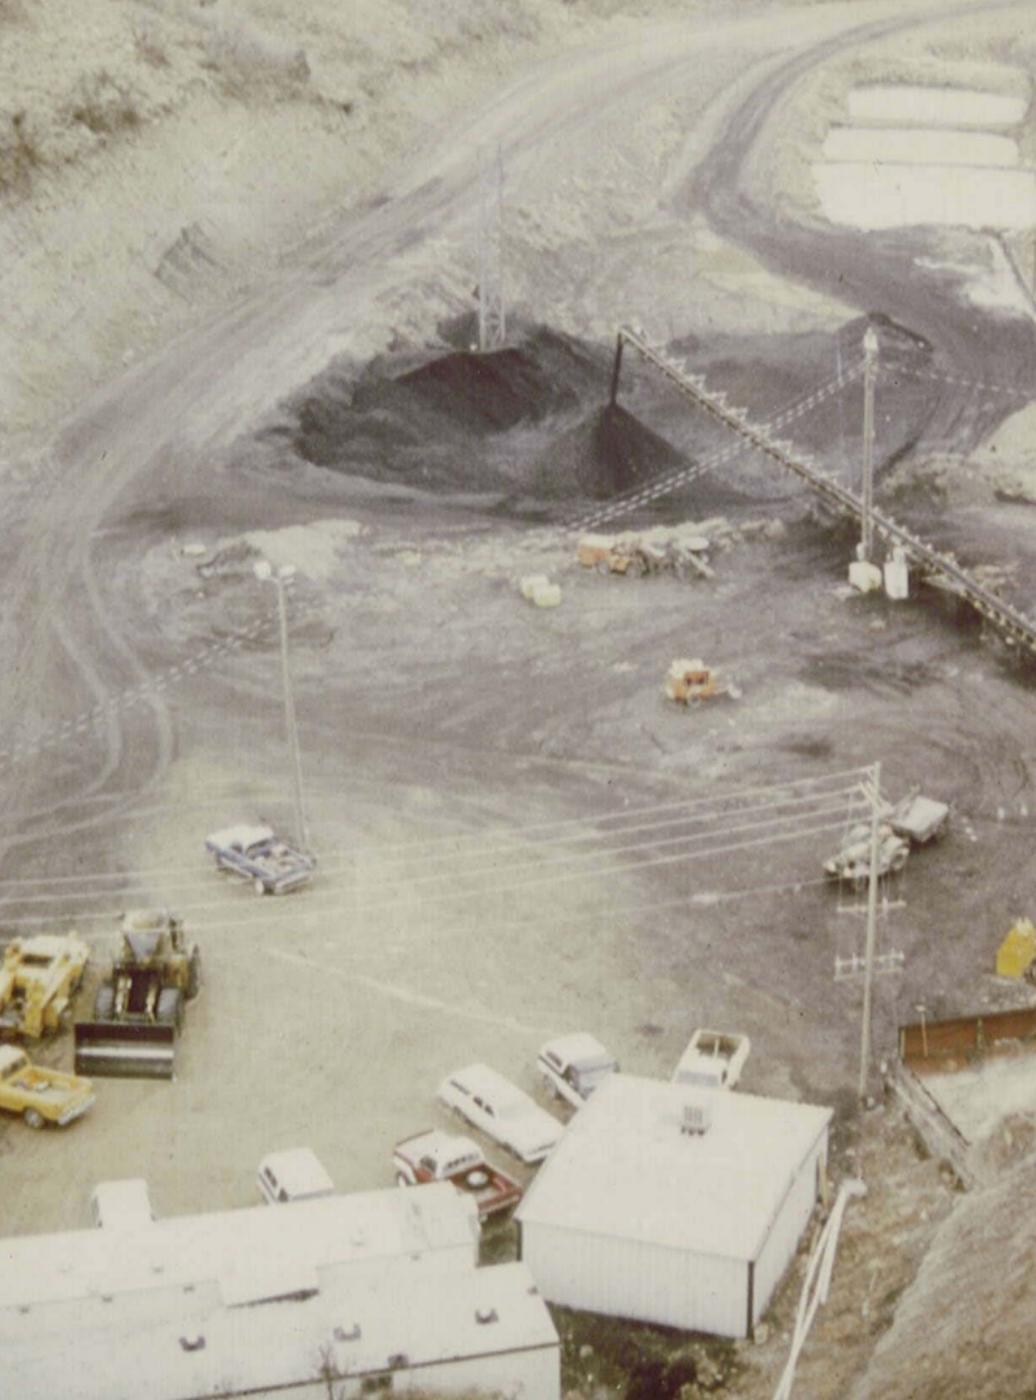
No. 3 Overview

(Active Mining)

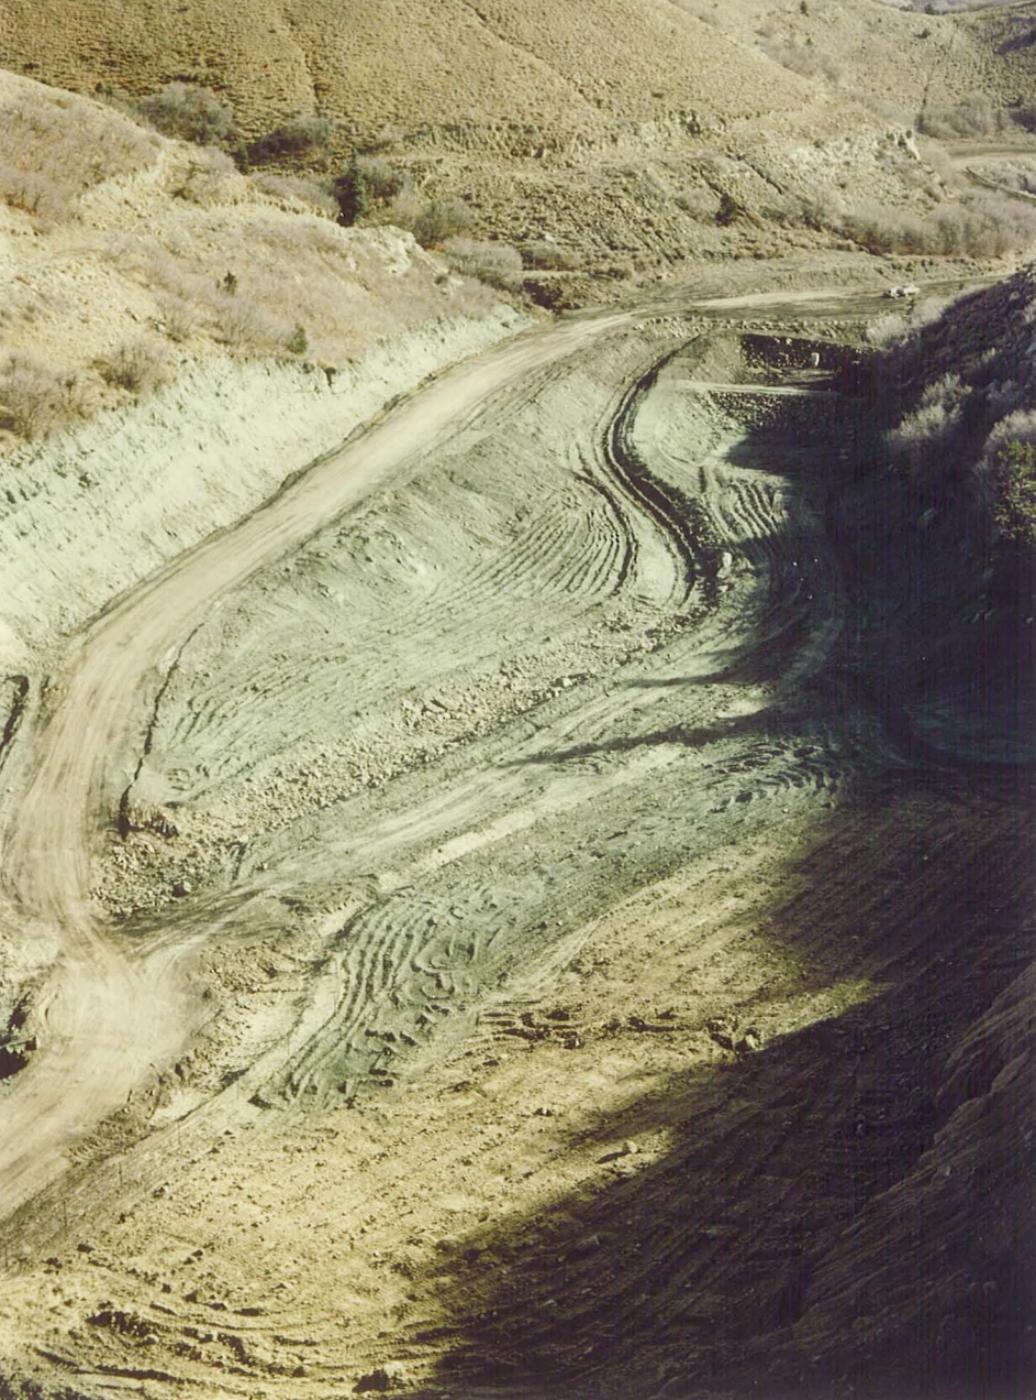
No. 3 Overview
(after Reclamation)

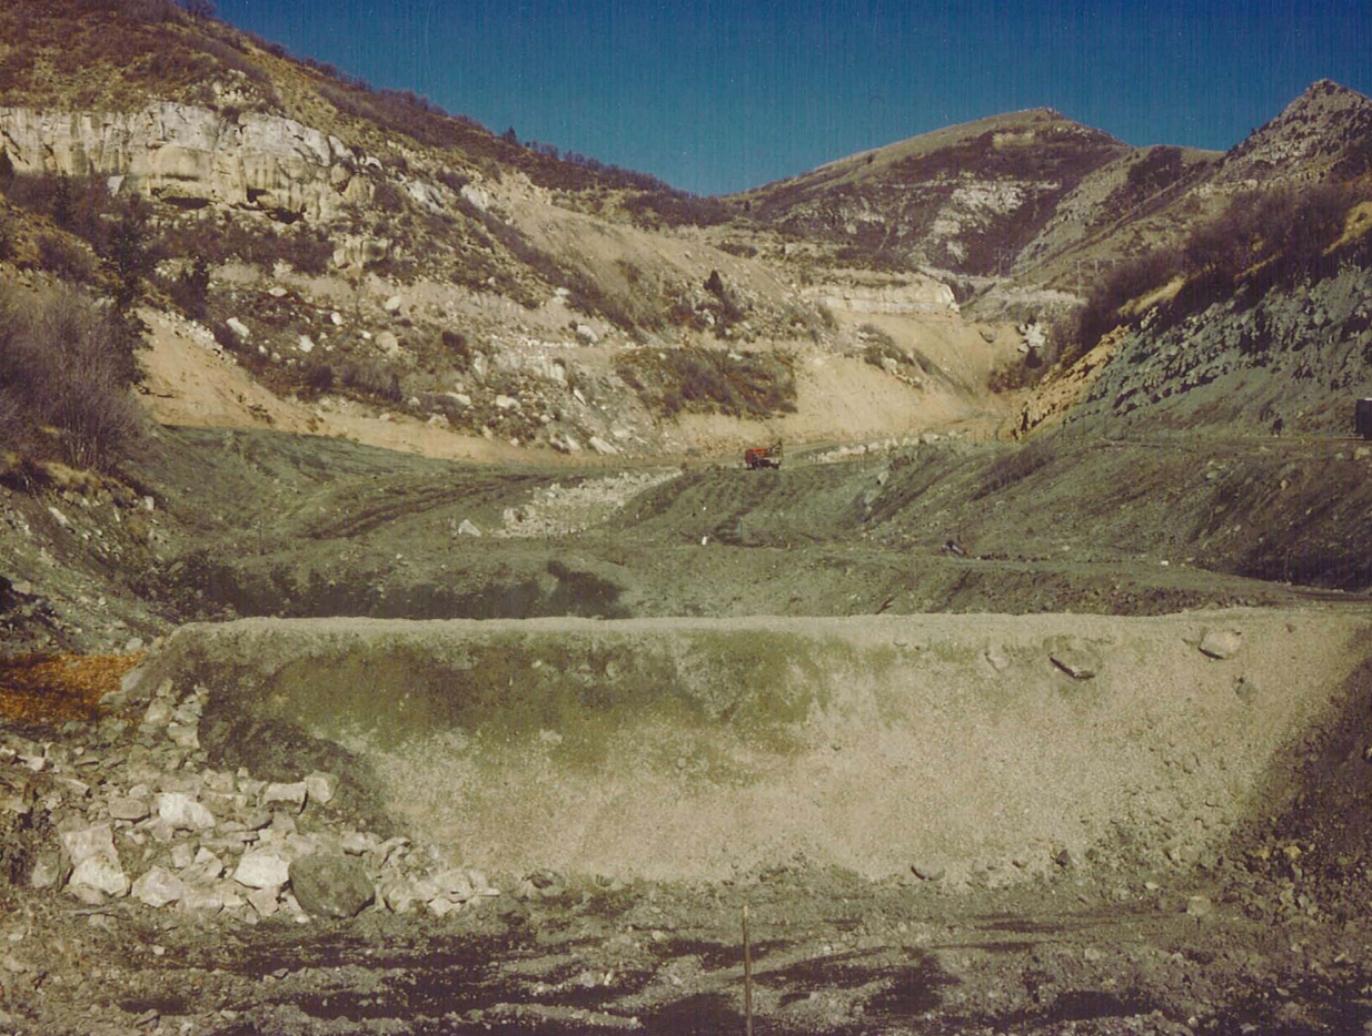
The Sedimentation ponds were redesigned and constructed to contain the runoff from a 100 year-24 hour precipitation event. The pond is a 2-celled system, in series, separated by a semi-permeable filter dike. This system was designed to allow for long-term water retention with minimal maintenance - the upper cell serves as a settling basin, the dike as a filter medium, and the lower cell as clean water storage for wildlife (and later for stock) watering. The system is equipped with adequately sized overflows, and is designed to allow the landowner the option of filling the ponds at his discretion upon bond release.

Permanent Ponds and
Restored channel

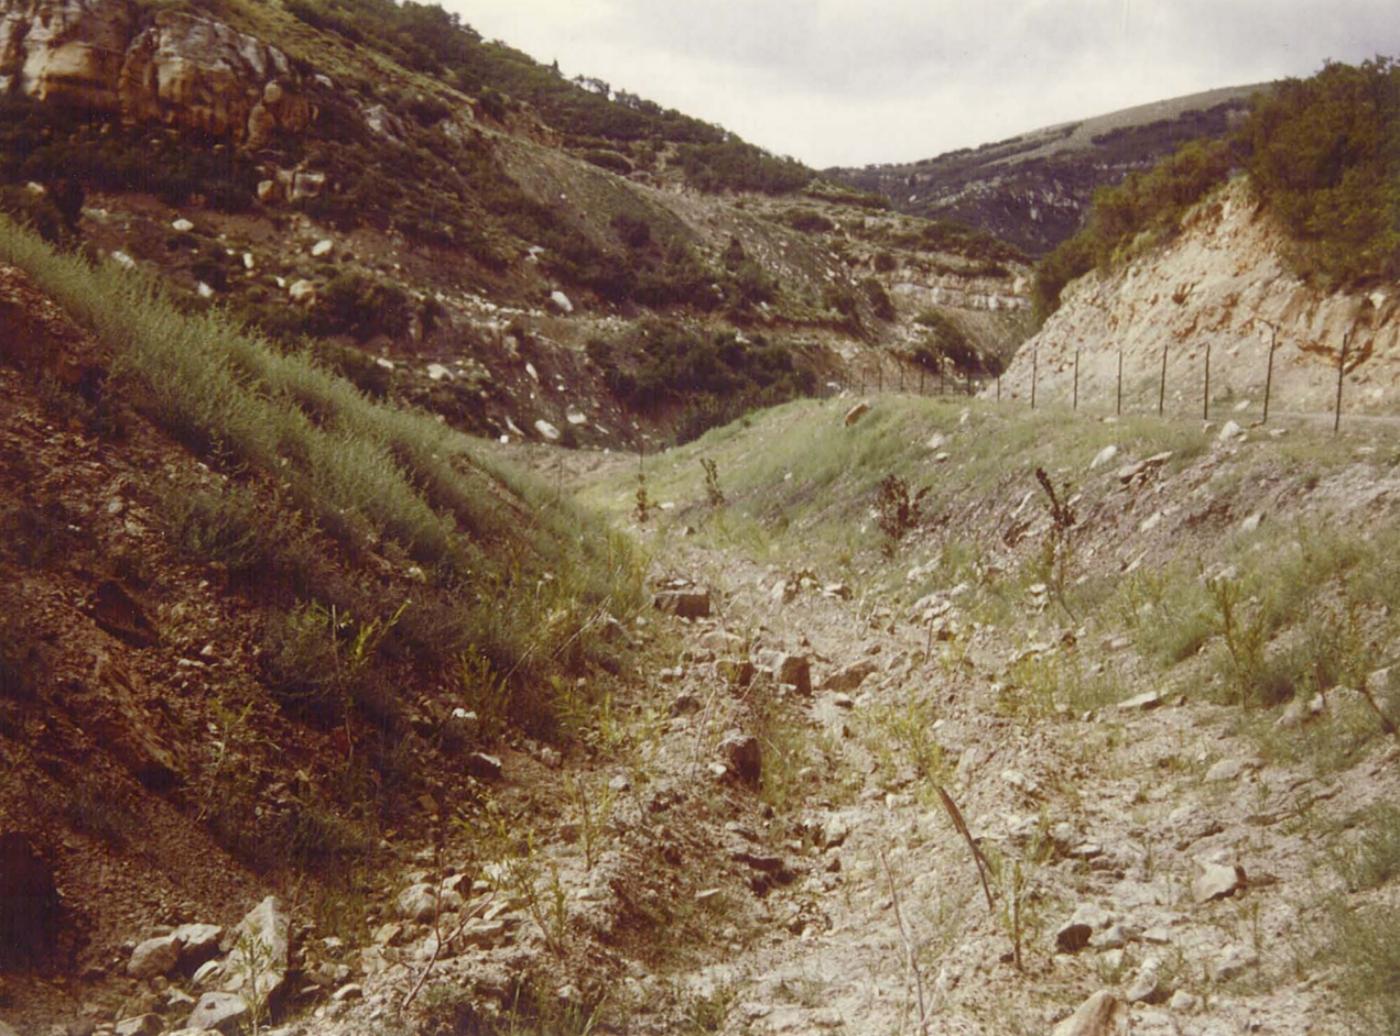
Restored Main Channel
and Riparian Vegetation

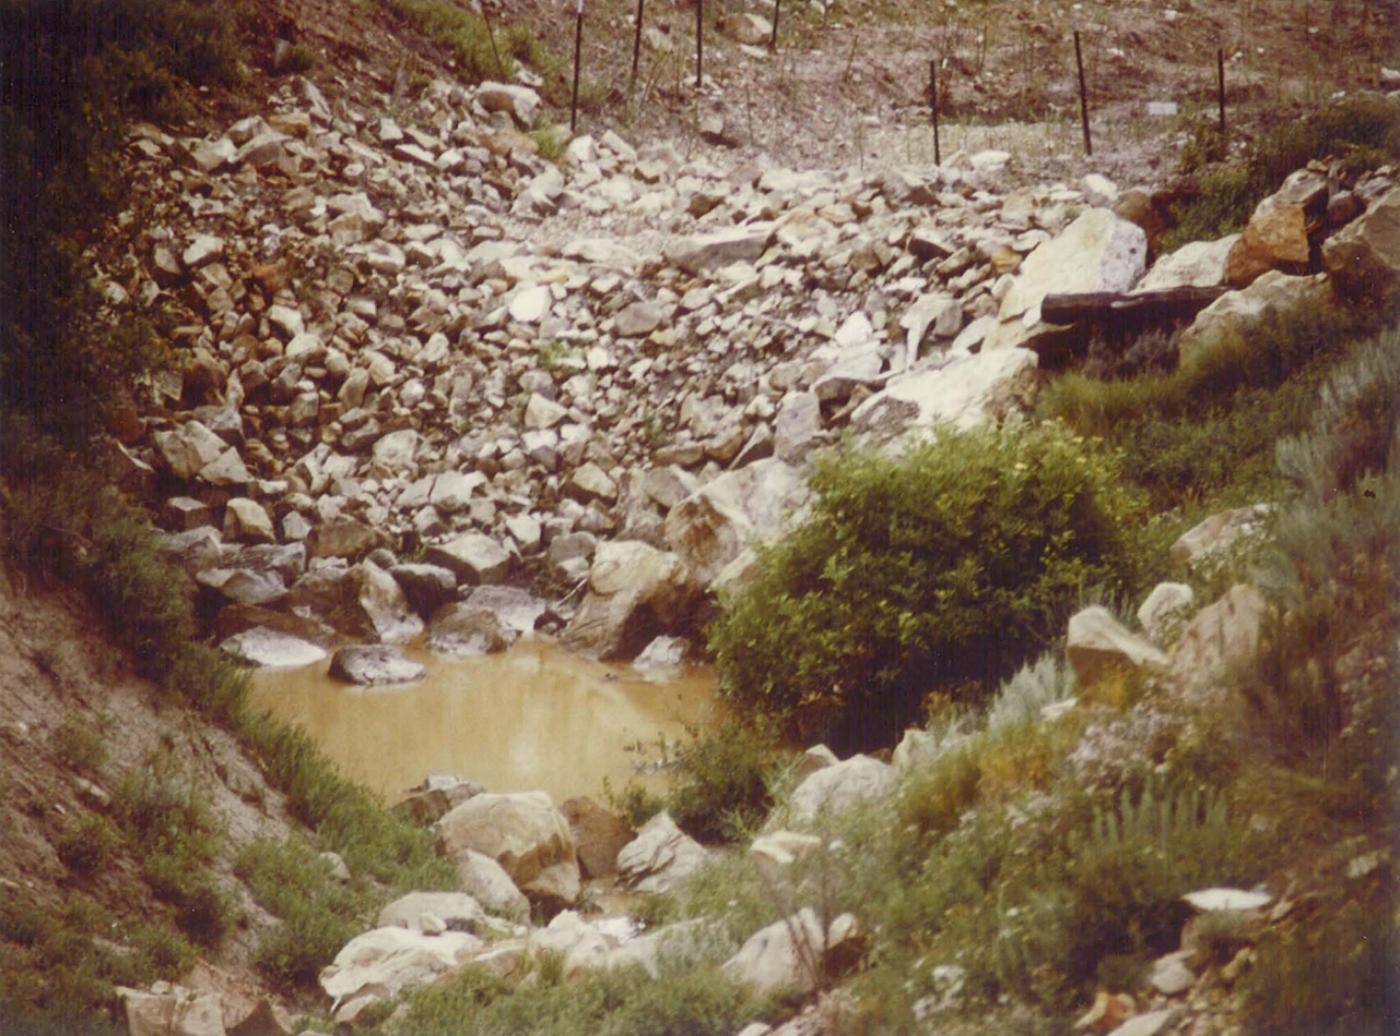
Another "natural" holding pond was created at the point where the natural drainage entered the 48" culvert. The culvert was removed, and the inlet area was covered with large rip-rap leading into the restored channel. The culvert had a 12' headwall, and once removed and replaced with a rip-rapped bank, a ponding area of approximately 1/4 acre was created in the natural incised drainage. This water now builds up near the overflow into the restored channel and then appears to slowly percolate through the channel area, creating a sub-terranean drainage and supplying water to the willows, saplings and other riparian vegetation.

Holding Pond in
Natural Drainage

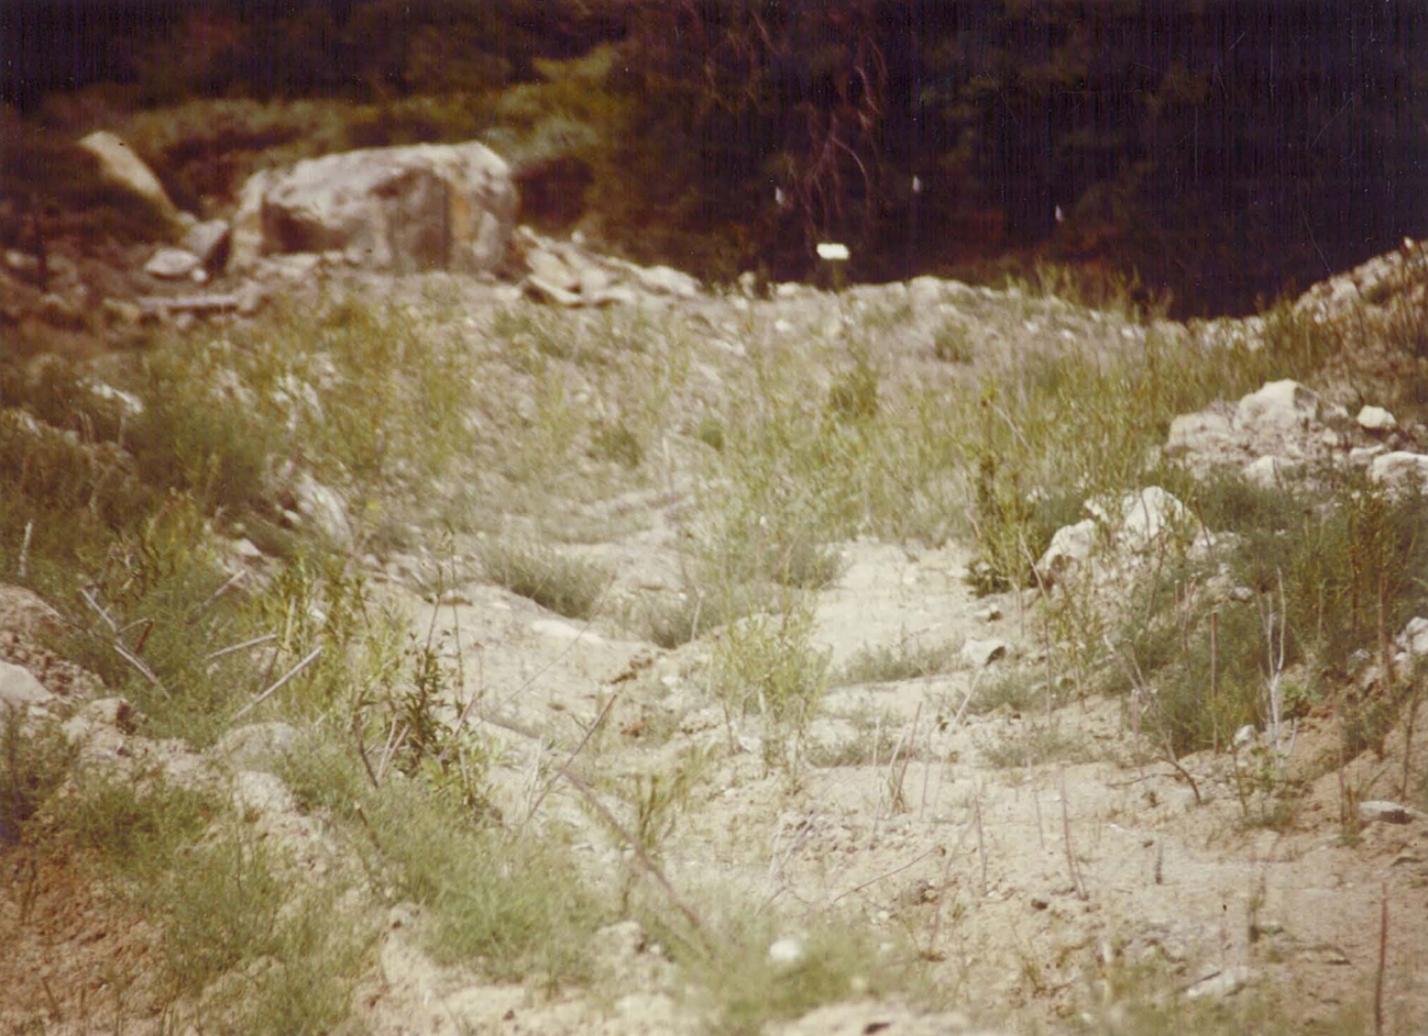
The system appears to be working well at this point. After nearly a year, water has never flowed openly in the restored channel; however, water has been retained in the ponds throughout the year, and the willows and saplings show a survival rate of more than 75% and 90% respectively. Wildlife usage of the area has been commonly noted since reclamation.

Restored Main Channel
Below Holding Pond
(85% Willow Survival)
