WATER QUALITY MEMORANDUM

Utah Coal Regulatory Program

RE: 2007 Third Quarter Water Monitoring, Canyon Fuel Company, Soldier Canyon Mine, C/007/0018-WQ-07-3, Task ID #2681

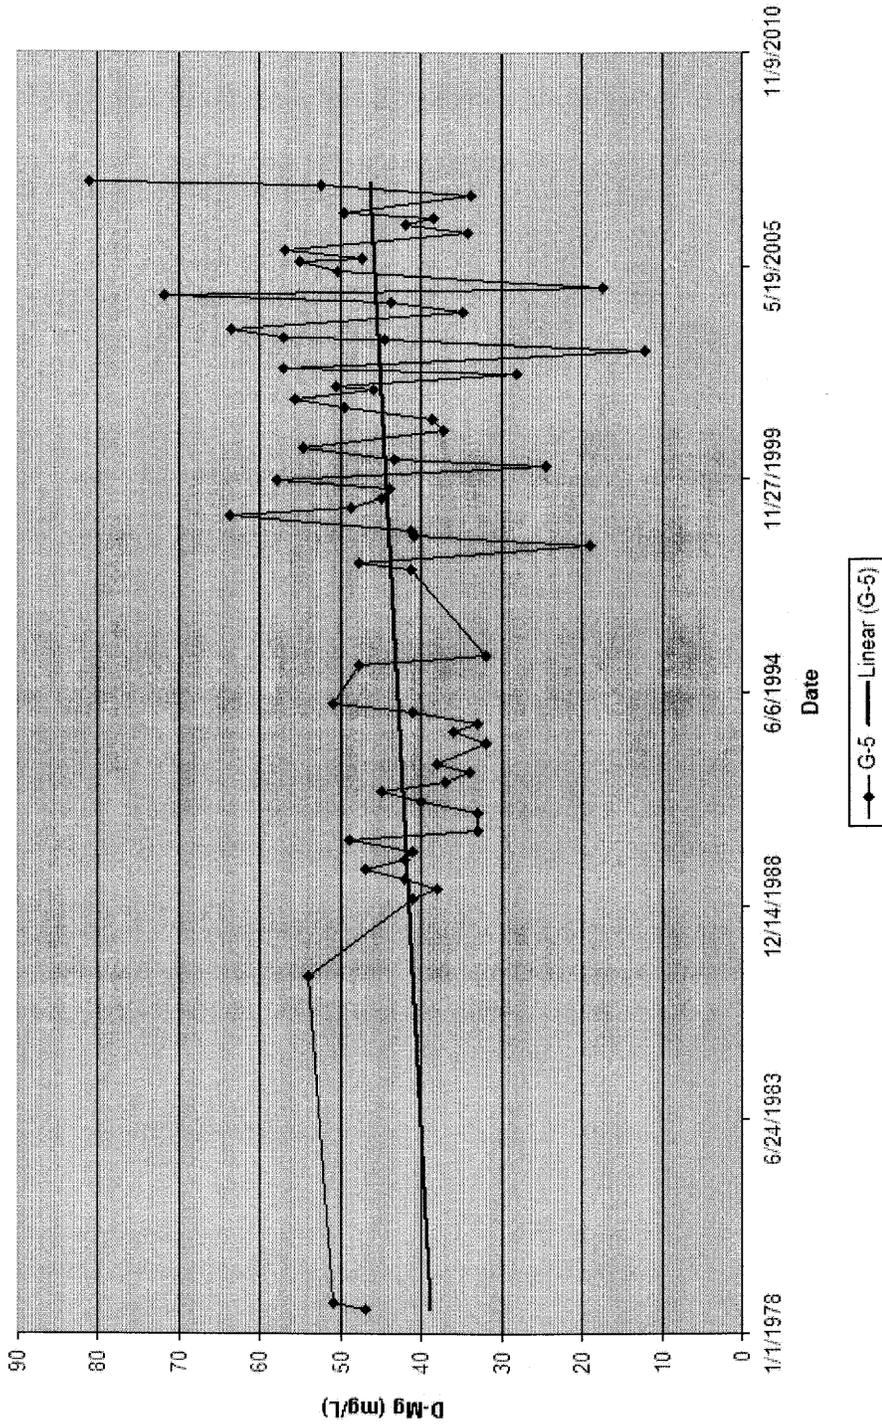
Dissolved Magnesium

The dissolved magnesium at G-5 was reported as 81.2 mg/L, 3.48 standard deviations above the average of 43.23 mg/L. There is no trend ($R^2 = 0.0223$), and a weak correlation to flow correlation to flow.

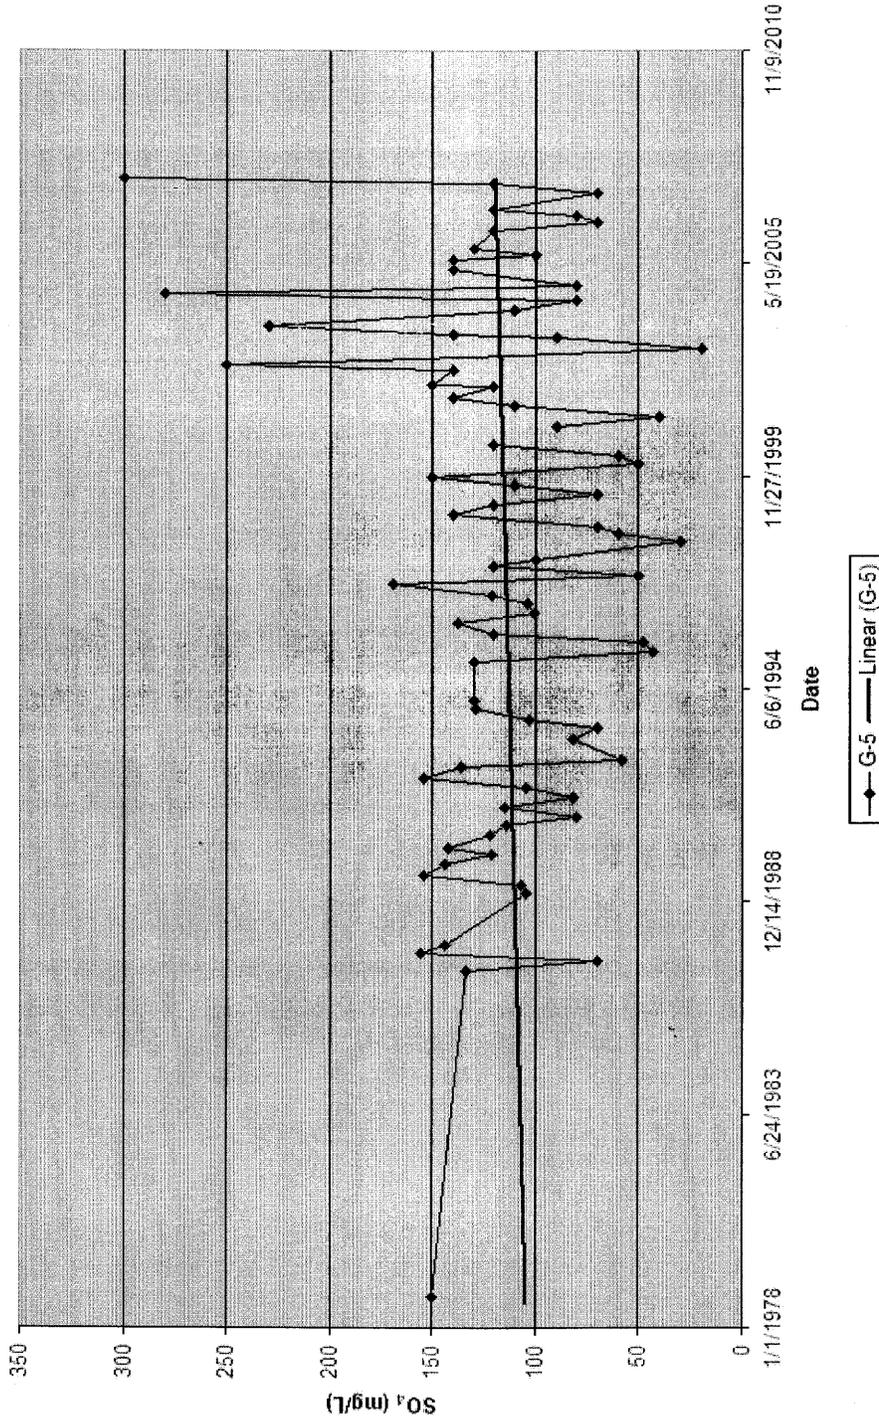
Sulfate

The sulfate at G-5 was reported as 300 mg/L, 4.19 standard deviations above the average of 112.04 mg/L. There is no trend ($R^2 = 0.0043$), and a weak negative correlation to flow.
