State of Utah  
DEPARTMENT OF NATURAL RESOURCES  
DIVISION OF OIL, GAS AND MINING

RE: Determination That the Willow Creek Mine Site Can Be Reclaimed to the Approximate Original Contours With Emphasis On the Cut Slopes on the Schoolhouse Canyon Road, Plateau Mining Corporation, Willow Creek Mine.  
[REDACTED]

TECHNICAL MEMO

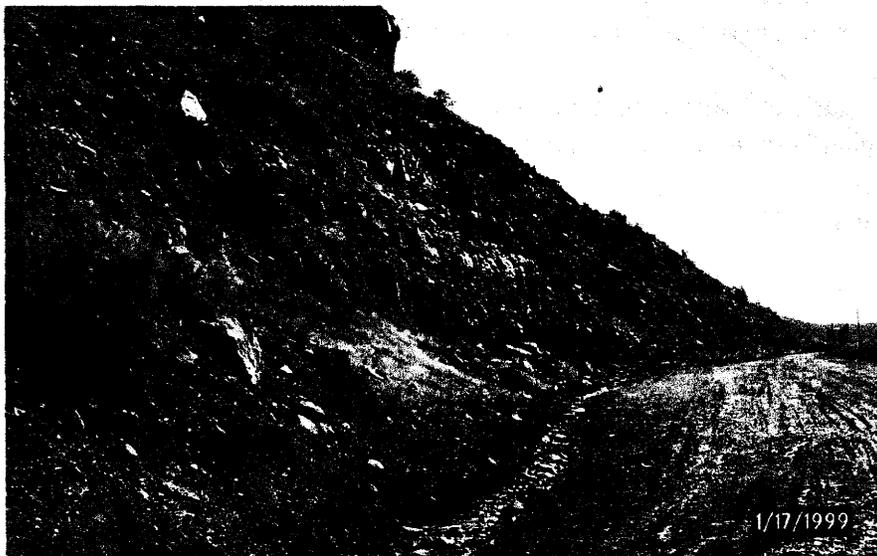
**Figure 1**

The cut slopes and surrounding topography are shown on Figure 1. The cut slope remnants will be similar but smaller than the natural cliffs in the area. The cut slope remnants that will remain after reclamation is similar to those that have already been approved by the Division and OSM at other sites.

The main requirement for cut slope retention is that the slopes are geotechnically stable. Figures 1 and 2 show the road cut was made in bedrock. The Division considers cut slopes in bed rock to be stable unless shown otherwise. The cut slope has existed for 23 years and there is no sign of instability.

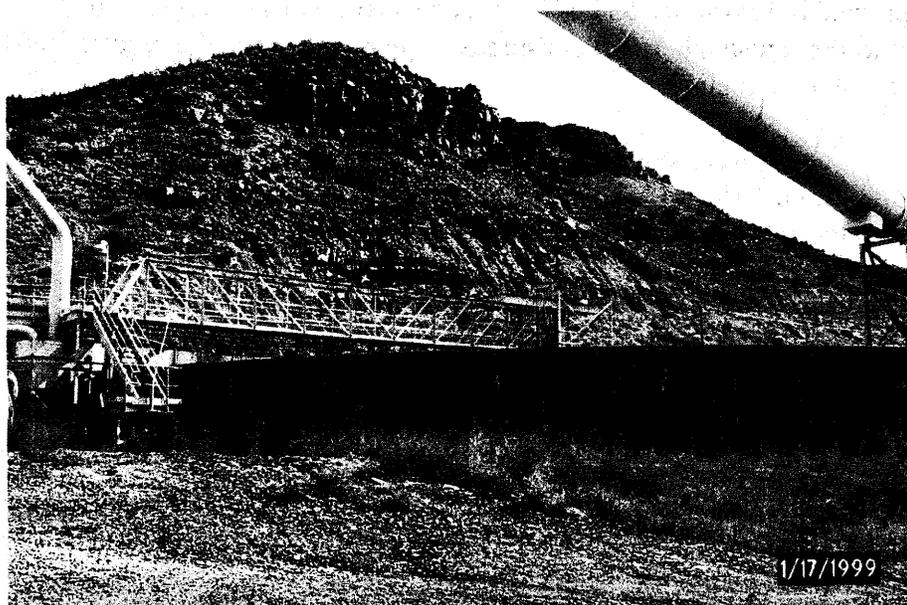
**Figure 2**

Figure 2 shows the cut slope for the access road. The cut slope was made in bedrock, which will remain stable in the present configuration.
