WATER QUALITY MEMORANDUM Utah Coal Regulatory Program

April 15, 2010

RE: 2009, 2nd Quarter Water Monitoring, Canyon Fuel Company (CFC), LLC,
Dugout Mine, C/007/0039-WQ09-2, Task ID #3326

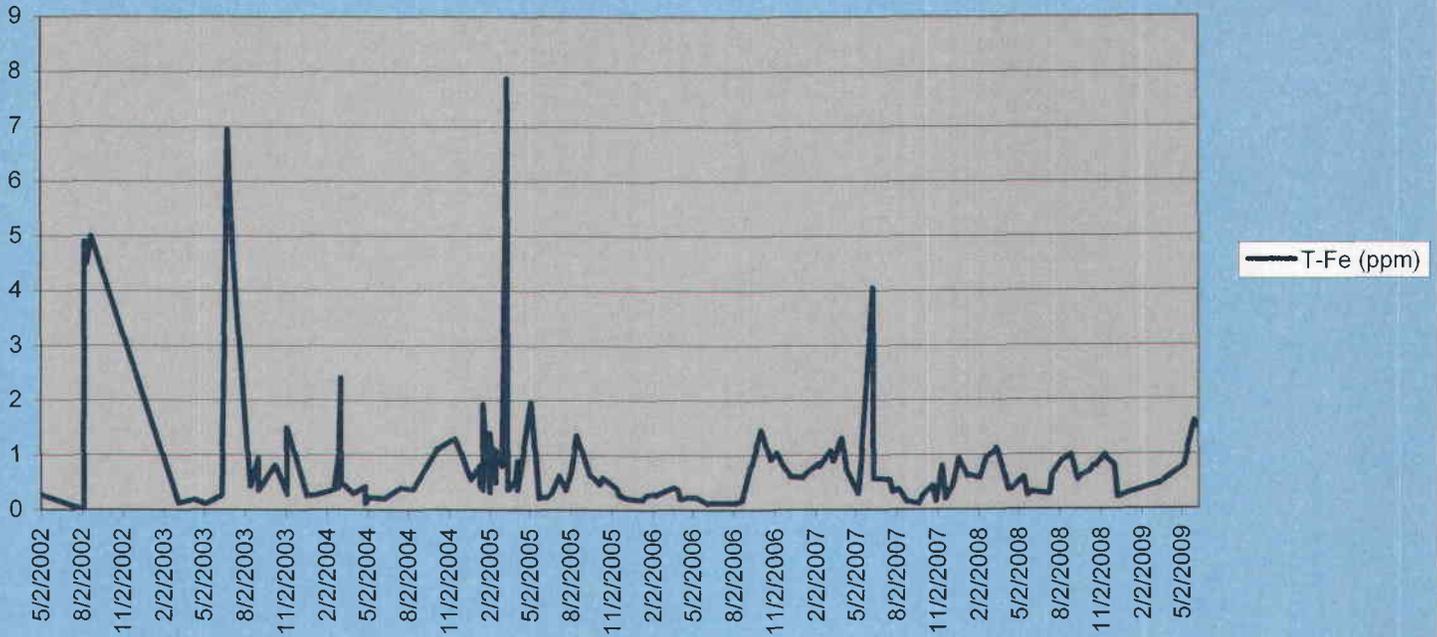
UPDES Outfall 001: T-Fe vs. Time

Site 001 averaged a flow of 156 gallons per minute (gpm). Of seven sampling events, two total iron (T-Fe) concentrations were reported outside of the compliance level established in the Permittee's UPDES permit (1.1 ppm). (See Chart Below)

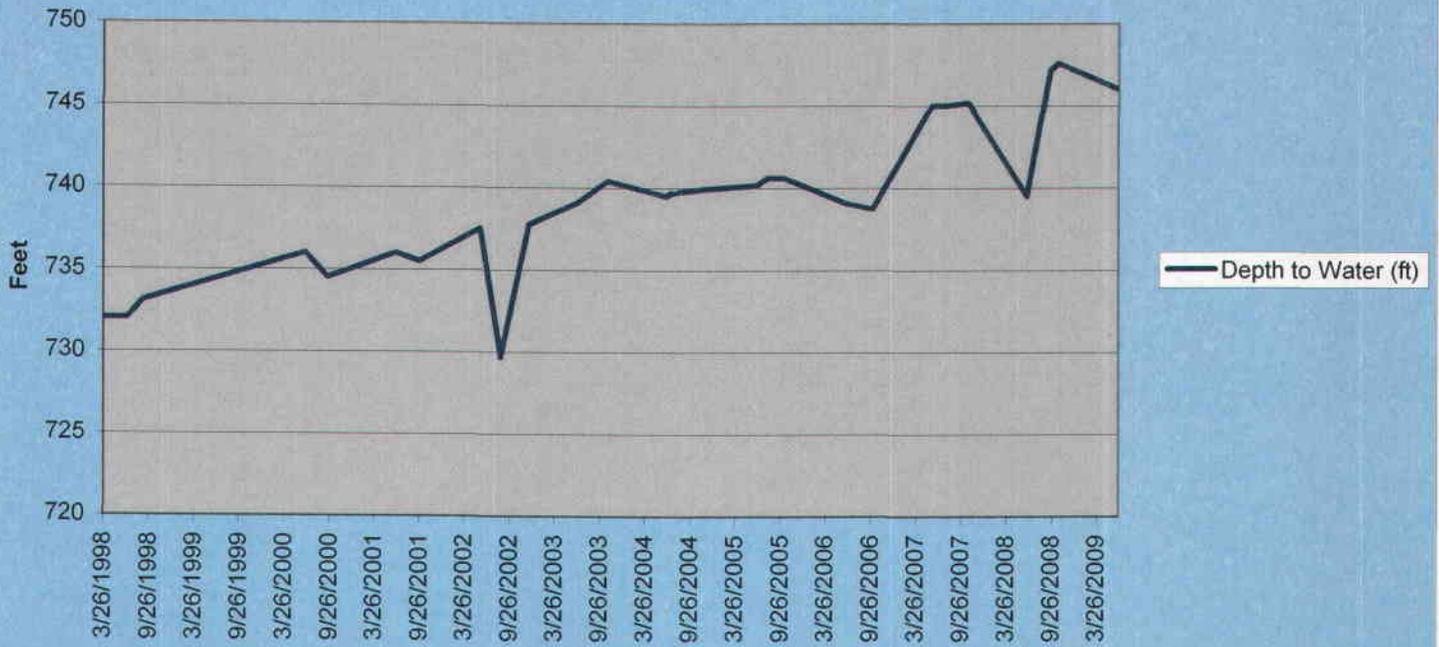
Monitoring Well GW-10-2

Monitoring well GW-10-2 reported a depth to water that was outside of two standard deviations (747.58') during the fourth quarter of 2008 (WQ 08-4). The well was inaccessible due to snow conditions the first quarter of 2009. The reported depth to water for this quarter was within two standard deviations of the mean. (See Chart Below).

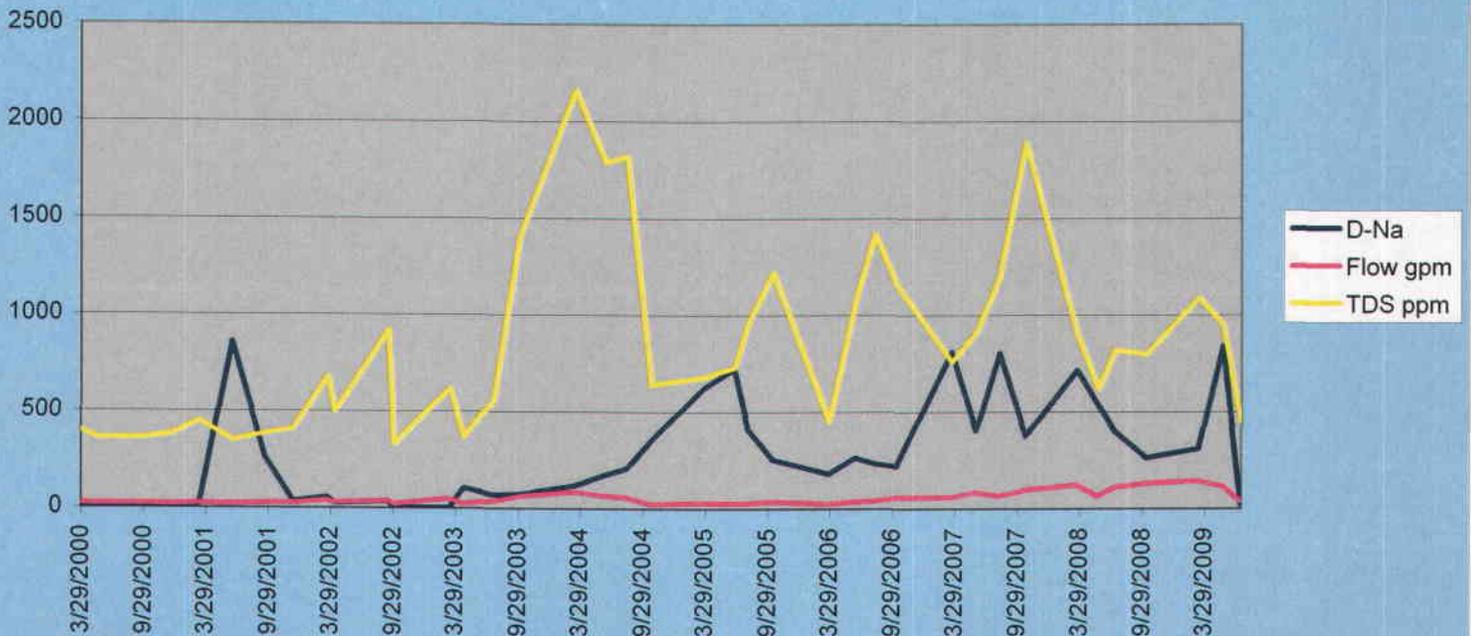
DC-1: D-Na, TDS and Flow vs. Time

DC-1 had reported elevated D-Na concentrations the previous two quarters (WQ08-4 and WQ09-1). The reported D-Na concentration for this quarter was back to within two standard deviations of the mean. The D-Na concentrations at this surface water monitoring point have historically been erratic (See Chart Below). Based upon the data set, it appears that the D-Na concentrations tend to spike during the spring and early summer, presumably as a result of snowmelt.

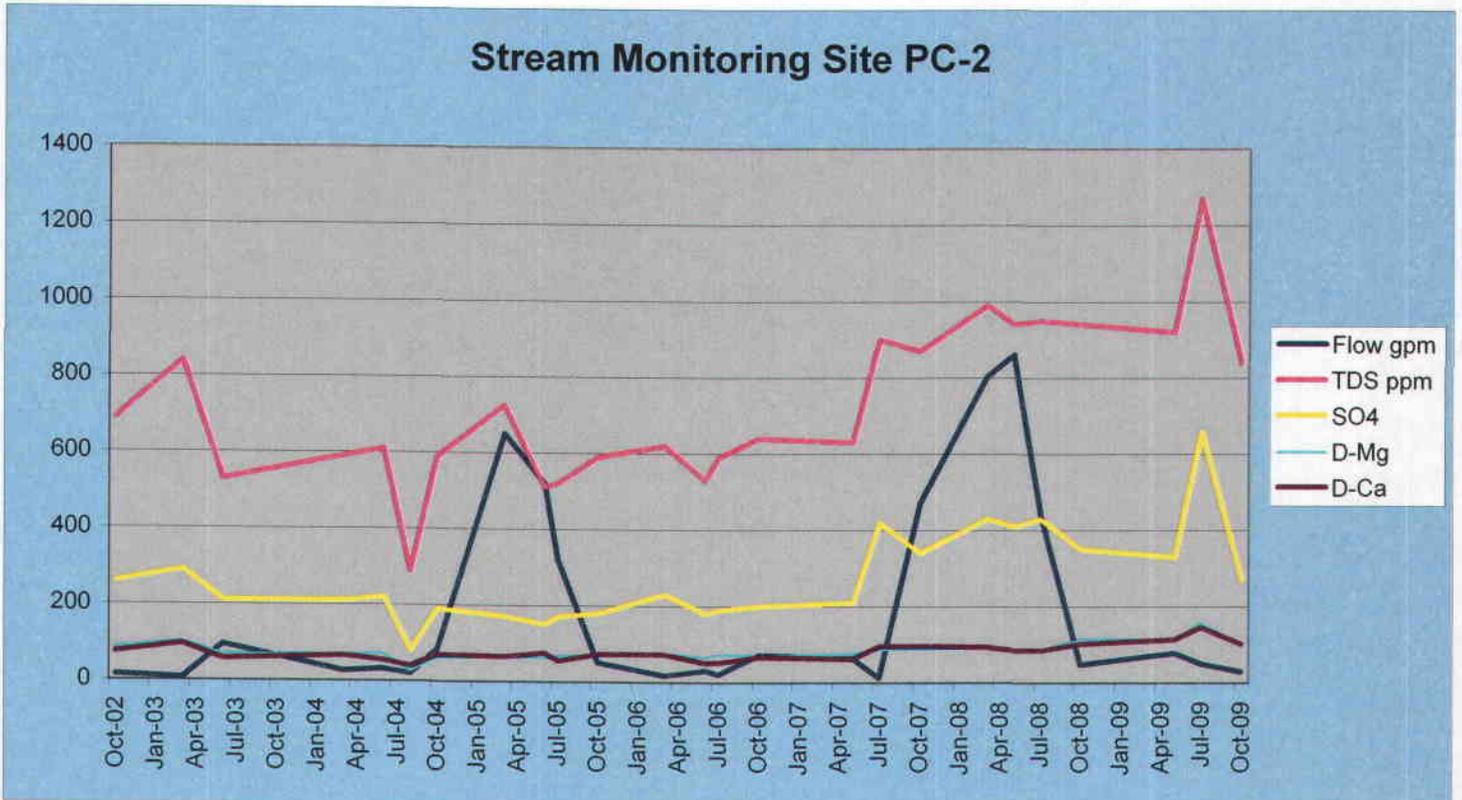
Site PC-2 had reported elevated dissolved magnesium (D-Mg) levels during the 4th quarter of 2008. However, the site could not be accessed due to snow cover the 1st quarter of 2009. Sampling values reported this quarter identified several parameters that were outside of two standard deviations of the mean: field conductivity, D-Ca, D-Mg, Cl, SO₄, total alkalinity, total dissolved solids (TDS), bicarbonate, total cations and total anions. (See Chart Below).
