**RE: Revised Probable Hydrologic Consequences, West Ridge Resources, Inc., West Ridge Mine, C/007/0041, DO 12-A, Task ID #4143**

Investigation of Fault Systems and  
Fault-Related Groundwater systems  
at the West Ridge Mine

RE: Geologic, solute chemical and isotopic investigation of the north-northwesterly fault zone and fault-related groundwater systems in the West Ridge Mine.

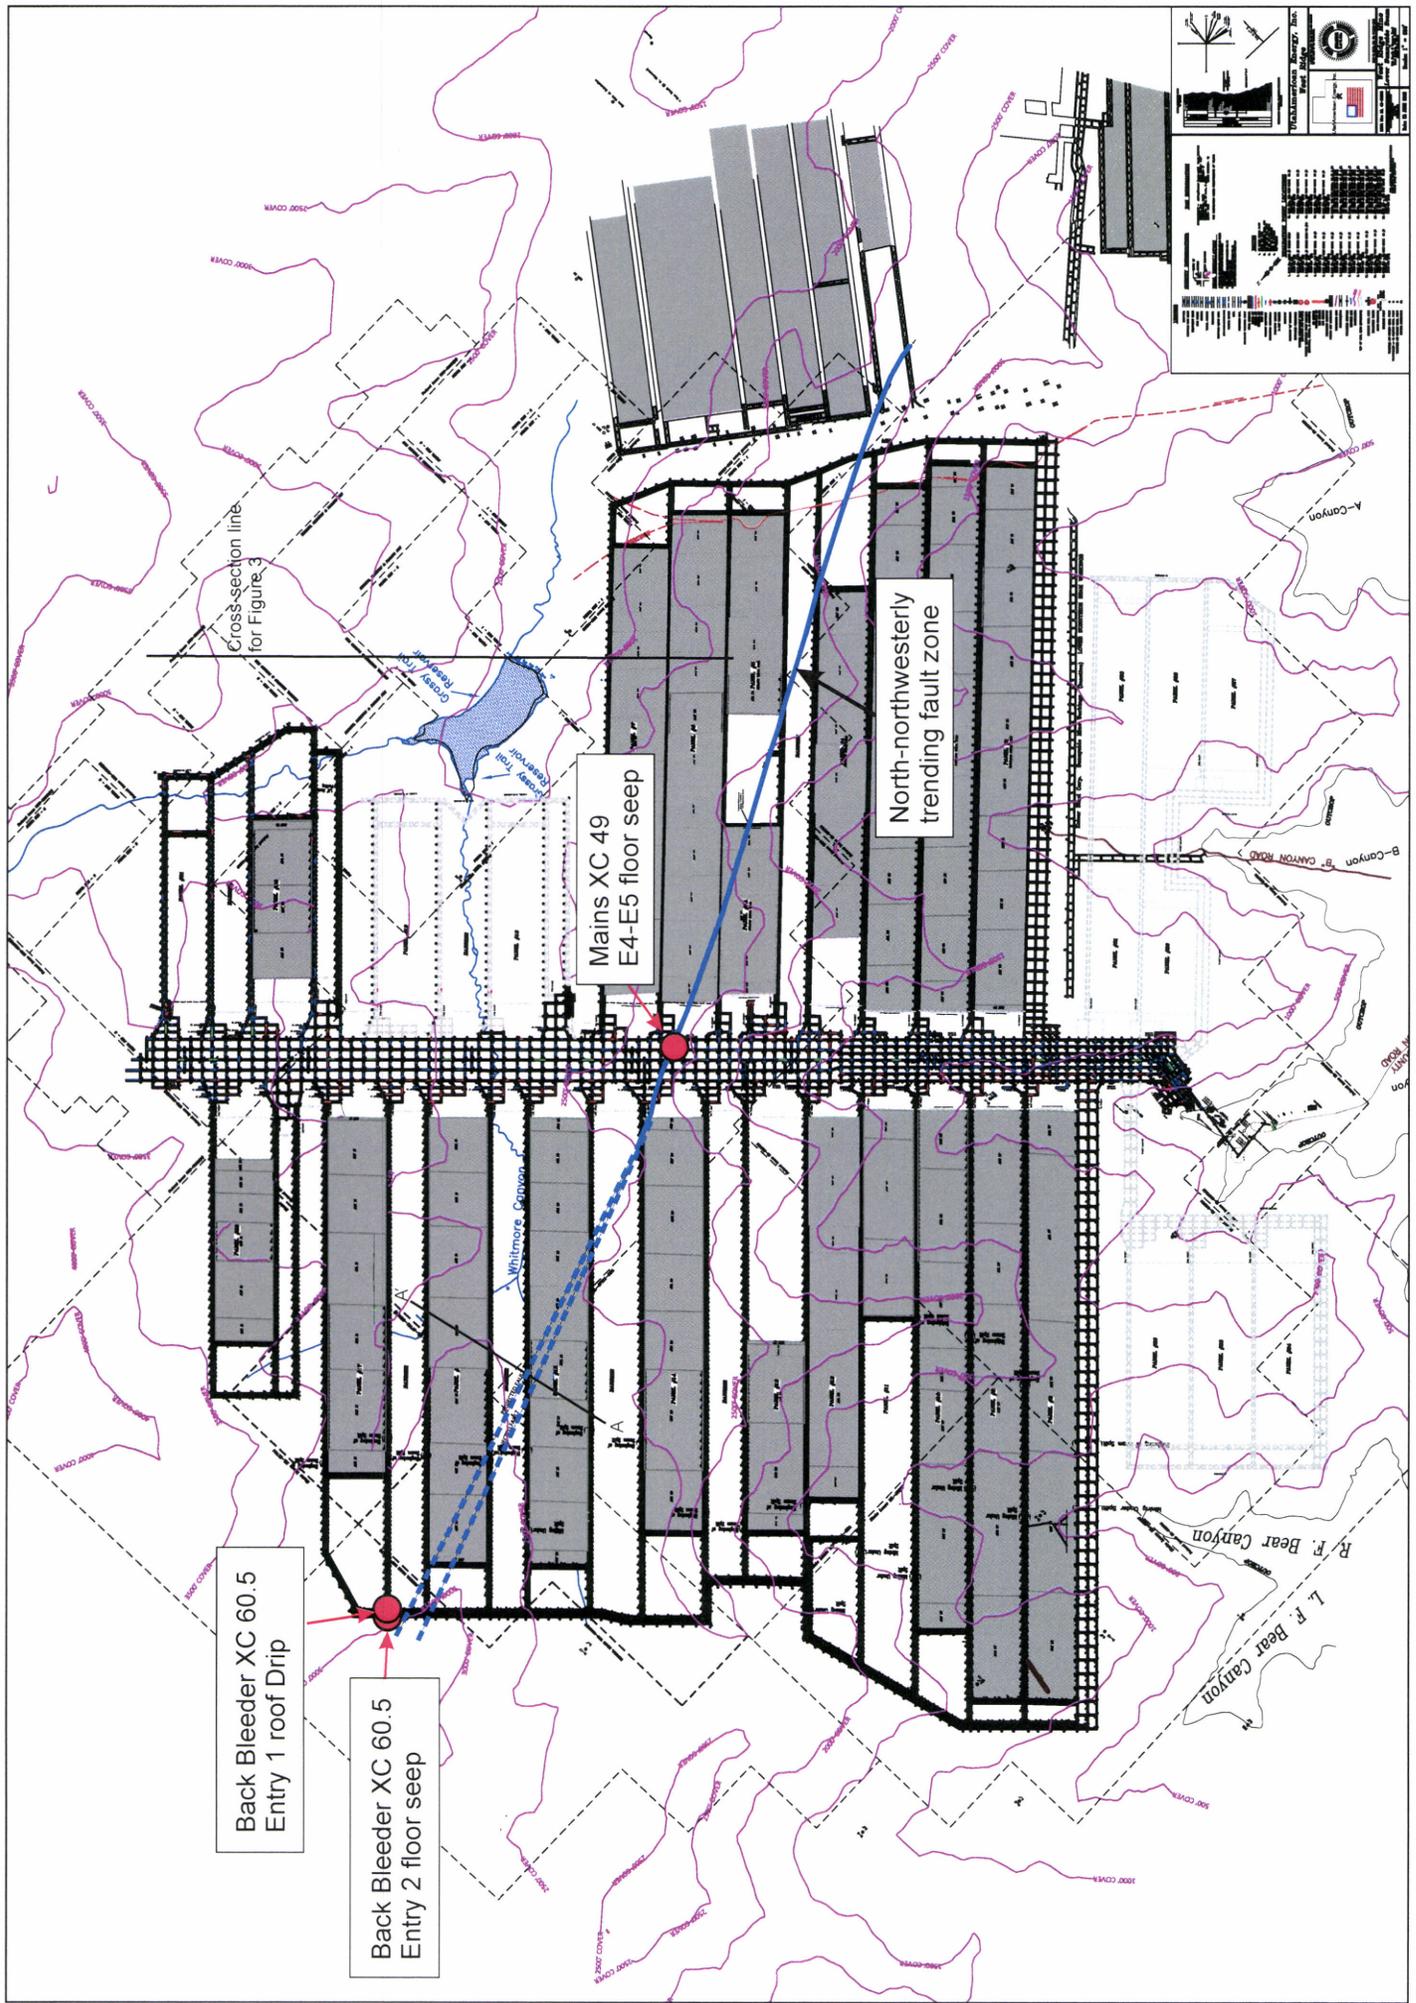
As part of this investigation, a sample of groundwater discharging from the north-northwesterly fault system was sampled on 19 October 2012 for solute and isotopic analysis. This sample (Mains XC 49 E4-E5) is located at the intersection of the north-northwesterly fault zone and the Mains entries in the central portion of the West Ridge Mine (Figure 1).

Figure 1 Fault-related groundwater sampling locations and north-northeast trending fault location at the West Ridge Mine workings.
