Re: Emery Deep Mine Permit C/015/015
Amendment to MRP (full extraction pillar splitting plan, planned subsidence life of mine panels, CLEAN COPY Task id 3086)

Title: Full extraction pillar splitting life of mine

The purpose of this report is to present baseline surface conditions prior to full extraction operations at several panels in the Consolidation Coal Company (CONSOL) Emery Mine, Emery County, Utah. The panels covered in this report include the following:

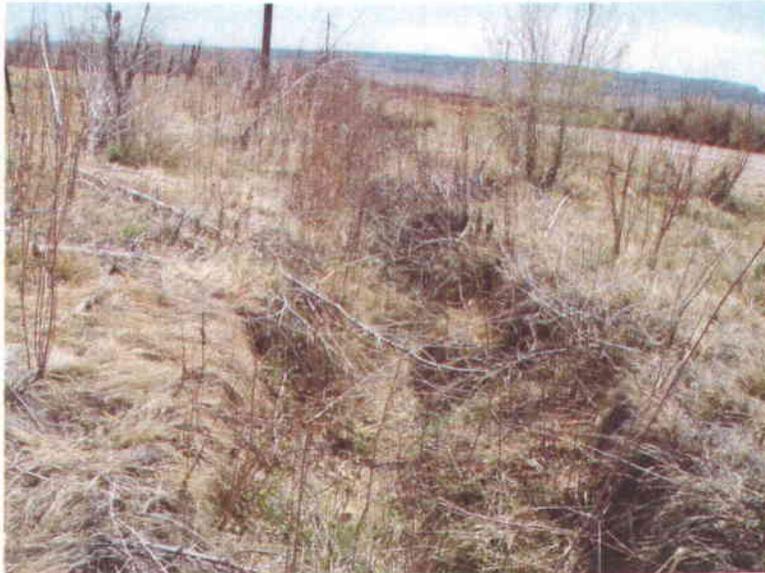
Feature 72. Irrigation Ditch. This feature has been updated from the Valley Engineering (1980) report. This ditch has earthen banks, is approximately three feet deep, and ranges from five to eight feet wide. There was no water within the ditch when it was surveyed in May 2008, but moist soil in its bottom suggested that it had been used recently. Water within the ditch flows from west to east until it reaches the paved road. From this point, water is diverted to the south through a culvert under the gravel road, and then east again under the paved road.

Feature 72. Irrigation Ditch. Looking east.

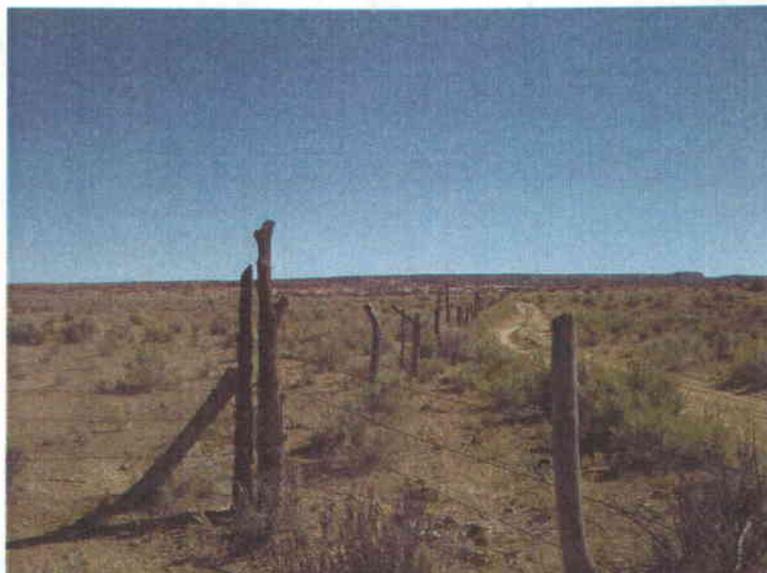
Feature 85. Dirt Road and Fences. This feature is essentially unchanged from how it is described in the Valley Engineering (1980) report, which states the following: “The road is a two-track, single lane, dirt road. The road surface consists of the natural sand and clay that is in the area, and has been compacted by vehicles that travel the road. The fences in the area are barbed wire with either natural rough cut wood posts or steel posts.” The fences are in fair to good condition.

Feature 85. Dirt Road and Fences. Looking west.

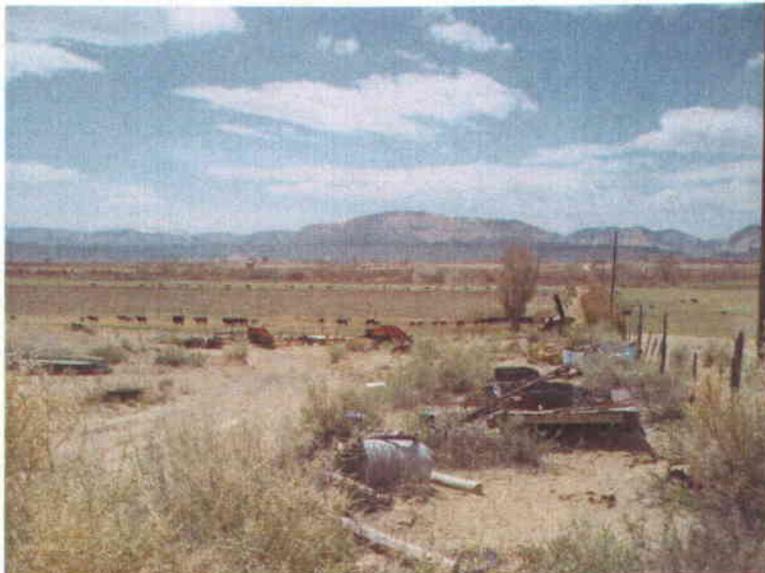
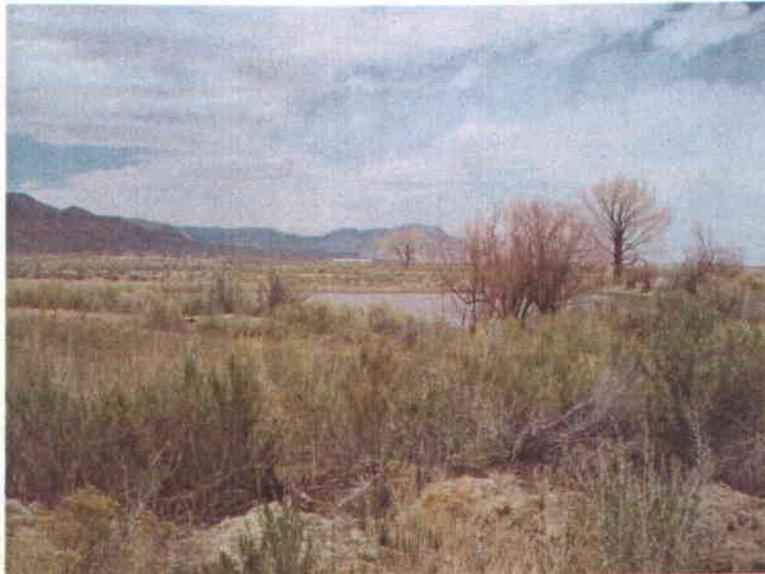
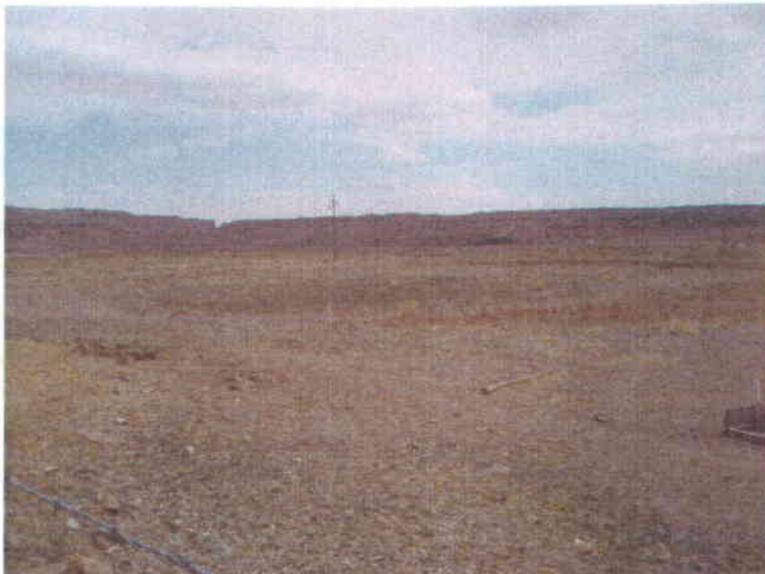
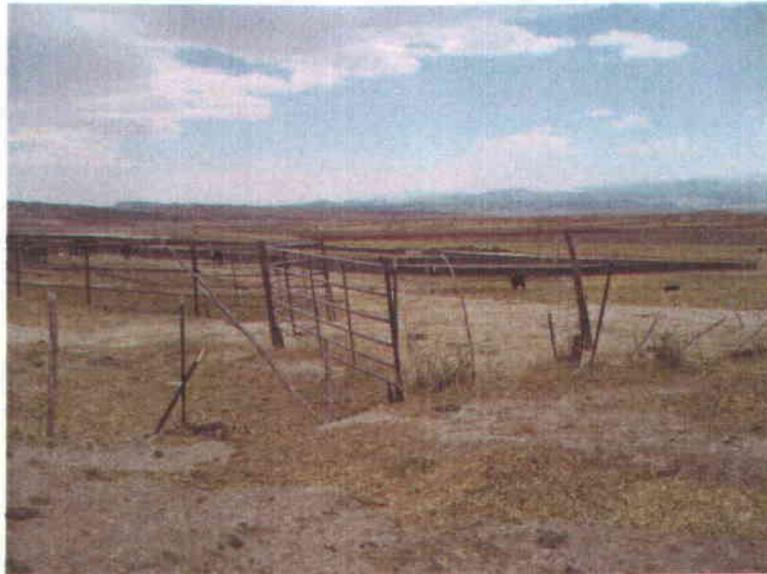
Feature 103. Farm Land, Corrals, Ponds, and Fences. The description of this feature has been updated from the Valley Engineering (1980) report. A fenced and gated hay storage area is located in the southeast corner of this feature. The fence and gate are in good condition. An unimproved dirt road (good condition) leads from the gravel road up to the hay storage area. Three small ponds are located north of the hay storage area. The two ponds that are adjacent to the hay storage area measure approximately 100 feet in diameter and are up to 5 feet deep. A larger pond measuring 400 feet by 200 feet is located about 700 feet to the northwest. Irrigated farm land and corrals surround the hay storage area. The corrals are constructed from metal tee stakes, finished and unfinished timbers, and metal tubing. They appear to be in good condition. The irrigated agricultural land consists of three fields totaling 70 acres. Irrigation is performed with a network of irrigation ditches that flow in a northwest to southeast direction as well as a buried plastic water line. The water line is 12" in diameter and runs north to south for 900 feet under the northwestern-most irrigated field of this feature. Two additional buried water lines are scheduled for construction during summer 2008. An unimproved dirt road in fair condition located about 800 feet north of the hay storage area provides additional access to the fields and corrals.

Feature 103. Farm Land, Corrals, Ponds, and Fences. Looking west at irrigated fields along Christiansen Wash.

Feature 103. Farm Land, Corrals, Ponds, and Fences. Looking north at one of the ponds.

Feature 103. Farm Land, Corrals, Ponds, and Fences. Looking southeast at one of the ponds, which was not filled when the survey was performed.

Feature 103. Farm Land, Corrals, Ponds, and Fences. Looking southwest at the fences and corrals.

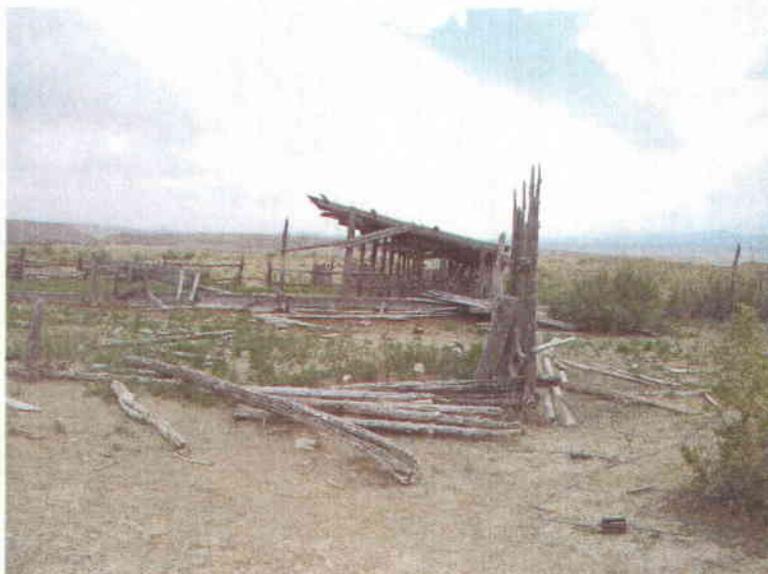
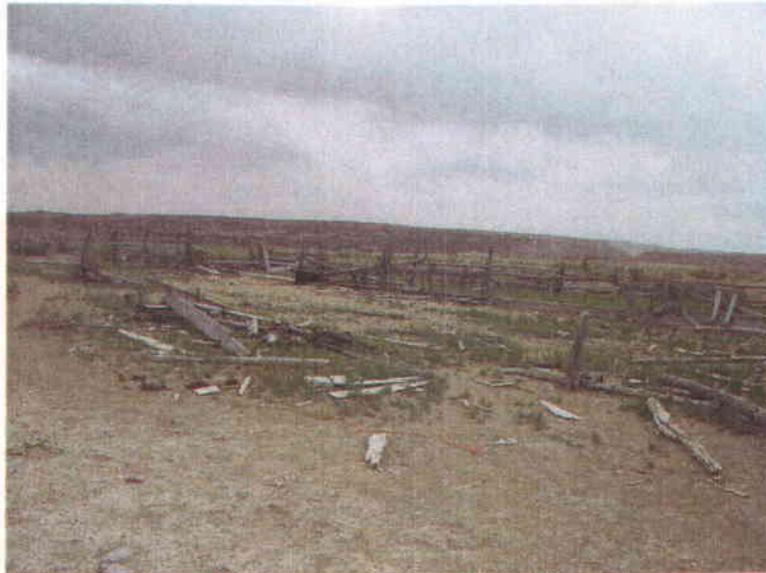
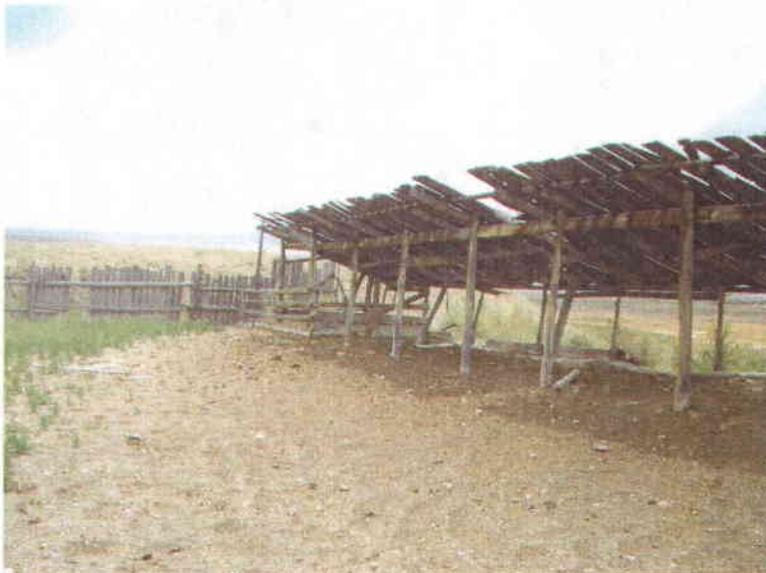
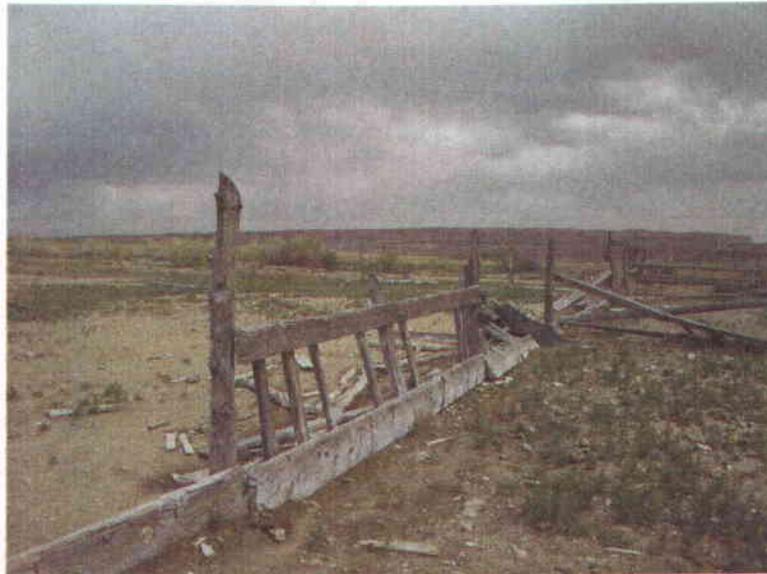
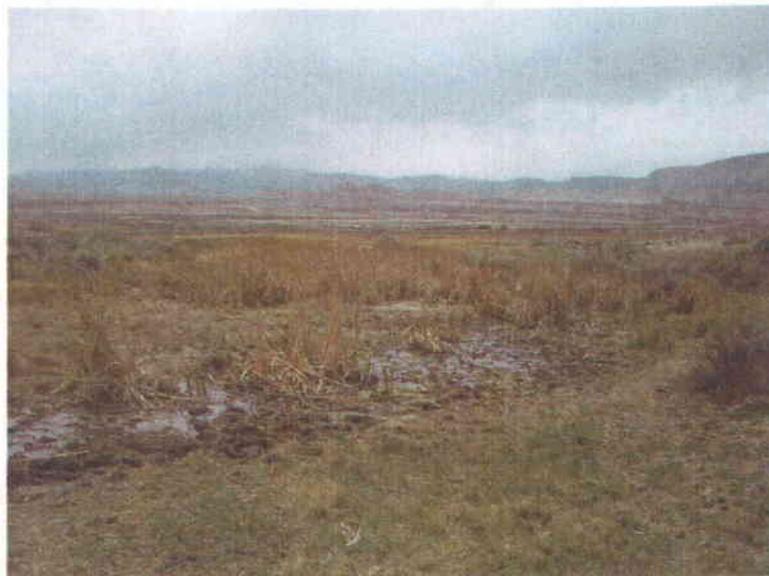
Feature 107. Corrals and Covered Shelters. The description of this feature has been updated from the Valley Engineering (1980) report. The corrals and shelters are in poor condition and are constructed of rough cut lumber and rough sawn boards. Several pieces of the fence are missing. The land slopes steeply downward just to the south of the corrals toward a broad, flat plain. During site reconnaissance, a marshy, grassy area was observed near the base of this slope. This marshy area corresponds to SP-9 on Plate VI-2/VI-2A and in the text of Chapter VI Volume 1 Section VI.A.2 (Springs and Seeps) of the Emery Mine Permit

Feature 107. Corrals and Covered Shelters. Looking south at west portion of corral and covered shelter. (Photo taken April 2007)

Feature 107. Corrals and Covered Shelters. Looking southeast at east portion of corral and covered shelter. (Photo taken April 2007)

Feature 107. Corrals and Covered Shelters. Looking southwest at covered shelter. (Photo taken April 2007)

Feature 107. Corrals and Covered Shelters. Looking east along northern edge of corral. (Photo taken April 2007)

Feature 107. Corrals and Covered Shelters. Looking southwest at marshy, grassy area below and south of the corral and covered shelters. (Photo taken April 2007)

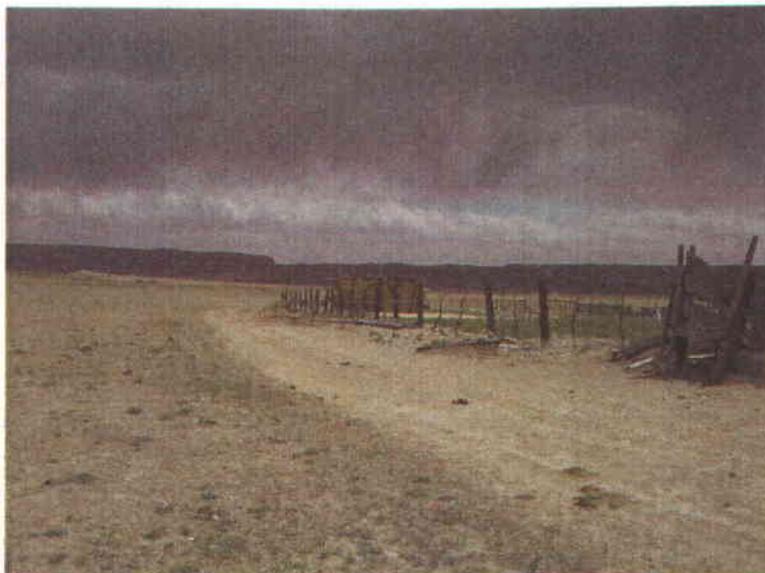
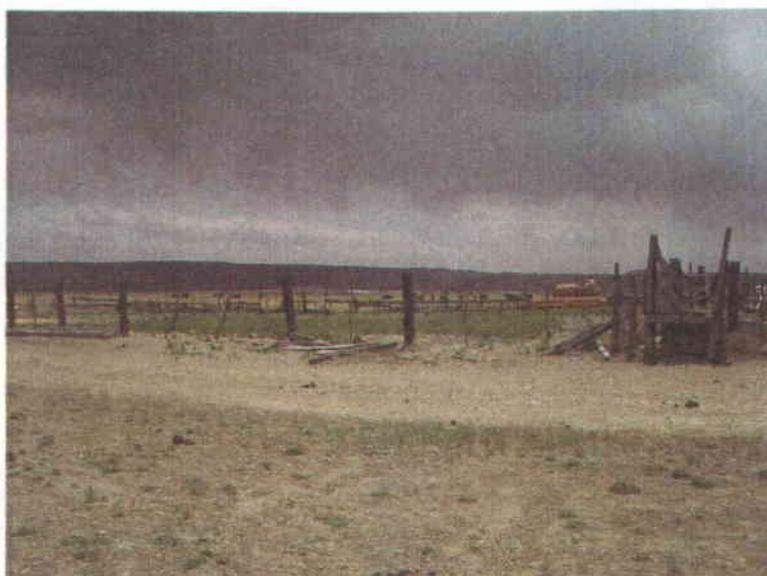
Feature 108. Corral. The description of this feature has been updated from the Valley Engineering (1980) report. This feature is in fair condition. It is constructed from square rough-cut wood posts, unfinished wood posts, and steel fencing reinforcement. Most of the corral is fenced with barbed wire. During site reconnaissance in May 2008, several hay bales were being stored in the corral, suggesting that it was being used

Feature 108. Corral. Looking southeast.

Feature 108. Corral. Looking south.

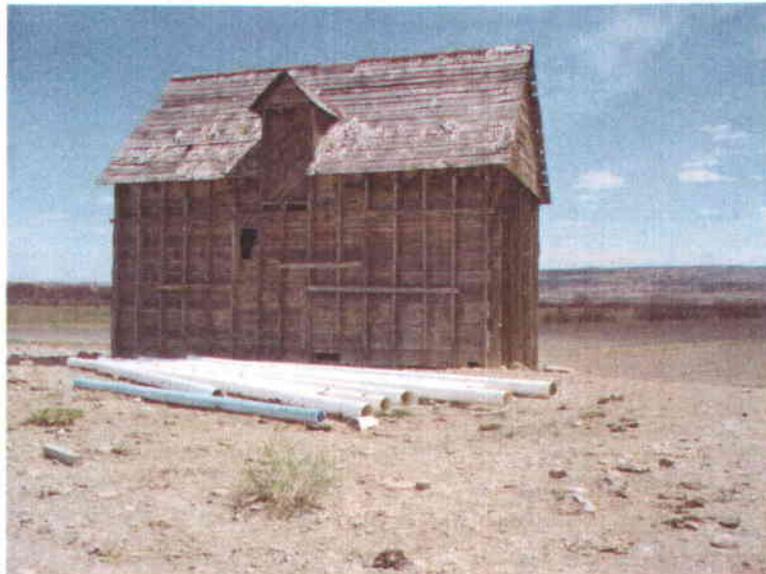
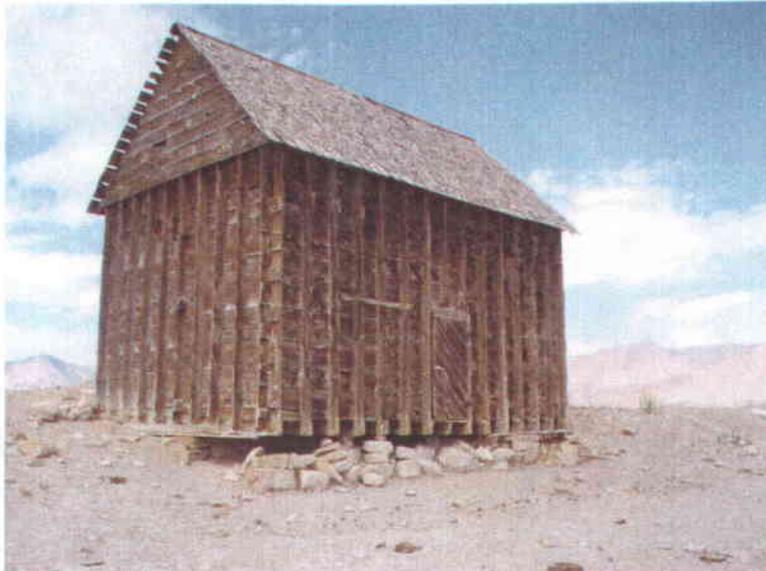
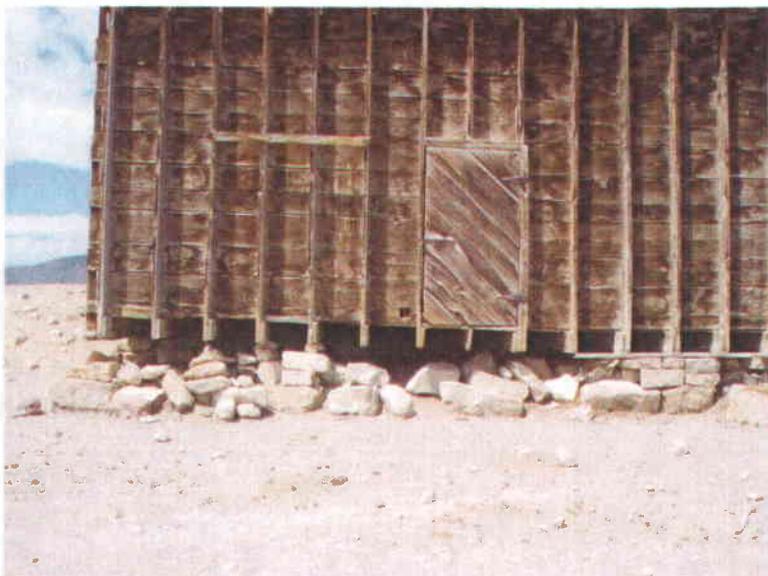
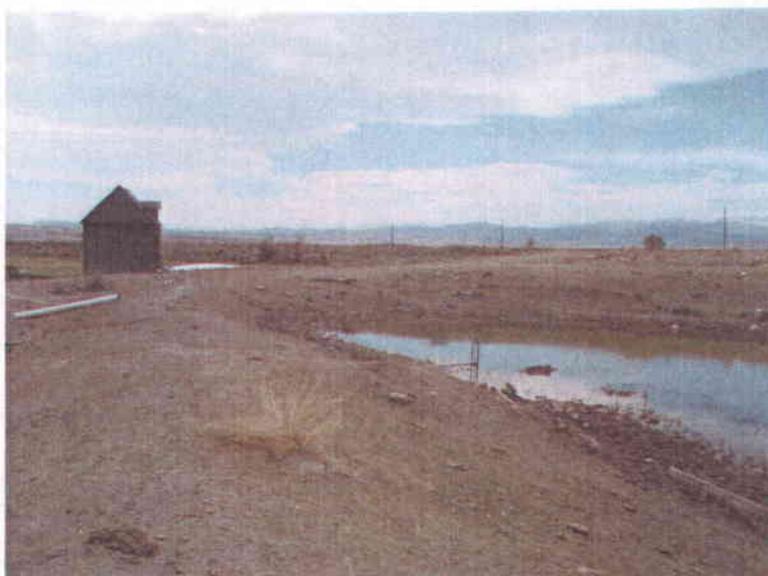
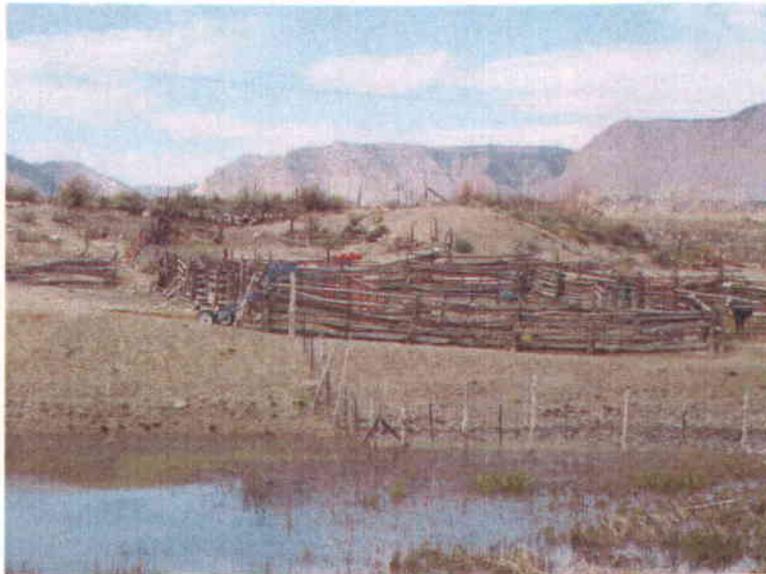
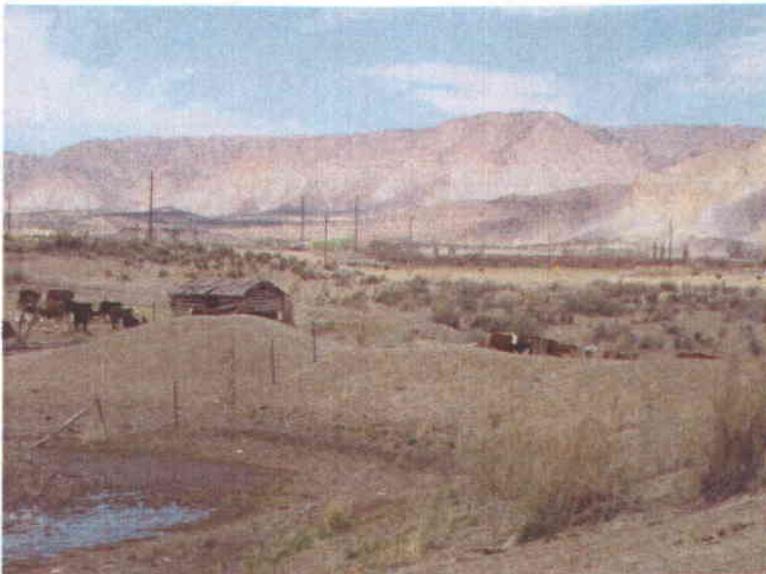
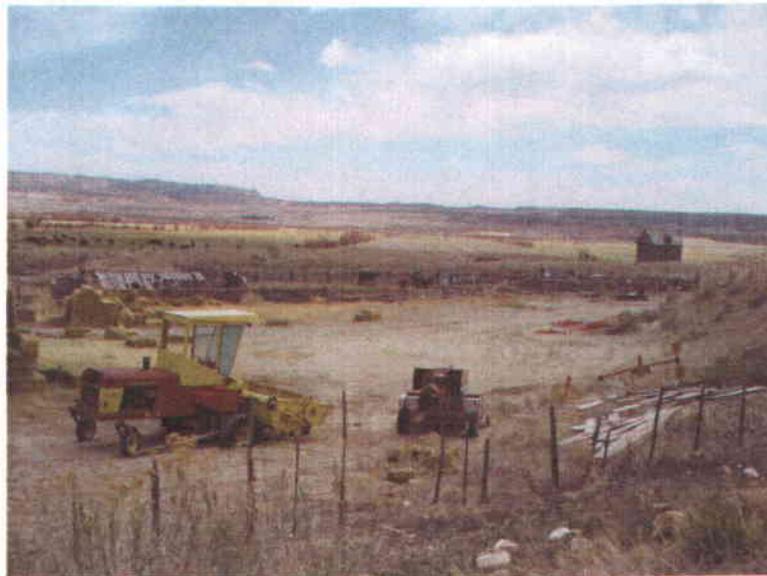
Feature 110. Corrals, Sheds, Barn, Pond, and Farm Land. The description of this feature has been updated from the Valley Engineering (1980) report. The corrals are constructed of unfinished and rough cut timbers as well as steel pipe fencing and are in good to fair condition. The sheds are constructed from rough cut logs and rough sawn boards and are in dilapidated condition. The roofs of the sheds have largely fallen apart. The barn is a two-story wood frame building in fair condition. It is founded on stacked rocks, which have started to fall over on the east side of the building. The pond measures approximately 300 feet long by 100 feet wide and has an earthen embankment that is approximately 10 feet tall on its east side. Irrigated fields of hay and grass covering an area of approximately 80 acres are located to the east and southeast of the corrals, barn, and pond.

Feature 110. Corrals, Sheds, Barn, Pond, and Farm Land. Looking east at barn.

Feature 110. Corrals, Sheds, Barn, Pond, and Farm Land. Looking west at barn.

Feature 110. Corrals, Sheds, Barn, Pond, and Farm Land. Looking west-southwest at foundation of barn.

Feature 110. Corrals, Sheds, Barn, Pond, and Farm Land. Looking south at pond and barn.

Feature 110. Corrals, Sheds, Barn, Pond, and Farm Land. Looking west across pond at corrals.

Feature 110. Corrals, Sheds, Barn, Pond, and Farm Land. Looking west at pond, corral, and shed.

Feature 110. Corrals, Sheds, Barn, Pond, and Farm Land. Looking southeast at corrals, shed, and farmland.

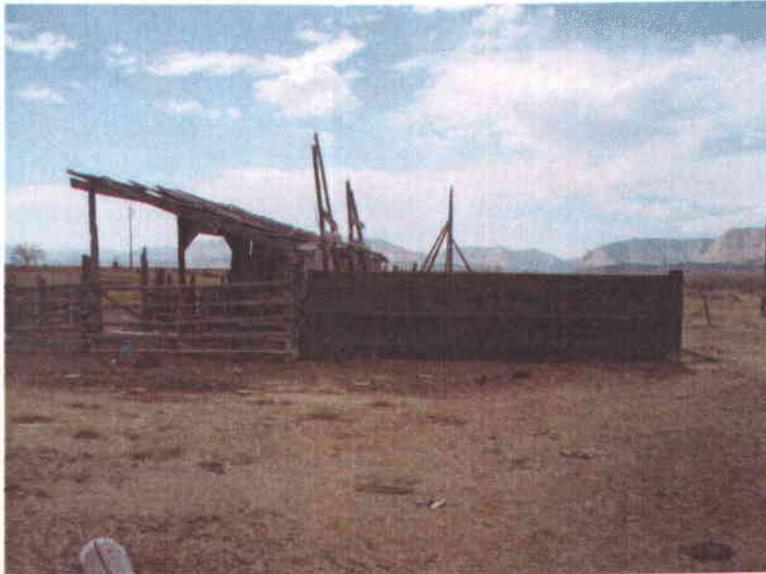
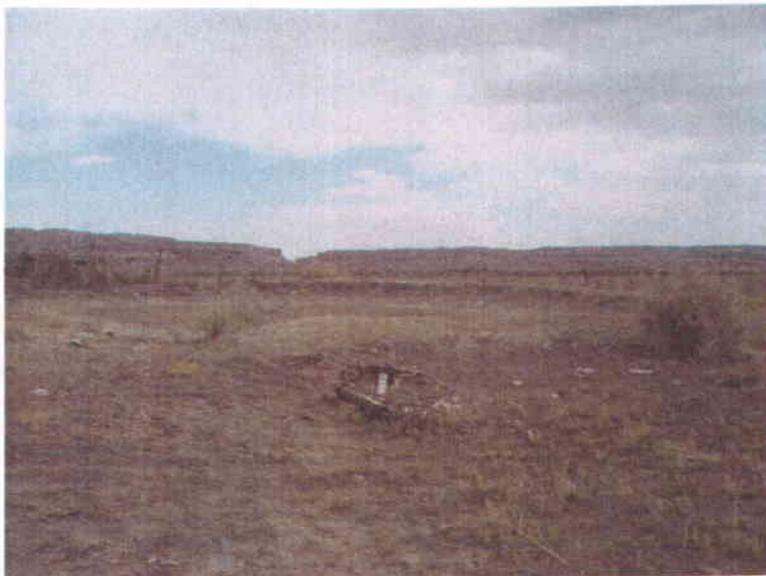
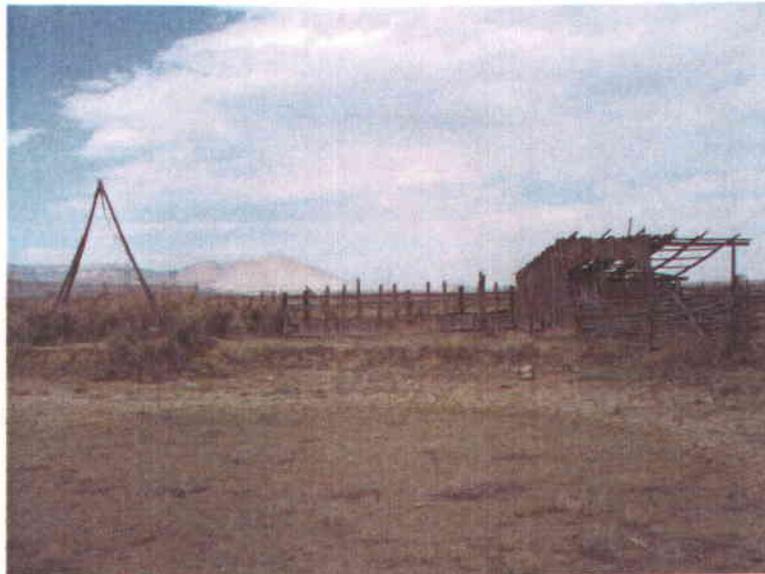
Feature 112. Corral. The description of this feature has been updated from the Valley Engineering (1980) report. This feature includes a corral, an animal shelter, remnants of a hay derrick, and two small ponds. The corral is constructed from rough-cut timbers, barbed wire, and conveyor belt material. It is in fair condition. The animal shelter is also constructed from rough-cut timber and is in dilapidated condition. Large sections of the roof are missing. The hay derrick is in fair to poor condition. The two ponds, which were empty during the Spring 2008 survey, are approximately 85 feet in diameter and have constructed with earthen embankments approximately 3 feet tall.

Feature 112. Corral. Looking west. The hay derrick is visible in the background.

Feature 112. Corral. Looking southeast at empty pond located east of corral.

Feature 112. Corral. Looking north at corral, shelter, hay derrick, and empty pond (in foreground).

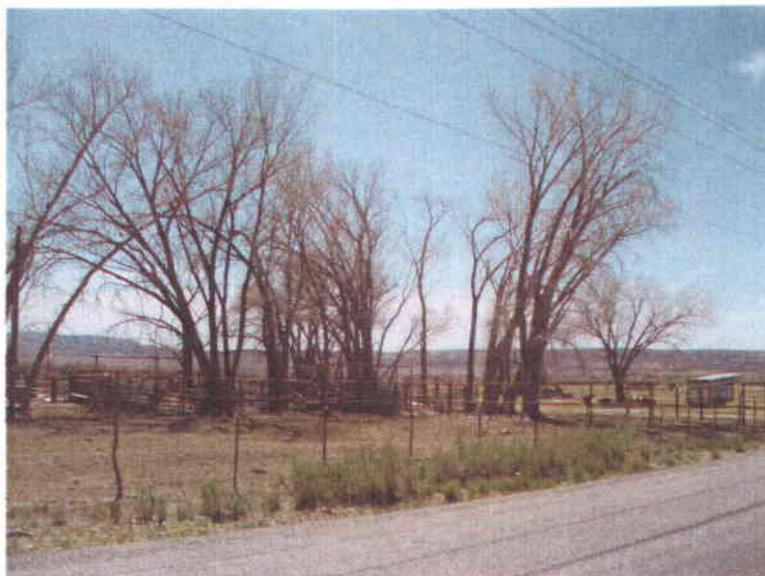
Feature 113. Corral. The description of this feature has been updated from the Valley Engineering (1980) report. The corral is constructed from both rough-cut timbers and painted metal tube fencing. The corral has been partitioned into several small areas. It is in good condition.

Feature 113. Corral. Looking southwest.

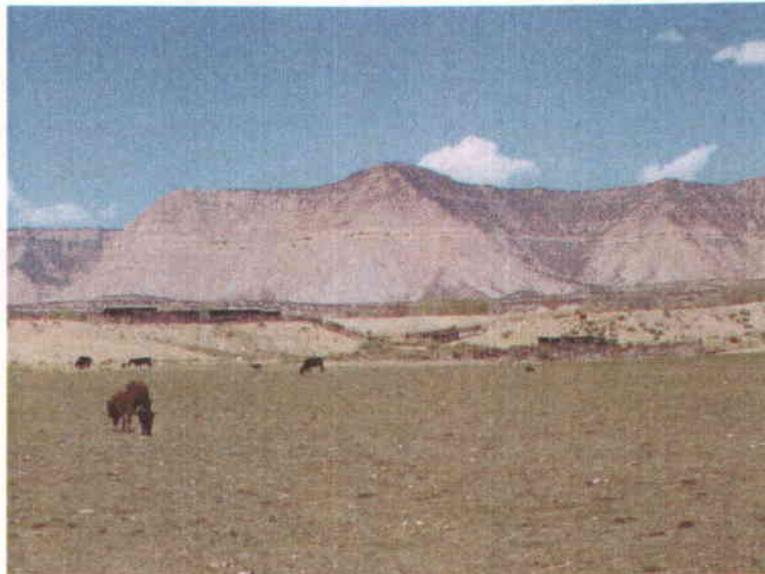
Feature 114. Corrals. The description of this feature has been updated from the Valley Engineering (1980) report. The corrals are constructed from rough-cut timbers which comprise the fence posts, fencing material, and sheltered areas. Hay was stored in one of the sheltered areas during the May 2008 survey. The corrals and shelters are in poor condition.

Feature 114. Corrals. Looking west. The corrals are in the distance. They were not directly accessible during the Spring 2008 survey due to the presence of livestock.

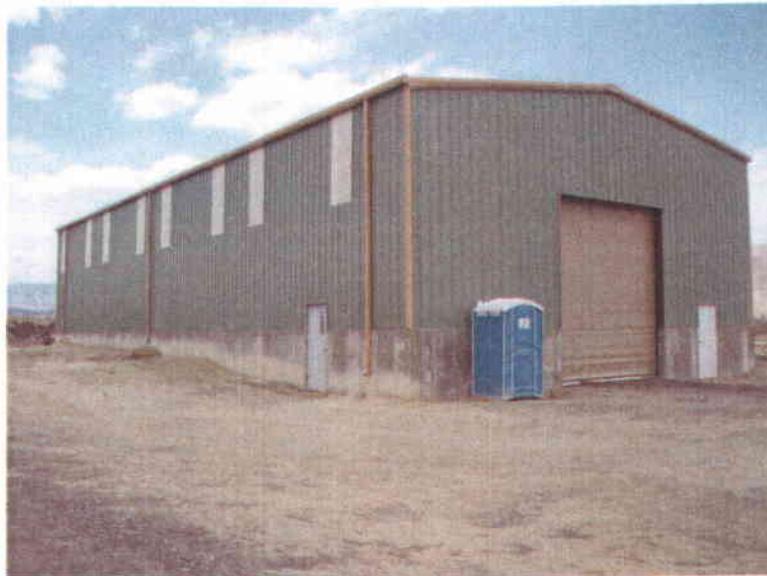
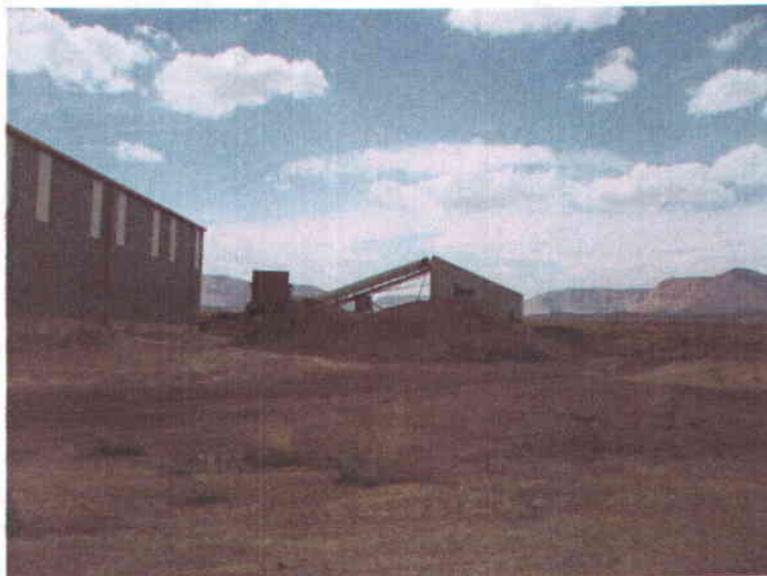
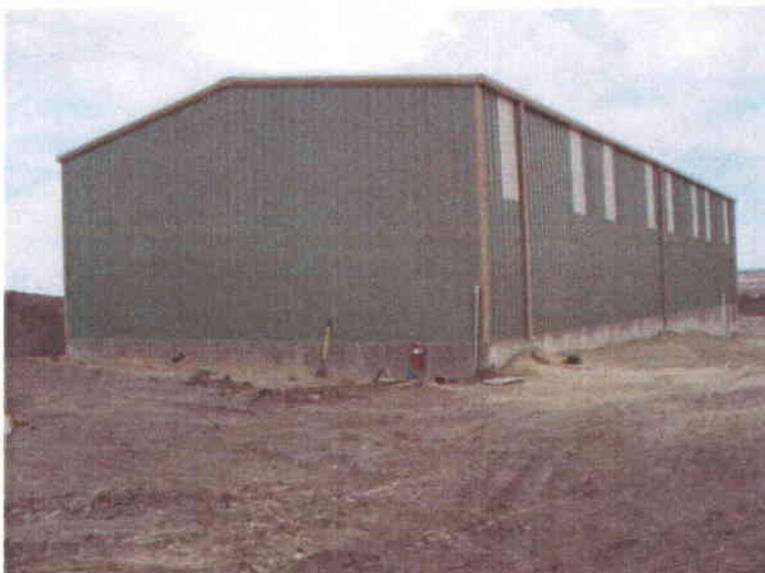
Feature 124. Shed. This feature was constructed after the Valley Engineering (1980) report was written. It is located about 1,000 feet north of the area scheduled for full extraction. The shed is built from corrugated metal with a concrete foundation and measures approximately 100 feet long by 40 feet wide by 30 feet tall. It is in excellent condition. A rock crusher is located adjacent to the shed on its northwest corner. An unimproved dirt road in fair condition leads from the graded gravel-surfaced road to the shed.

Feature 124. Shed. Looking west.

Feature 124. Shed. Looking southwest along side of shed at crusher.

Feature 124. Shed. Looking east.

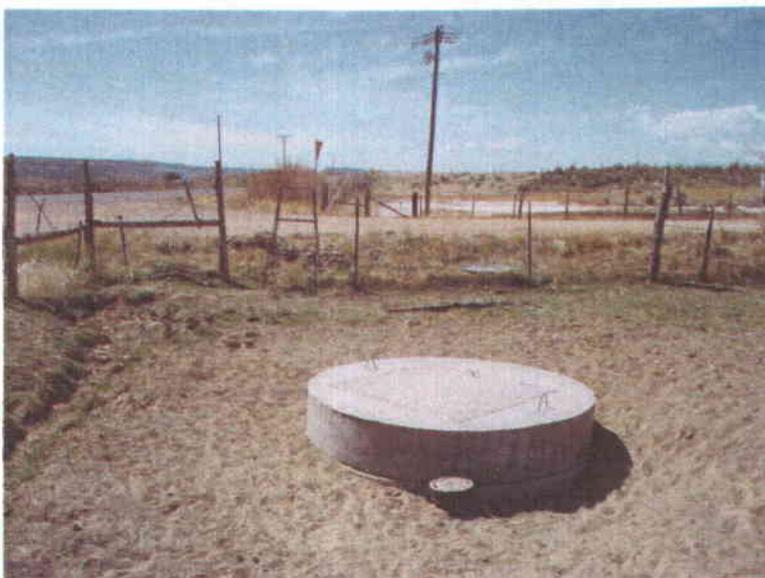
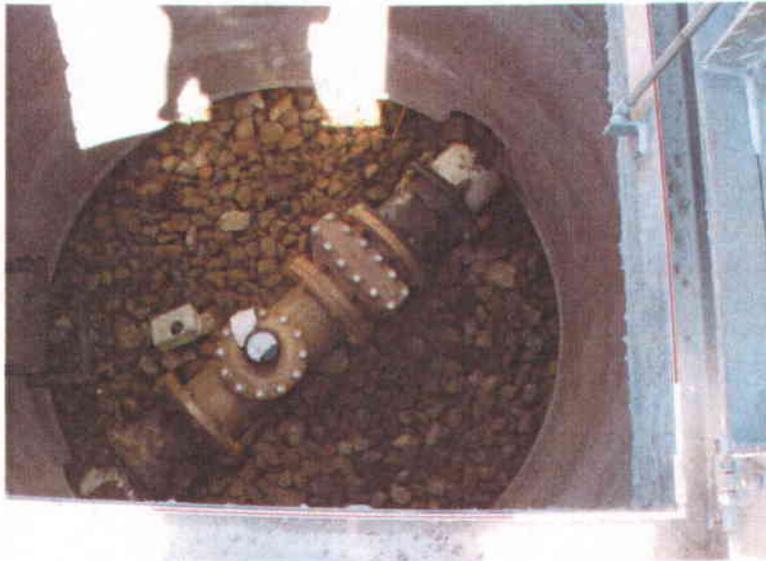
Pacificorp to mitigate subsidence damage to power lines within the full extraction area. An emergency shutoff valve has been installed on the buried water line just north of where subsidence is expected to occur. A buried fiber optic cable formerly located in the full-extraction area has been relocated to the west.

Feature 125. Water Line Manhole with Emergency Shutoff Valve. Looking south.

Feature 125. Water Line Manhole with Emergency Shutoff Valve. View into manhole looking at emergency shutoff valve.
