**EMERY MINE HYDROLOGY MONITORING REPORT  
2014-2015**

C/015/0015  
Additional Annual  
Report Information  
Received 8/22/16  
Task ID #5168

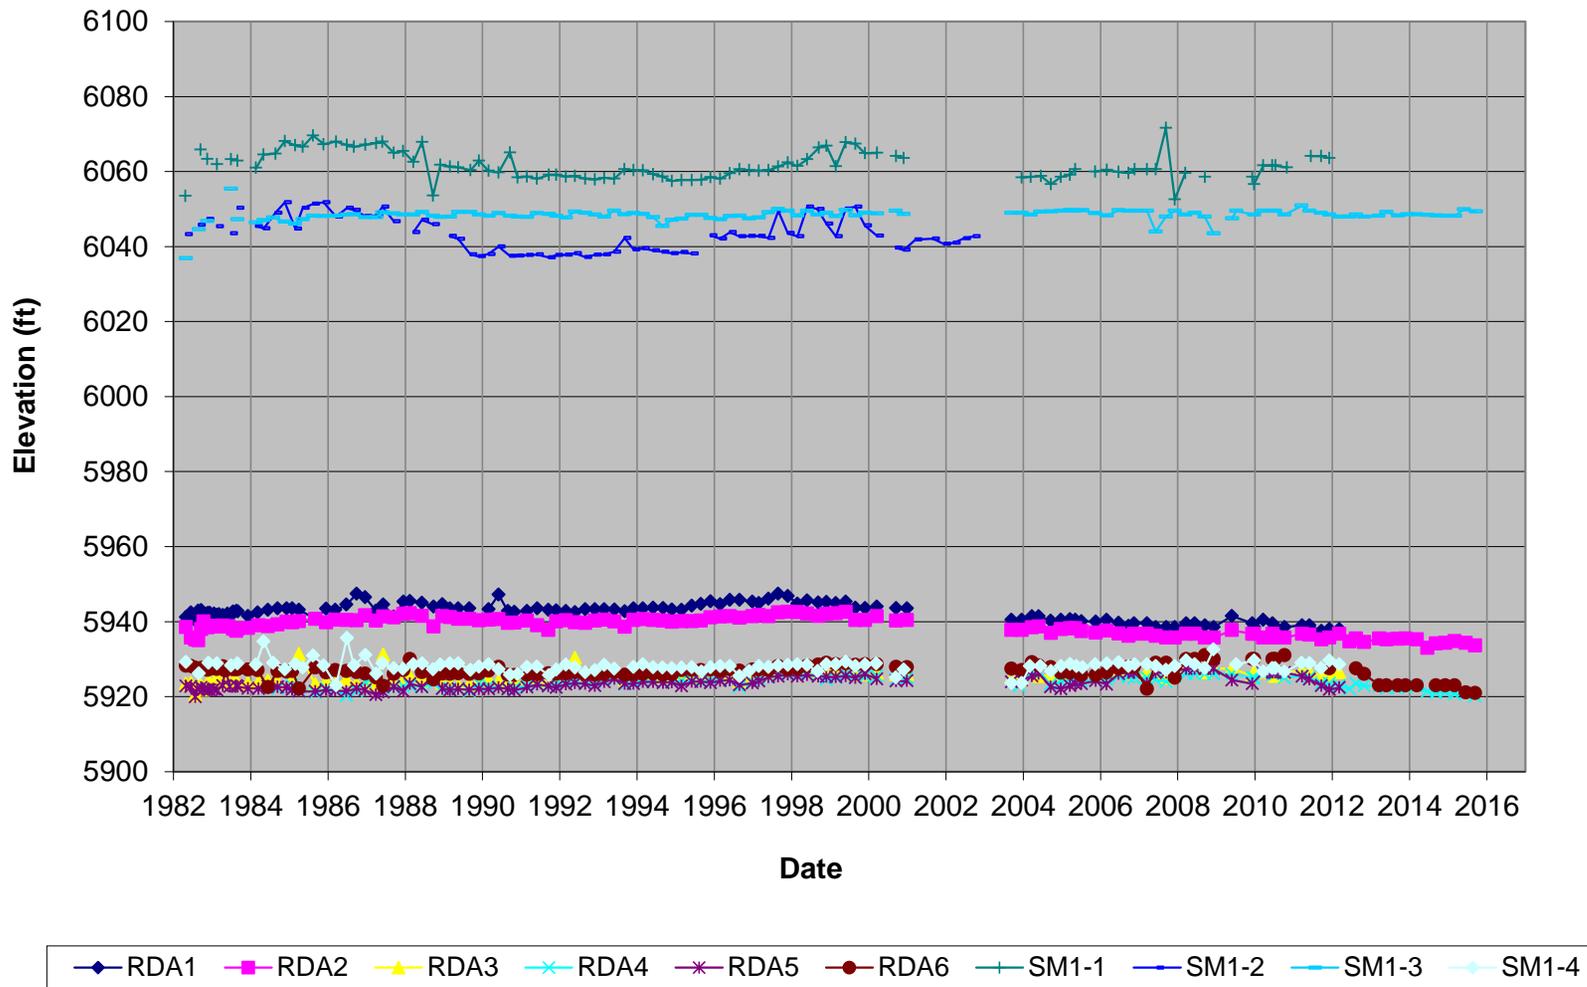
FIGURE VI-2. HYDROGRAPHS OF WELLS COMPLETED IN QUATERNARY DEPOSITS.

- Water levels remained essentially unchanged during 2014 and 2015 (compared to previous years) in wells monitoring Quaternary alluvium. Concentrations of total dissolved solids (“TDS”) vary substantially between the two wells from which samples were collected from Quaternary alluvium. At a value of approximately 47,000 mg/L, the TDS concentration of groundwater sampled at well RDA-6 is within the range of values measured at that well for the past 15 years. However, the TDS concentration of groundwater collected from well SM1-3 (at about 30,000 mg/L) was substantially lower than measured at that well since the mid-1980s, probably due to cleaning of the well to remove sediment from a flood that occurred in the adjacent Christiansen Wash in the fall of 2014 (see below).

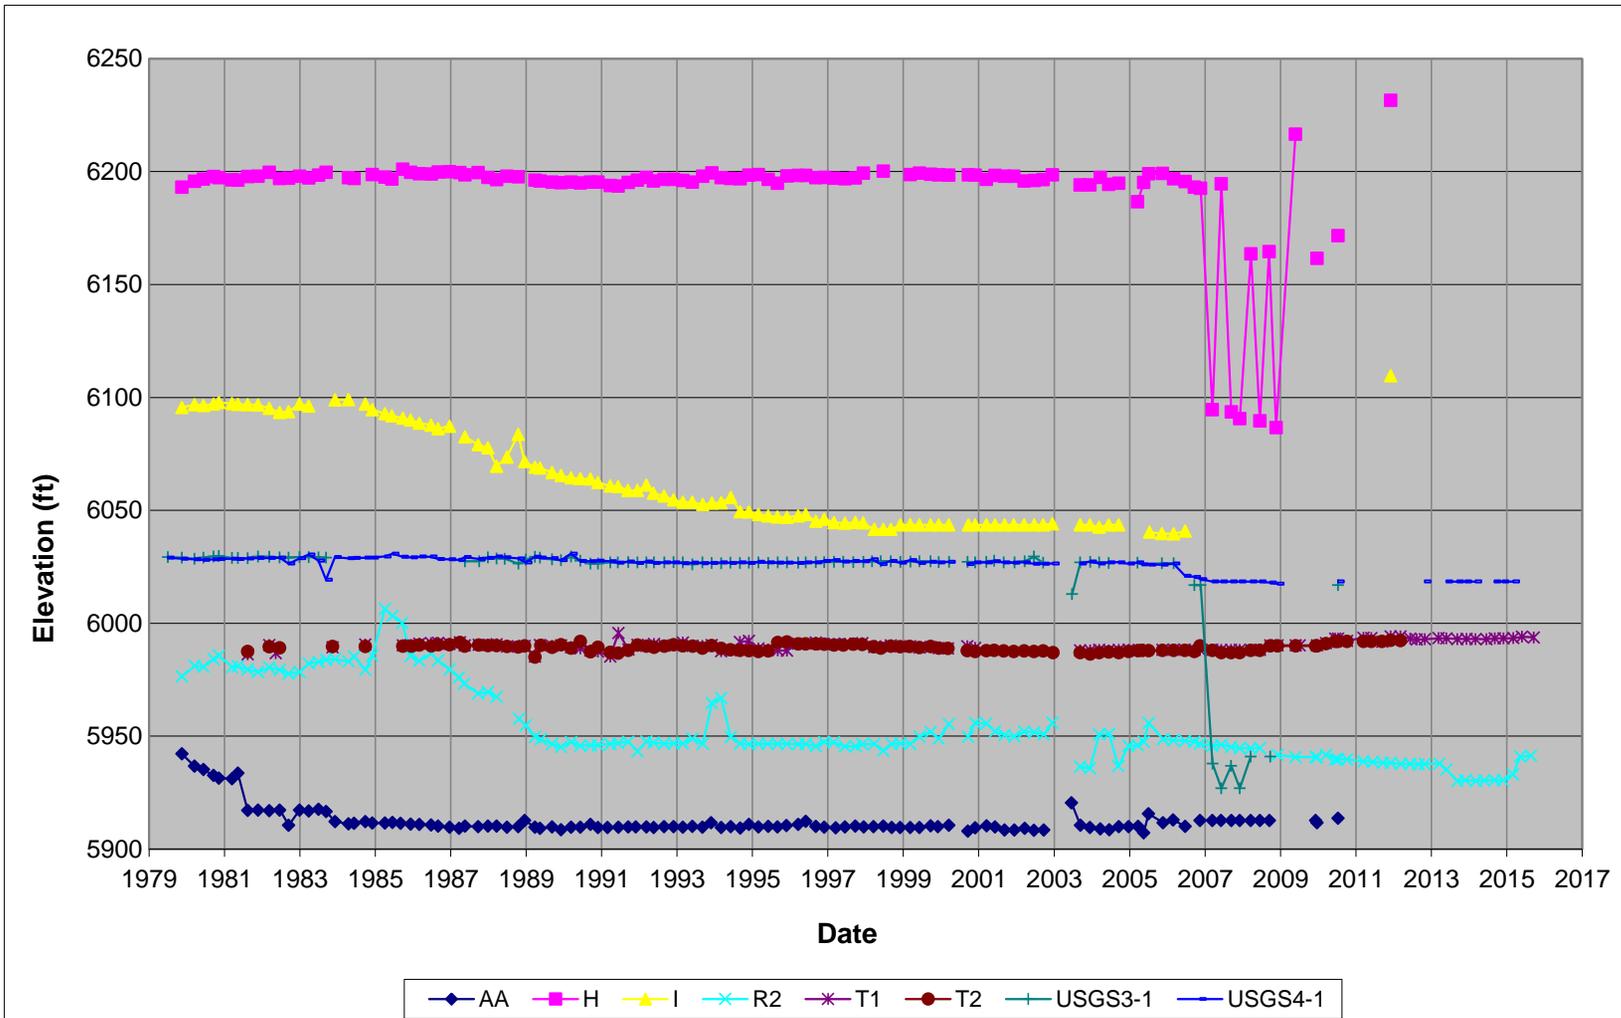
FIGURE VI-4. HYDROGRAPHS OF WELLS COMPLETED IN THE BLUE GATE MEMBER

- The depth to groundwater in well T1-B monitoring the Blue Gate Shale remained relatively constant during 2014 and 2015, with no substantial changes from prior years. Water levels increased in well R2-B during 2014 to levels similar to those prior to 2013 and then remained relatively constant during 2015. Well USGS4-1 is functioning properly but has been dry since 2007. Unfortunately, the depth-to-water data reported for this wells in the DOGM database since 2007 are actually the depth to the bottom of the dry well. The DOGM database should be changed to remove the water-level data for that period and simply indicate that the well was dry. This can only be done by DOGM personnel.

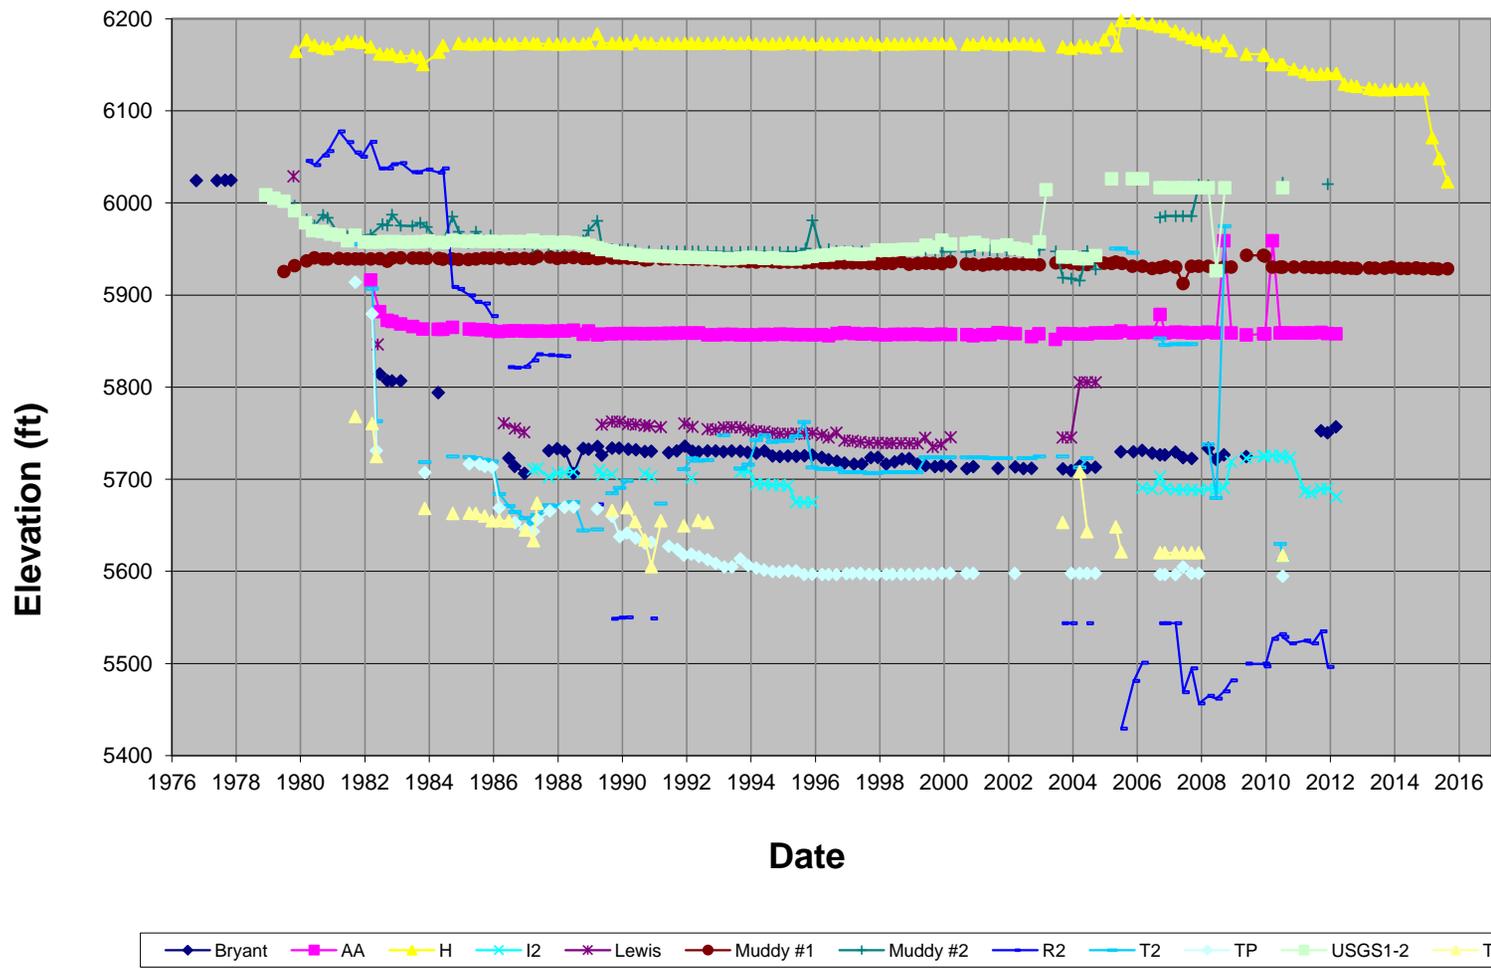
FIGURE VI-5. HYDROGRAPHS OF WELLS COMPLETED IN THE UPPER FERRON SANDSTONE.

- Water levels in well Muddy #1, monitoring the upper Ferron Sandstone, remained relatively constant during 2014 and 2015 and similar to levels measured in prior years. However, the elevation of the groundwater surface continued to decrease in well H-U during 2014 and 2015, a phenomenon that has been occurring in this well since 2005. With no mining and no increased groundwater use known to be occurring in the vicinity of well H-U for the past several years, the reason for the decreasing water levels at H-U remains unknown.

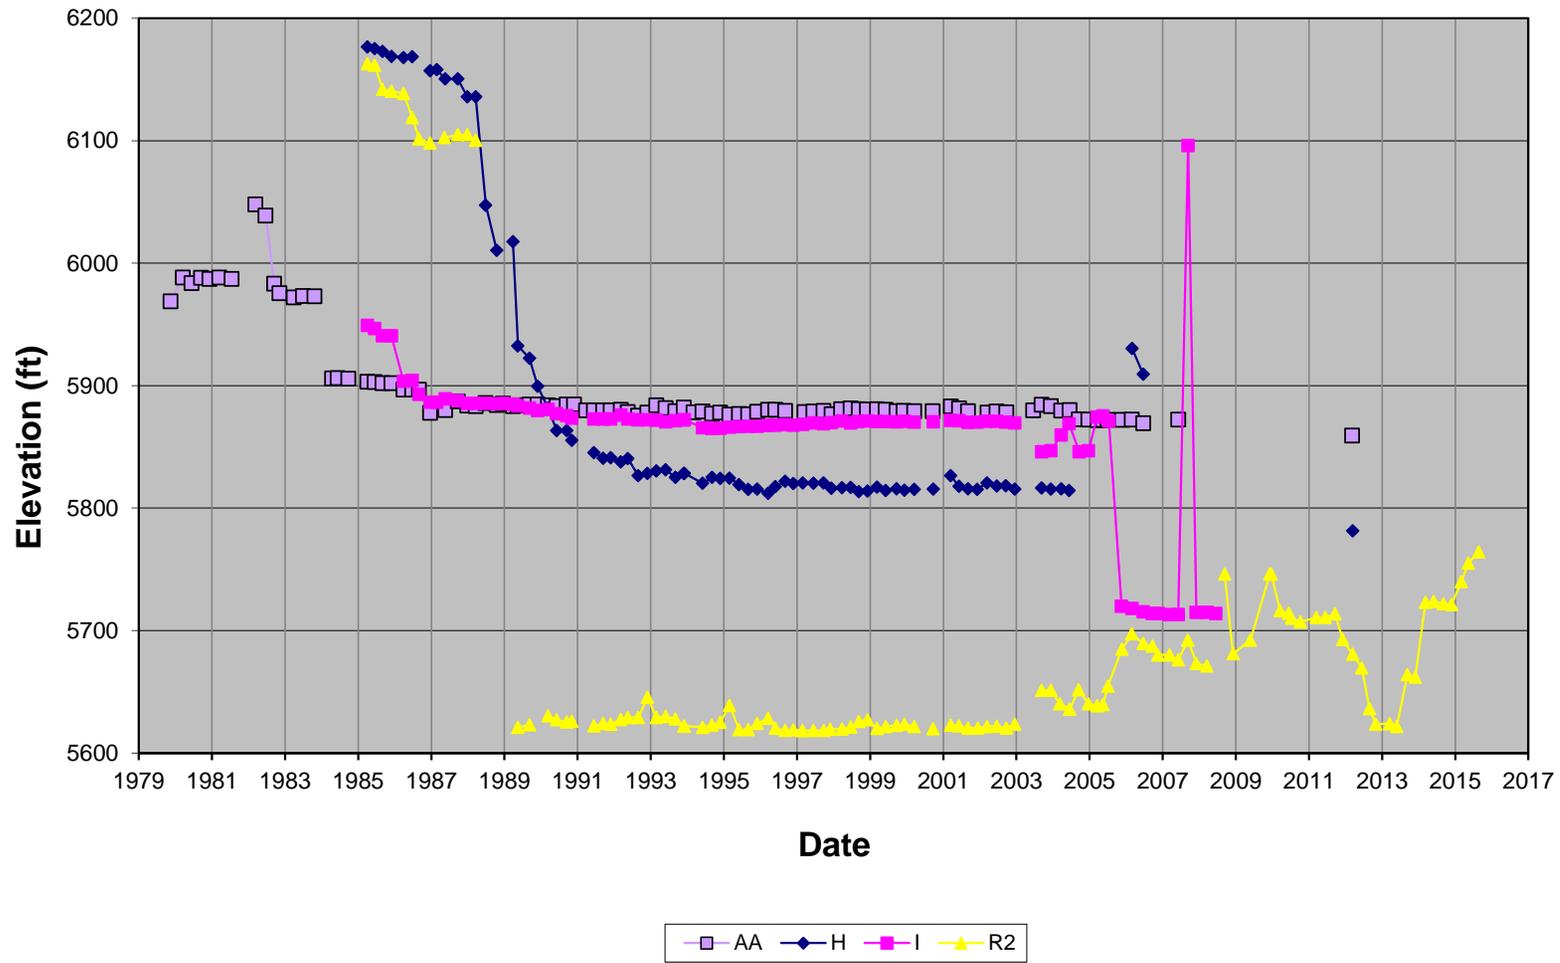
FIGURE VI-6. HYDROGRAPHS OF WELLS COMPLETED IN THE MIDDLE FERRON SANDSTONE.

- The elevation of the groundwater surface has been increasing in well R2-M, monitoring the middle Ferron Sandstone, since 2013.

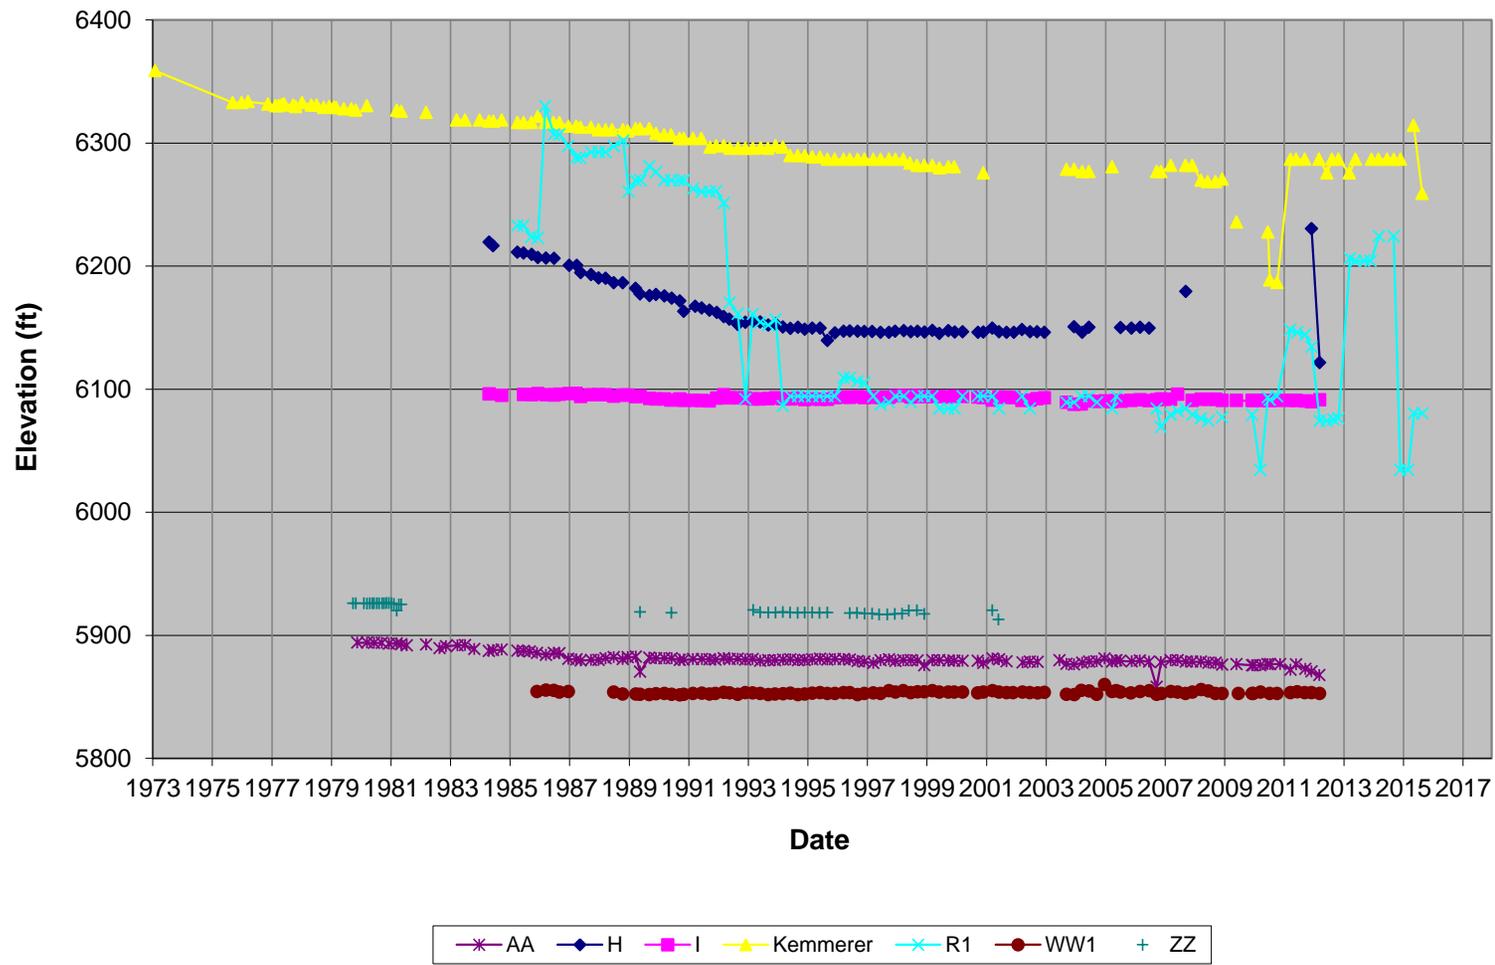
FIGURE VI-7. HYDROGRAPHS OF WELLS COMPLETED IN THE LOWER FERRON SANDSTONE.

- Water levels in the Kemmerer well and well R1-L, monitoring the lower Ferron Sandstone, remained with the range of historic data collected from these wells. It is of note that a new pressure gauge was installed on the Kemmerer well in late 2011 or early 2012, to replace the prior gauge that had been providing spurious data since 2009. Therefore, the depth-to-water data reported in the database for 2009 through 2011 are not considered valid. Furthermore, beginning in 2002, the pressure data (measured in psi) were reported sometimes as the depth to water, sometimes as the flow from the well, and sometimes as a comment only. Also, between 1995 and 2002, the depth-to-water data were all reported as "0", which was the common practice at the time for all pressure measurements. Thus, the water-level data contained in the DOGM database for the Kemmerer well need to be converted from a positive pressure value or other value to a negative depth value for the period of 1995 through 2014. Similarly, pressure measurements (in psi) collected from R1-L were entered into the DOGM database as the depth to water since at least 1994. Some of these pressure measurements were entered as negative values and some were entered as positive values. In any case, none of the values were properly entered into the database. Any inaccurately-recorded data should be converted to a negative depth to water and the DOGM database should be properly updated. This must be done by DOGM once the correct data are provided to them.
