**RE: Bronco Utah Operations LLC
Emery Mine
DOG M Permit No. C/015/0015
Emery 2 Second Left Panel Full Extraction Revision Clean Copy task 5847**

The purpose of this report is to present baseline surface conditions prior to full extraction operations from the Emery 2 portal of the Bronco Utah Operations, LLC. (Bronco) Emery Mine, Emery County, Utah. The areas covered in this report include the following:

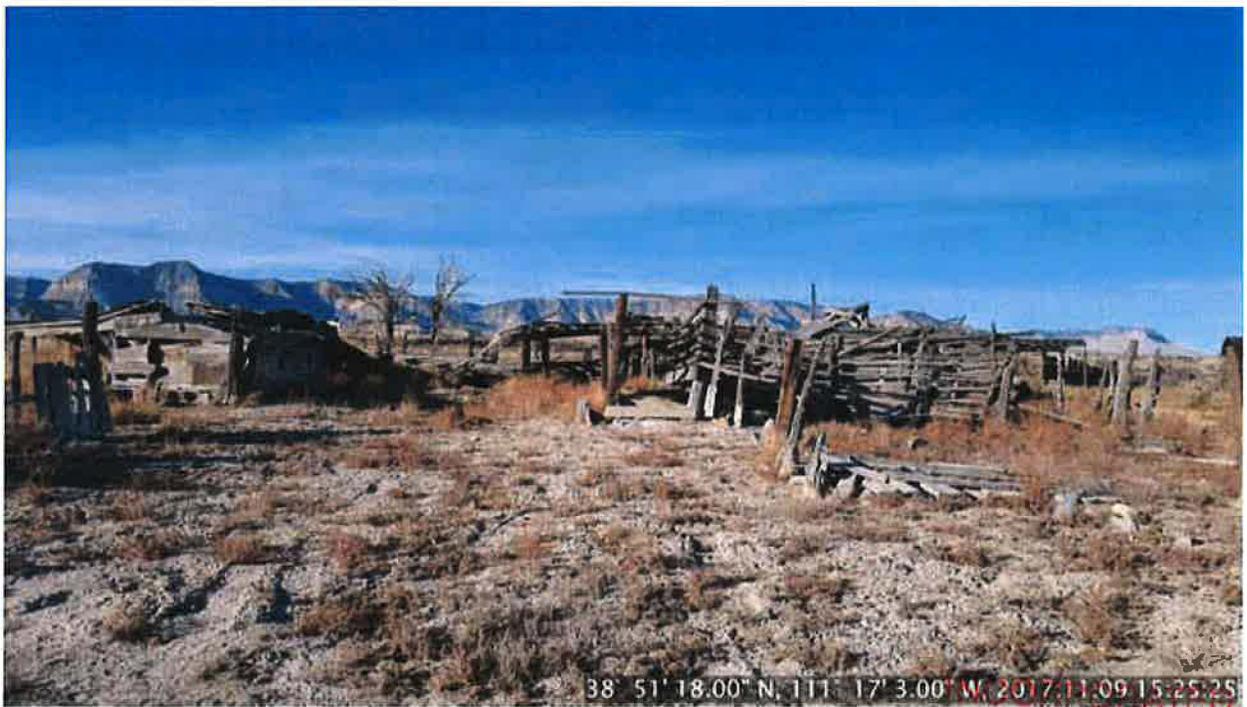
that section of the house has collapsed. One corner of the cinder block building has collapsed. The remaining buildings and corrals are constructed of rough wood logs and rough cut boards. The wood roofs on these building are failing. The corrals are unusable and have mostly fallen to the ground. There are several types of fences in the area; the most common was barbed wire or wire mesh on the bottom with barbed wire above the mesh. Fence posts were mainly steel or rough cut tree limbs.

Feature 1. Ranch House, Buildings, and Corrals. Corrals.

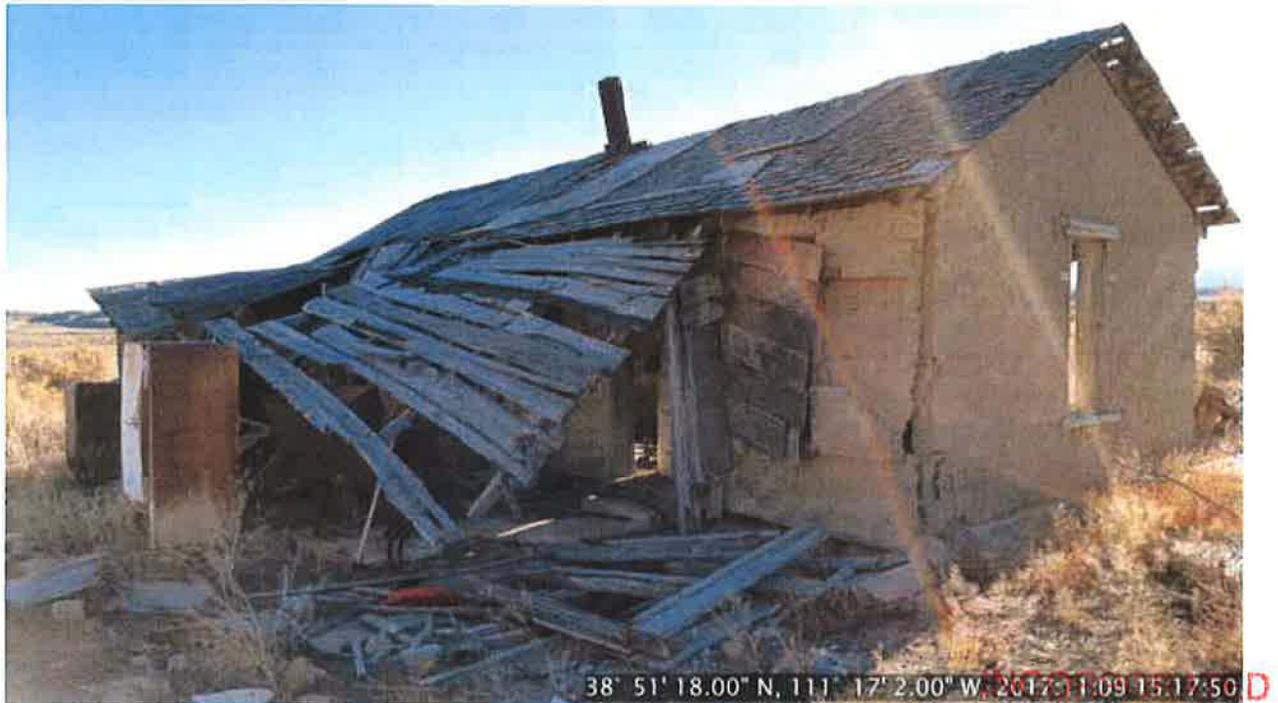
Feature 1. Ranch House, Buildings, and Corrals. Ranch House.

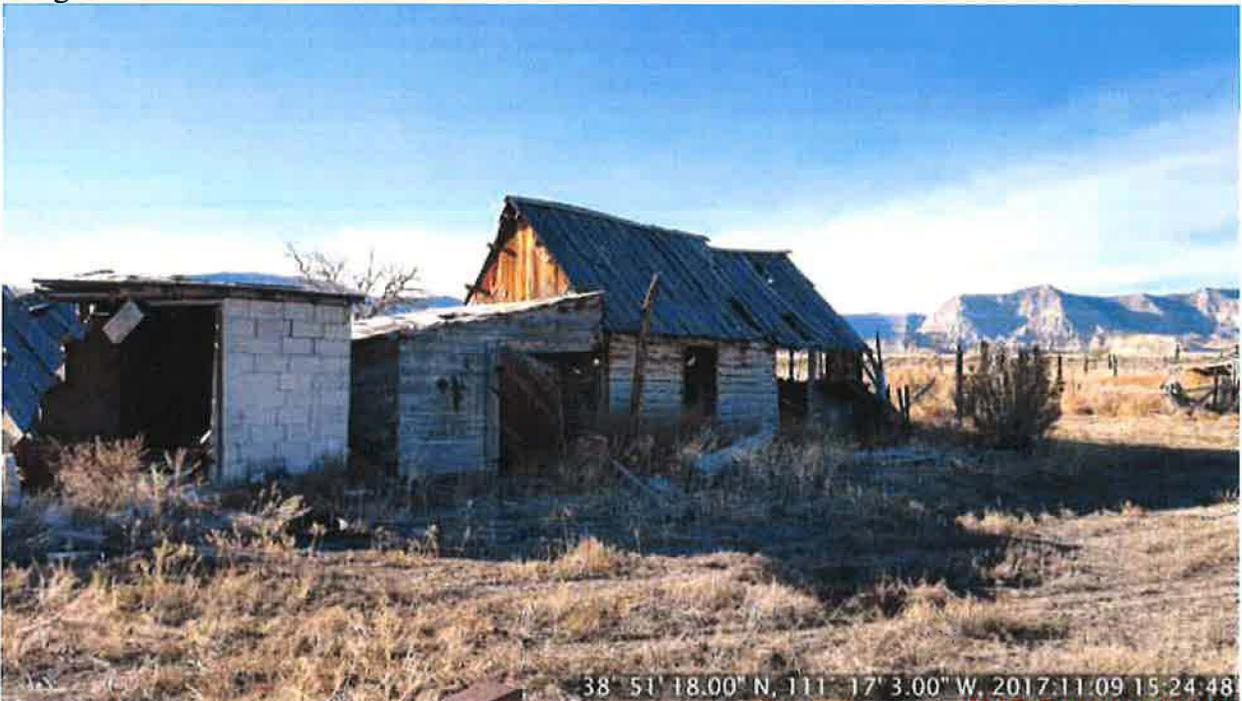
Feature 1. Ranch House, Buildings, and Corrals. Buildings. Cinder block building in foreground.

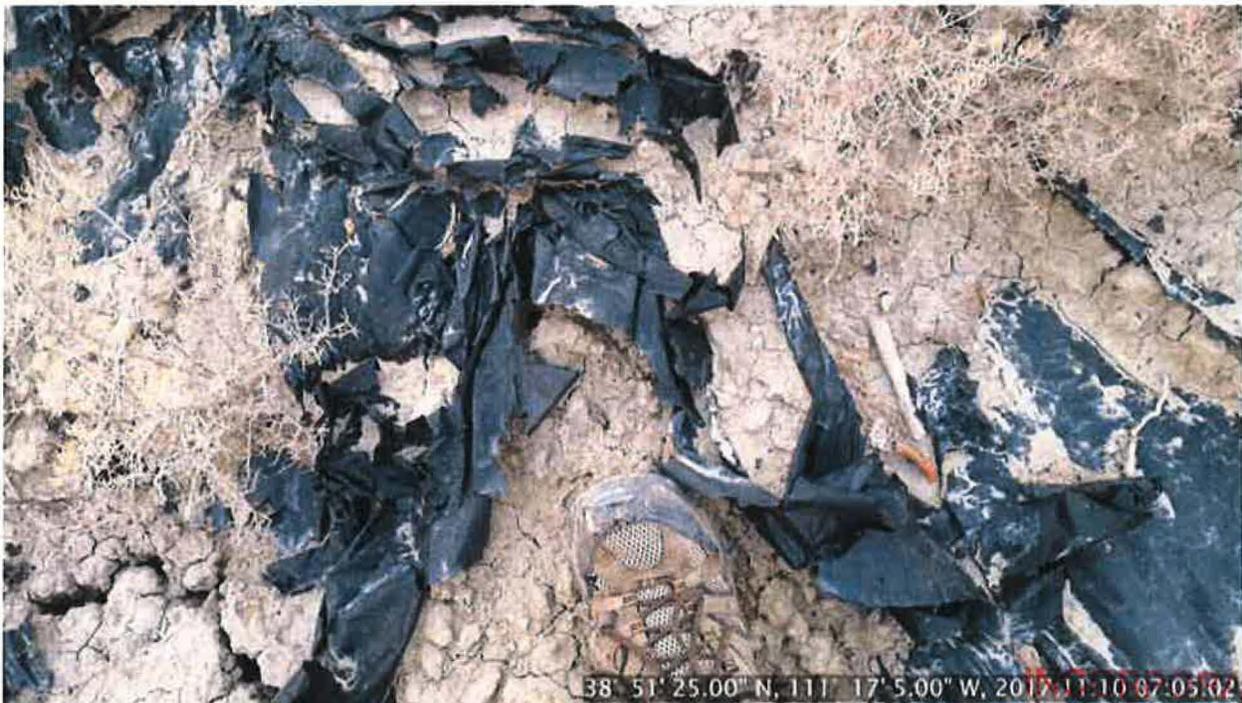
Feature 6. Pond. Disintegrated pond liner.

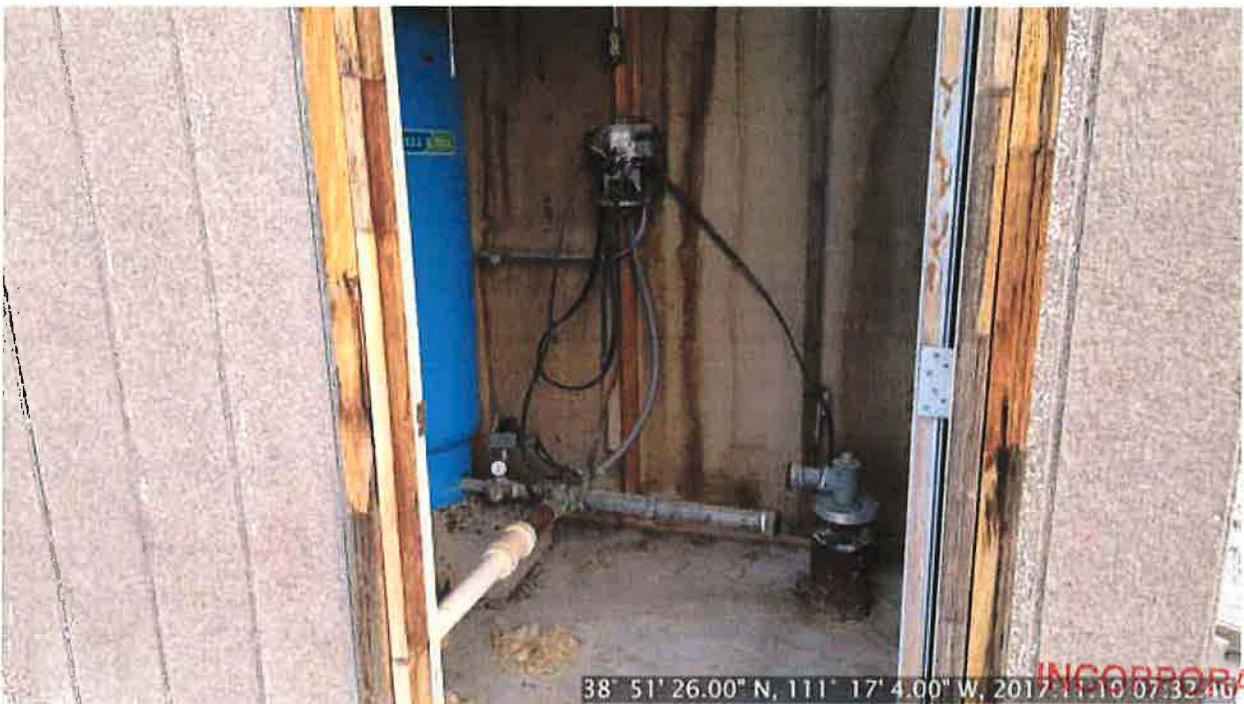
Feature 8. Well. Piping is disconnected from wellhead.

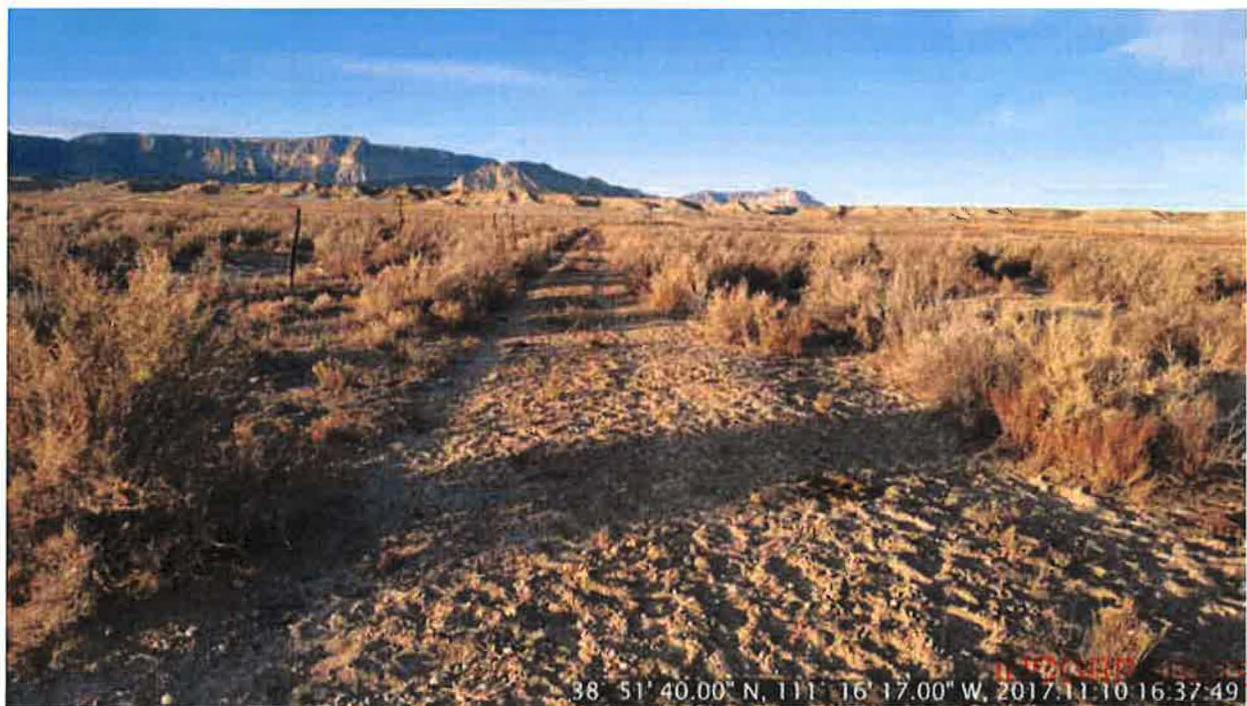
Feature 27. Area Roads. Looking north. Road disappears south of this location. JAN 24 2019

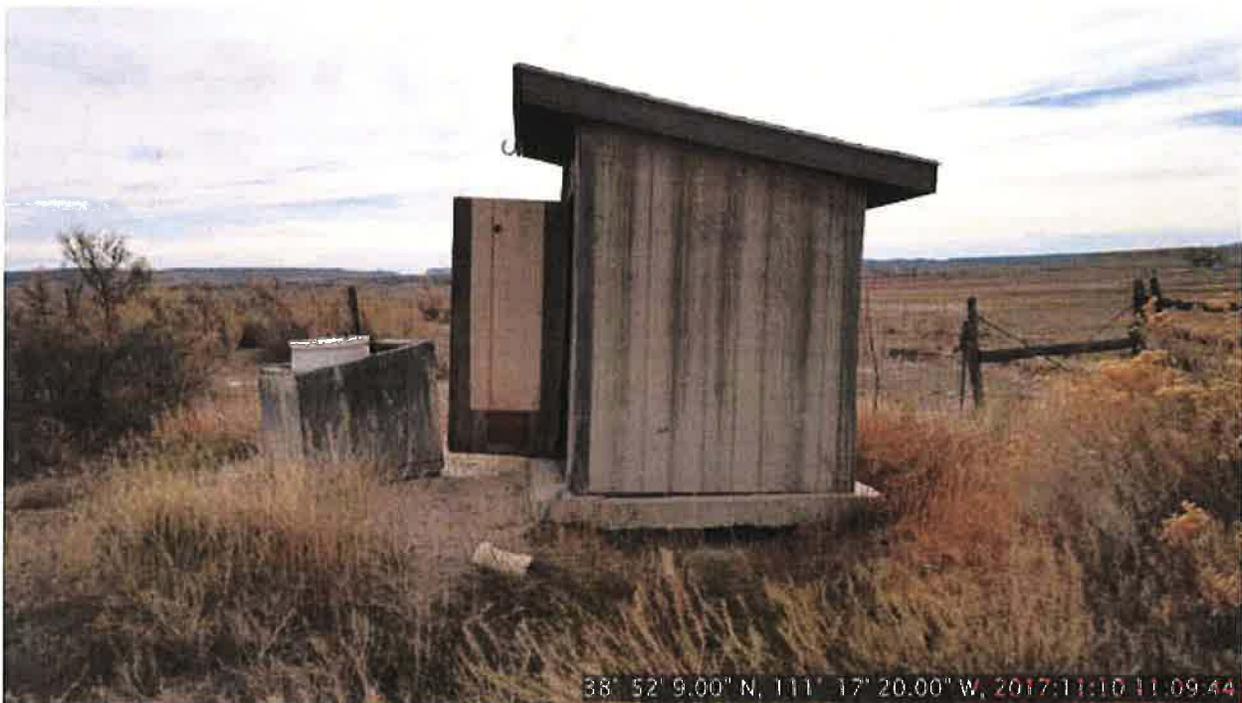
the Lewis Well, formerly provided water for a ranch house and buildings (Feature 35) located to the north. Water is currently provided to this ranch house by Emery Town municipal water. The concrete slab poured around the well casing and which supports the small well house covering the well casing has experienced differential settlement of several inches. The slab slopes from north to south. The worst settlement has occurred at the well casing. The concrete slab surrounding the casing has cracked, separated, and dropped in elevation approximately 4 inches.

Feature 34. Culinary Well. Concrete pad surrounding wellhead is cracked and separated from rest of pad.

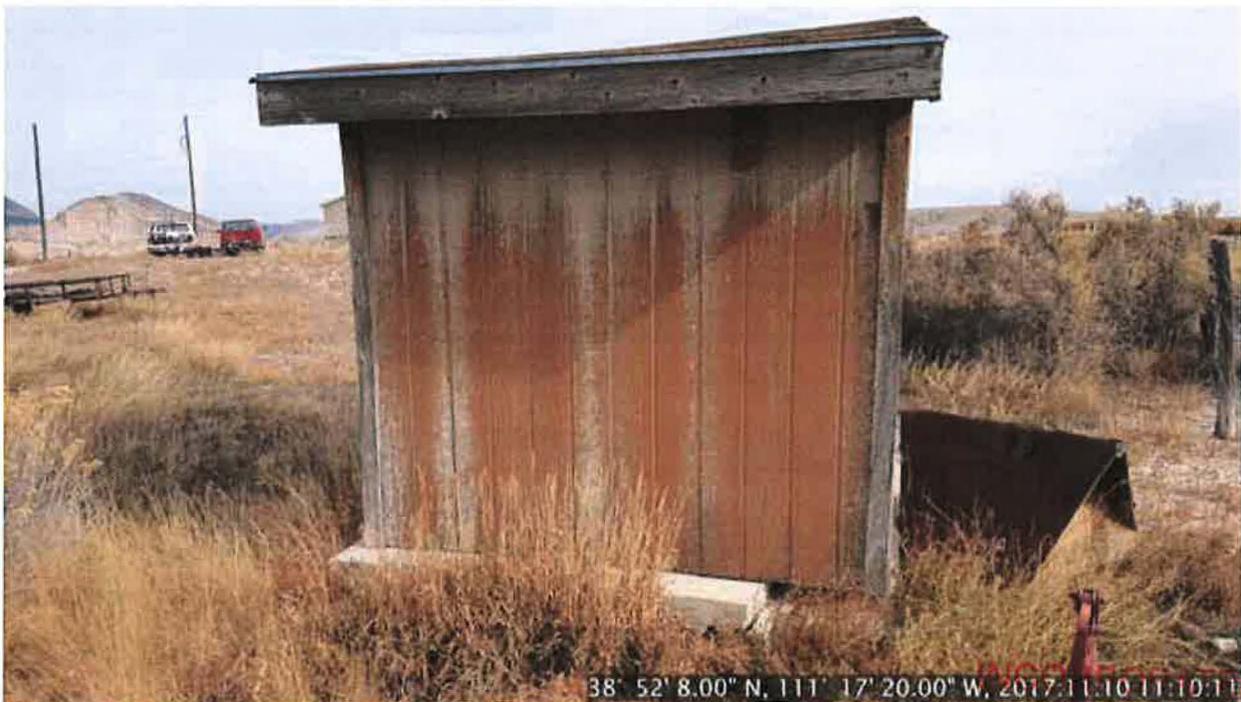
Feature 34. Culinary Well. Looking north. Concrete pad is cracked and offset.

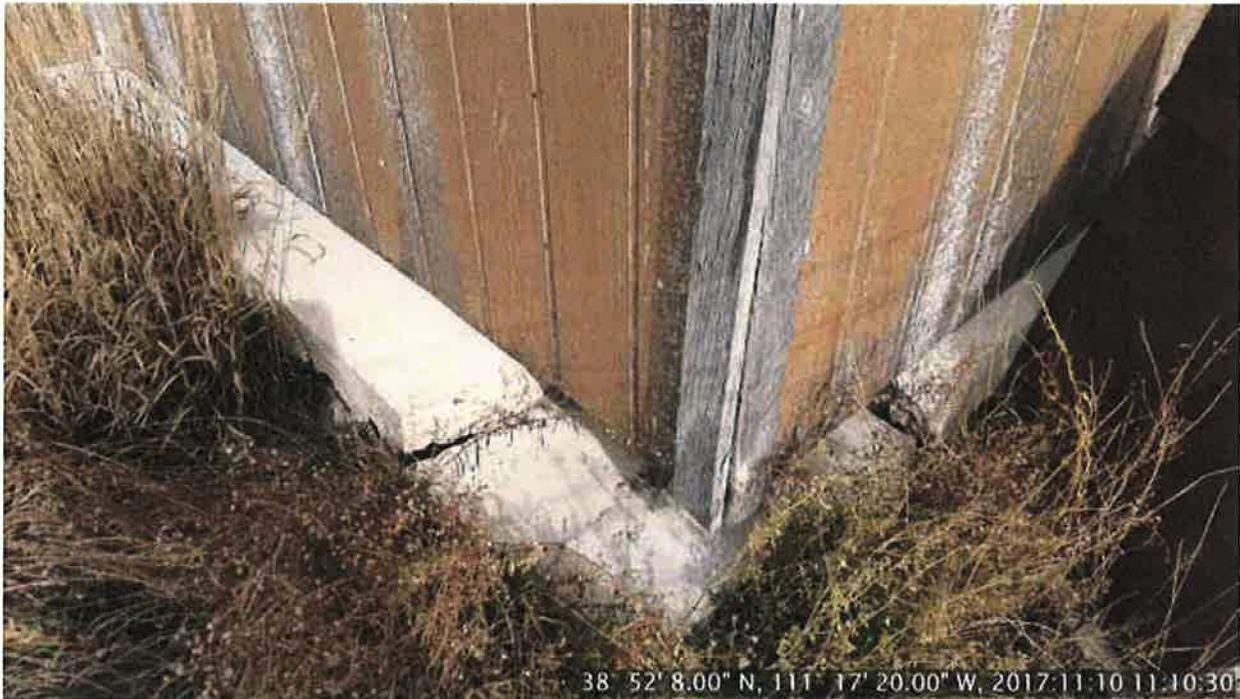
Feature 34. Culinary Well. The corner of the cracked concrete pad surrounds the wellhead located in the well house.

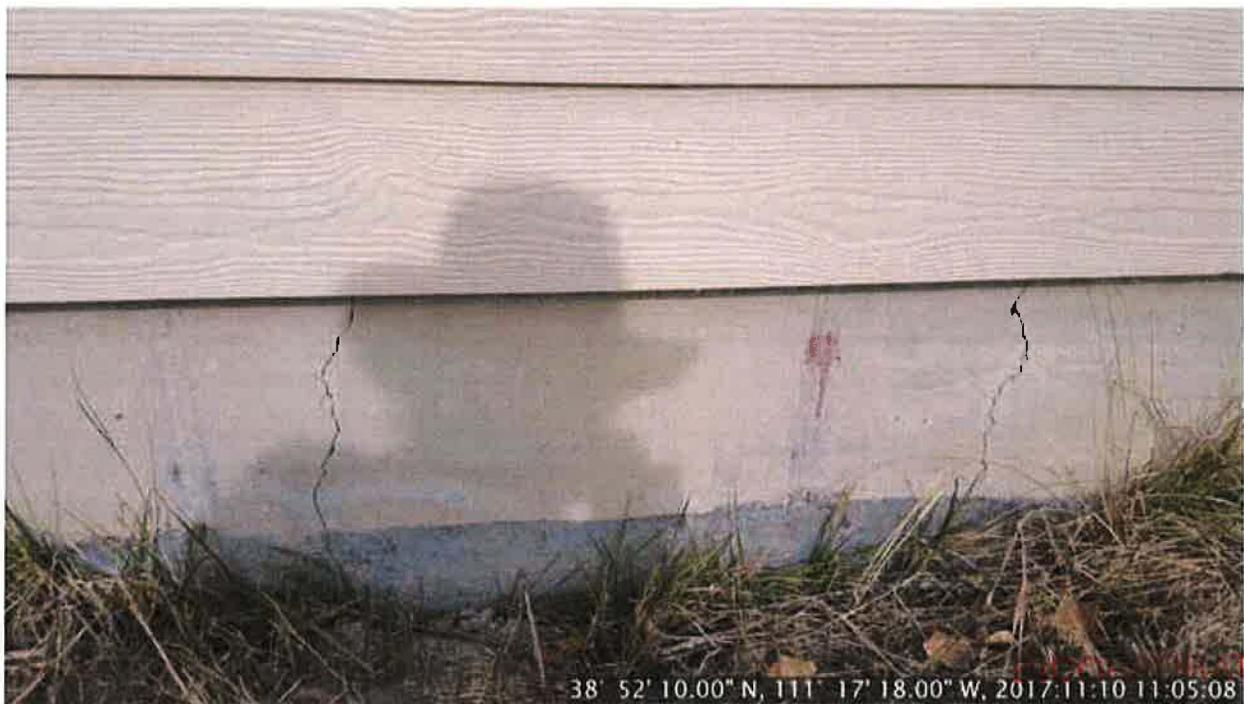
- A double wide manufactured home installed after the 1980 report. This home is installed on a concrete foundation that is intact with only two small cracks that are typical of cracks found in most residential home foundations. Overall, the home appears to be in good condition.

Feature 35. Ranch House and Buildings. Manufactured home. Small cracks in foundation.

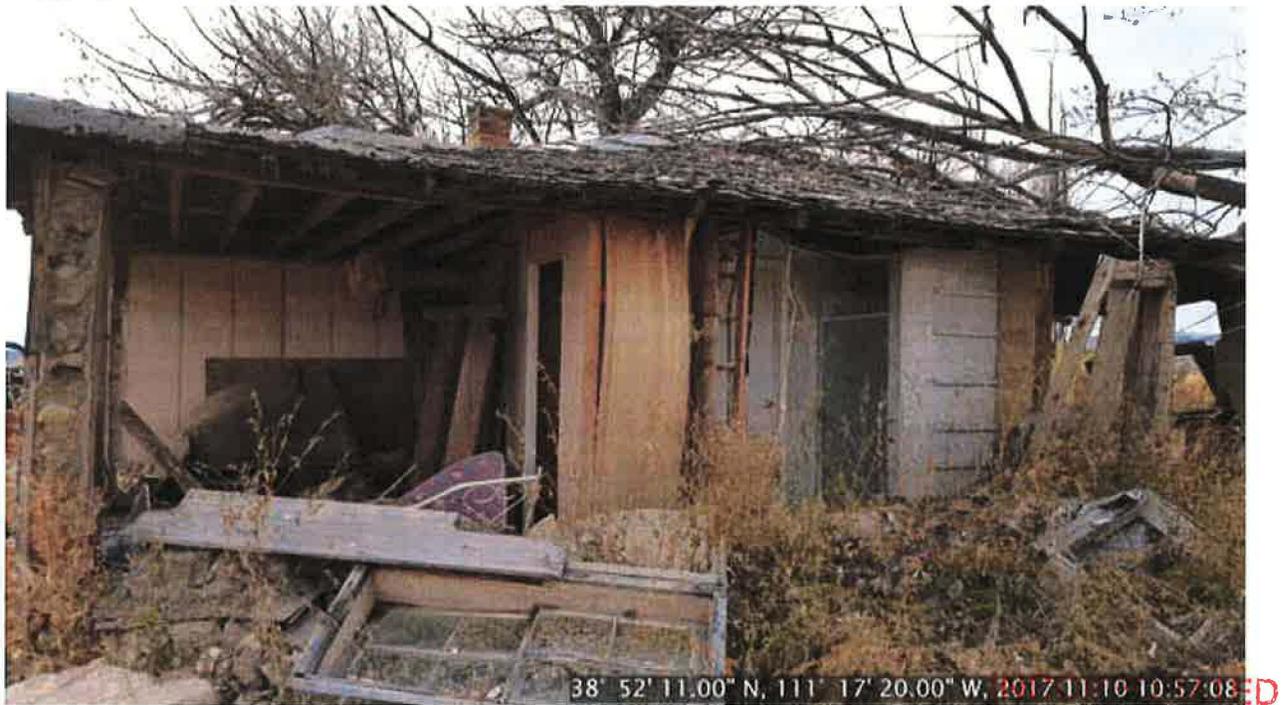
- Wood outhouse constructed of natural rough cut logs. This structure appears to be in fair condition.
- Ranch house constructed of rough sawn logs and adobe brick. The adobe walls have fallen down, exposing the north end of the house to outside elements. It is dilapidated and unlivable. A concrete structure located near the ranch house appears to be an old septic tank.

Feature 35. Ranch House and Buildings. Side view of ranch house. Adobe wall crumbled. Sagging roof.

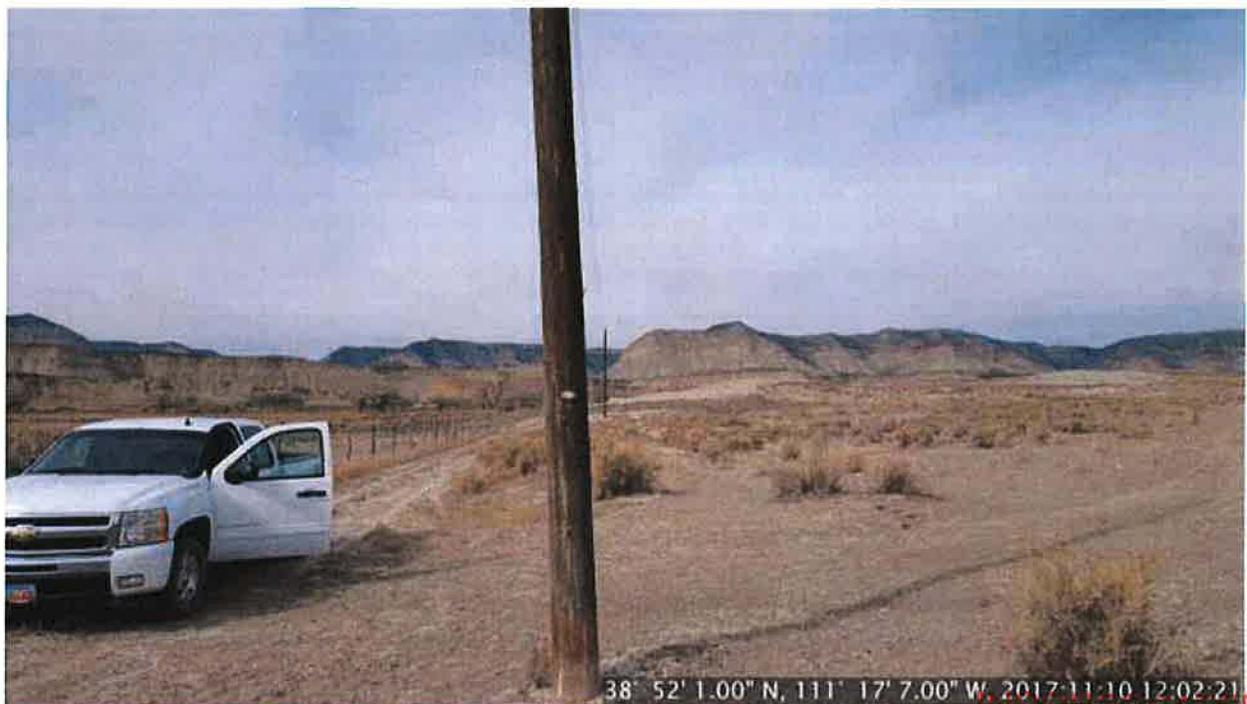
Feature 36. Utility Power Line. The description of this feature has been updated from the Valley Engineering (1980) report. A portion of this feature is located within a buffer zone, depicted on Figure 1 and Plate V-5, where subsidence is not anticipated. The electrical power line is a single line that supplies electricity to the ranch house and buildings (Feature 35). The poles are typical power line poles, approximately 35 feet tall and in good condition. The eastern most pole in this line, which also forms a part of the north/south power line (Feature 5) that this line ties into, leans to the south and west.

Feature 36. Utility Power Line. Looking northwest. Top of pole in foreground leans slightly left.
