The Effects of the Deer-Creek Mine  
C-2 Overland Conveyor  
on

Mule Deer Migration

VAL PAYNE

APRIL 1983

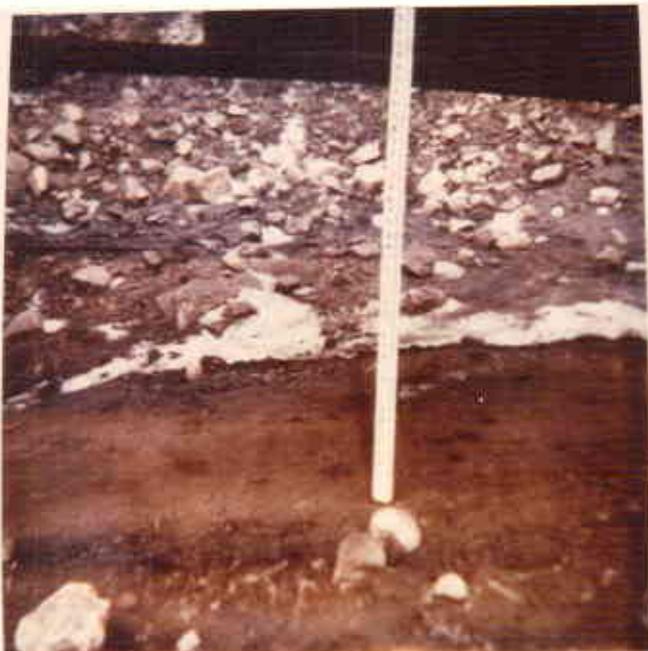
LOCATION: 0 to 1  
COMMENTS: Note tracks under belt.

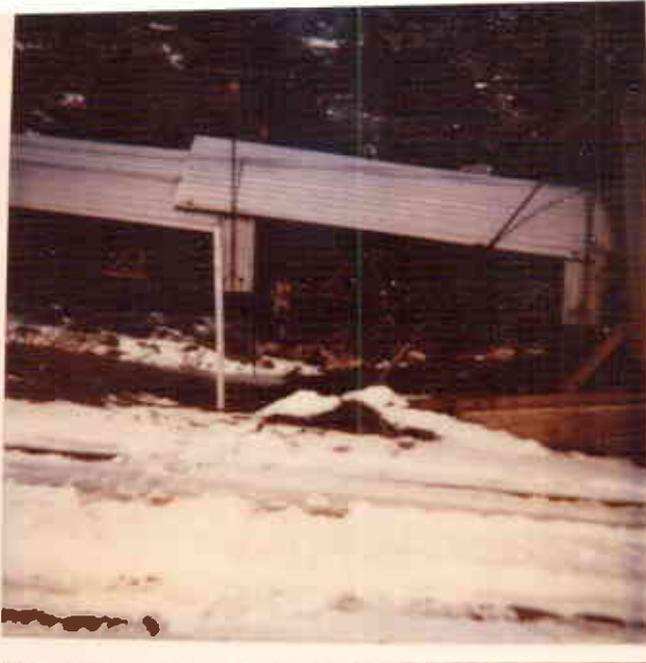
LOCATION: 22 to 23  
COMMENTS: Tracks 2" long on  
concrete anchor base. Distance  
from track to belt is 26".

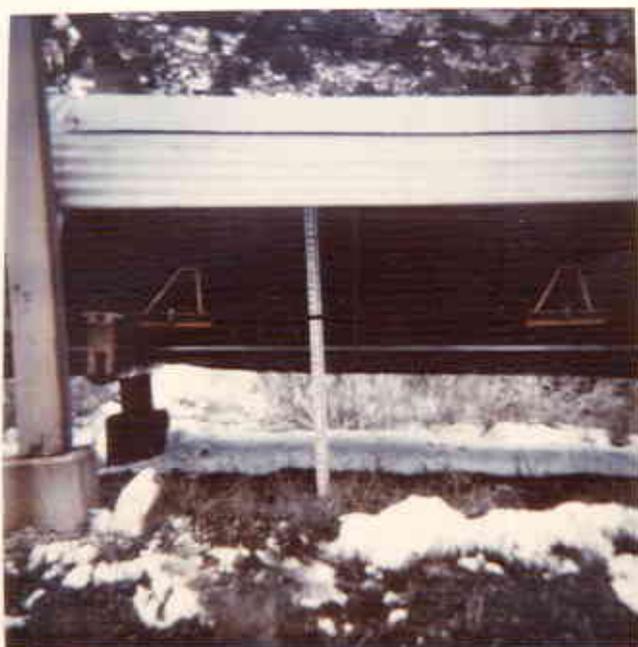
LOCATION: 108 to 109  
COMMENTS: Single track crossing  
North.

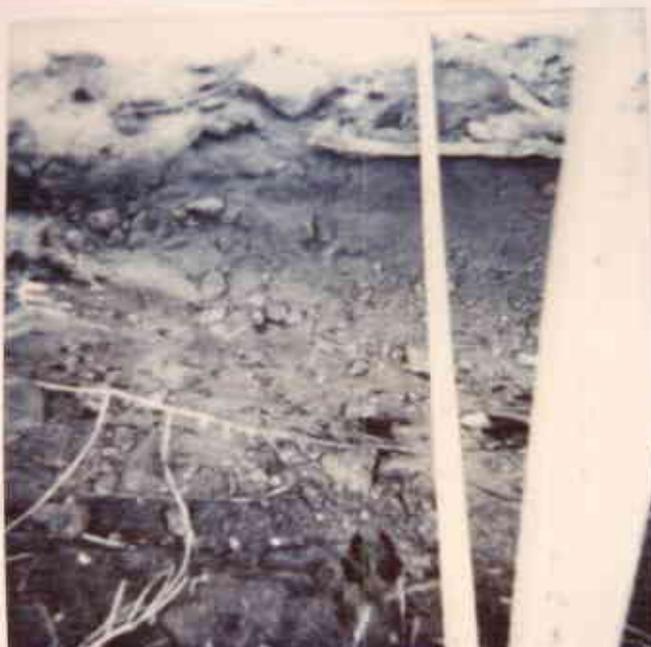
LOCATION: 95 to 96  
COMMENTS: Note tracks at upper  
right-center of photo.

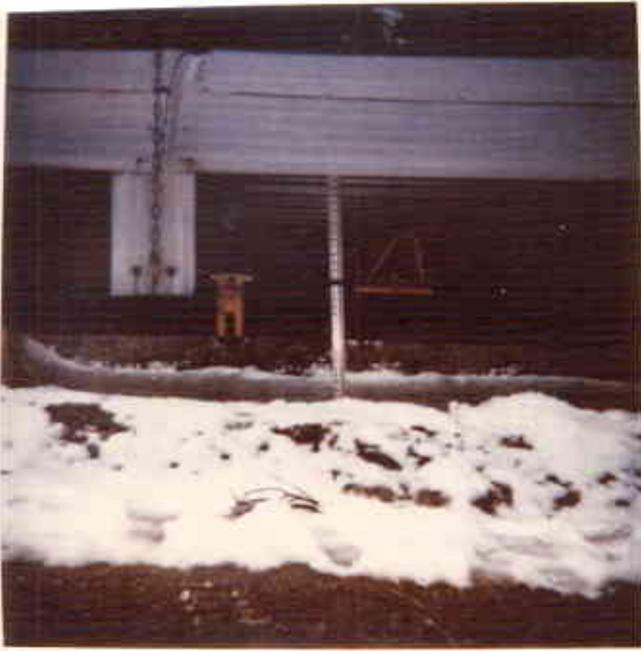
LOCATION: 95 to 96  
 COMMENTS: 2 1/2" tracks under belt.  
 Note small "window" size.

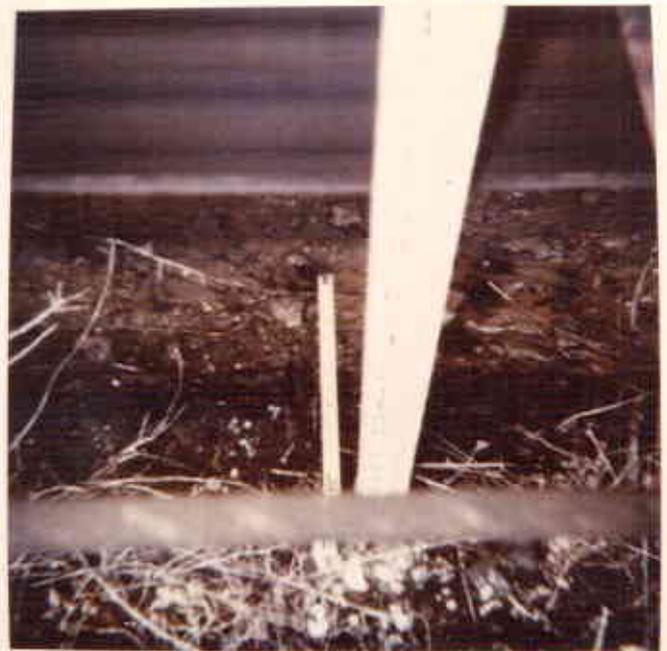
LOCATION: 95 to 96  
 COMMENTS: Note location of track  
 in relation to conveyor ropeline  
 and belt.

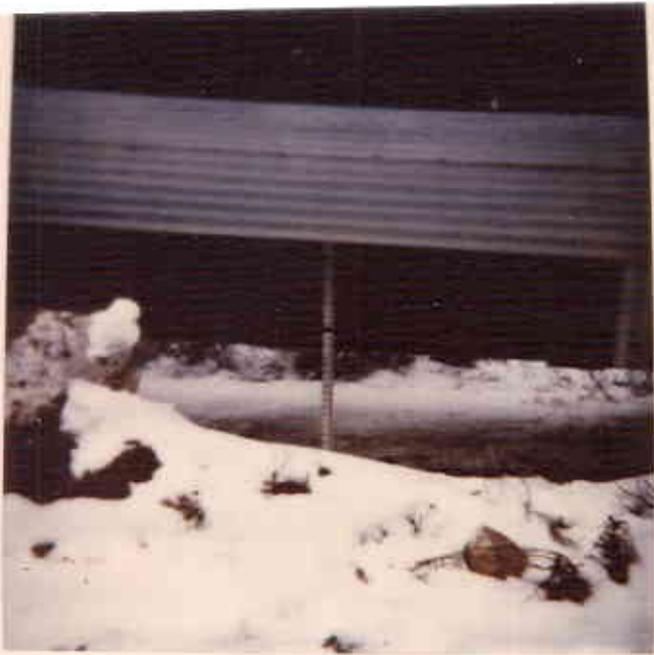
LOCATION: 89 to 90  
 COMMENTS: Single track crossing  
 North.

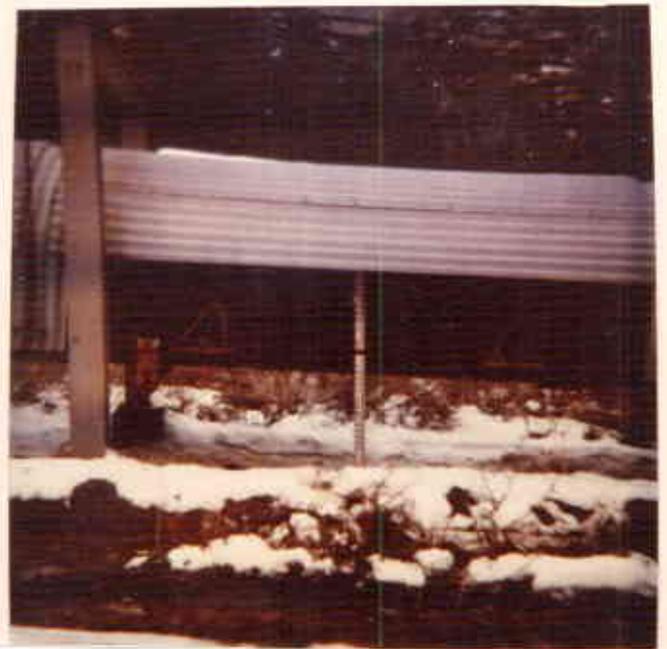
LOCATION: 77 to 78  
 COMMENTS: Track crossing North  
 and South.

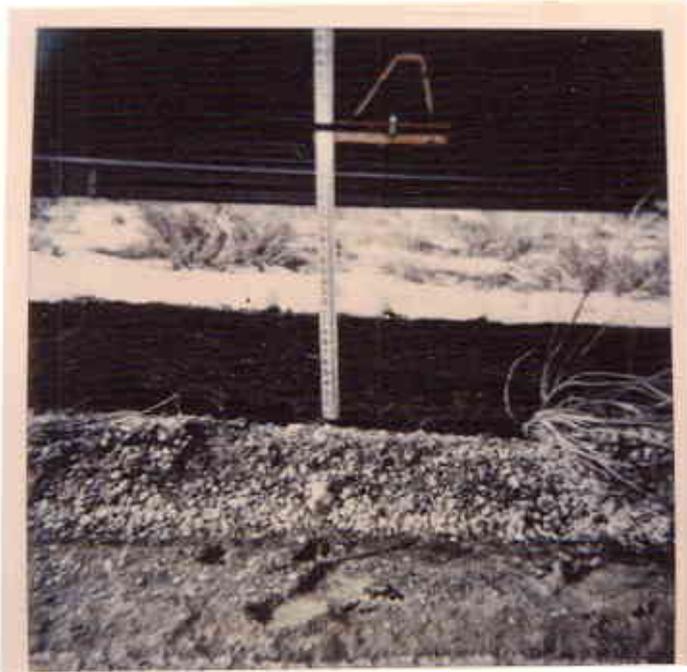
LOCATION: 144 to 145  
COMMENTS: Tracks crossing North.  
Lateral movement 15' along service  
road (see next photo).

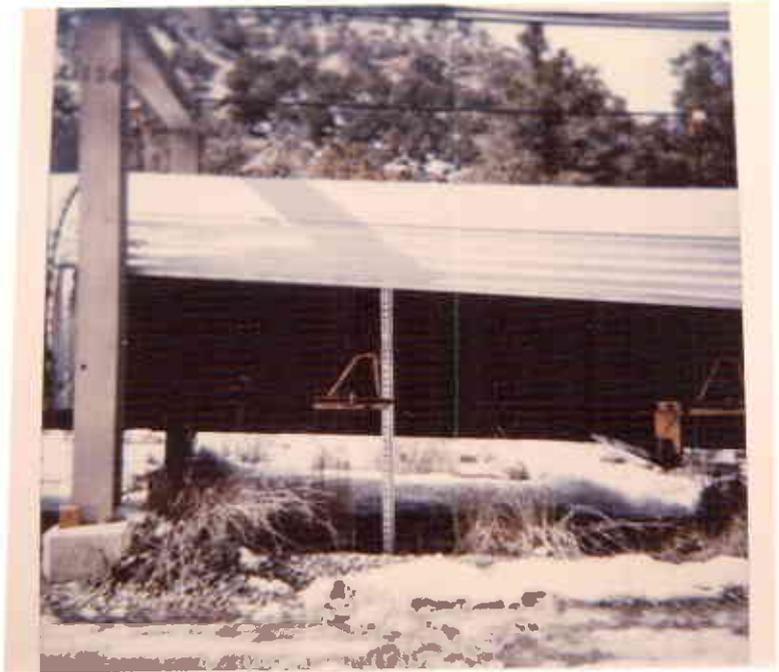
LOCATION: 134 to 135  
COMMENTS: Track crossing South.

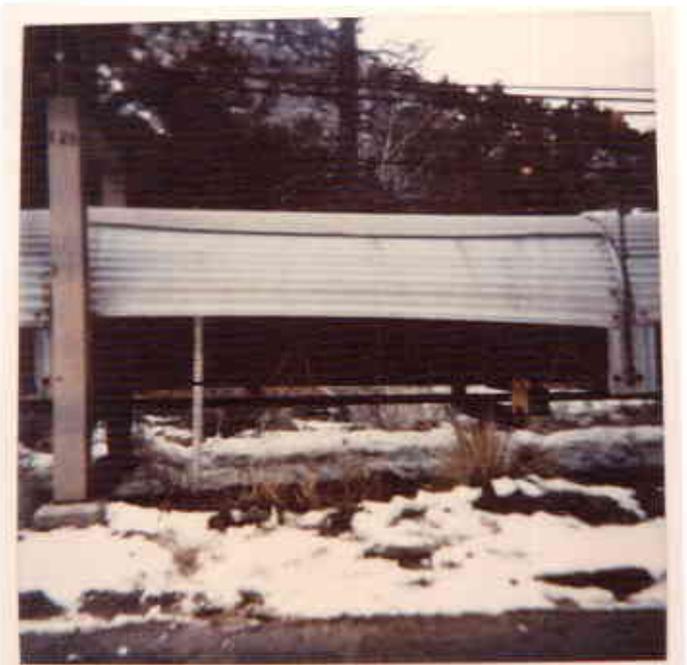
LOCATION: 129 to 130  
COMMENTS: Tracks crossing  
North and South.

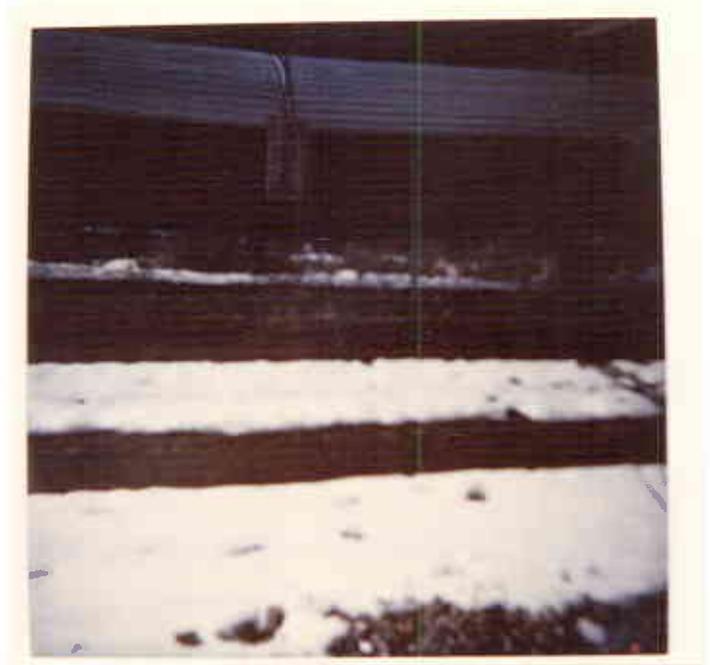
LOCATION: 144 to 145  
COMMENTS: Note tracks along road.

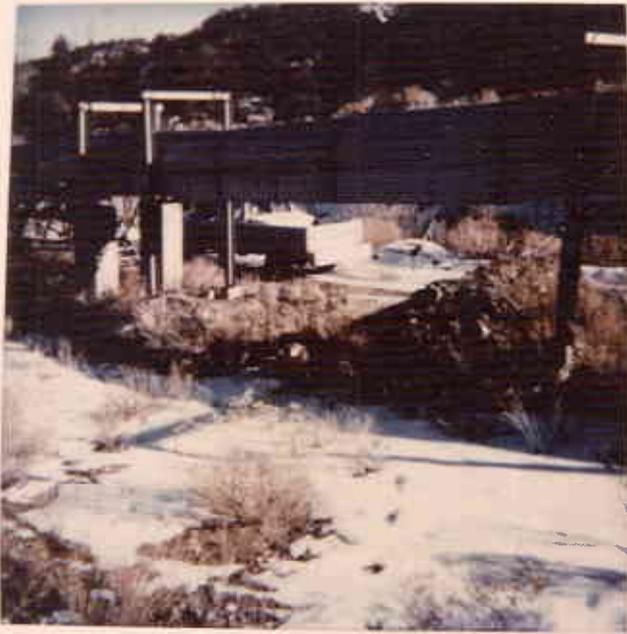
LOCATION: 118 to 120  
COMMENTS: North side of conveyor system. Note tracks in foreground.

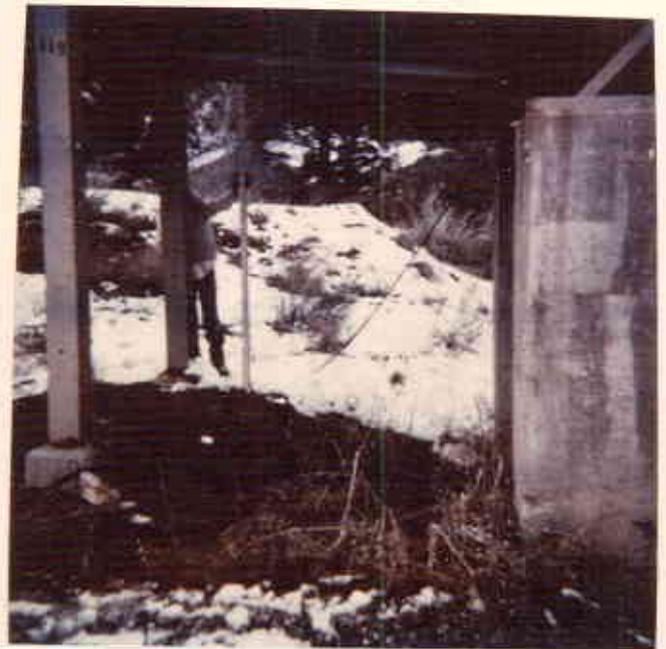
LOCATION: 119 to 120  
COMMENTS: Tracks crossing North and South and between columns at 119.

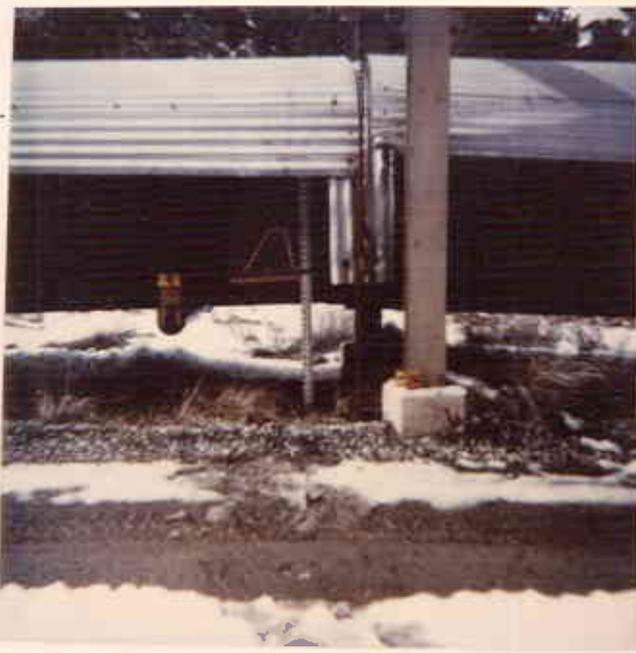
LOCATION: 133 to 134  
COMMENTS: Tracks 2 1/4" long crossing North and South.

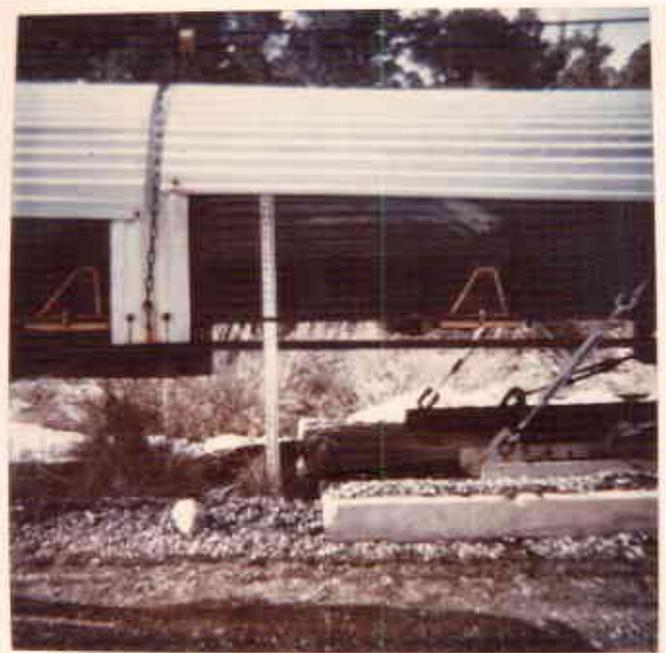
LOCATION: 149 to 150  
COMMENTS: Two inch track under belt. Clearance is 19 1/2".

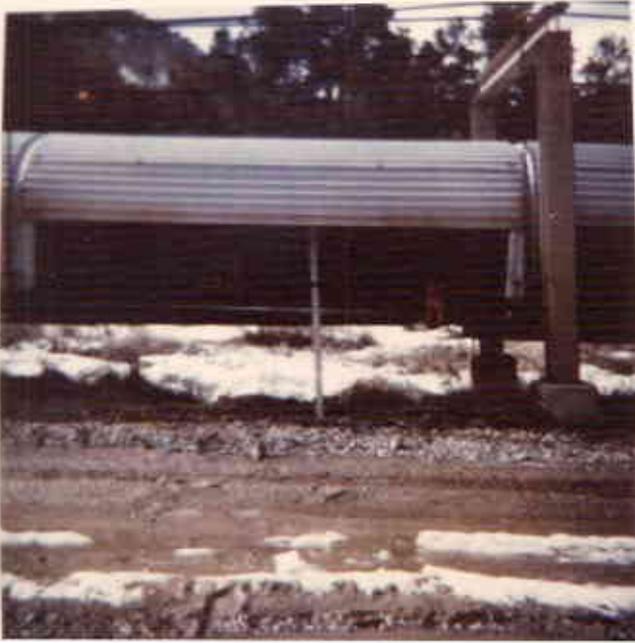
LOCATION: 158 to 159

COMMENTS: Location of established trail under conveyor.

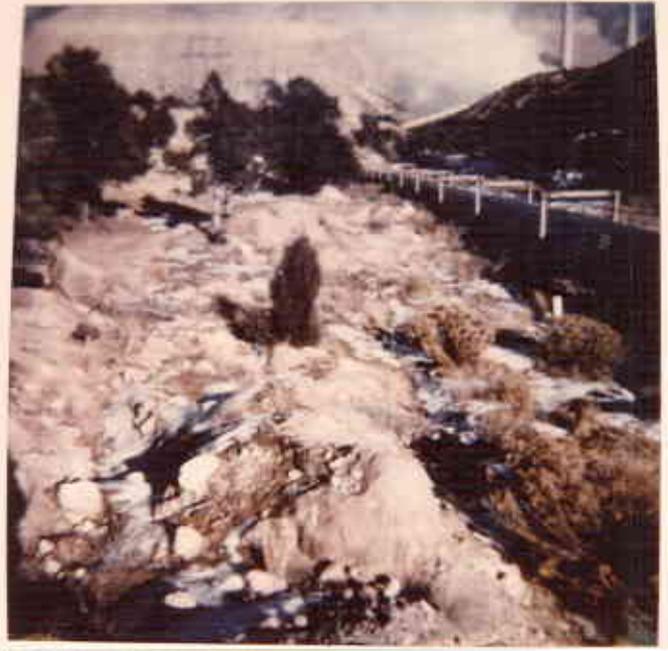
LOCATION: 158 to 159

COMMENTS: Looking East along North side of conveyor. Trail crossing is at right-center of photo.

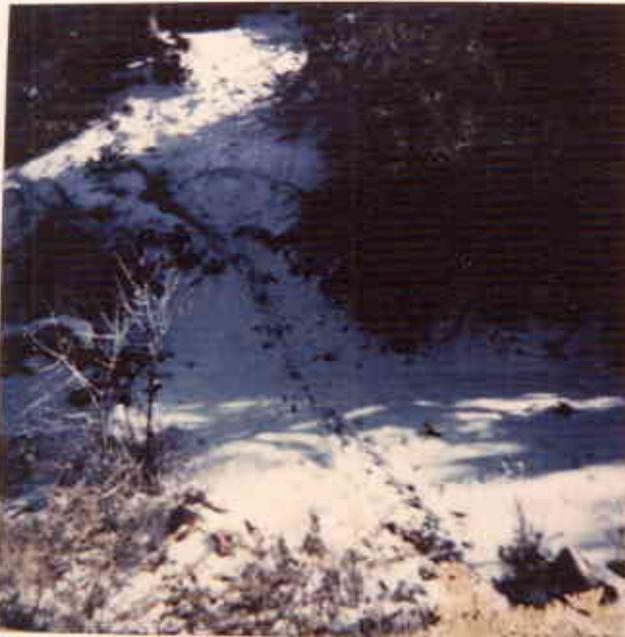
LOCATION: 159

COMMENTS: Trail crossing stream bed South from 159.

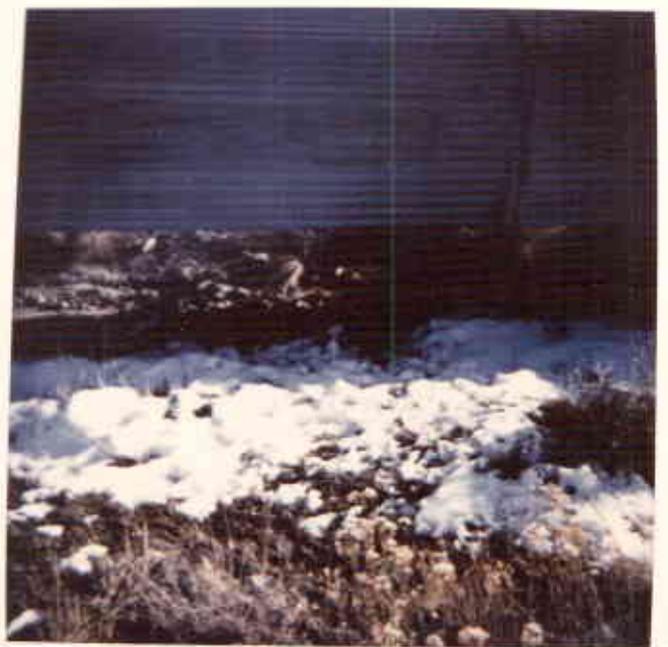
LOCATION: 158 to 159

COMMENTS: North side of conveyor at trail crossing.

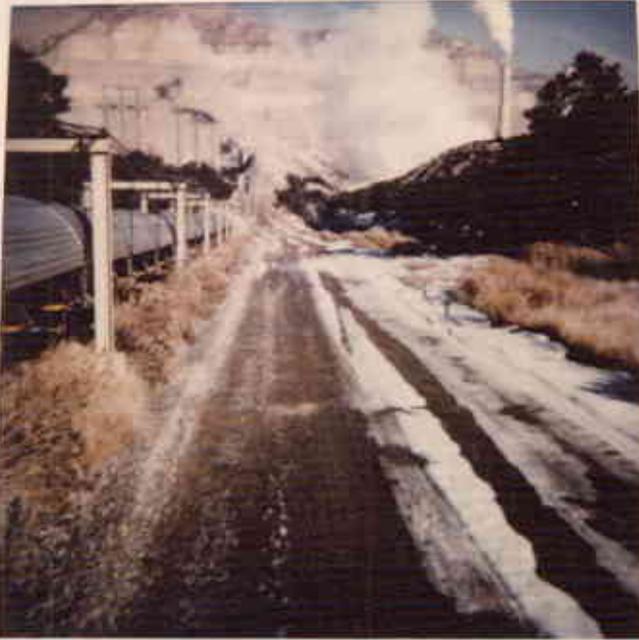
LOCATION: 159

COMMENTS: Looking East along South side of conveyor at trail crossing.

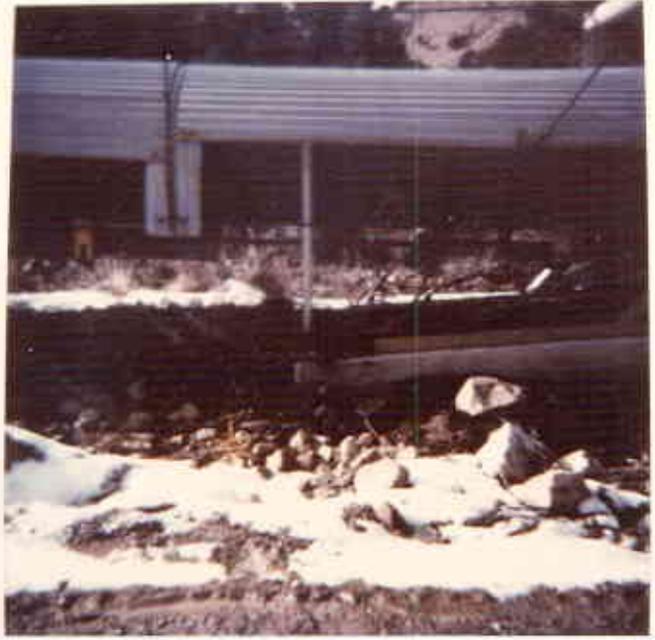
LOCATION: 165 to 166

COMMENTS: Tracks at concrete pad.

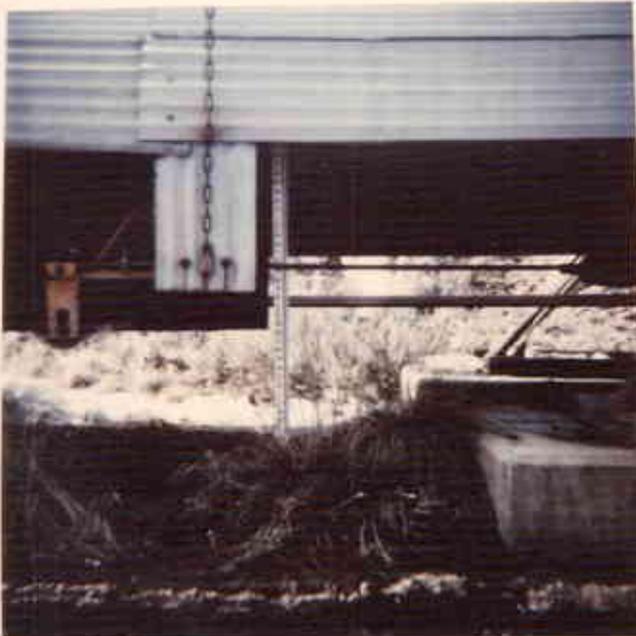
LOCATION: 183-184

COMMENTS: Tracks crossing North and South.
