REVIEW OF MINE PLUG INSTALLATION PLAN

Deer Creek Mine

April 1, 2016

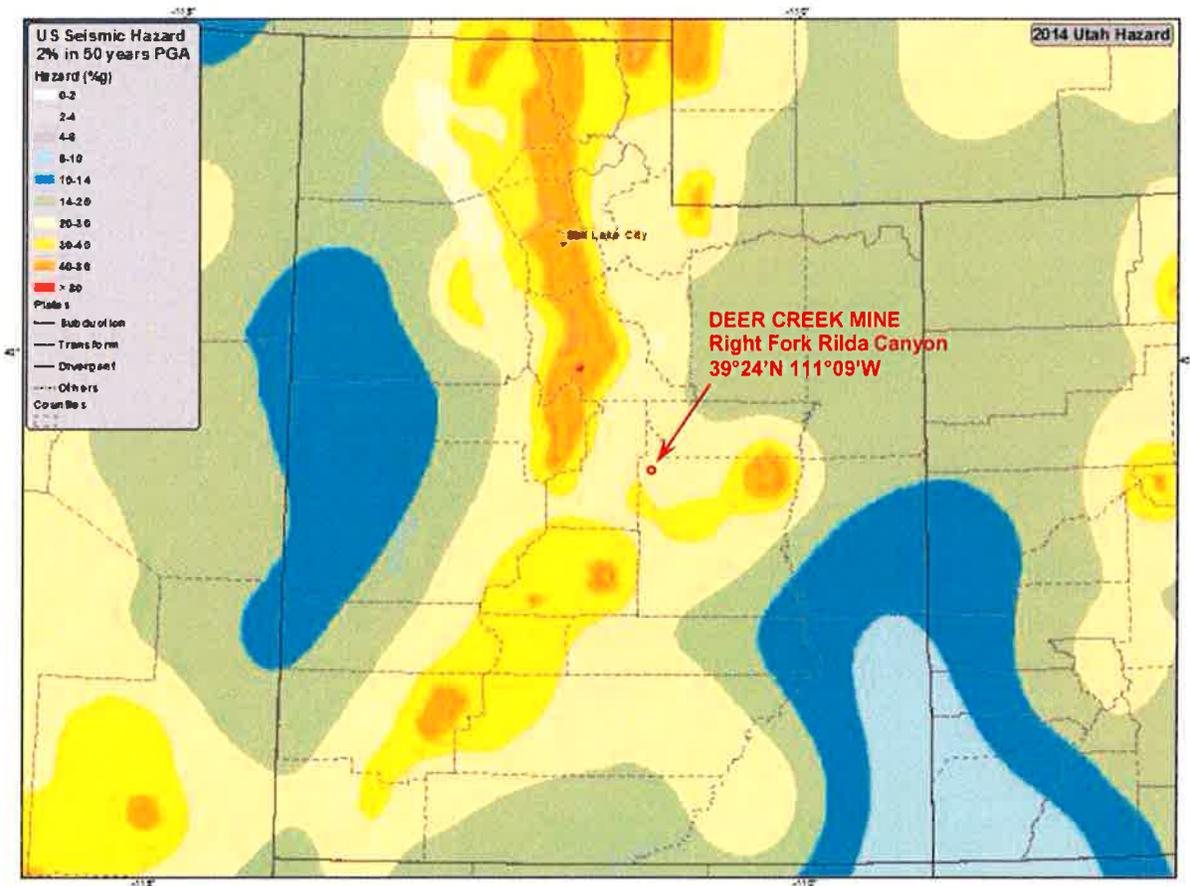
Plate 1: 2014 National Seismic Hazard Map for Utah

In calculating factors of safety against the potential increased load provided by seismic activity, Plate 1 downloaded from the 2008 U.S. Geological Survey (USGS) National Seismic Hazard Maps collection for Utah (USGS, 2014), shows that the estimated peak ground acceleration (PGA) with a return period of 4,975 years (i.e., at a probability of 2% over 50 years) is approximately 0.27 g – yielding a short-duration, additional water hammer load (per Lang, 1999) on the plugs of approximately 30 psi.
