CO-OP MINING COMPANY

Re: Water Monitoring Data Review, Birch Springs, Bear Canyon Mine, ACT 015025, #2
Emery County, Utah

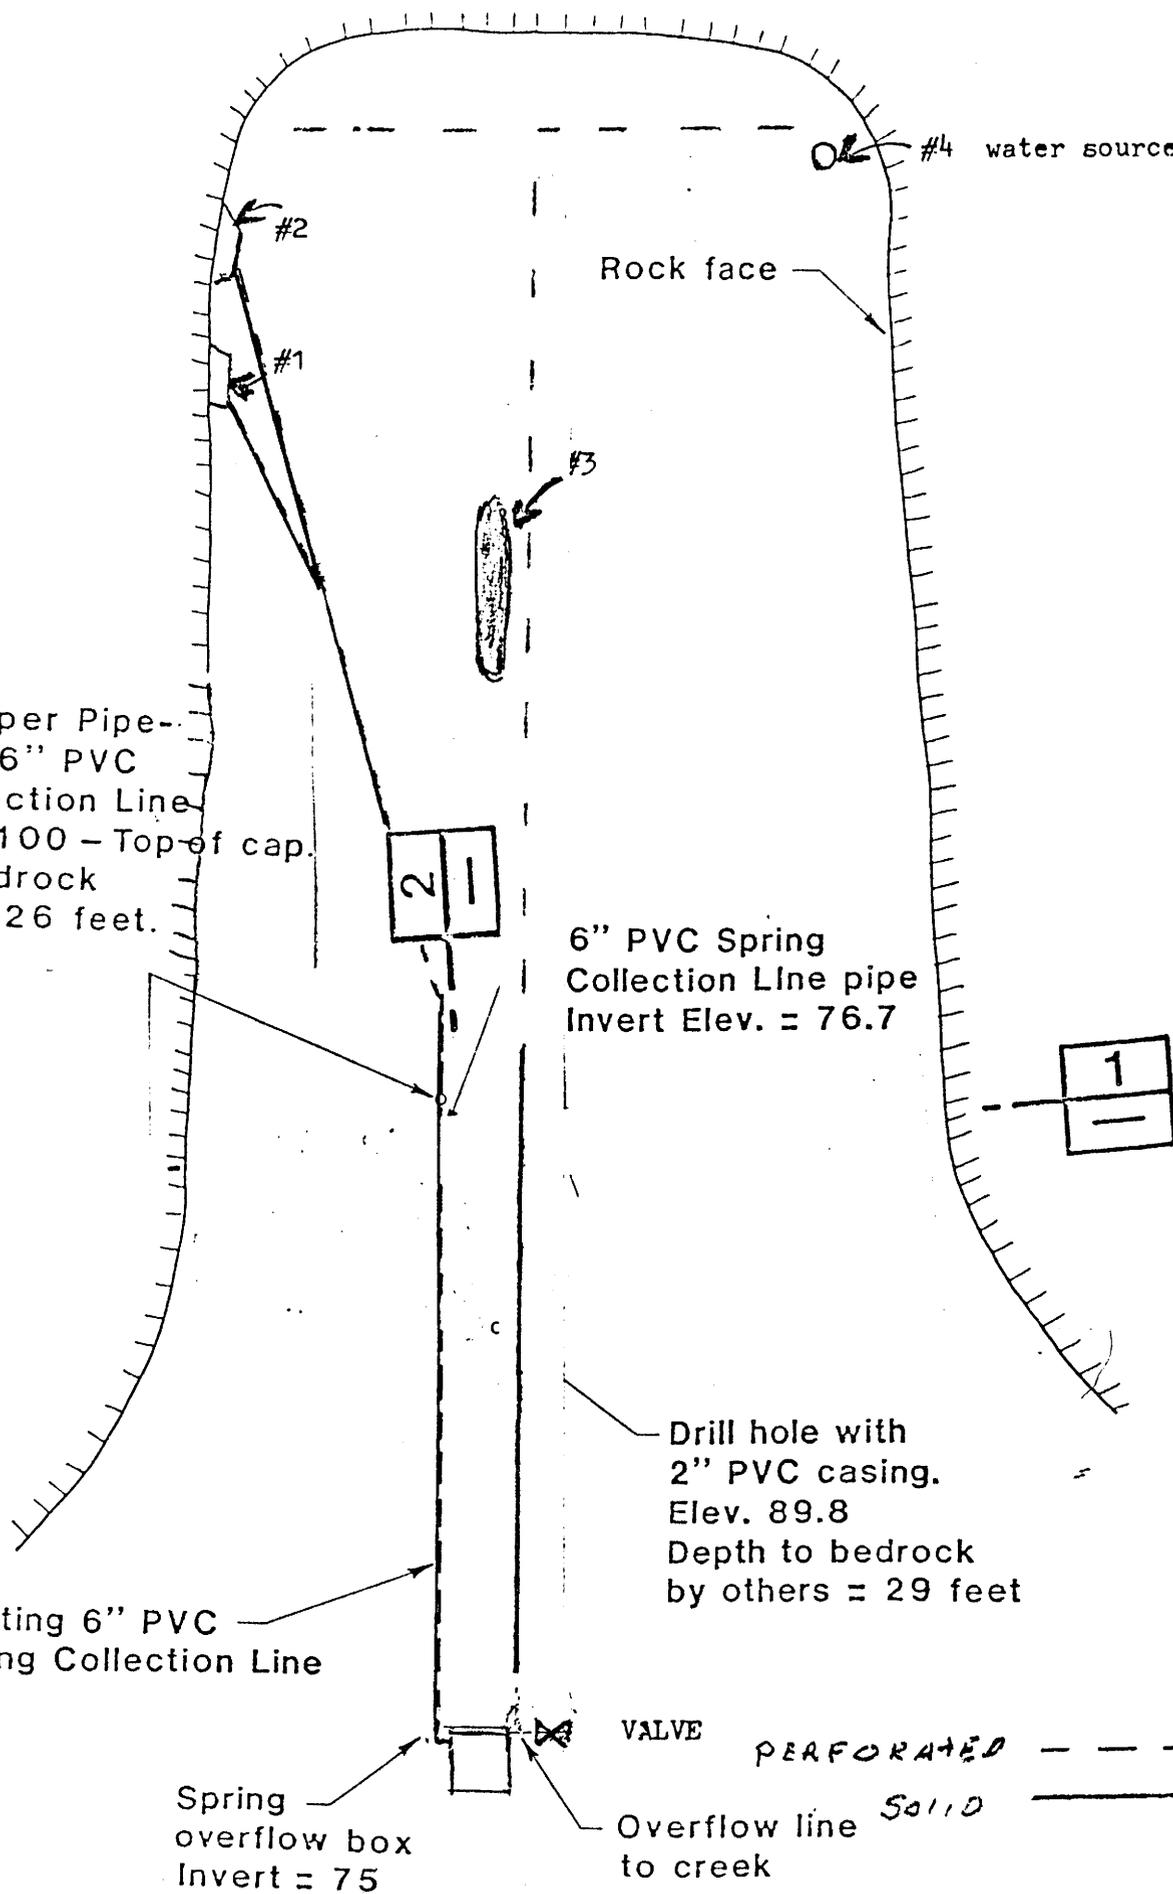
Existing Upper Pipe -
Air vent to 6" PVC
Spring Collection Line
BM Elev. = 100 - Top of cap.
Depth to bedrock
by others = 26 feet.

6" PVC Spring
Collection Line pipe
Invert Elev. = 76.7

Drill hole with
2" PVC casing.
Elev. 89.8
Depth to bedrock
by others = 29 feet

Existing 6" PVC
Spring Collection Line

Spring
overflow box
Invert = 75
