Appendix 2-A
VIOLATION LIST

Trail Canyon Permit # ACT/015/021

Bear Canyon Permit # ACT/015/025

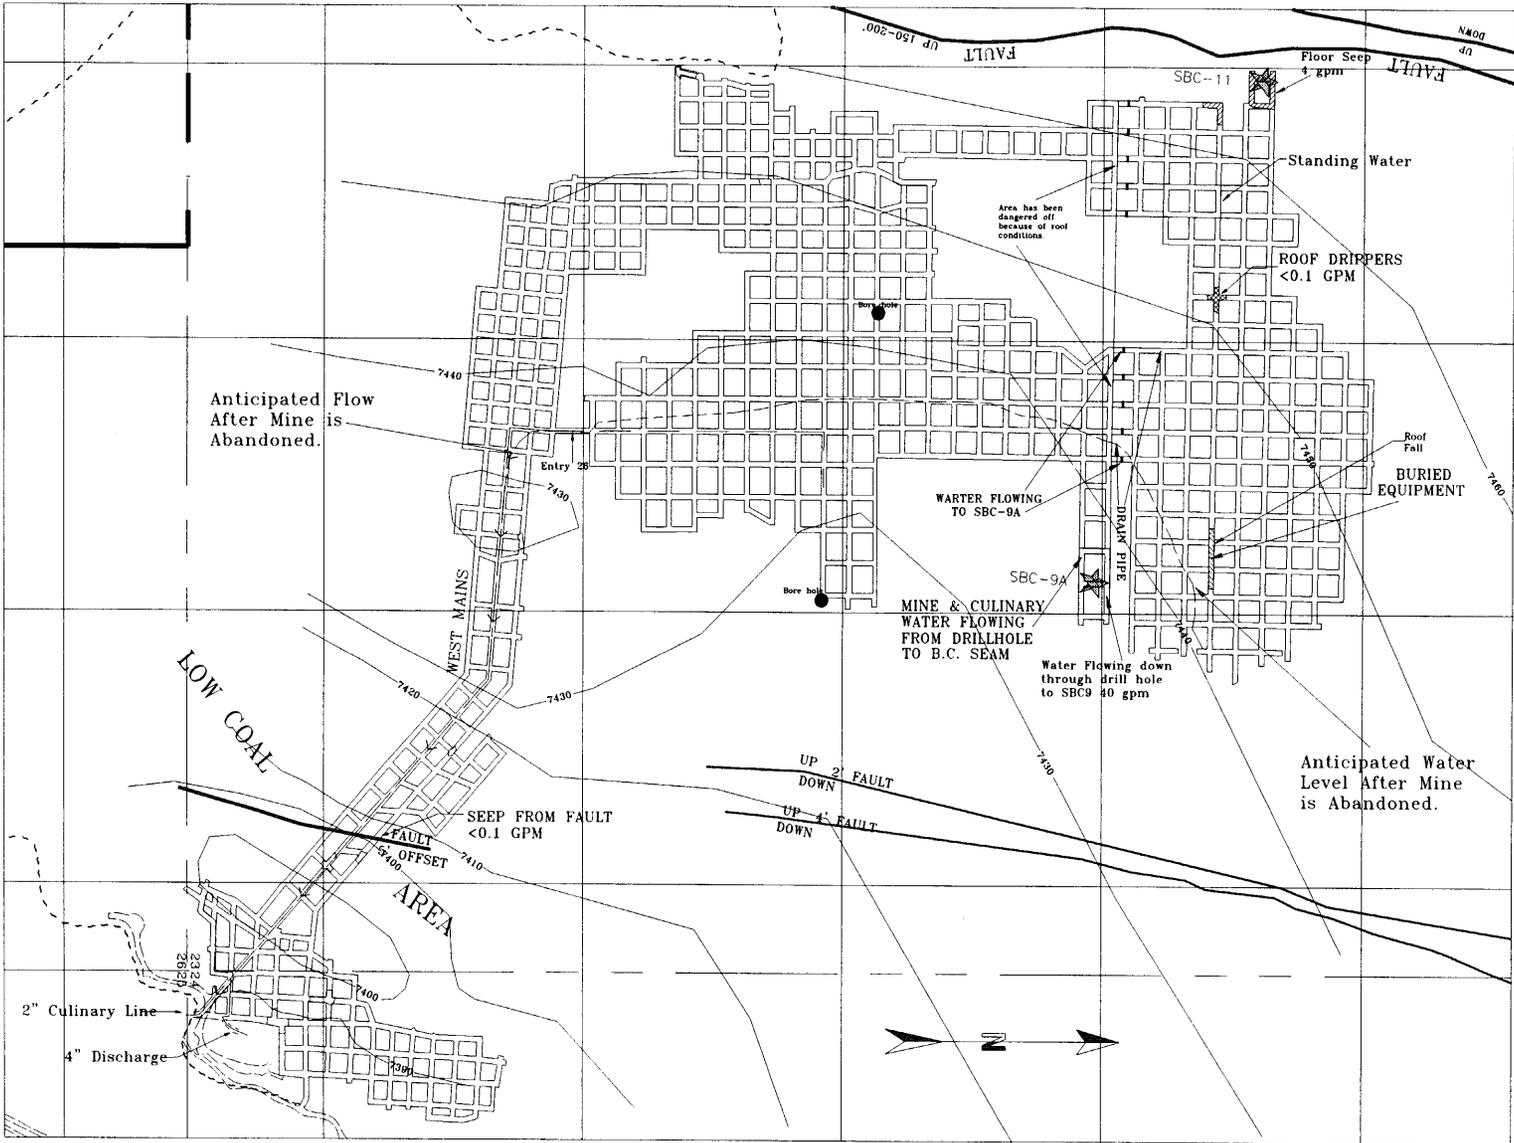
Figure 7P-1 Hiawatha Seam Mine Water

On January 14, 2003 a roof fall occurred in the Hiawatha seam of the #1 Bear Canyon Mine. This roof fall buried a coal hauler, a distribution box, and a shop trailer. After the roof fall all remaining equipment was removed from the section and the area was sealed off. This is a concern for groundwater contamination since water monitoring site SBC-11 is in the area and there are floor and roof seeps in the area. The entry where the equipment was left is higher than the surrounding entries so water should flow around it. Also drainpipes were installed in the seals close to SBC-11 and also at a lower elevation than the abandoned equipment so water should drain out of the area before reaching the level of the equipment. The water is currently draining from the area through the pipes into monitoring site SBC-9A. Because of hazardous roof conditions in that area it will be abandoned in 2003 or 2004 and the water will be allowed to fill until it reaches entry 26 at which point it will drain to the portals. Co-Op Mining Company uses the water for mine and culinary use and will continue to monitor it for the life of the mine. The anticipated path of the water is illustrated on the following diagram. A copy of the MSHA accident report has also been included. The area of the roof fall is also shown on Plate 7-10B.
