WATER QUALITY MEMORANDUM Utah Coal Regulatory Program

RE: 2009 Fourth Quarter Water Monitoring, Canyon Fuel Company, LLC, SUFCO Mine, C/041/0002, WQ09-4, Task ID #3443

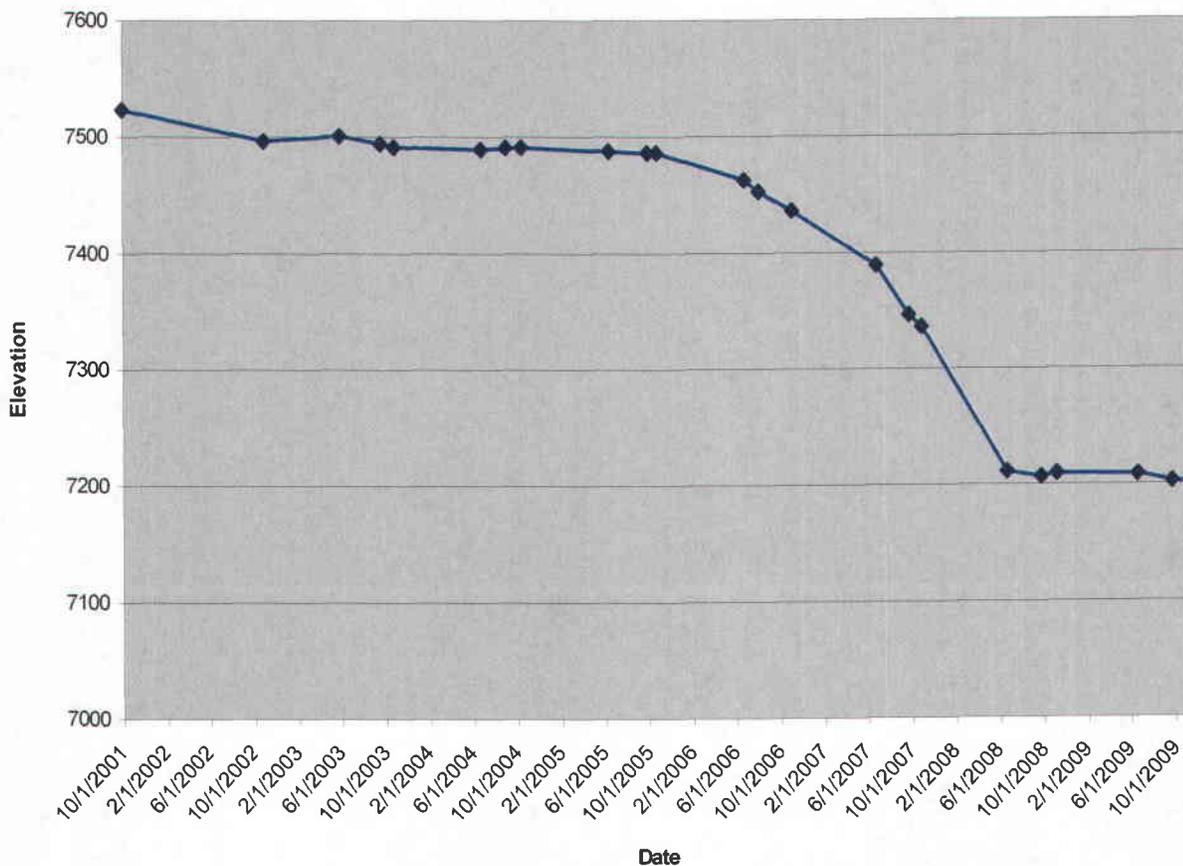
Groundwater Elevation for Well 01-8-1

The Permittee submitted all required samples for the wells. Groundwater elevations for well 01-08-1 have been submitted since 2001 monitoring the groundwater in the SITLA Muddy Lease tract. As can be seen in the chart, there was a decline in groundwater elevations of approximately 275 feet evident from the period between October 2005 and June 2008 while this area was being actively mined. Groundwater levels have begun to stabilize but it is not apparent as of yet if groundwater elevations will rebound to pre-mining levels.
