PINES TRACT VEGETATION STUDY

Prepared by
Keith Zobell, Environmental Specialist
August 10, 2010

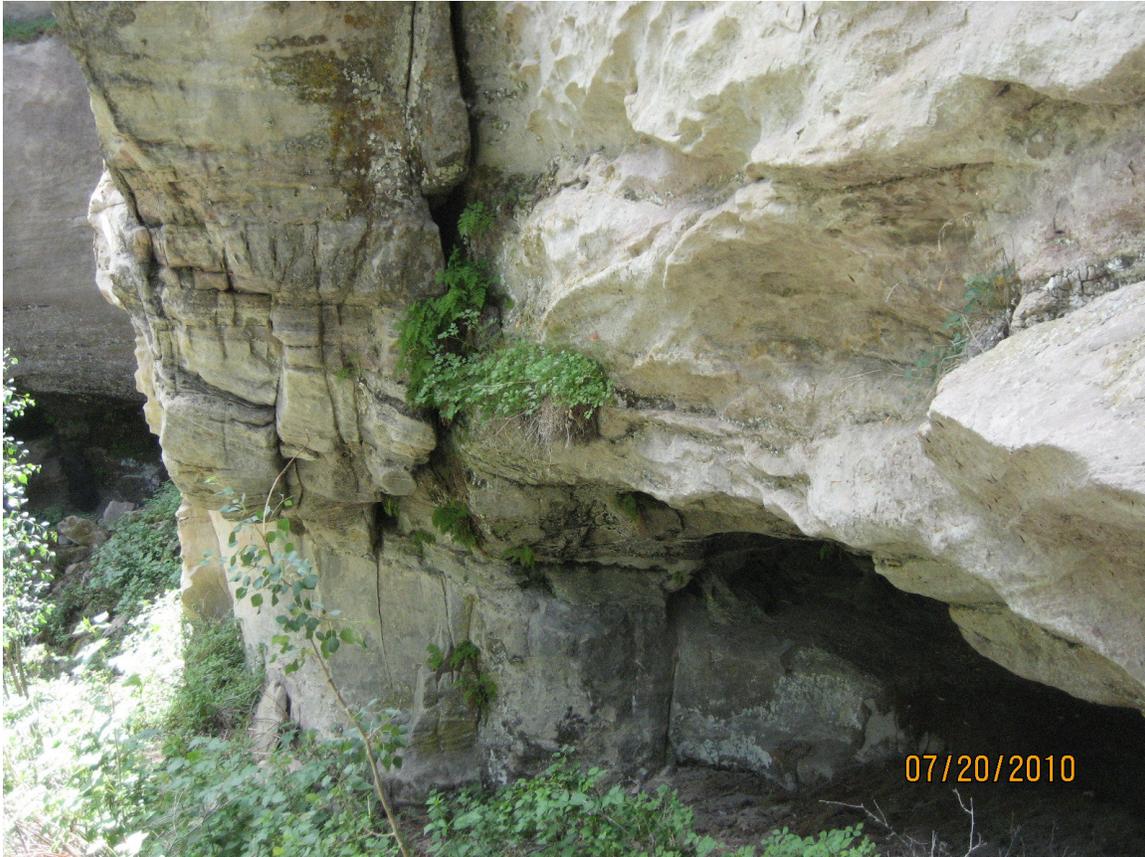
Photo Point 1a

There are three columbine plants at this site. The plants have fair vigor. Two plants have some inflorescences, which are 15-18 inches in length. The third plant has no inflorescences.

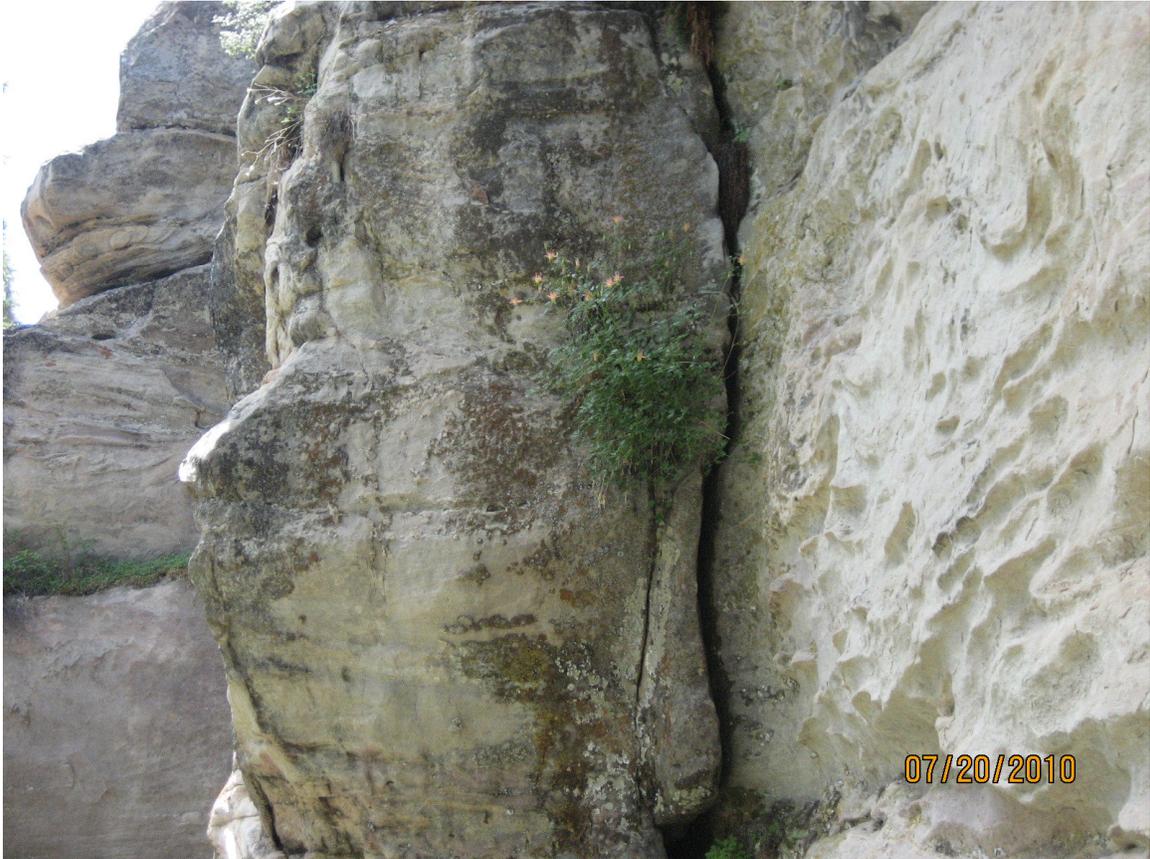
Photo Point 1b

At this photo point there is only one living plant. This plant has good vigor and 15-18 inch inflorescence. The second plant that was at this site appears to be dead. These plants are up on the cliff face so close examination can not be made. There appears to be some moisture coming from the rock fracture that they are growing in.

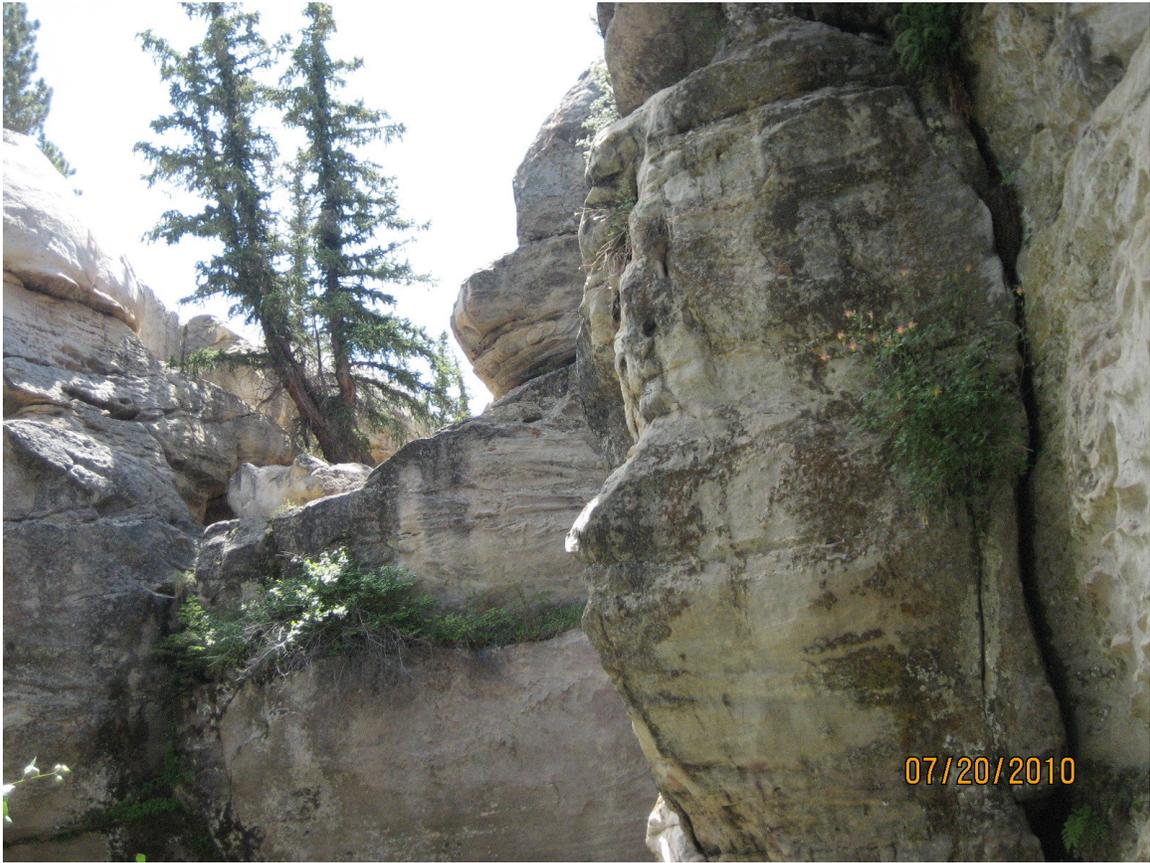
Photo Point 1c

At this photo point there is only one columbine plant and it now appears to be dead. The plant is located approximately 20-25 feet up on the cliff face, so no measurements or examinations can be made.

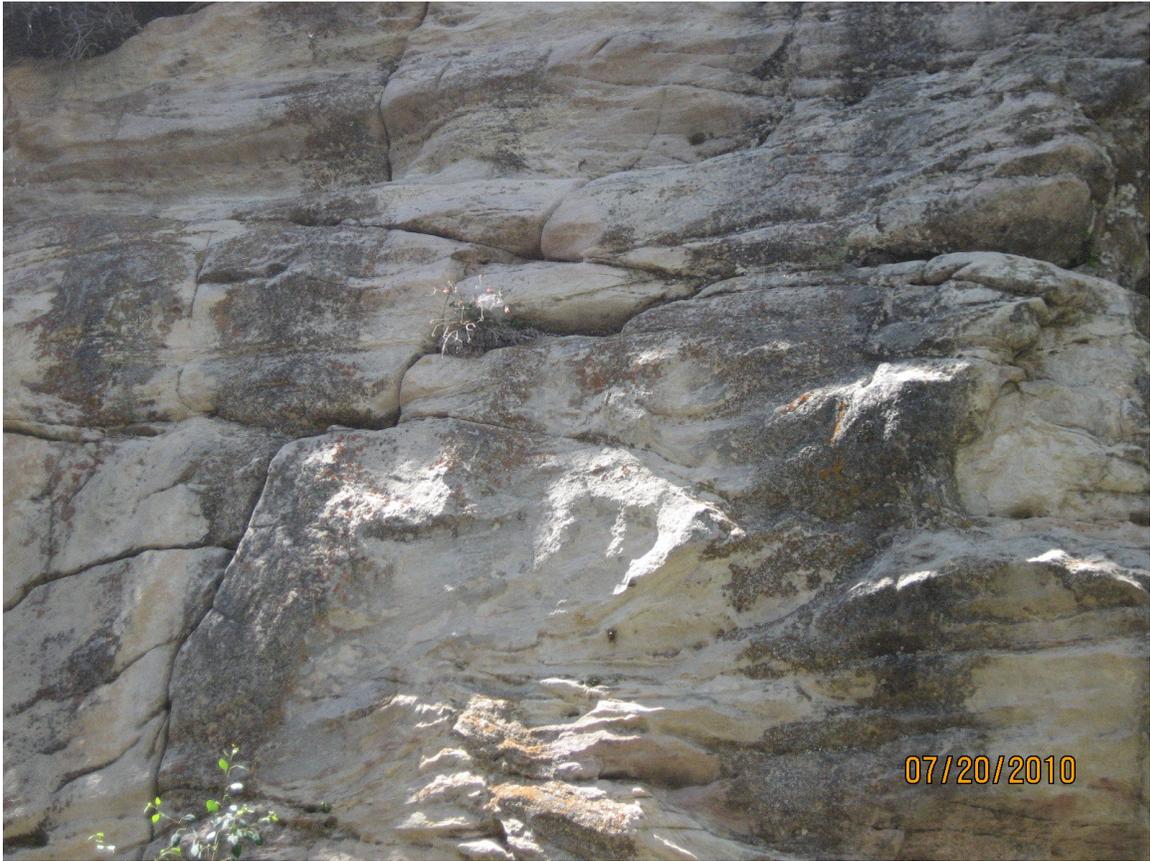
Photo Point 2

At this photo point there is only one plant still alive. Originally there were three. The surviving plant is small with poor vigor. It has several flowering heads that appear to be 6-8 inches long. The plant is located 20-25 feet up on the cliff face so exact measurements cannot be made. There does not appear to be any moisture coming from the rock fracture that the plant is growing in. The lack of moisture is probably the cause of the poor vigor and the other plants dieing.

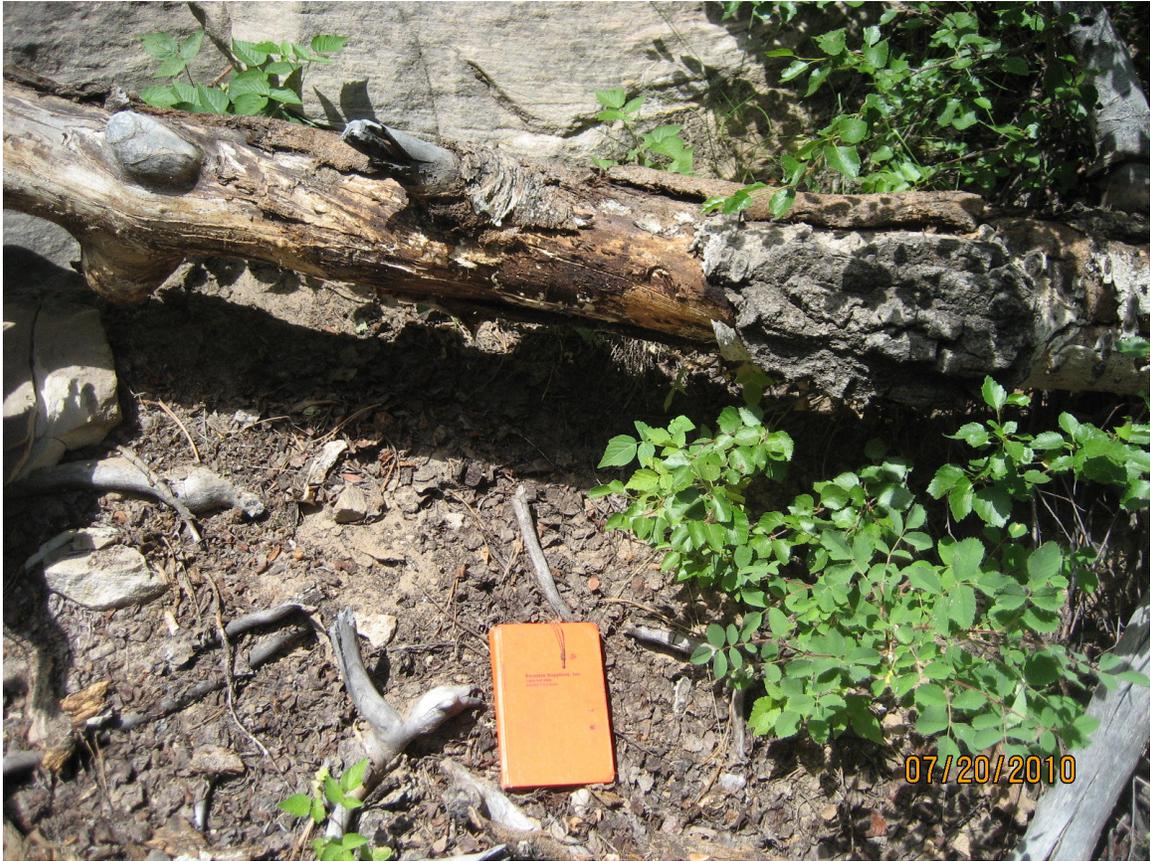
Photo Point 3

There is one small plant at this photo point, which is growing behind the log and at the base of the rock. Last year this plant appeared to be a seedling. This year the plant is still small with fair vigor but has no inflorescence.

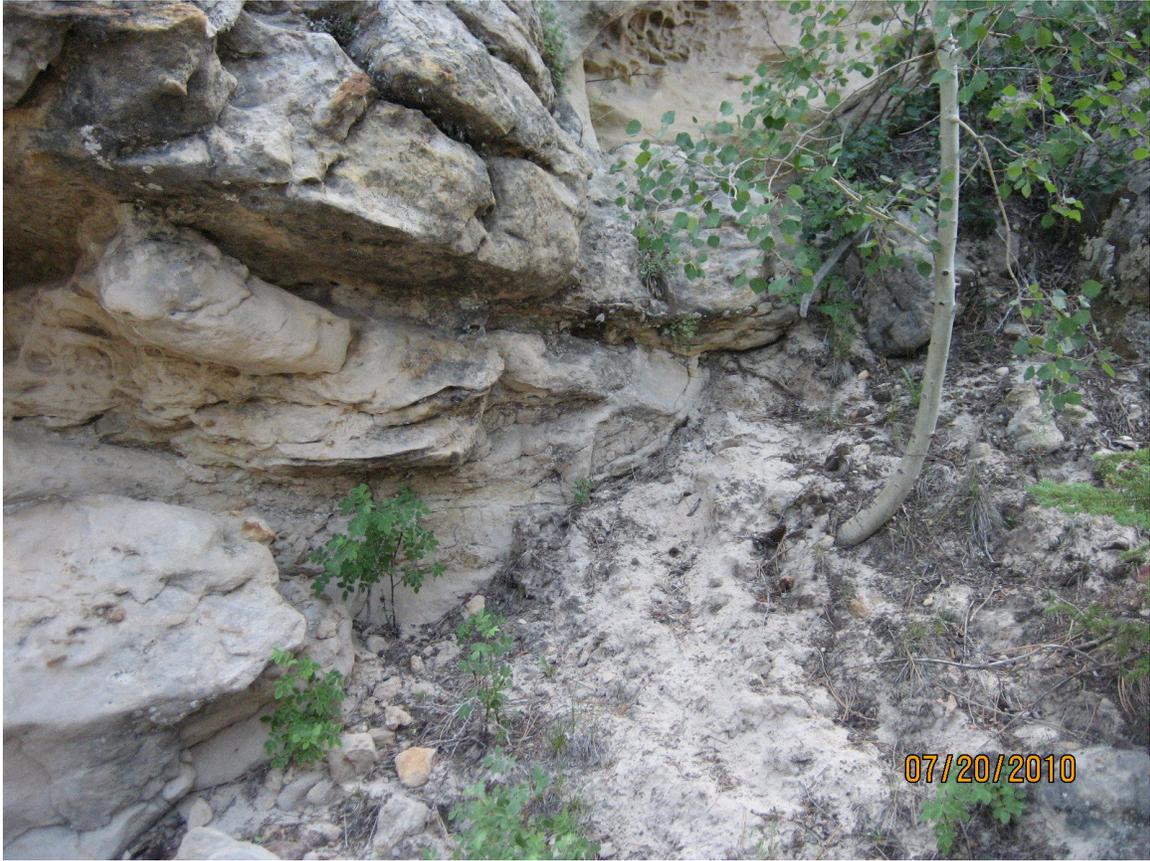
Photo Point 4

At this photo point there are several columbine plants. Only one columbine plant has any inflorescence, which is 7 inches long. All of the other columbine plants have 3-4 inches of basal growth and have low vigor. *Carex* (*Carex spp.*) plants are sparse and have 3-4 inches of basal growth. Woods Rose (*Rosa spp.*) has 4-5 inches of new growth but have no flowering or seed heads. *Potentilla* (*Potentilla spp.*) has 2-4 inches of new growth. Aspen (*Populus tremuloides*) has new growth of 4-5 inches. This is a very dry site. The overall vigor at this site is poor and is probably due to lack of moisture and being a very dry site.

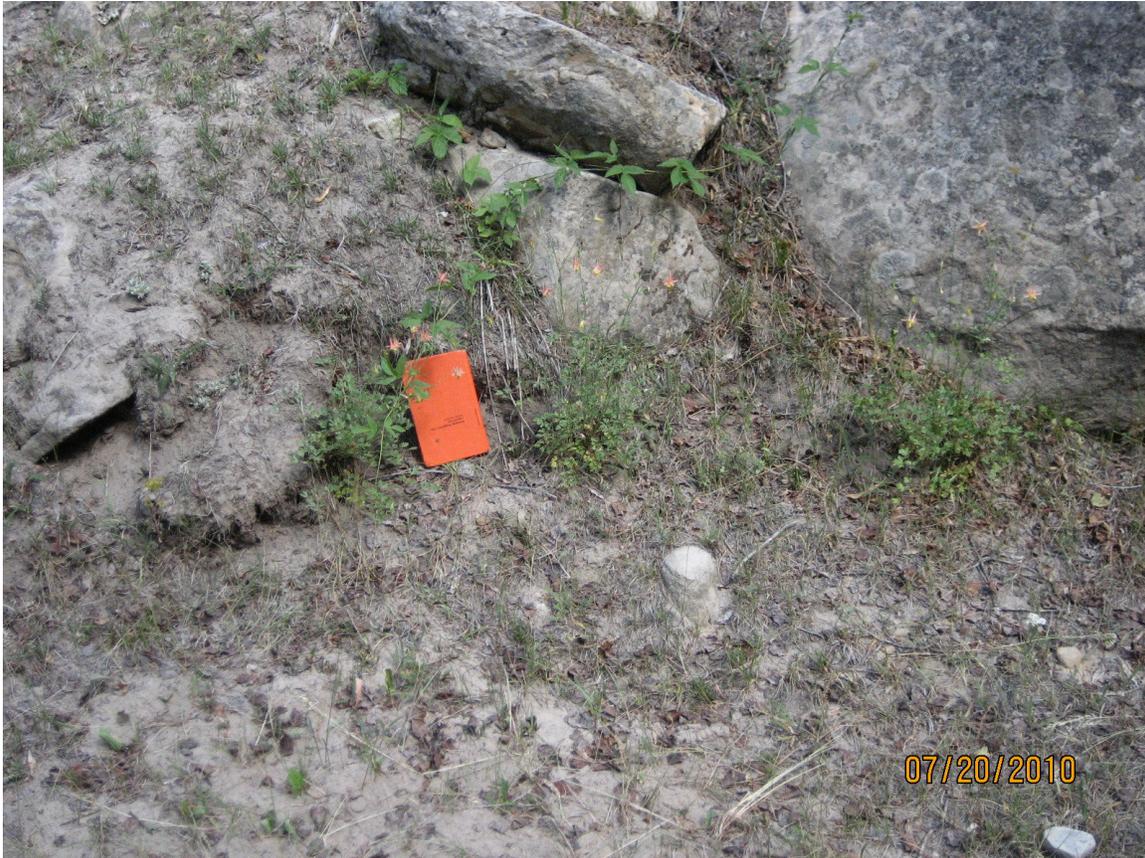
Photo Point 5

At this photo point there are still three main columbine plants, however there are two new seedling columbine plants. The inflorescence on the main columbine plants are 12-14 inches in height, with both flowers and seed heads. The new seedlings have 3-4 inches of basal growth. There are a few Bluegrass (*Poa pratensis*) plants with 12-14 inch seed heads. Carex (*Carex spp.*) has 3-4 inches of growth. Yarrow (*Achillea millefolium*) plants have 10 inch seed heads. Geranium (*Geranium spp*) plants have 3-4 inches of basal growth. The site has not been grazed but is in poor condition. Overall vigor is poor to fair. There is some leaf litter on the ground. There is 35-40% bare ground at this site. There is no water in the creek bed.

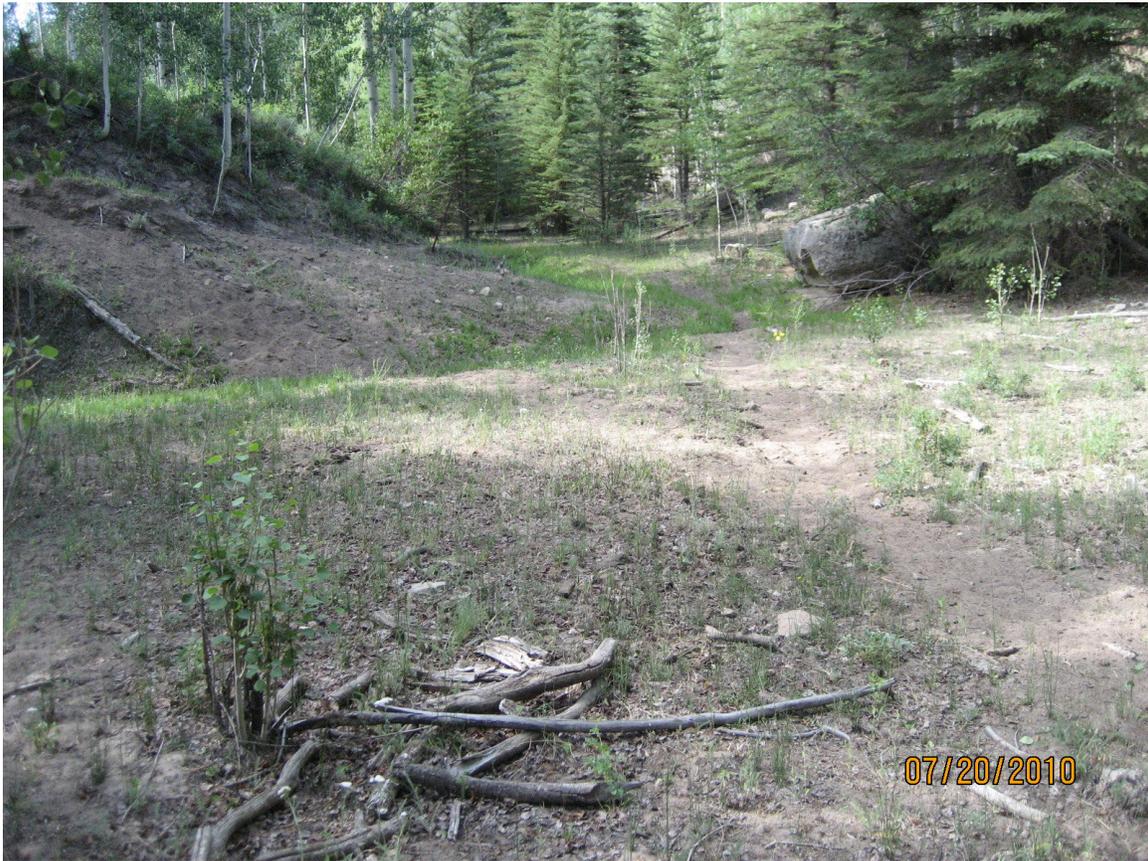
Photo Point 6

This photo point site has been lightly grazed this year. The site has 40% bare ground with some leaf litter. The Aspen has 6-8 inches of new growth. There are very few Bluegrass plants which have 3-4 inches of basal growth and 10 inch seed heads. There are a few scattered Carex plants that have 2-3 inches of new basal growth. The Yarrow plants have 3-4 inches of basal growth with a few 10-12 inch seed heads. There are only a few Big Sage (*Artemisia tridentate*) plants which have 1-3 inches of new growth. There are a few Herbaceous Sage (*Artemisia ludoviciana*) on the site which have a current growth of 8-10 inches. The Woods Rose (*Rosa woodsii*) have new growth of 3-4 inches. Joint Grass (*Equisetum spp.*) have shown up in significant numbers and are 4-7 inches in height. The overall condition of the site is very poor. There is no water in the Creek at this site.

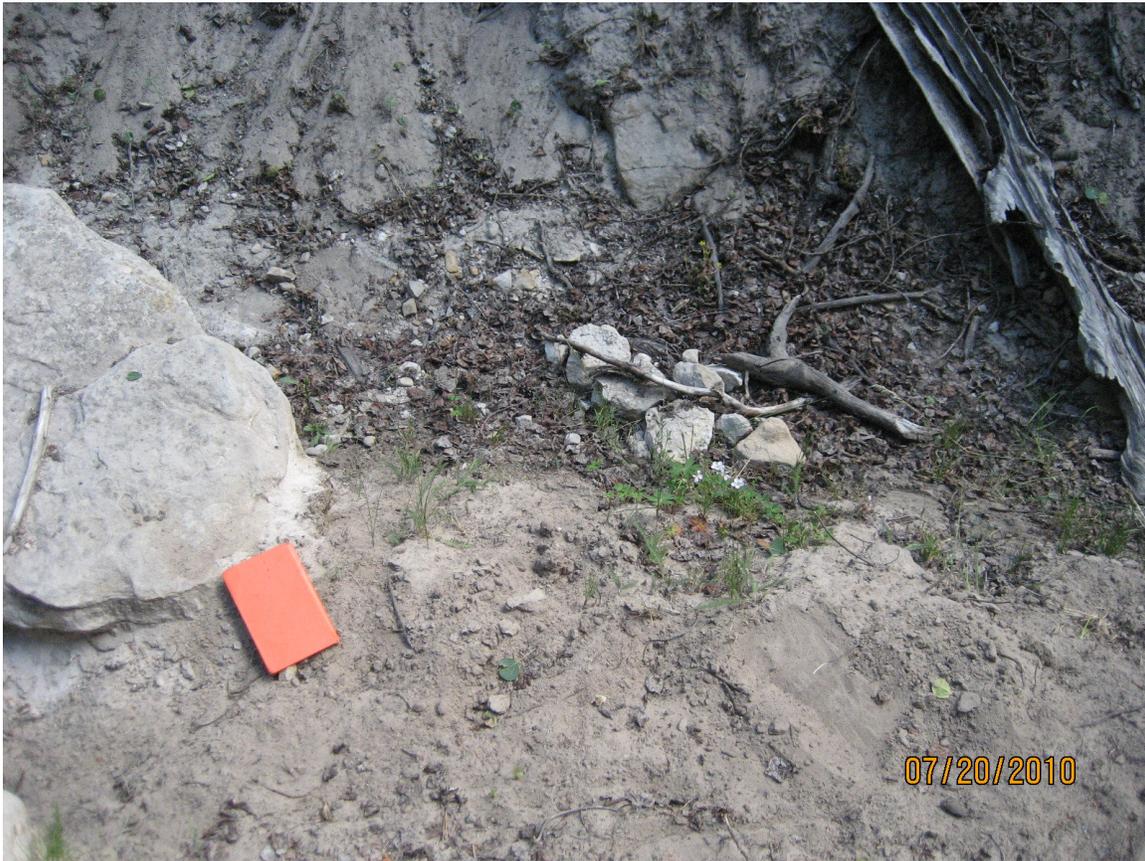
Photo Point 7

At this photo point there are still no columbine plants. There are a few Geranium plants that have 3-4 inches of new growth but no inflorescence. There are a few Yarrow plants with 3-4 inches of new growth but no seed heads. There are also a few Carex plants with 5-7 inches of new growth with no seed heads. There is no Bluegrass plants at the site. The site is 95 % bare ground. There is no water in the creek at this site.

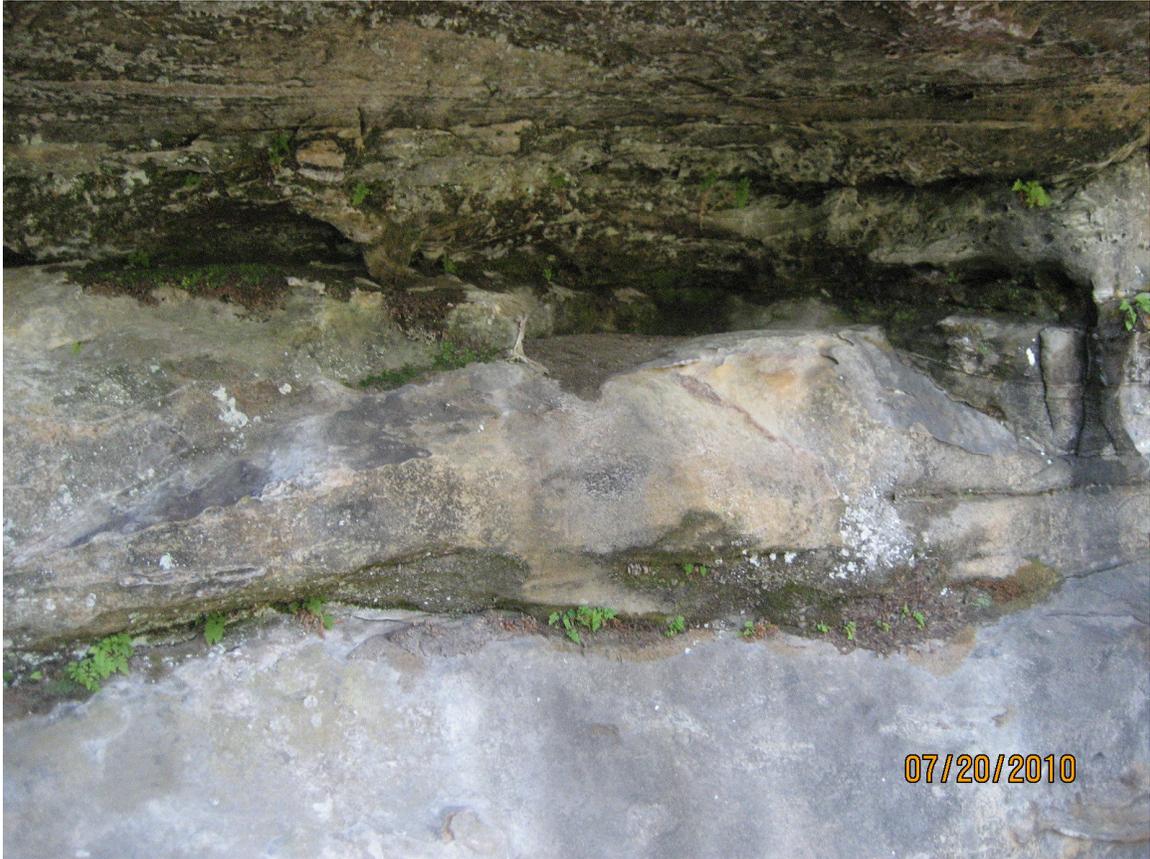
Photo Point 8

This photo point is a hanging garden area located in the “Grotto” area. The ferns and the lichens receive moisture that is coming from the fractures in the cliff face. The fern and lichen density is low and approximately the same as last year. The current fern growth is 2-3 inches. There is some moisture on the face of the cliff but there is no flowing or dripping moisture.

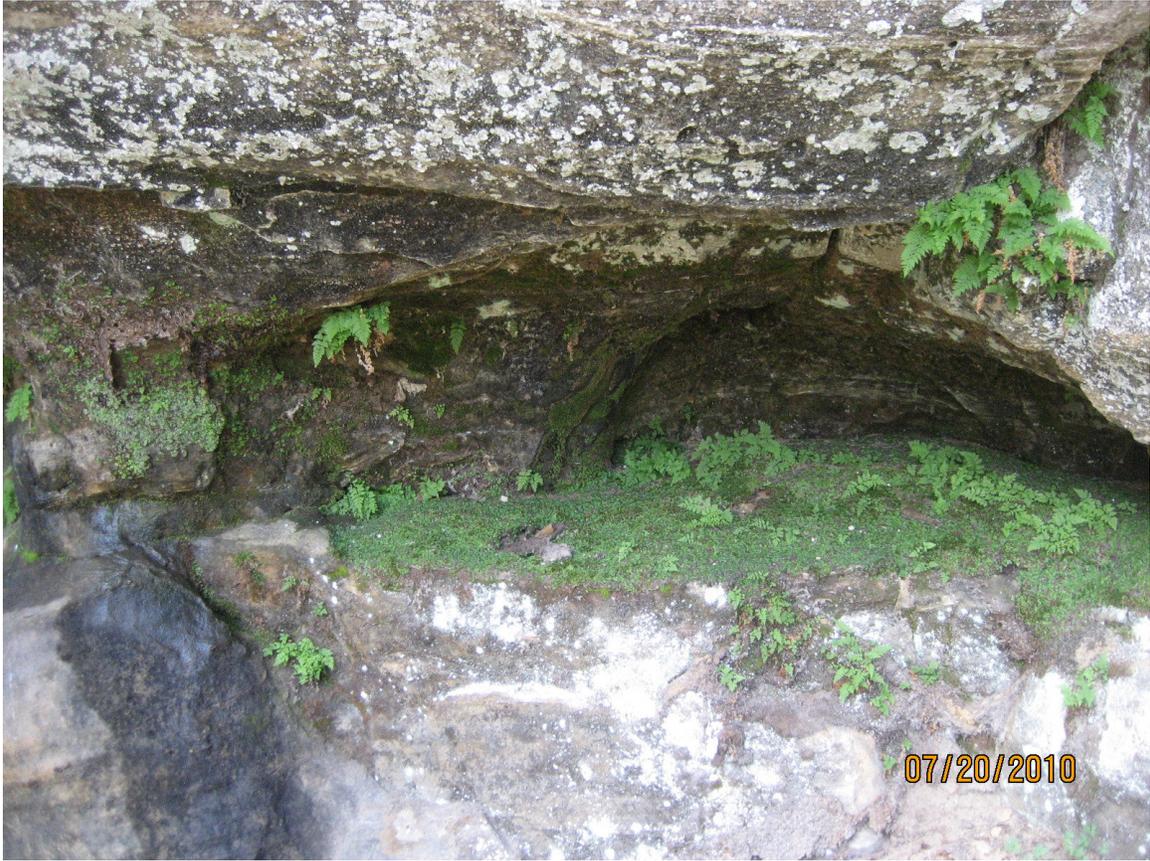
Photo Point 9a

At this photo point there is no dripping or flowing moisture, however there is some dampness in the alcove area. Lichen growth is poor. The fern growth is 3-4 inches.

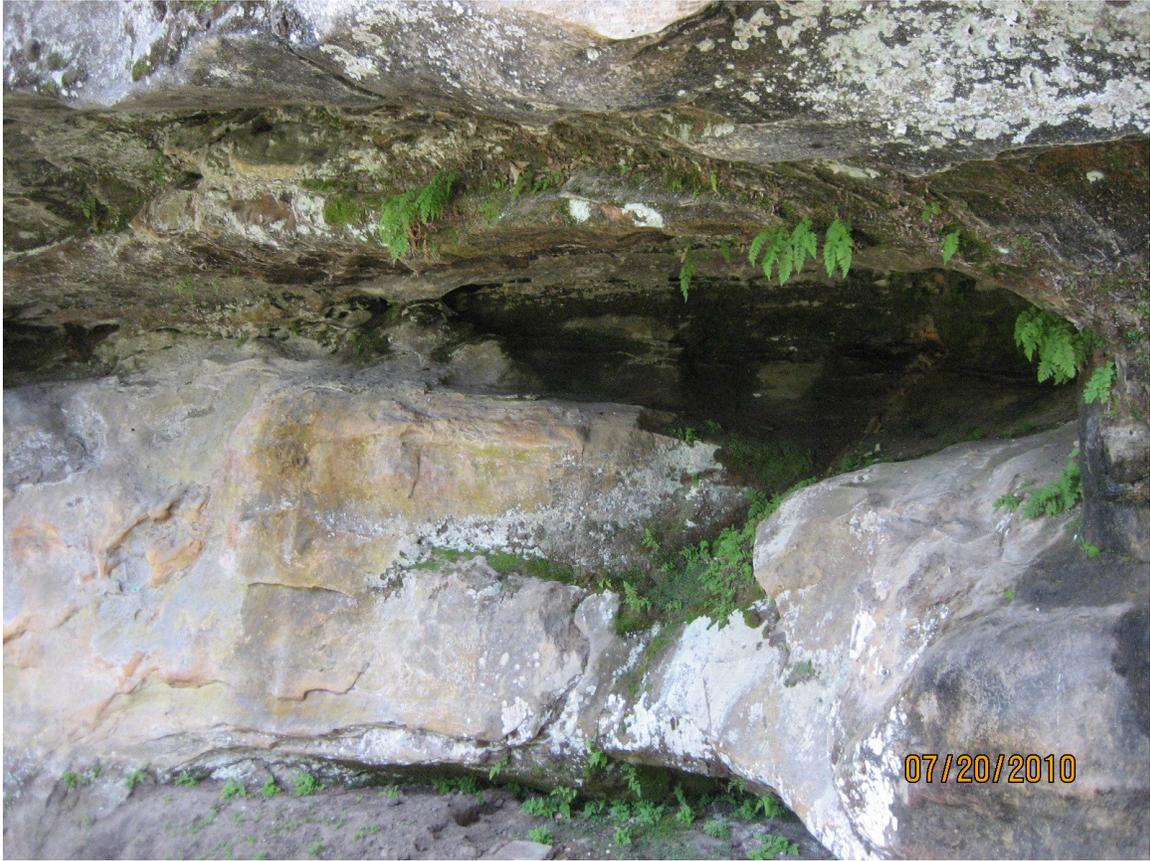
Photo Point 9b

The rock face is damp but there is not dripping or flowing water. The lichen and fern density is low. Fern growth is 3-4 inches.

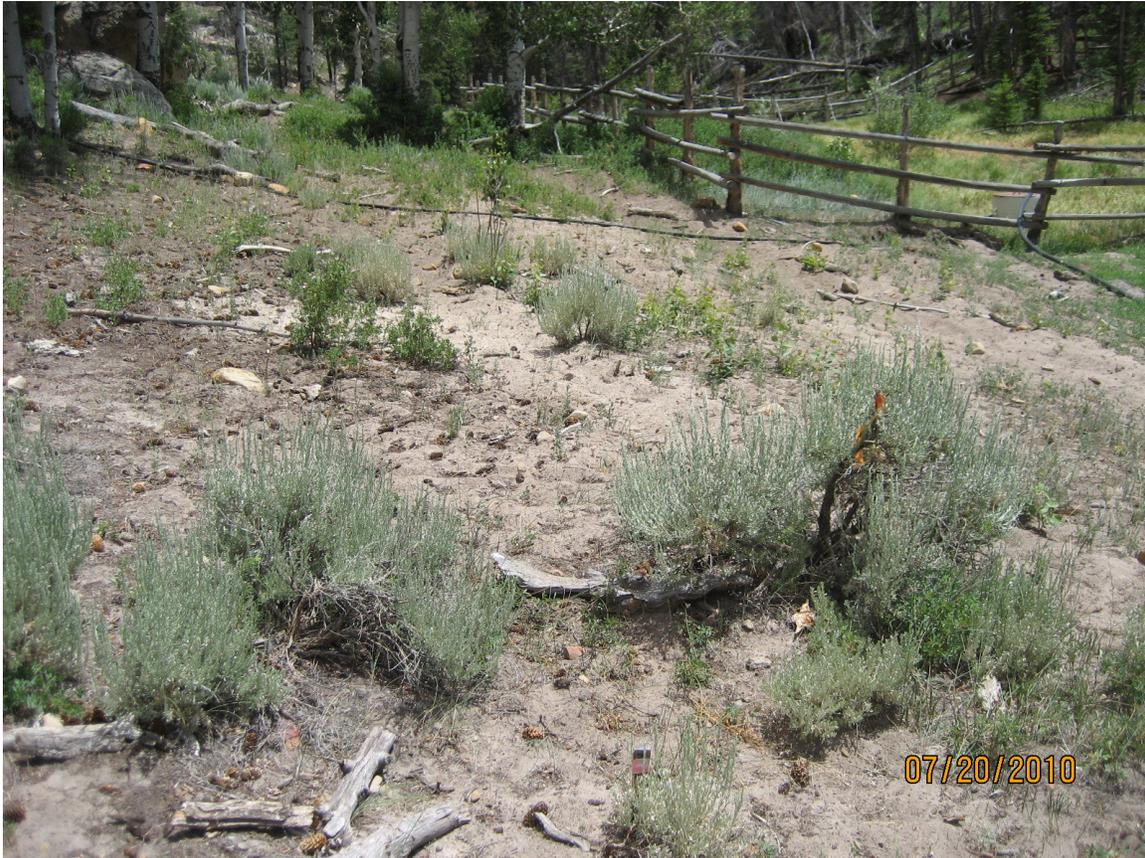
Photo Point 10

At this photo point the vegetative condition and vigor is very poor. The overall trend is down. There is no apparent grazing at the site. The site is 95% bare ground with very little (if any) litter. The Aspen growth is 12-15 inches. Woods Rose growth is 4-6 inches. Wire Grass (*Juncus spp.*) is sparse and has 4-6 inches of new growth.

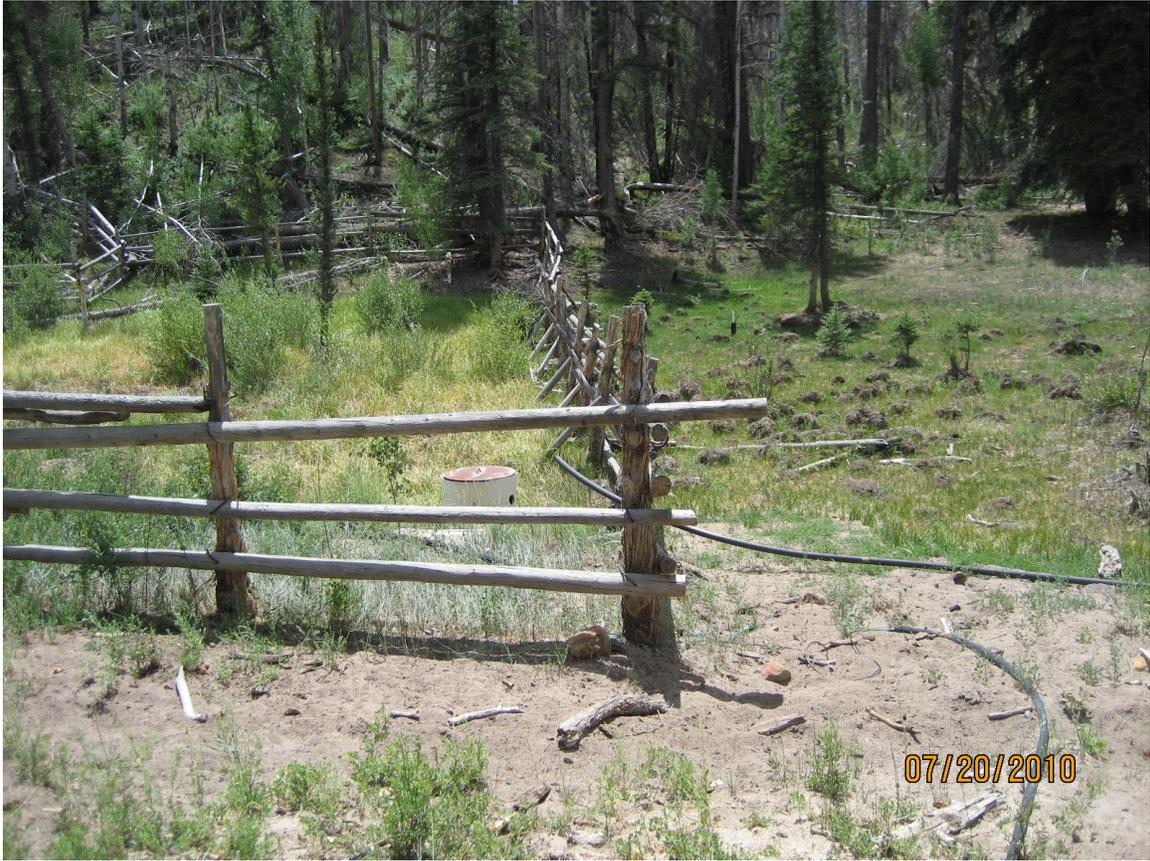
Riparian Area adjacent to Photo Point 10

This photo point shows a fence line contrast between the protected area (on the left) and the area open to grazing (on the right). The area open to grazing has been lightly grazed but still has good density. The current willow growth is 5-8 inches and the current Carex growth is 5-7 inches.
