PINES TRACT VEGETATION STUDY

Prepared by
Keith W. Zobell, Environmental Specialist

August 1, 2011

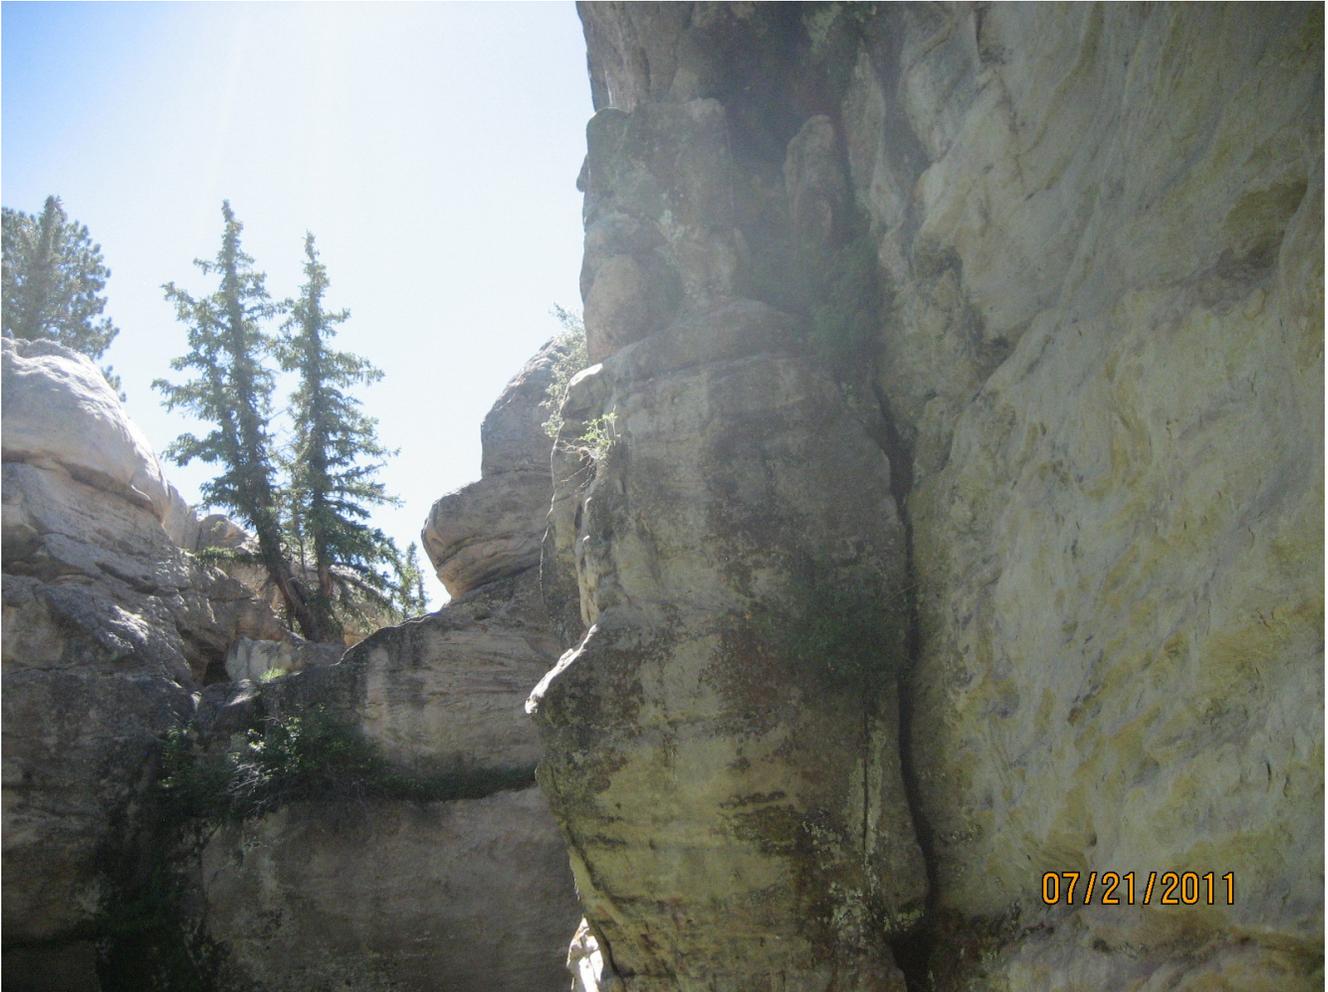
Photo Point 1b

At this site there are two Columbine plants. One plant has good vigor with 16-18 inch flower stocks while the other plant has poor vigor and no flower stocks

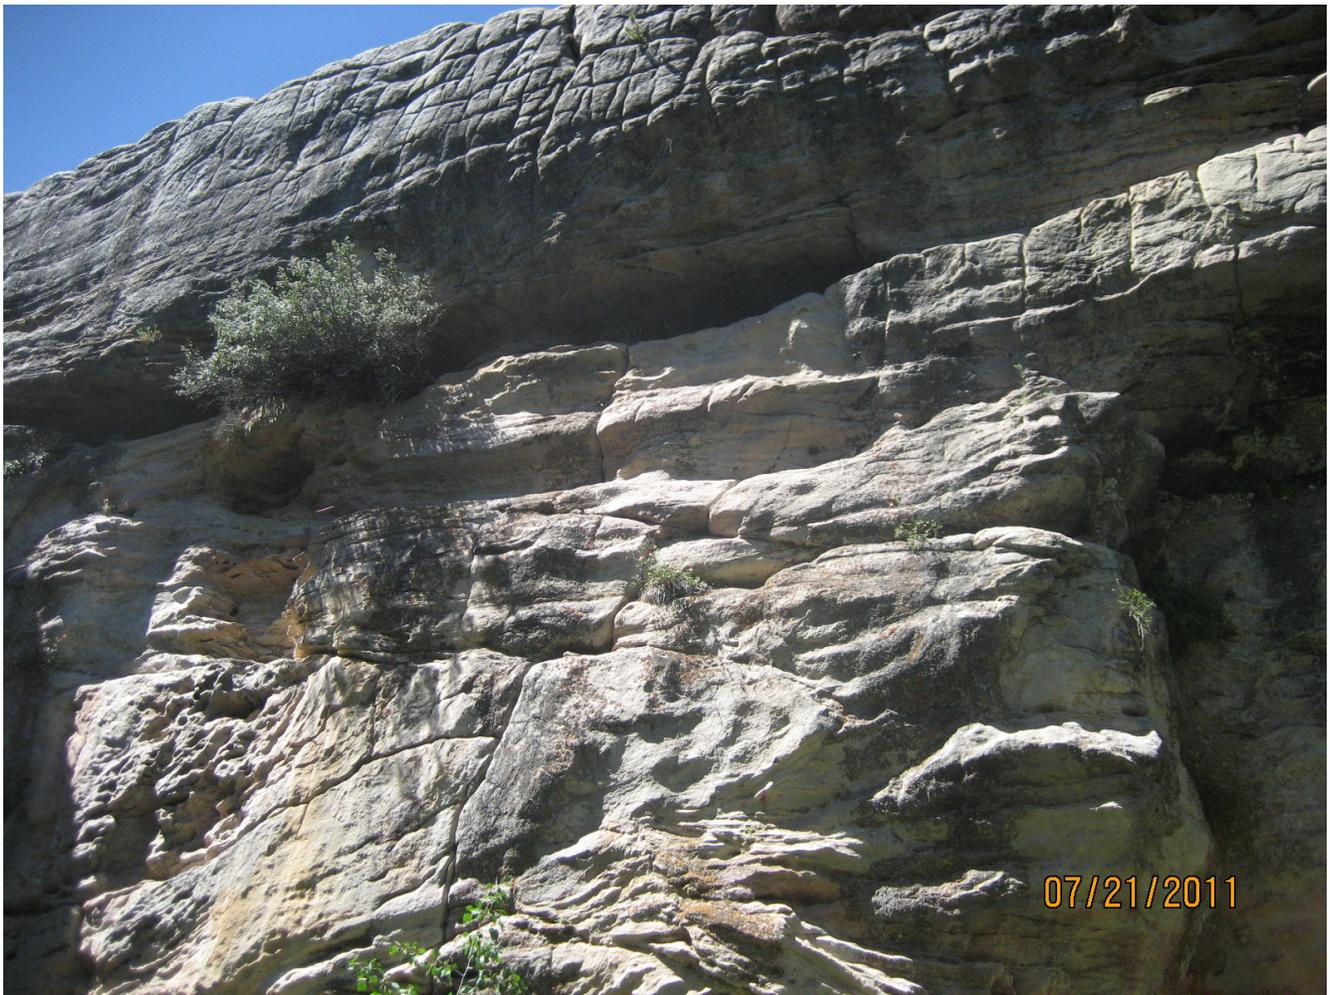
Photo Point 1c

Sorry but for some unknown reason the photograph for this site didn't turn out. However, field notes were taken for this site which indicates that there is one Columbine plant approximately 25 feet up on the cliff face and appears to be dead.

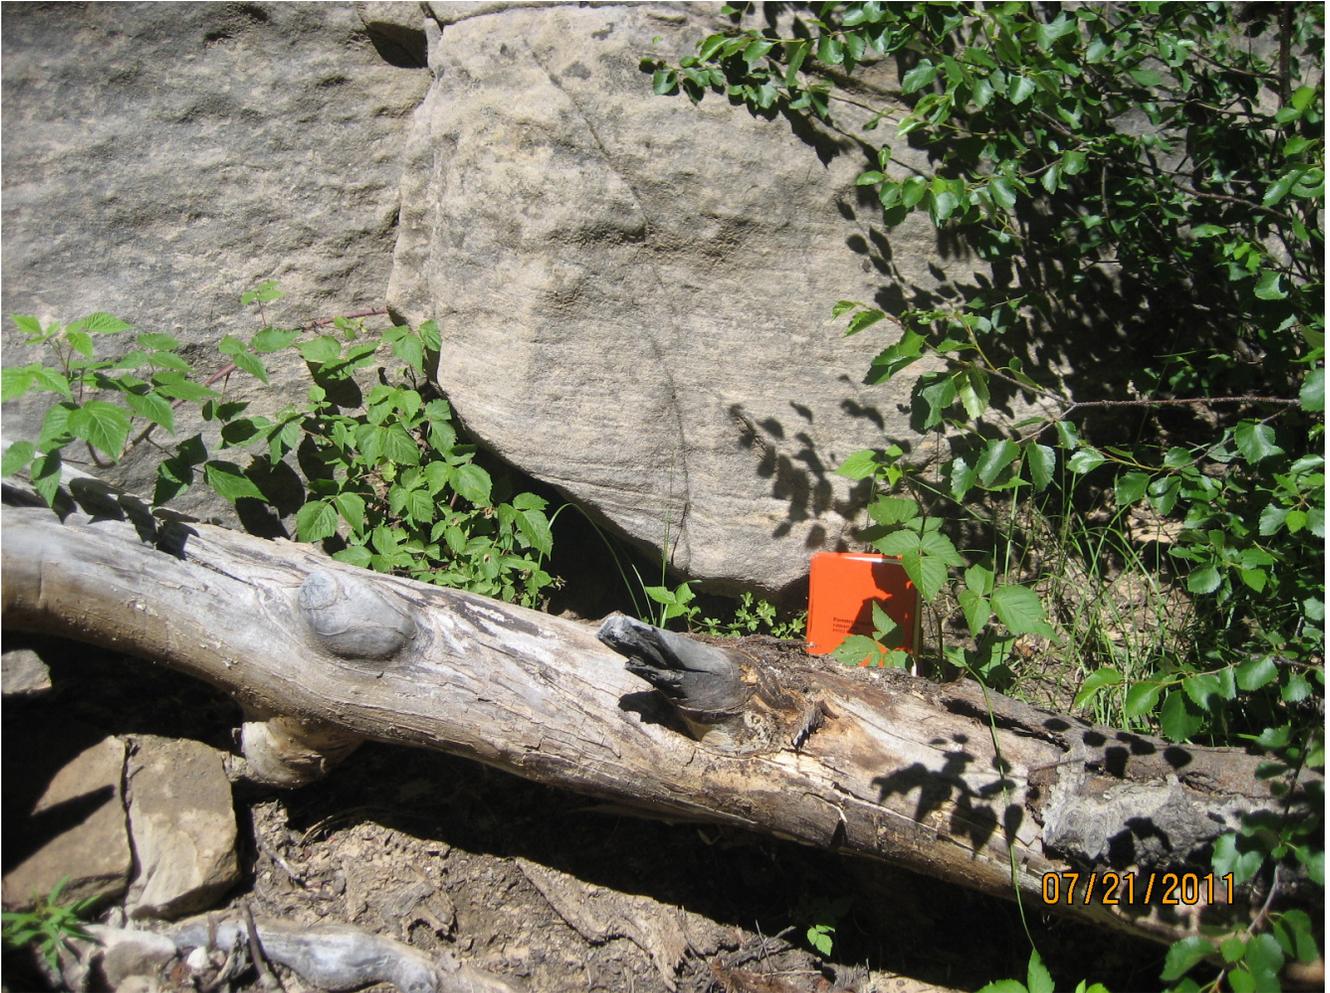
Photo Point 2

There are two columbine plants at this site with fair to good vigor. One plant has flower stocks 8-10 inches in length while the other has flower stocks 12-14 inches in length. Both plants are located 20-25 feet up on the cliff face. There is no water coming from the cracks in the cliff face.

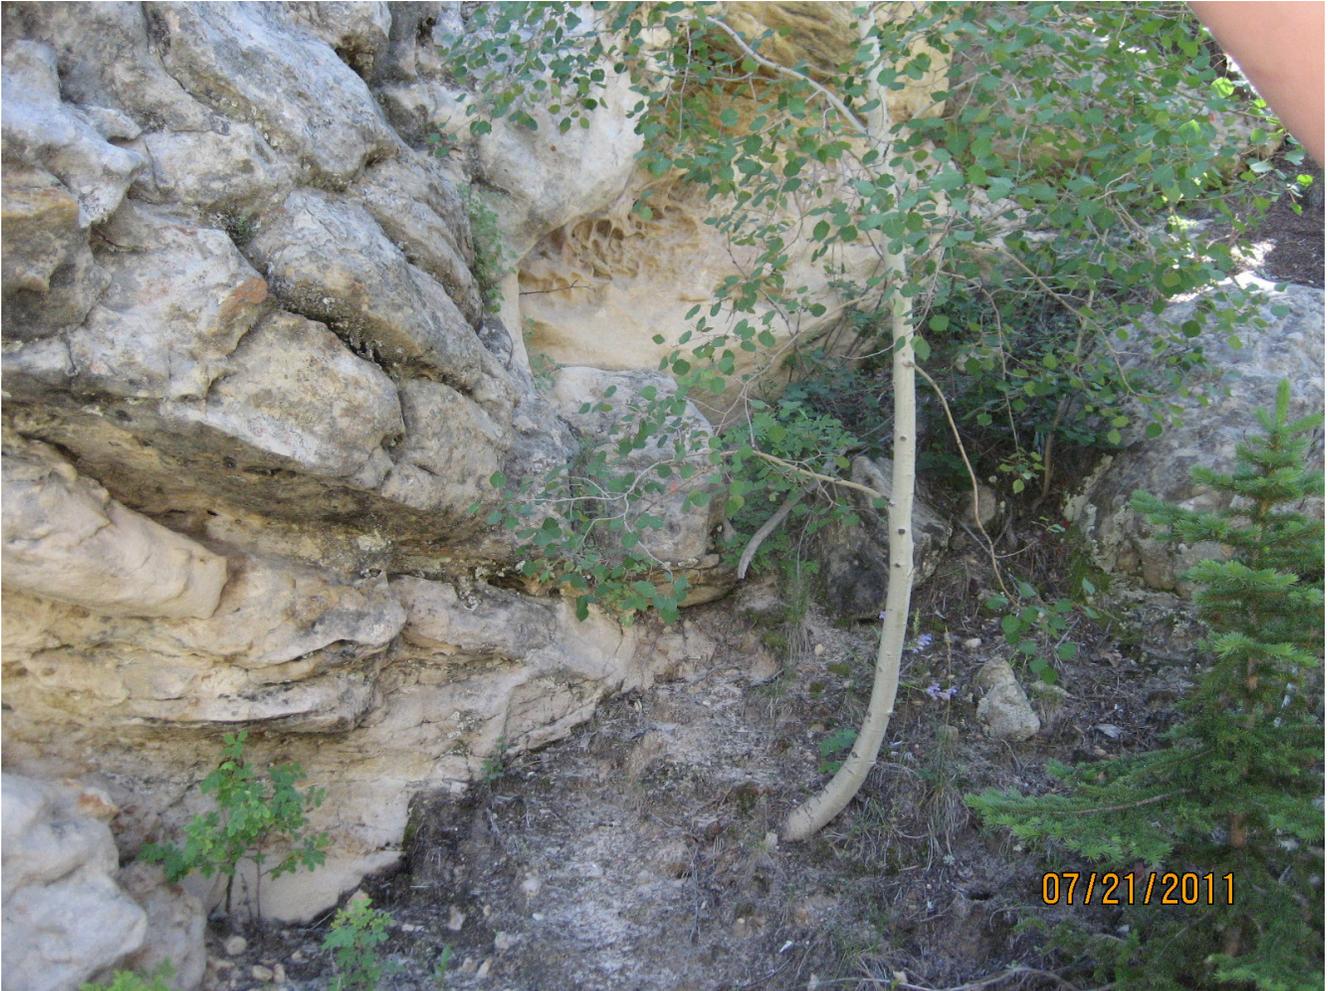
Photo Point 3

There is one small columbine plant located behind the fallen log at the base of the rock. This plant is a young seedling with good vigor but no flower stocks.

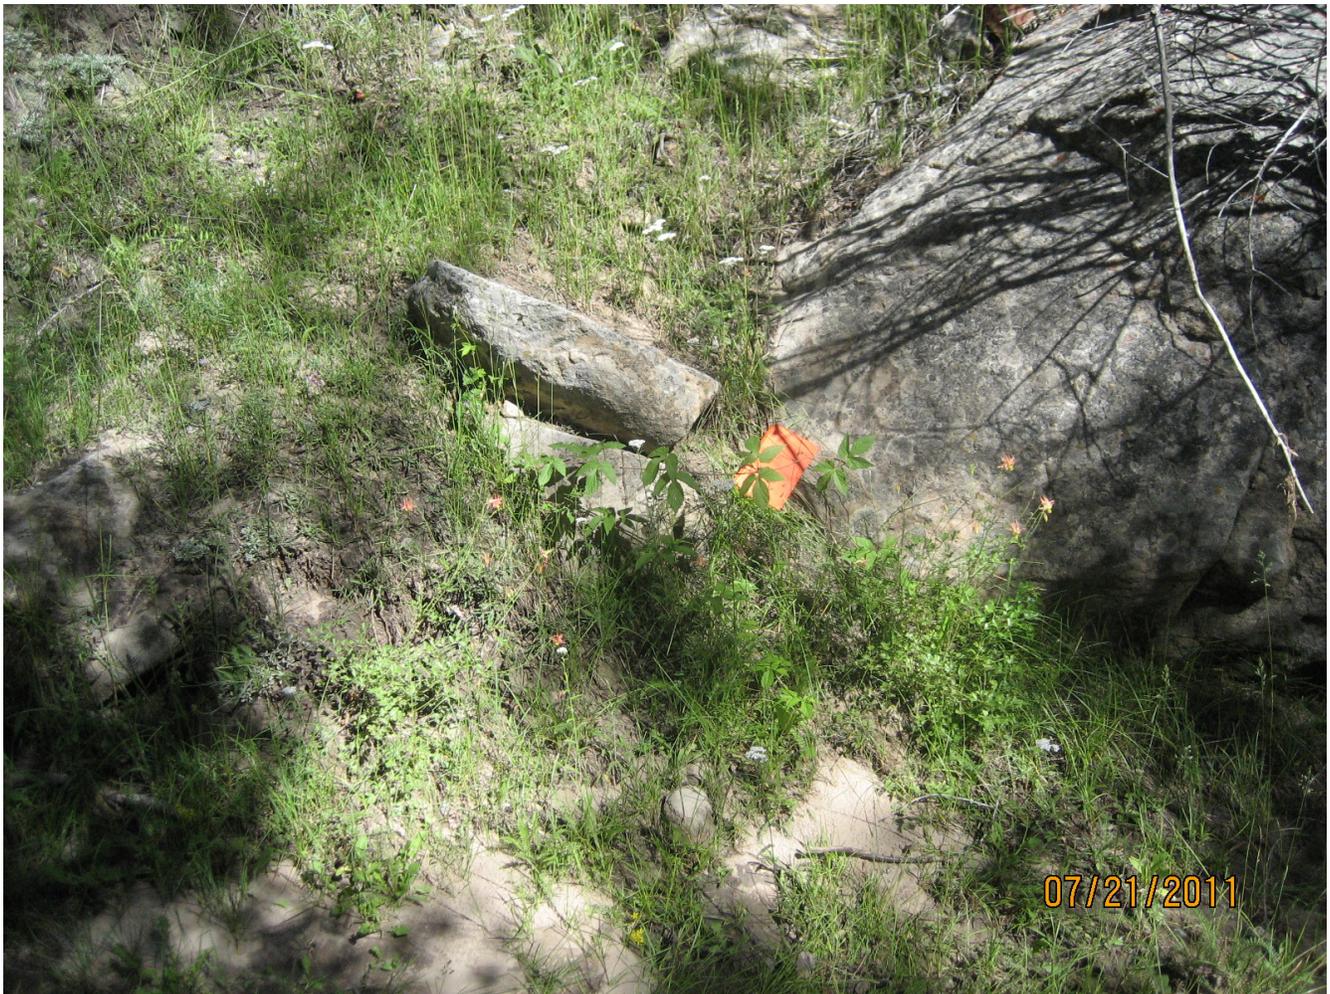
Photo Point 4

This is a very dry site with shallow soils. There are currently three columbine plants at this site. The vigor is poor to fair (probably due to the dry site and shallow soil). Only one plant has flower stock and they are 10-12 inches in length. *Carex* (*Carex spp.*) plants are sparse and have a basal growth of 2-3 inches. Woods Rose (*Rosa woodsii*) has 3-4 inches of new growth but have no flowers or seed heads at this time. *Potentilla* (*Potentilla spp.*) has 1-2 inches of new growth. Aspen (*Populus tremuloides*) 4-5 inches of new growth. Sandberg Bluegrass (*Poa secunda*) was found at the site for the first time and had a basal growth of 4 inches with 10 inch seed heads

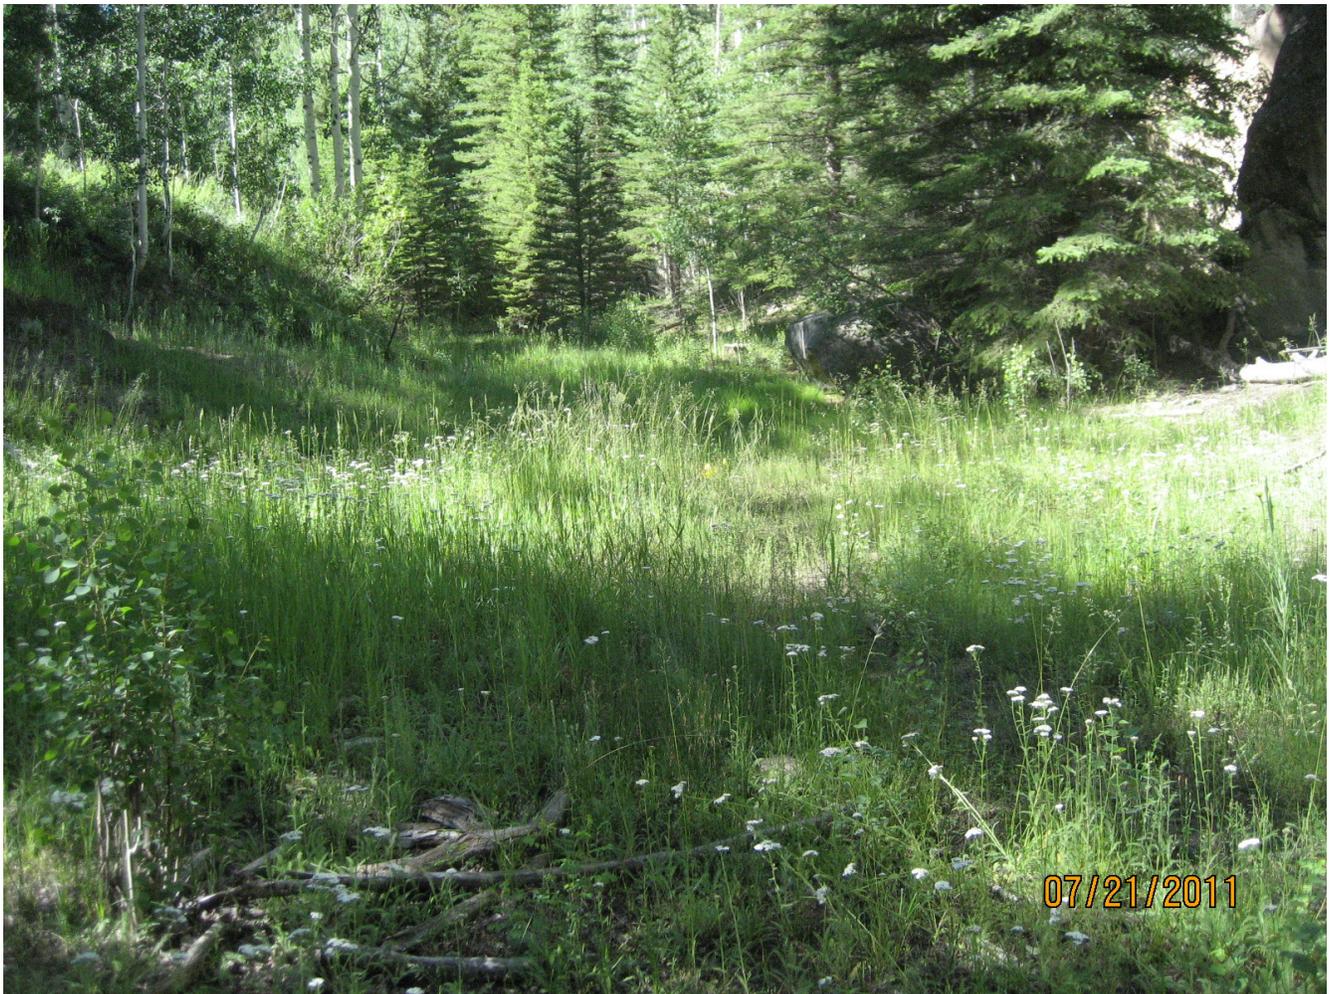
Photo Point 5

There are three mature columbine plants and two seedling columbine plants at this site. All of the plants have good vigor. The mature plants have 18-24 inch flower stocks while the seedling have good basal growth do not have any flower stock. The Bluegrass (*Poa pratensis*) plants have 6-8 inches of basal growth and 18-24 seedheads. Carex (*Carex spp.*) plants have 6-8 inches of basal growth but no seedheads. Yarrow (*Achillea millefolium*) plants have 3-4 inches of basal growth with 12-14 inch flower stocks. One Hairgrass (*Deschampsia caespitosa*) plant have 6 inch basal growth with 12-14 inch seedheads. There is a Red Raspberry (*Rubus strigosus*) creeping onto the site and has 36 inch leader. The site has approximately 20% bare ground. There are a few scattered annuals growing on the site. No Geranium plants were found during this site visit.

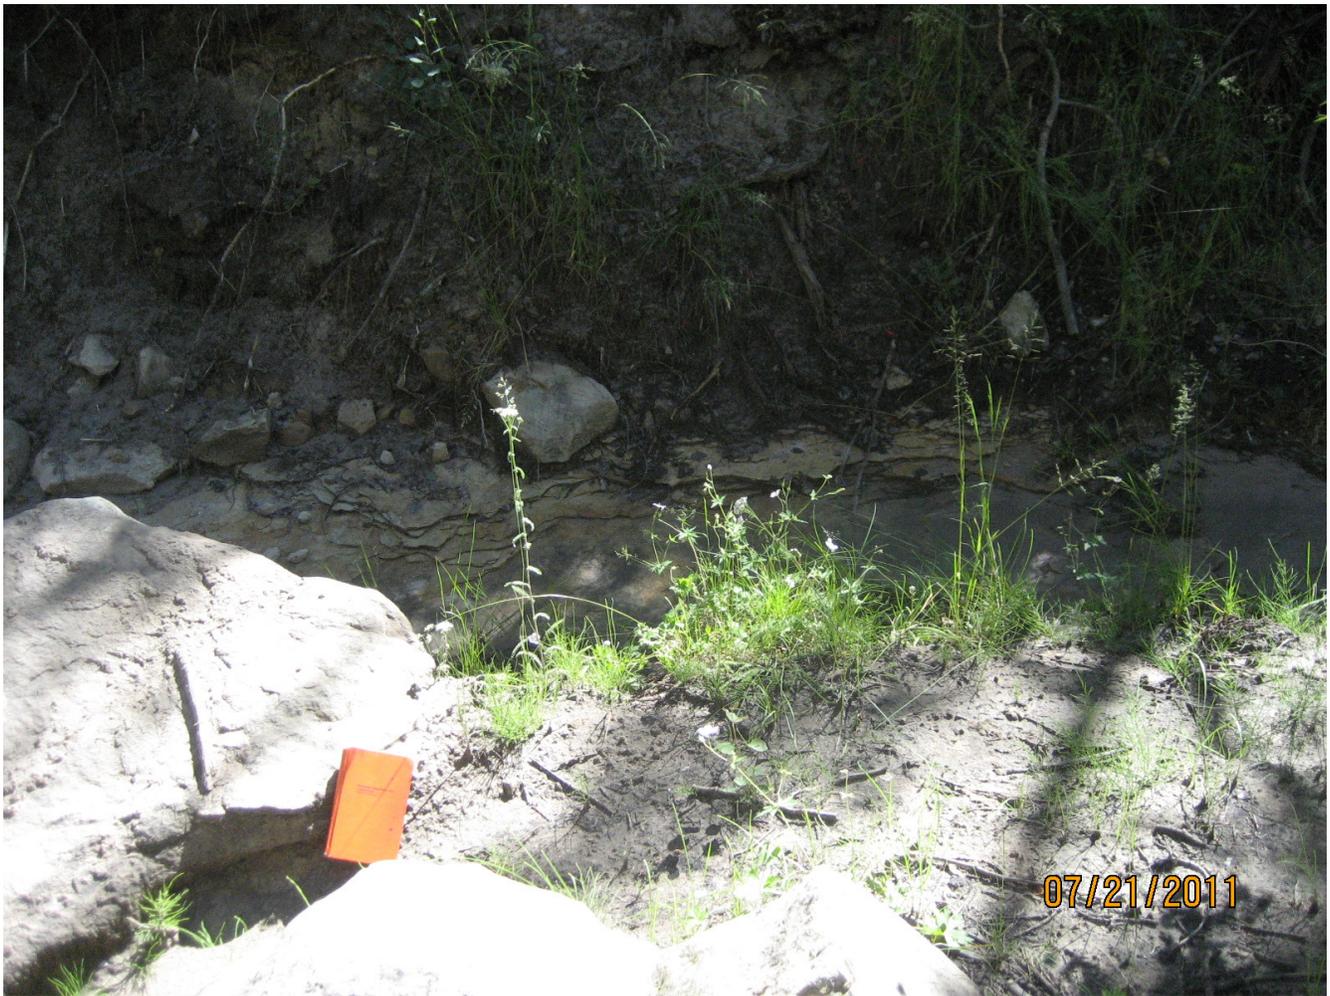
Photo Point 6

There has been no domestic grazing at this site this year. The site has 40% bare ground with 60 % vegetative cover. The overall vigor of the site is fair to good. There is no water in the Creek although the Creek bed is moist due to recent runoff from a storm event. Aspen has 15-18 inches of new growth. Carex has 8-10 inches of basal growth with 12-14 inch seed heads. Yarrow has 4-6 inches of basal growth with 20-24 inch flower stocks. The wiregrass (*Juncus spp.*) plants have 18-24 inch seed heads, however the plants are sparse at this site. Herbaceous Sage (*Artemisia ludoviciana*) has 20-24 inch seedheads. Woods Rose has 6-8 inches of new growth but no flowers yet. Joint Grass (*Equisetum Spp.*) has 8-10 inches of new growth, however the plants are sparse at this site. Mountain Brome (*Bromus marginatus*) was found at the site during this visit. It had 24-30 inch seed heads. There are numerous annuals growing on the site.

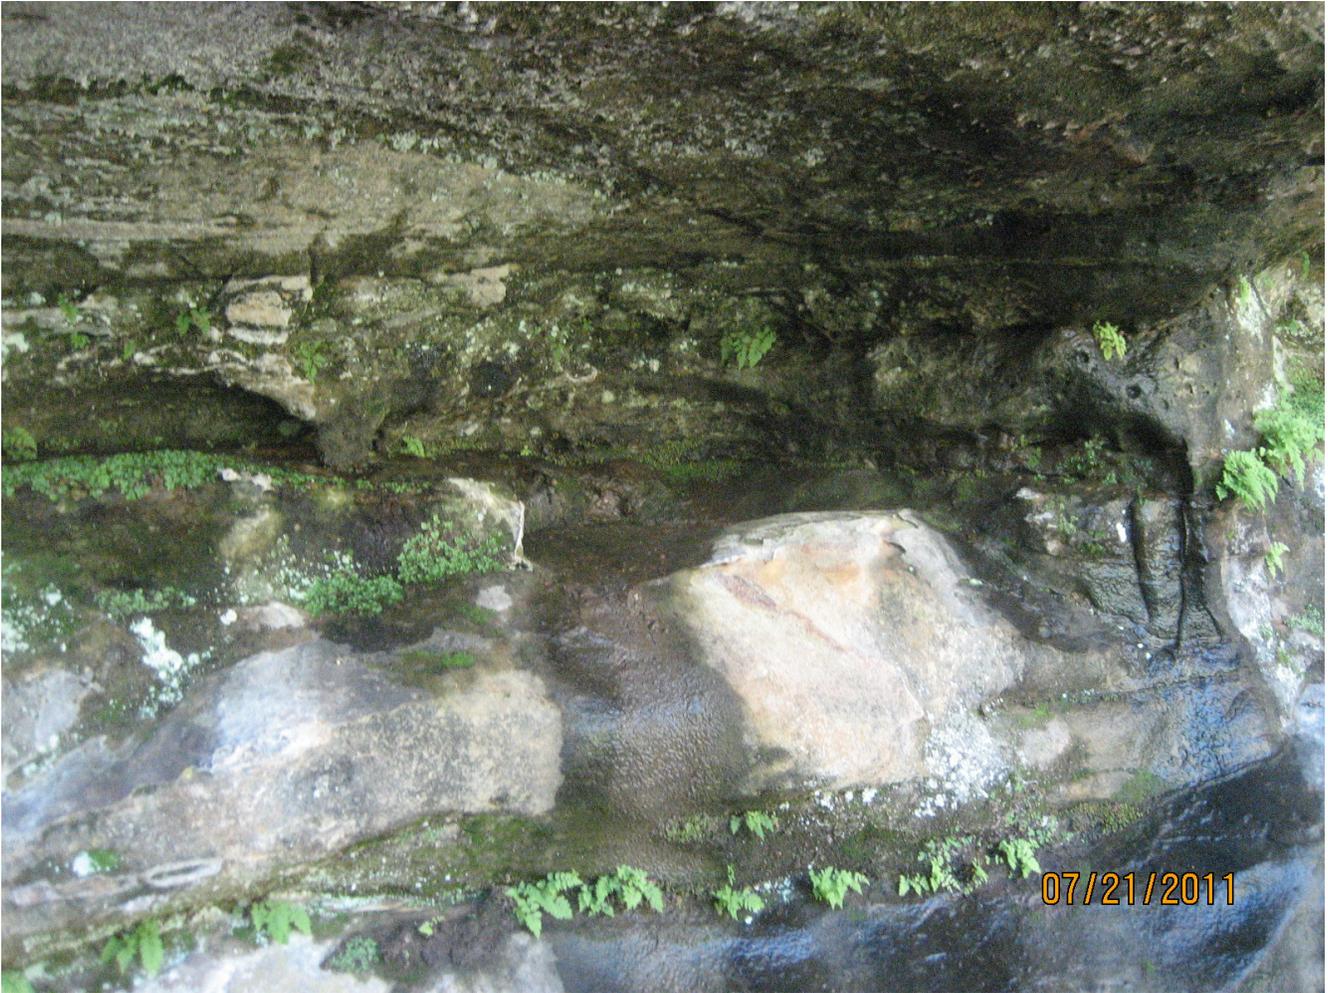
Photo Point 7

At this photo point there are still no columbine plants. There are a few Geranium plants that have 8-10 inches of new growth. Yarrow has 4 inches of basal growth and 16-18 in flower stocks. Carex is sparse and has 5-7 inches of basal growth. Bluegrass has 5-7 inches of basal growth with 22-24 inch seedheads. There is one new Aspen shoot with 6 inches of current growth. There are a few annuals growing on the site. It is estimated that the site has 60% bare ground.

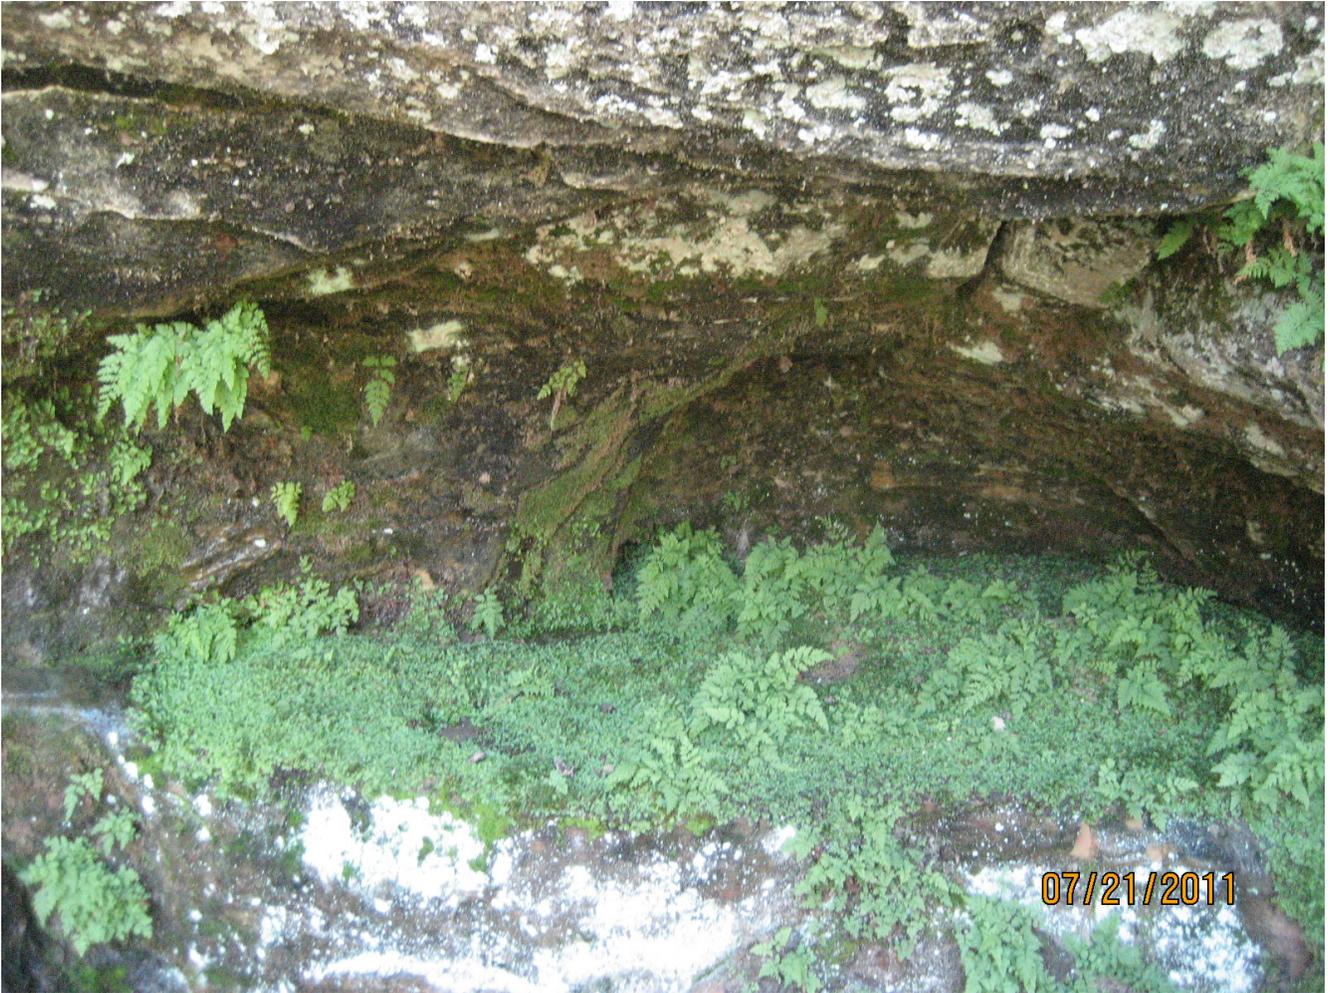
Photo Point 8

This photo point is a hanging garden area located in the “Grotto” area. The ferns and lichens receive moisture that is coming from the fractures in the cliff face. The fern and lichen density is overall fair and better than last year. Fern leaf length is 3-6 inches. There is water dripping from the fractures in the cliff face.

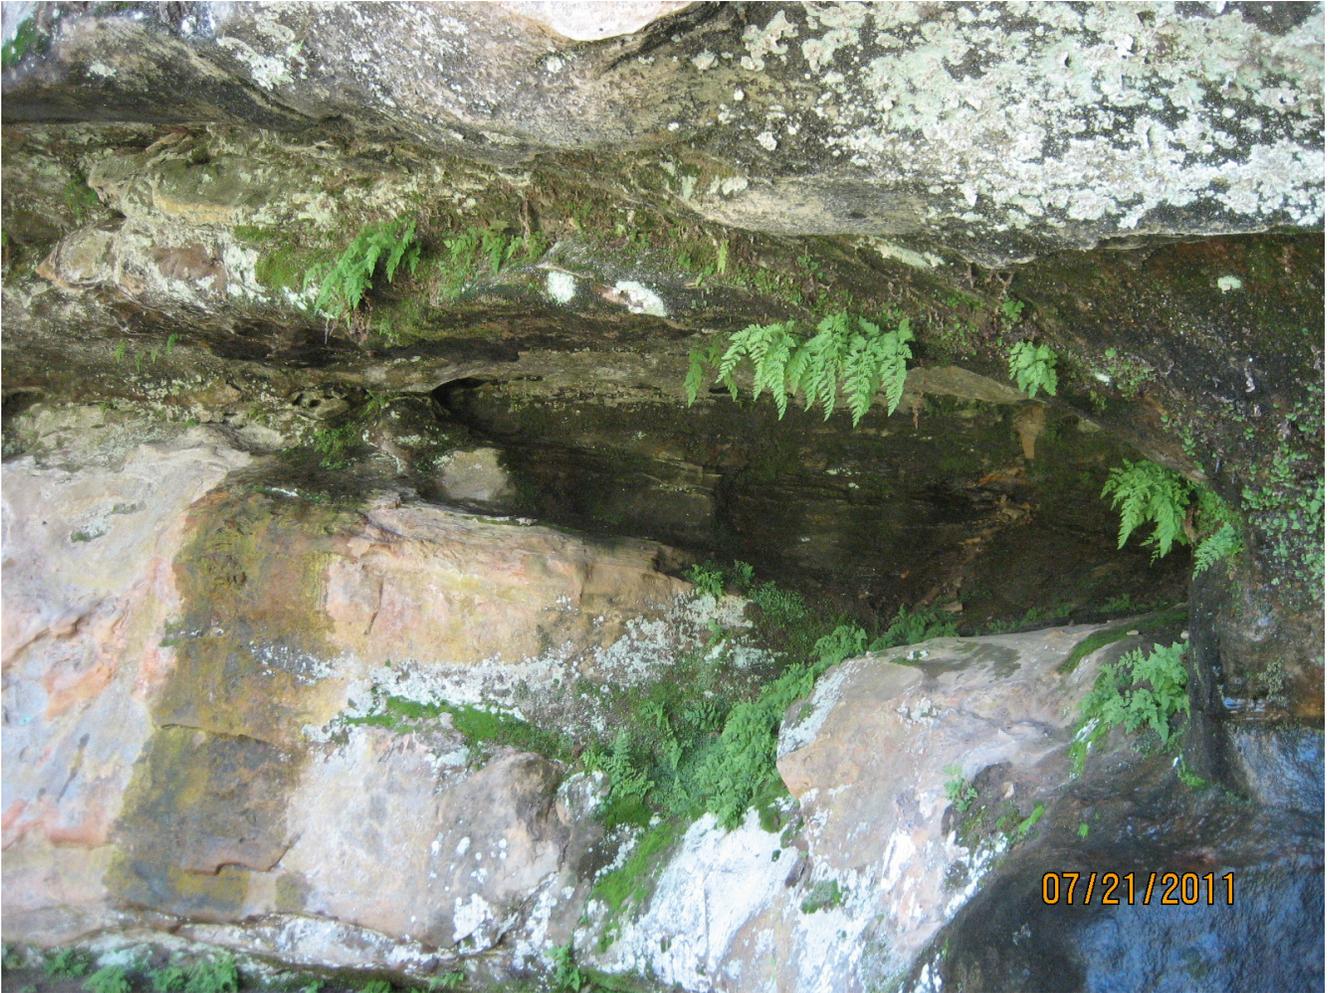
Photo Point 9a

There is water dripping from the rock fractures in the cliff face. The fern and lichen density is good. The fern leaf length is 5-7 inches.

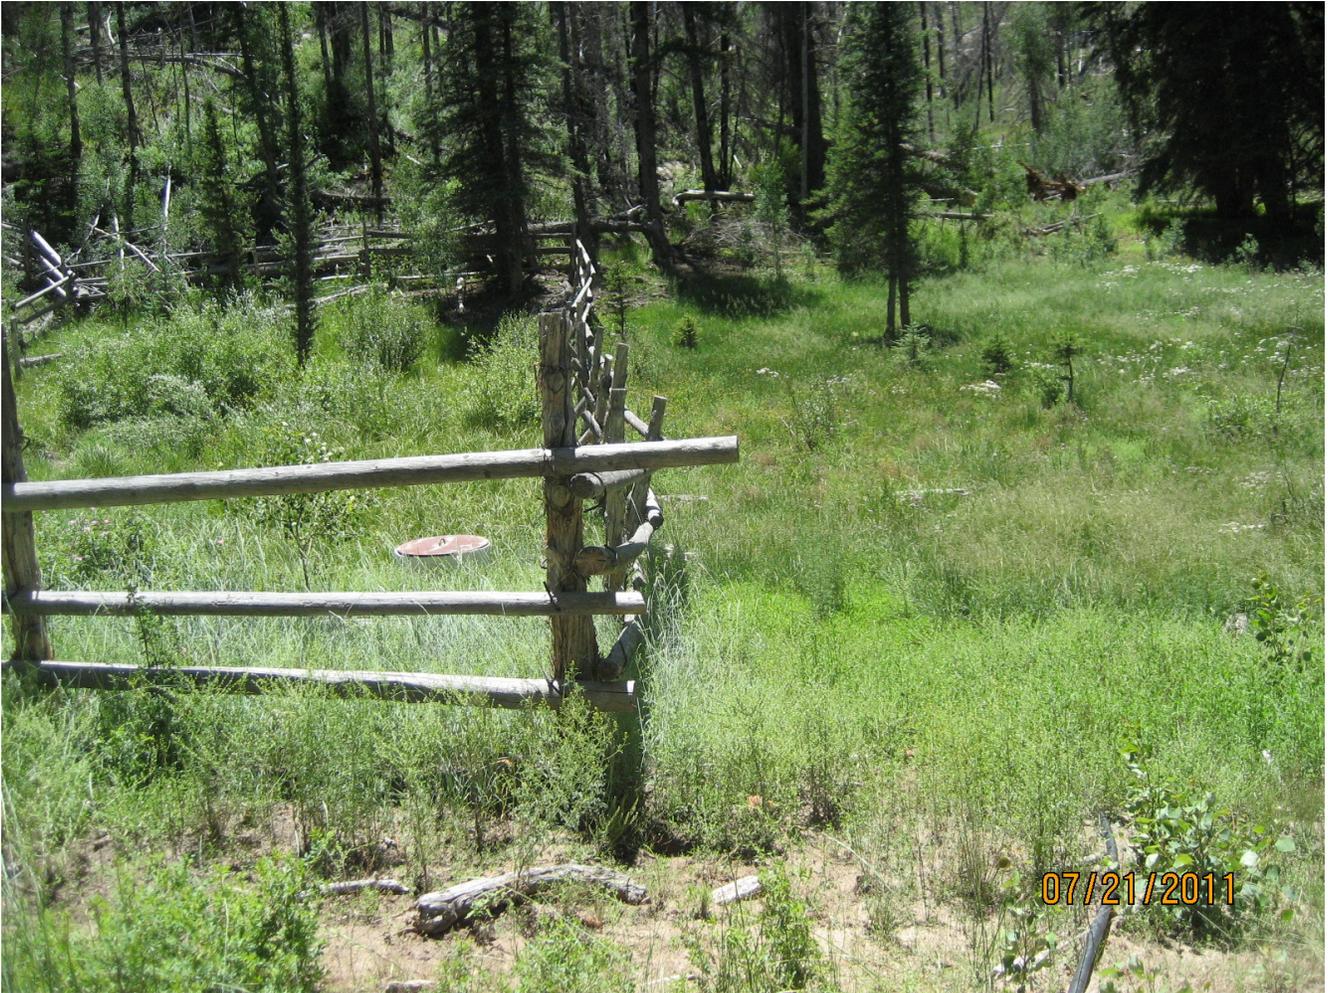
Photo Point 10

There has been no domestic livestock grazing at this site. It is estimated that there is 70% bare ground with 30% vegetative cover. The vegetative condition is poor with a slight upward trend from last year. This upward trend is probably due to the good moisture the area has received. There is very little if any litter on the ground. Aspen has 6-9 inches of new growth. Woods Rose has 4-6 inches of new growth with no flowers or seed heads. Wiregrass is 8-10 inches in length with no seed stocks and is sparse throughout the site. Big Sage has 5-8 inches of current growth. There are a few Slender Wheatgrass plants (*Agropyron trachycaulum*) that have 24 inch seed heads.
