Subject: White Oak Mine Reclamation with Biosolids

## White Oak Stabilization Project Completion Report

State Procurement Solicitation #AR-1135

October 14, 2011

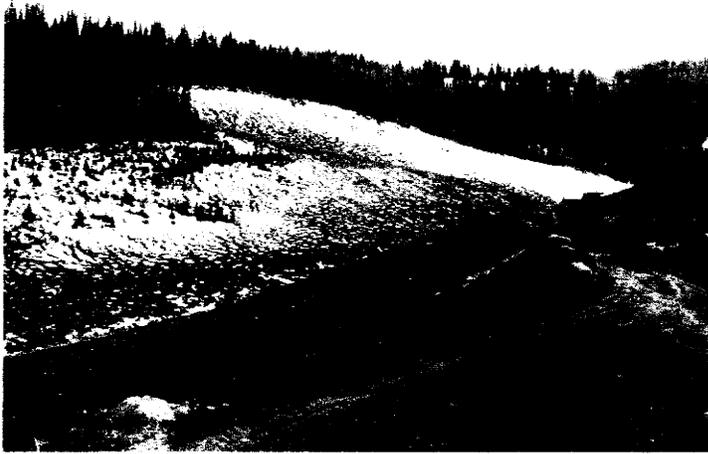
November 6, 2010. An operator (standing on the berm) controls the distribution of the biosolids spray from the rock-chucker using remote control.

The rock chucker was suitable for distributing granular, dried, digested biosolids, such as that produced by PRWID. However, the addition of polyacrilamide (PAM) to the Spanish Fork biosolids made it very difficult to scatter the biosolids using this method. The PAM created a jello mass that clogged the machinery. A bull dozer was more suitable for distribution of the PAM treated biosolids. Biosol is an option for difficult to reach slopes.

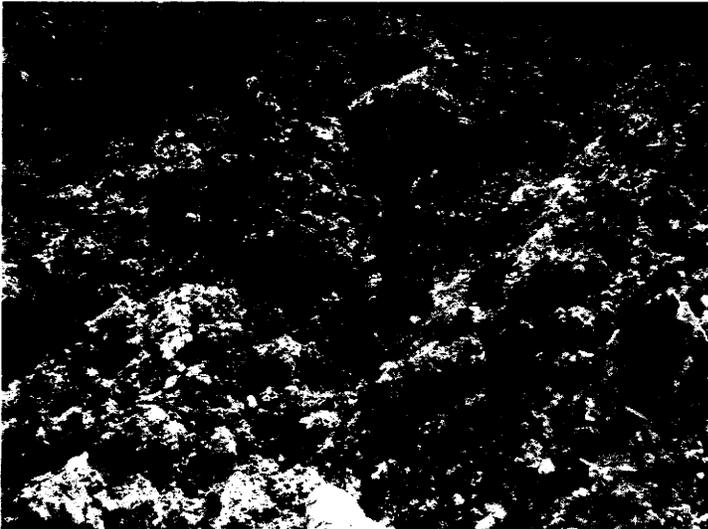
The photo to the left shows the surface appearance of the biosolid application.

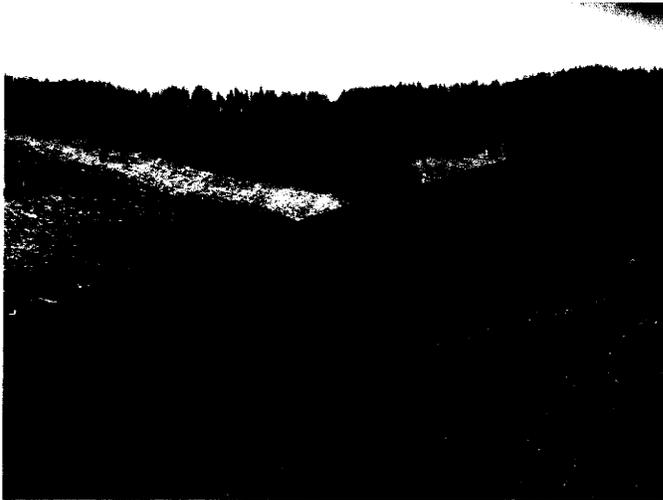
November 6, 2010. Biosolids applied to roughened slope between middle and lower terrace.

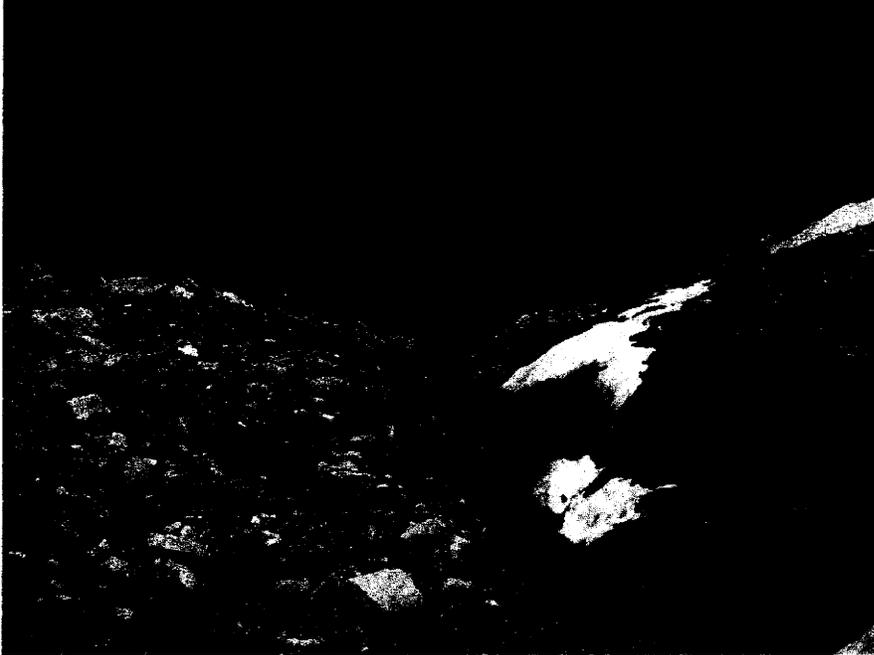
2009. Pre-construction. Reach 4.

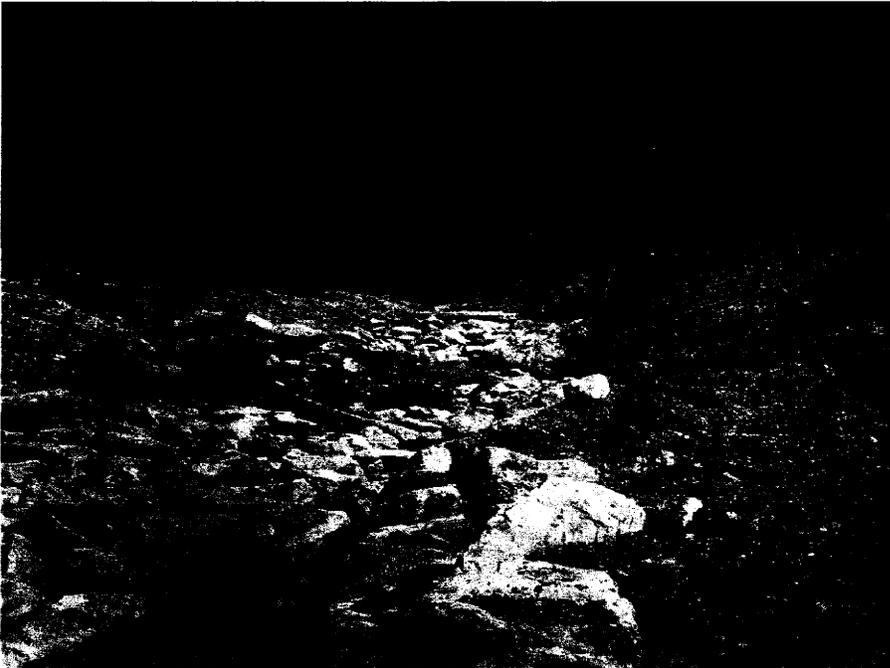
08/18/2011. Post Construction. Reach 4.

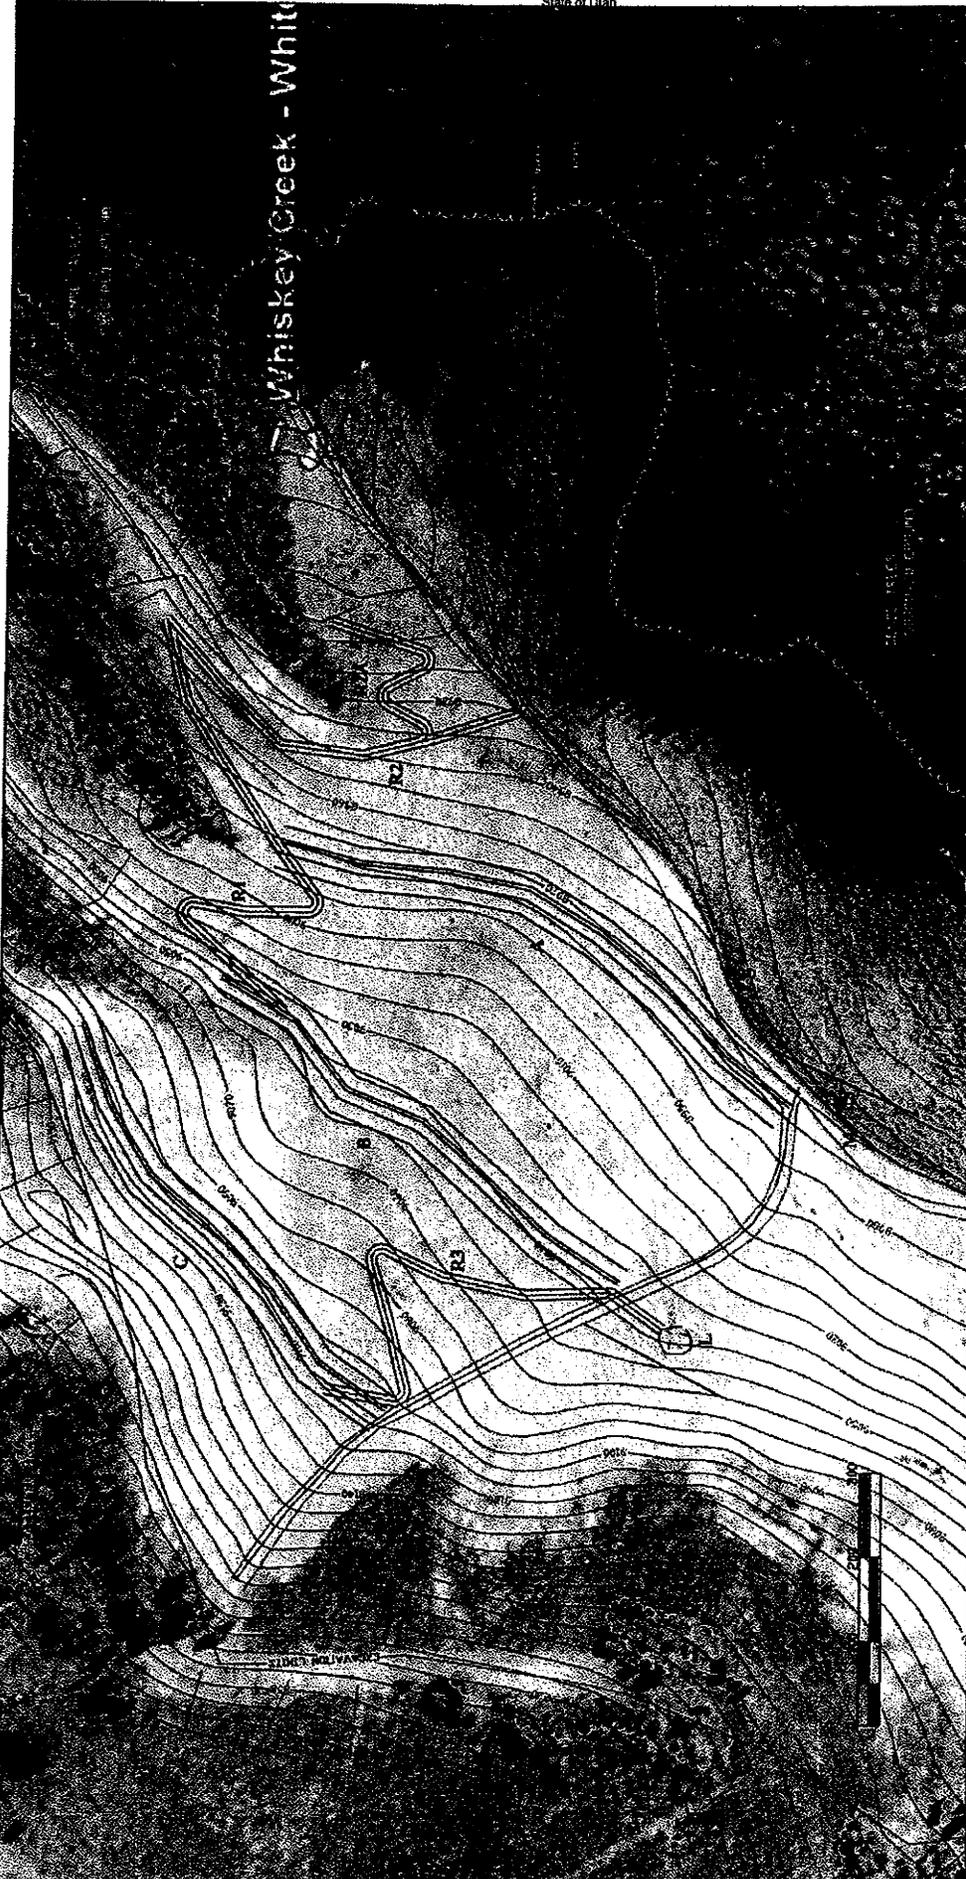
WO-8 Terraces & Access Roads

The east facing slope was divided into three shorter slopes by the construction of terraces. Terraces allowed water to be held longer on the slope and also conveyed excess water to an existing, constructed side channel. Three access roads were temporarily constructed for equipment access. Map WO-8 in Attachment 1 shows the location of the terraces and access roads.
