Subject: Shaft Inspection at Crandall Canyon on Federal Coal Lease UTU-071737

An inspection was held at the shaft located up Crandall Canyon on January 22, 2002. Personnel that were in attendance were Stan Perkes (BLM), Jeff McKenzie (BLM), and Steve Rigby (Cyprus/AMWEST).

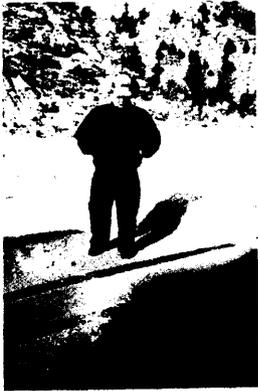
Exhaust Shaft

Exhaust Shaft: We then went down the canyon to the exhaust shaft. This cap has had a hole drilled through the cap in the past. No methane readings were taken because the wind was blowing so hard up the canyon. The center of the cap had the snow melted away from it. This could be from the sun or from warm air inside the shaft.

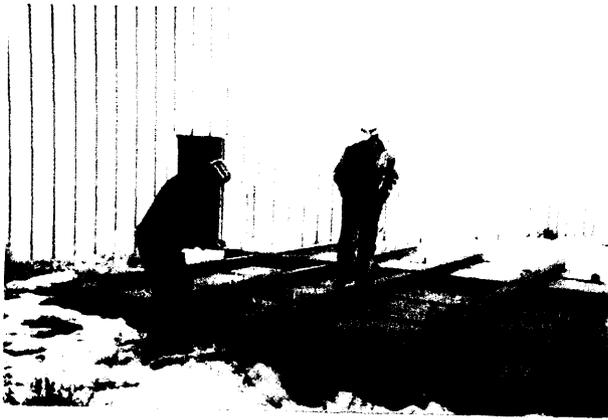
North Fan Slope Methane Measurement

to the head frame enclosure open. Methane measurements were taken and no gas was detected. The seal over the shaft looked to be in good shape. The cage guide rails were protruding through the cap and the cage was blocked up on top of the cap. We then went outside and looked at the caps on where the fans had been located on the intake shaft. There apparently were slopes driven from the fan foundations down into the shaft. The temporary caps did not seal the slopes well. On the north slope methane was checked from a gap in the shaft cap and 0.5% methane was recorded. The wind was blowing very hard so it is unknown what the true reading was from the air going from the shaft to the atmosphere. It is also unknown what the methane concentration is inside the shaft. At the cap over the south slope we could not detect methane coming out. It was interesting that the in-take shaft was exhausting at the north slope. It is unknown why this is the case. No barometric pressures were recorded nor was any data analyzed. The return shaft was in the sun light at the time of the measurements.

1. There is easy access to these shafts. The caps are temporary and are not solid. There was methane gas coming out of the north slope entry of the intake shaft. We are not sure of the concentration because of outside conditions at the time the measurements were taken. We are also unsure why the north slope of the intake shaft was exhausting. The concrete caps appear to be adequately designed and constructed to support personnel. However, they are accessible to vehicles and it is not known if they would support such a live load. We feel that there should be a fence with a locked gate around each of the shafts and the slopes. This would limit access danger to the public and liability from potential problems from the shaft. **This should be done immediately.**
