**WASTE ROCK PILE SLOPE STABILITY ANALYSIS,
SKYLINE MINE**

CANYON FUEL COMPANY
Skyline Mine
Scofield, Utah

February 2007

EARTHFAX ENGINEERING, INC.
Engineers/Scientists
Midvale, Utah
www.earthfax.com

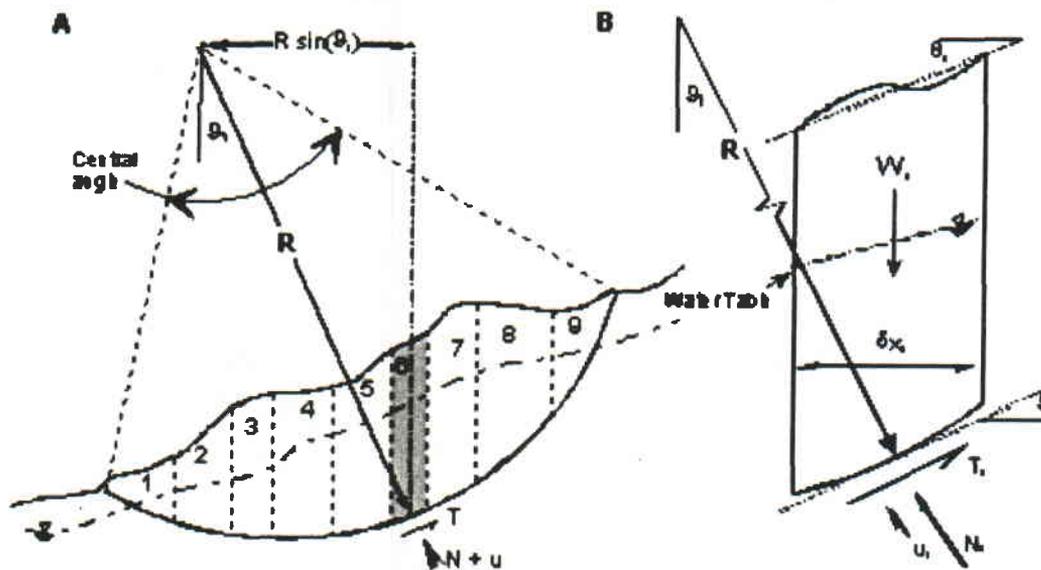
$$F_s = \frac{RT_i}{R \sum W_i \sin(\theta_i)} = \frac{\sum \left[\frac{b \delta x_i}{\cos(\theta_i)} (c - u_i \tan(\phi)) + N_i \tan(\phi) \right]}{\sum W_i \sin(\theta_i)}$$

R = radius of circle	u = pore water pressure
T = shear force	δx = width of the slice
W = sum of the unit weights	b = width (in and out of paper)
c = cohesion	θ = slope angle (θ)
ϕ = angle of internal friction	N = normal force

FIGURE 2. ILLUSTRATION OF BISHOP'S METHOD OF SLICES TO DETERMINE THE FACTOR OF SAFETY (FS) AGAINST ROTATIONAL SHEAR FAILURE

Slope stability was evaluated using Bishop's Method of Slices. This method is a limit equilibrium analysis that calculates a factor of safety (FS) against rotational shear failure based on the ratio of forces that cause and resist failure. An FS of 1.0 would indicate that the driving and resisting forces are equal, and that failure, if it has not already occurred, is likely. A minimum FS of 1.5 is required for all waste rock pile slopes to meet the requirements of R645-301-500.

Bishop's Method of Slices tests various circular failure planes with radii that are centered at various distances above the slope. The FS is derived by calculating the moments of numerous vertical slices within the failing arc of soil about the center of the circular surface. The method applies strength (friction angle and cohesion) and density data for each soil type. The method also accounts for pore water pressures and the presence of a phreatic surface. Figure 2 shows a typical diagram of how Bishop's Method of Slices is applied. The computer program STABLE for Windows (M. Z. Associates, 2002) was used to perform the numerous calculations required to find the critical failure surfaces and their respective FS values.

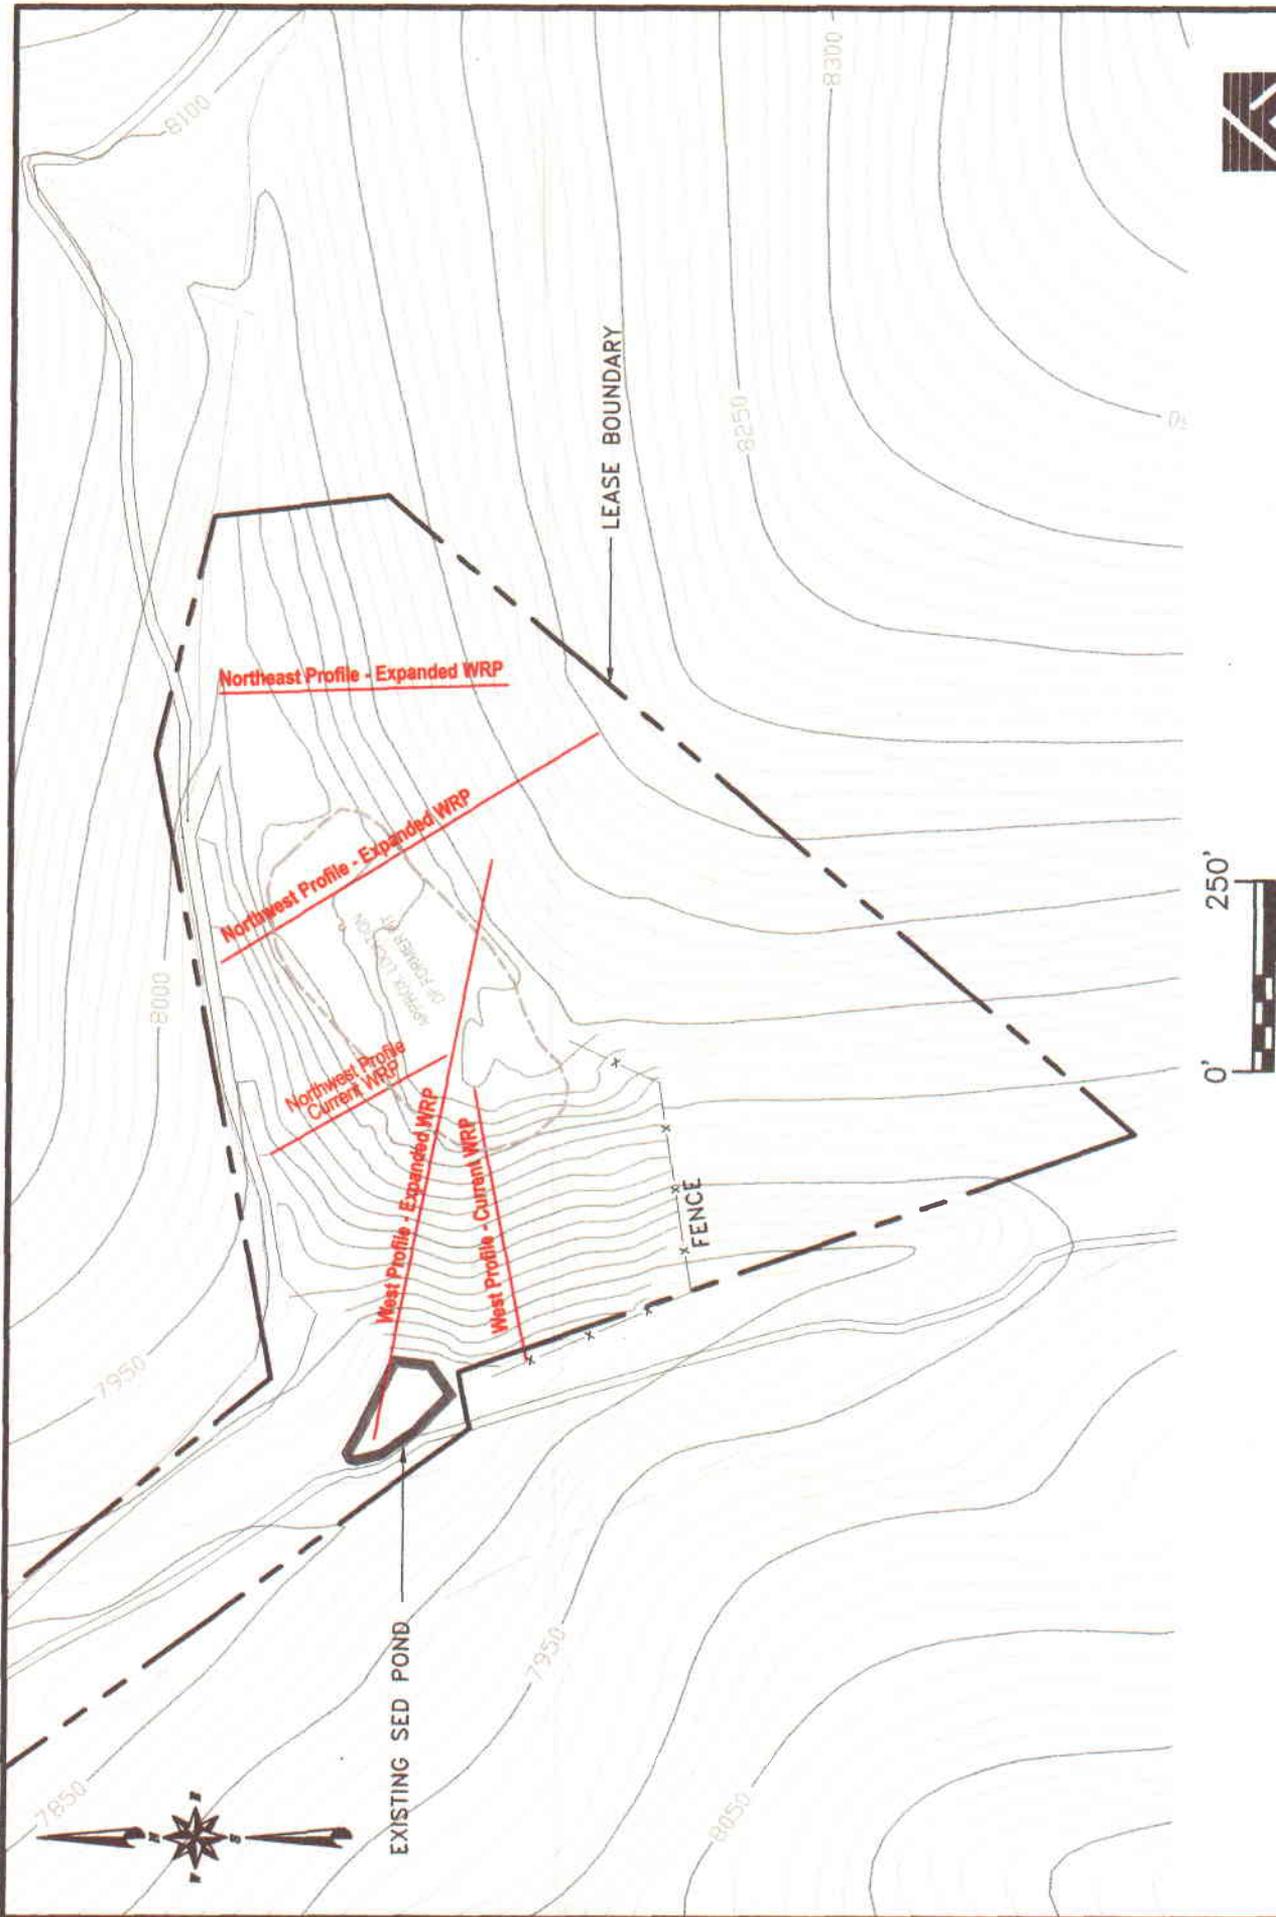
FIGURE 3A. MAP OF WASTE ROCK PILE, CURRENT CONFIGURATION

Figures 3a and 3b shows the locations of each of the four profiles used to model the stability of the WRP. Figures 4-9 illustrate the geometries of each profile, which are briefly described below:

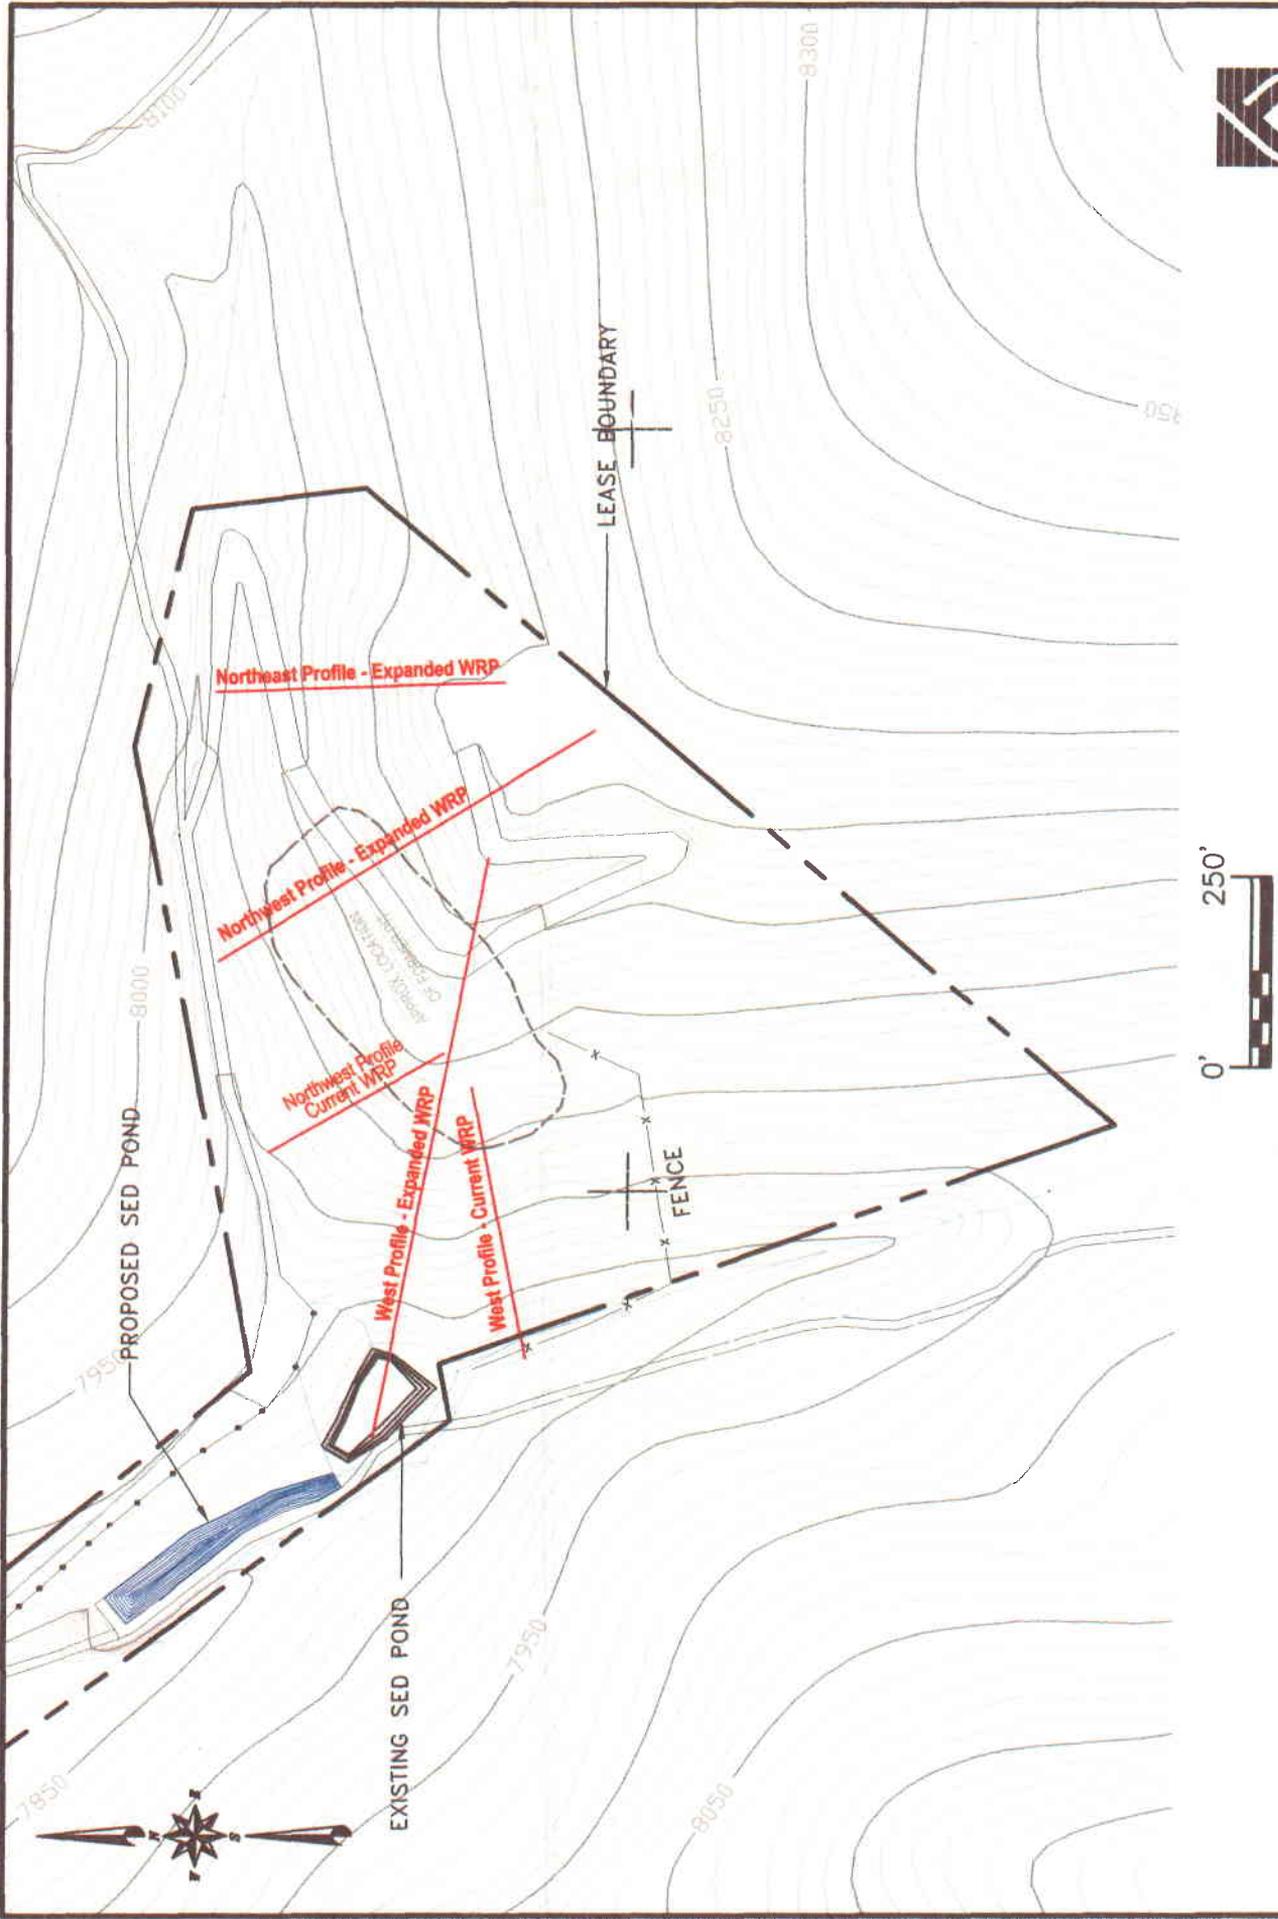
FIGURE 3B. MAP OF WASTE ROCK PILE, EXPANDED CONFIGURATION

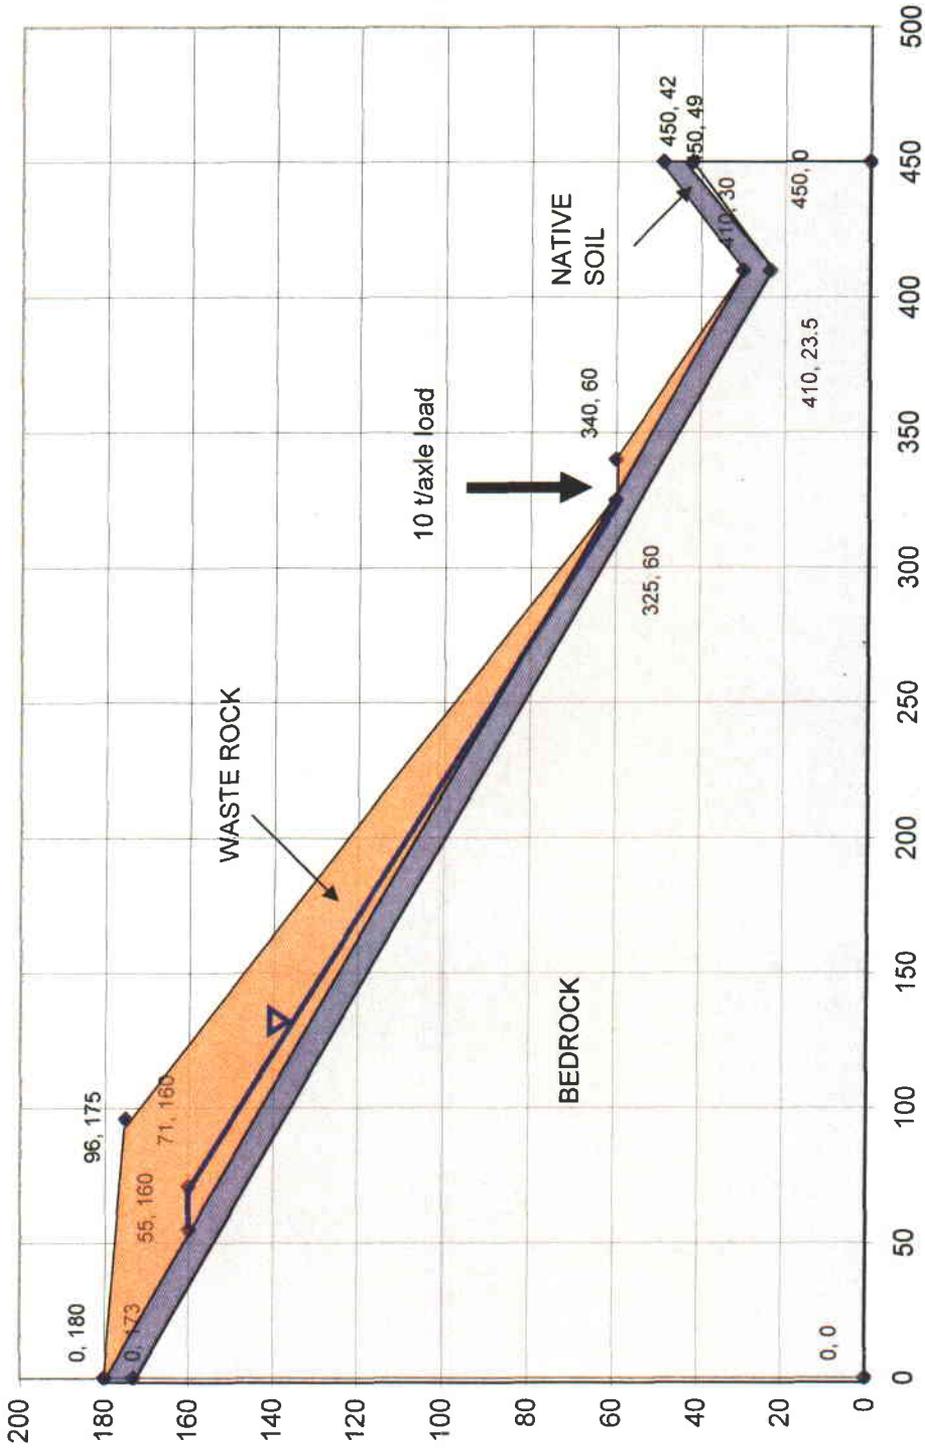
FIGURE 4. NORTHEAST PROFILE

- **NE Profile:** The area represented by this profile will be used for waste rock storage only if the WRP is expanded to the lease boundary. The profile includes an access road at the bottom and a 2H:1V (26.6°) slope up to a gently sloping area at the top of the WRP. (See Figure 4)

When the WRP is extended up to the lease boundary, the FS against rotational shear failure ranges from 1.63 (West Profile) to 1.69 (Northeast Profile) for the dry condition. The FS ranges from 1.52 (West Profile) to 1.61 (Northeast Profile) for the saturated condition. Note that this assumes that the west slope of the WRP is graded at 2.2H:1V. If the west side of the WRP is graded at 2H:1V, the FS is reduced to 1.51 for the dry condition and 1.44 for the saturated condition.

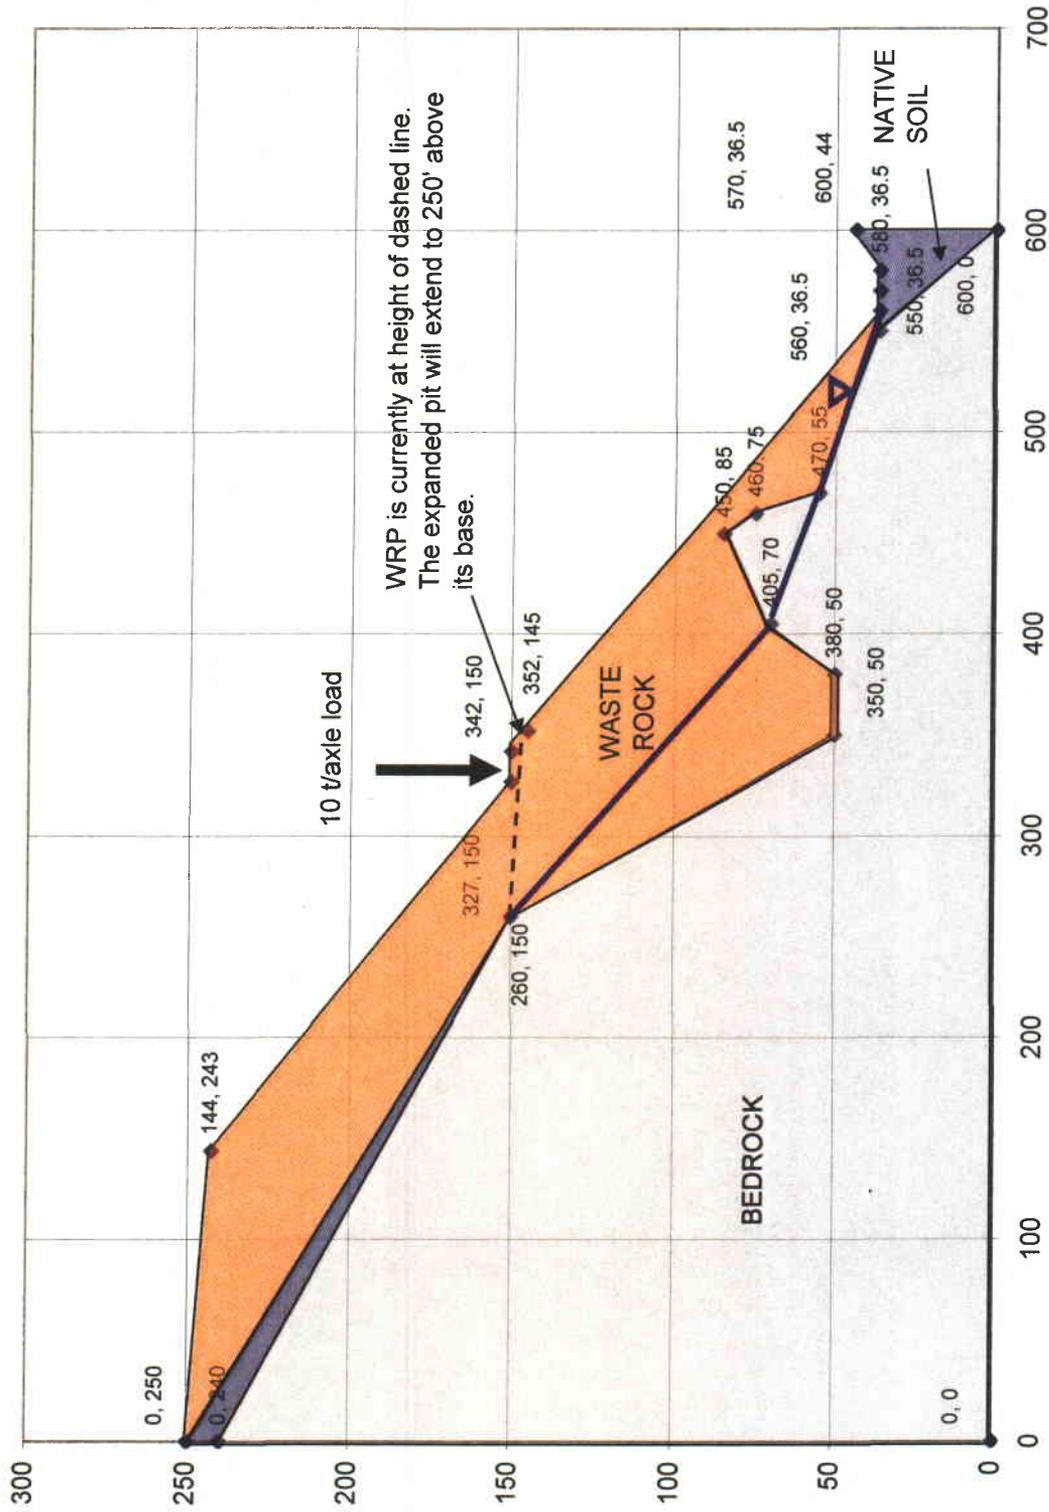
FIGURE 5. NORTHWEST PROFILE

- **NW Profile:** This profile represents the bulk of the existing WRP which has been placed inside the former open pit. The former pit measures between 25 and 75 feet deep and up to 65 feet wide. Waste rock has been piled from the drainage bottom to near the top of the former pit at a 2H:1V (26.6°) slope. If the WRP is expanded up to the lease boundary, it will be extended upwards for approximately 100 feet at the same slope, with a road cut at an elevation of approximately 8,060 feet. The underlying native soil surface above the former pit was taken to be 2.6H:1V (21.0°), based on the steepness of adjacent slopes. The top of the extended WRP will slope gradually to promote positive drainage. (See Figure 5)

According to the slope stability analyses, the current waste rock pile has a FS against rotational shear failure for the dry condition ranging from 1.63 for the West Profile to 1.72 for the Northwest Profile. For the design saturated condition for the current WRP, the FS ranges from 1.53 for the West Profile and 1.72 for the Northwest Profile.

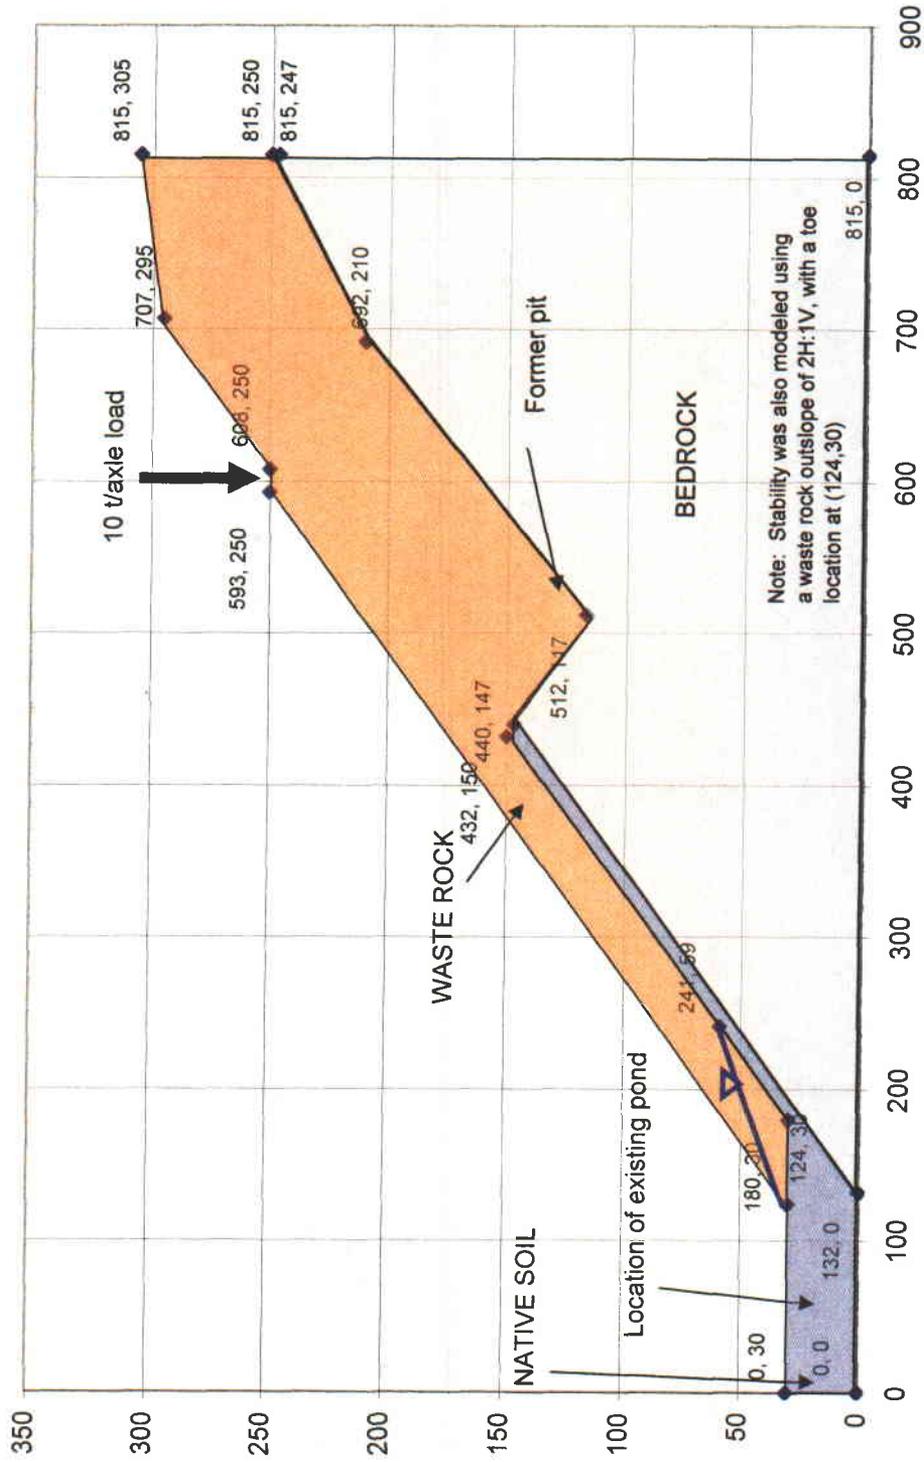
FIGURE 6. EXPANDED WEST PROFILE, 2.2H:1V OUTSLOPE

- **W Profile – Expanded:** This profile had been modeled as two scenarios. The first scenario, which is depicted in Figure 6, represents the area on the western edge of the current WRP following expansion of the pile up to the elevation of the lease boundary (approximately 8,150 feet). This profile has been modeled for the pile to be angled at a slope of 2.2H:1V (24.4°). An access road cut has been placed at an elevation of 8,090 feet. The second scenario, which is depicted in Figure 7, represents the western slope following expansion of the pile into the existing sedimentation pond. The top of the pile for this profile is at the current elevation of the top of the pile (approximately 8,050 feet), and the slope angle is 2H:1V (25.6°). In both scenarios, at the bottom of the pile, the waste rock overlies a thin native soil surface (approximately 6.5 feet thick) that slopes at 2.1H:1V (25.4°). The top of the pile overlies the former pit.

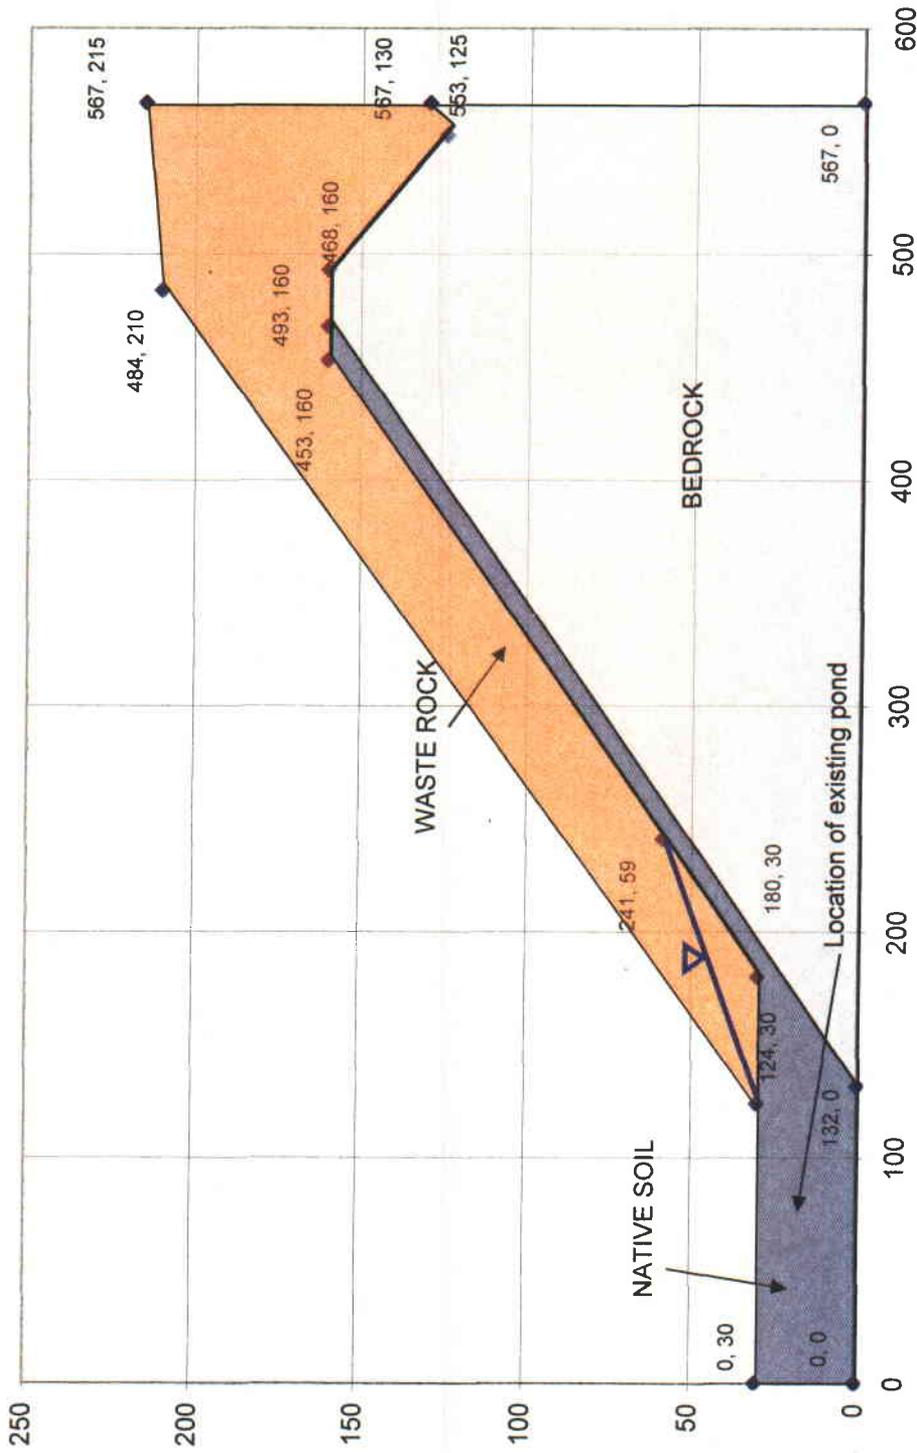
FIGURE 7. CURRENT WEST PROFILE, 2H:1V OUTSLOPE

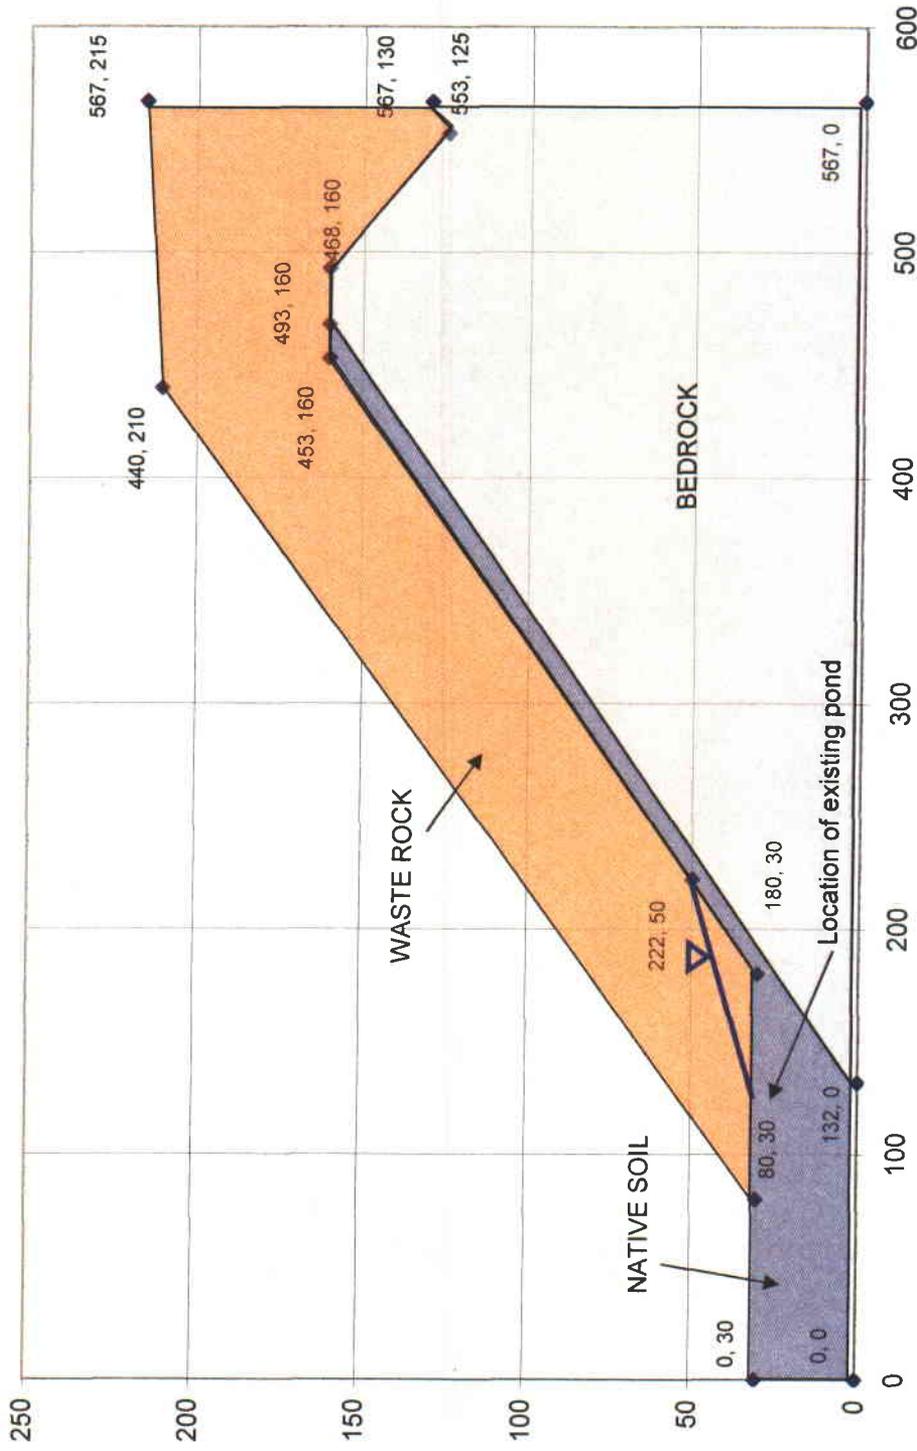
FIGURE 8. WEST PROFILE FILLING EXISTING POND,
2H:1V OUTSLOPE

- **W Profile – Current:** This profile represents the area on the western edge of the current WRP. The former open pit underlies the top portion of this profile. The bottom of the profile has been modeled as a veneer of waste rock placed at a slope of 2H:1V (26.6°) above a native soil surface that slopes at 2.1H:1V (25.4°). In 1997, a slope failure occurred near this slope profile, which at the time was sloped at 1.8H:1V (HLA, 1997). (See Figure 8)

The slope stability modeling results for the expansion of the WRP to cover the existing sedimentation pond are presented below. When the slope is constructed at an angle of 2H:1V (25.6°), the FS against rotational shear failure is 1.65 for the dry condition and 1.57 for the saturated condition.

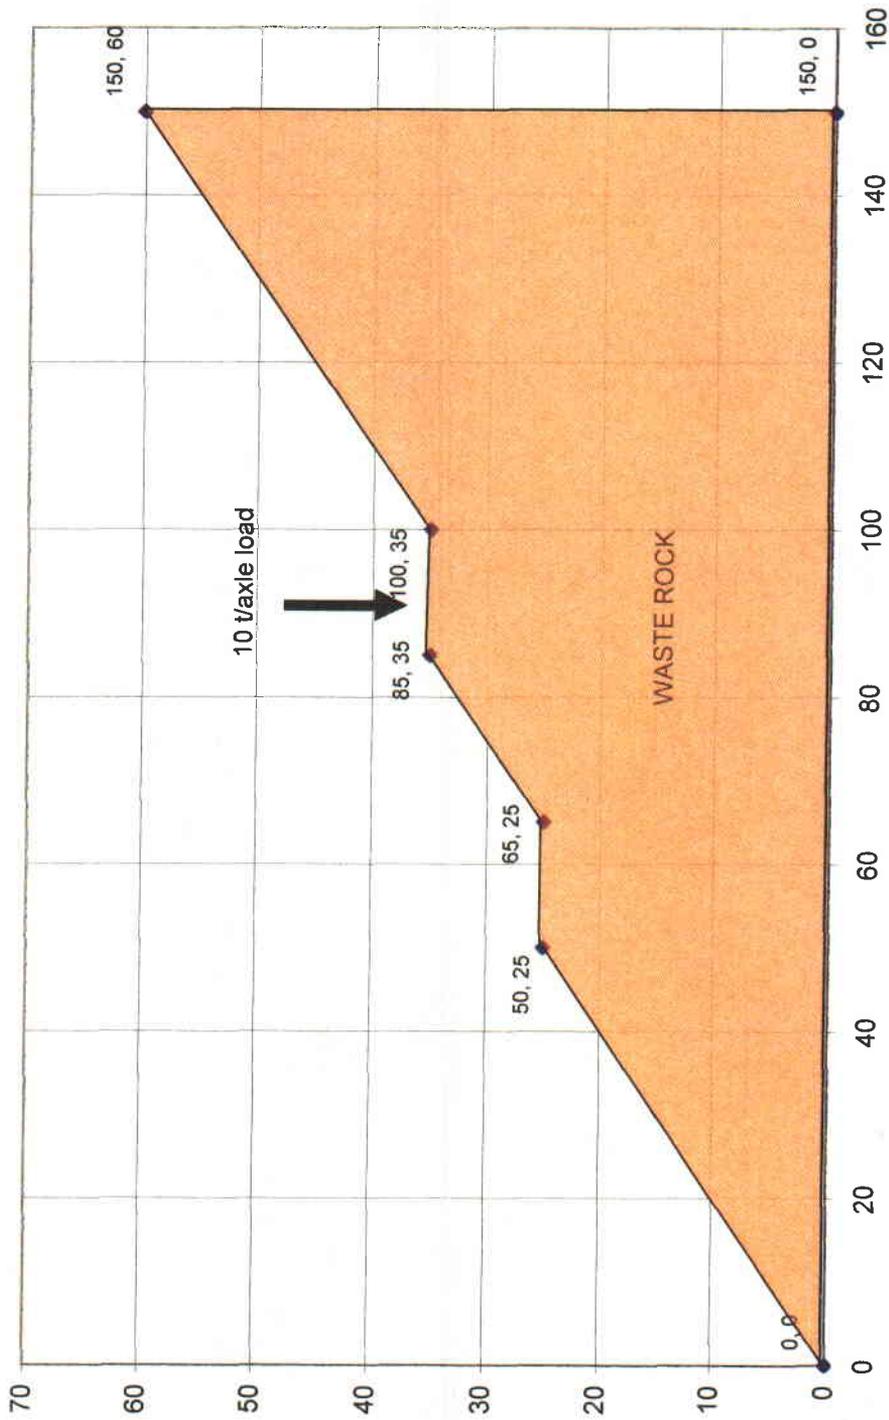
FIGURE 9. ROADCUT SWITCHBACK PROFILE

- **Generic Road Cut Switchback Profile:** This profile represents an access road switchback on the WRP. The roads measure 15 feet wide and are sloped at 2.5H:1V (21.8°) between the two roads until they are separated by at least 10 vertical feet. The slopes below the lower road and above the upper road are inclined at 2H:1V (26.6°). The roads have been loaded on the road surface with a weight of 10 tons, which is assumed to be the maximum axle weight of a full haul truck. (See Figure 9)

Results from stability analyses of roadcut switchbacks show that a FS against rotational shear failure of 1.69 can be achieved if the slopes are graded at 2.5H:1V in the hinge of the switchback until the roads are separated by 10 vertical feet. Since switchbacks will be located on the edge of the WRP, only the dry condition was evaluated.

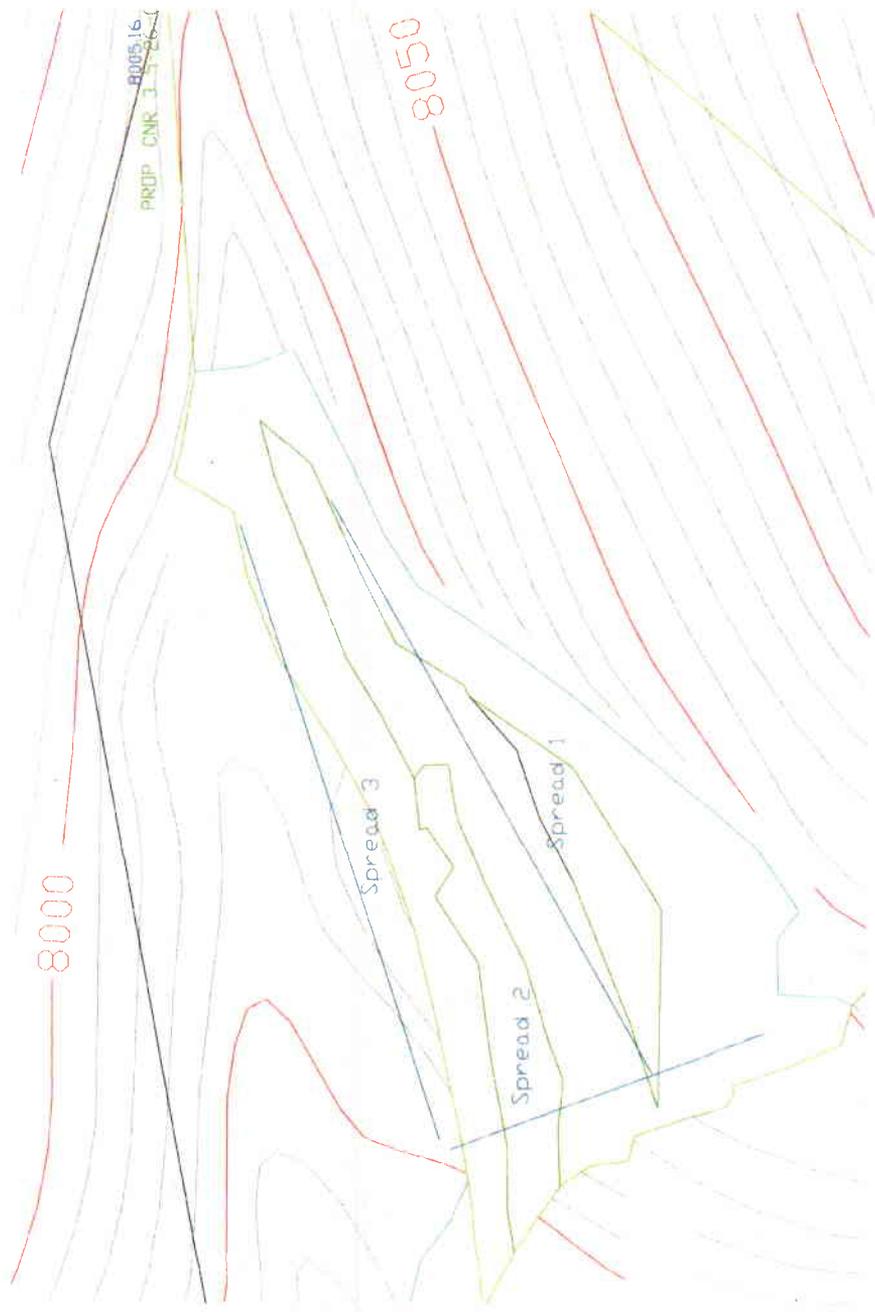
Figure 1

Locations of Seismic Refraction Lines

Five refraction surveys were conducted at the project site in order to determine the compression wave (P-wave) velocities of the shallow subsurface material. The locations of the refraction surveys are shown on Figure 1. The data were collected utilizing a Geometrics SmartSeis S12 seismograph, 8 Hz geophones and 12-pound hammer source. Each spread was approximately 220 feet long with 12 geophones placed at 20-foot intervals. Data collection consisted of center shot and two off end shots at each end of the seismic spreads. The auto-stacking feature of the seismograph was used to stack multiple shots at each location in order to reduce the signal to noise ratio of the data. Data from the test was recorded by and stored in the seismograph.

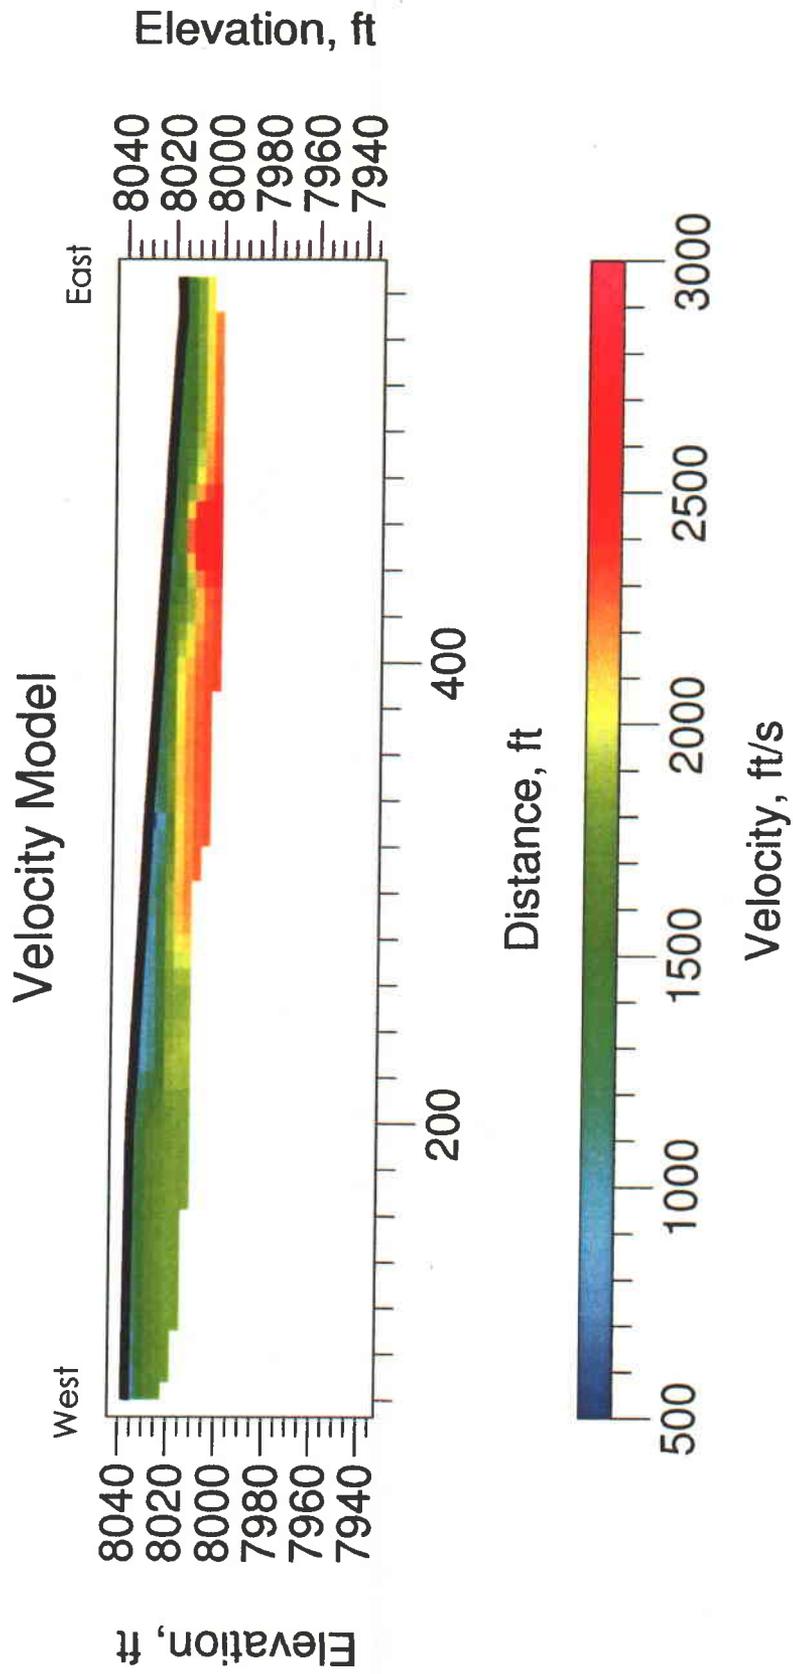
Figure 2

Seismic Refraction Profile
Line 1

The data were processed using Rimrock Geophysics SIP software to pick the first arrivals at each geophone location and create an ASCII input file. The five seismic lines were combined into three profiles for input into the processing software. The three input files were processed using Optim's SeisOpt Pro modeling software. The refraction profiles show the calculated P-wave velocities for the subsurface materials and are presented on Figures 2, 3 and 4.

Profiles of the results of the seismic modeling for Lines 1, 2 and 3 are presented in Figures 2,3 and 4. The profiles for Lines 1 and 3 generally indicate increasing velocity with depth. Line 3 does have low velocity material extending deeper at approximately 400 feet. The profile for Line 2 indicates a very low velocity zone at the northern end of the profile the line drops off the northern edge of the waste rock pile

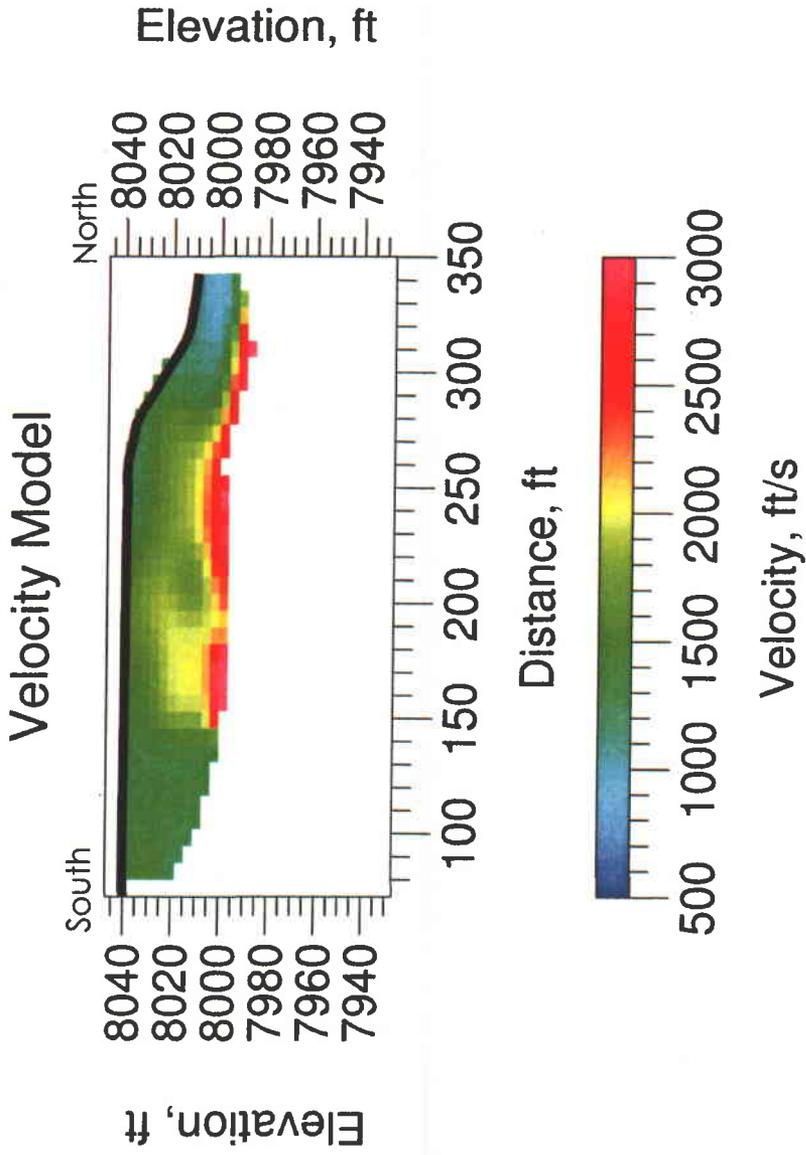
Figure 3
Seismic Refraction Profile
Line 2

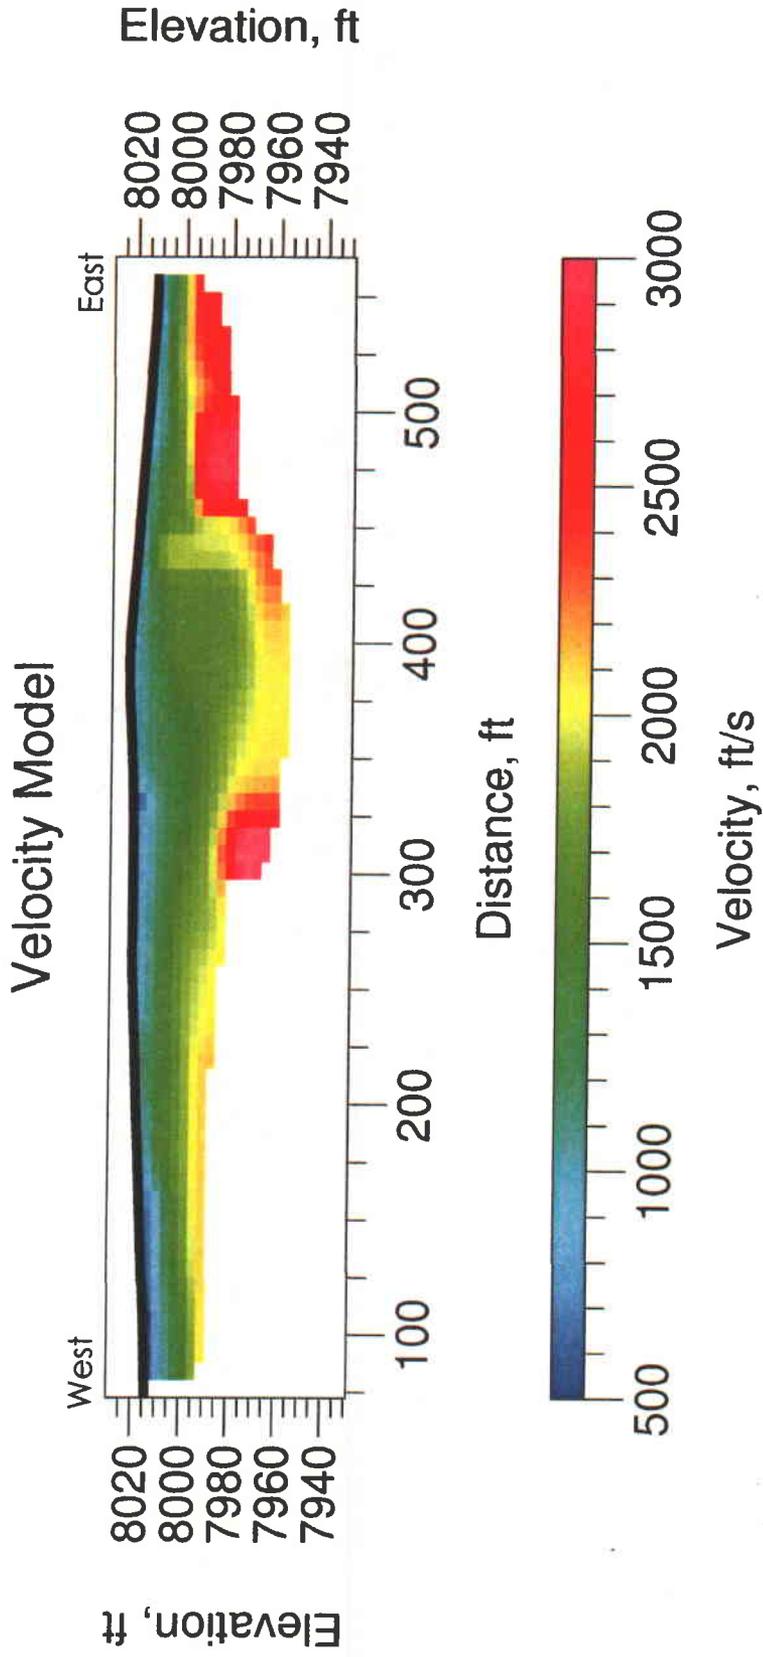
Figure 4
Seismic Refraction Profile
Line 3
