Canyon Fuel Company, LLC

Skyline Mines

C/007/005

2008 Annual Report

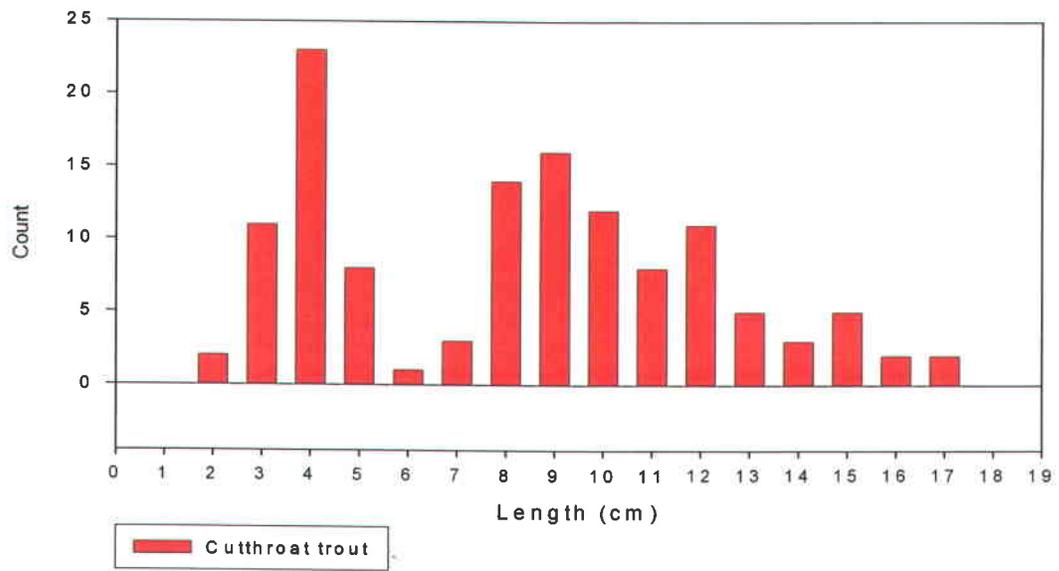
Figure 1. Length Frequency, James Canyon Creek, 2007.

The length frequency of fish in James Canyon Creek in 2007 show a clear bimodal pattern (Figure 1). The first peak representing age 0+ fish, ranging between 2 to about 6 cm in length, while the second, with a modal peak at 9 cm but ranging up to 17 cm in length, represents fish in the 1+ and possibly higher age classes. These numbers suggest spawning success in 2006 as well as in 2007. This stream population appears to be recovering from the drought impacts.

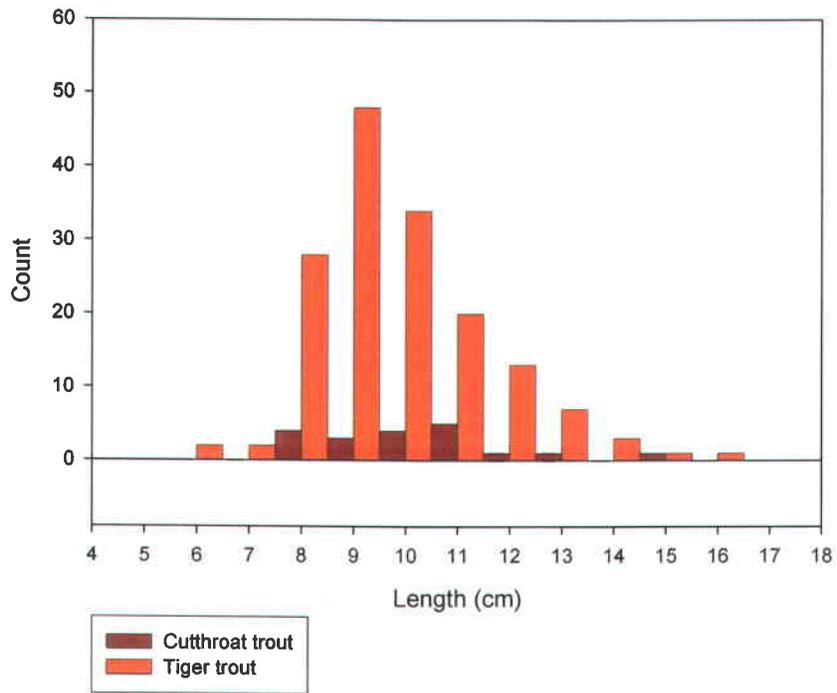
Figure 2. Length Frequency, Burnout Canyon Creek, 2007.

recovering in James Canyon Creek. The decline in Burnout Creek appears to be a combination of low water levels in the last six years, the advent of whirling disease, and the addition of tiger trout into the stream. Future trends in James Canyon Creek will help decipher which factors are most important in the decline within Burnout Creek.
