ANNUAL REPORT

1989

PERMIT NO. PRT-719890

**CYPRUS PLATEAU MINING CORPORATION
P. O. DRAWER PMC
PRICE, UT 84501**

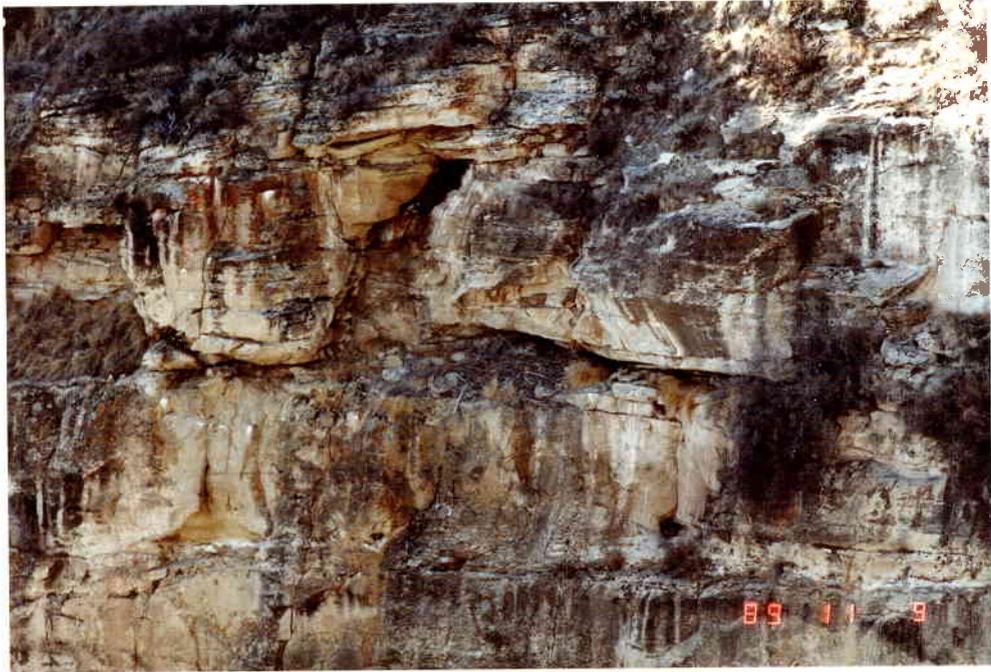
PHOTOGRAPH 1 - NEST NO. 20

Close-up photographs of Nests 20 and 21 were taken on November 9, and can be seen as Photographs 1 and 2. The nests have not been damaged in any way by subsidence. The chain link fencing is still in place, as can be seen in the photographs.

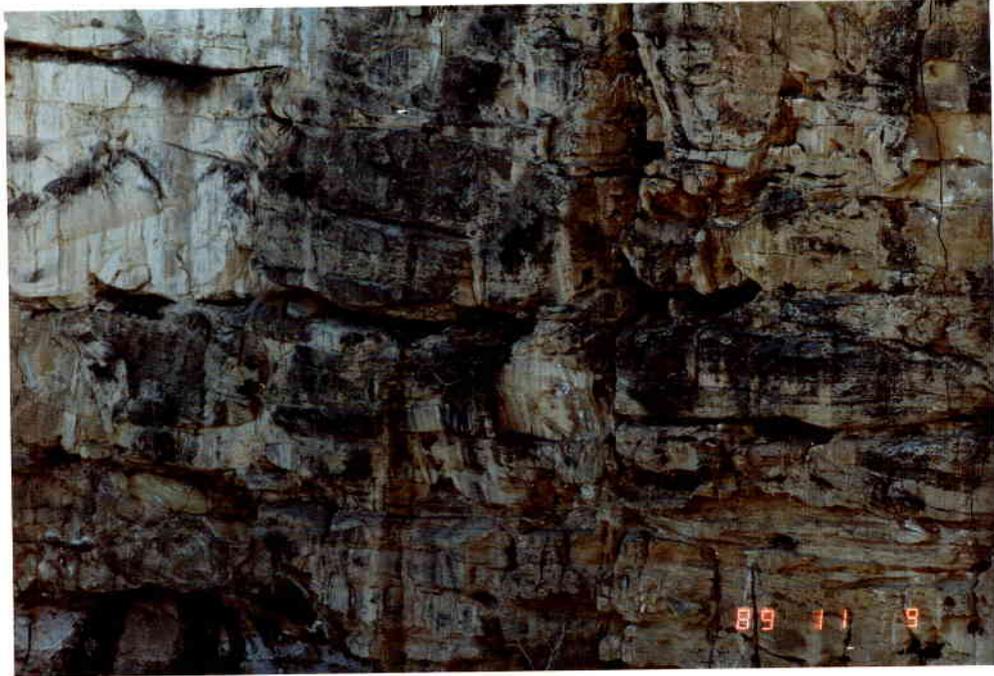
PHOTOGRAPH 3 - NEW NEST NO. 189.006

On October 13, 1989, a previously unknown cliff nest (No. 189.006) was located approximately 25 feet south and approximately 30 feet below Nest No. 20, as shown on the October 27, 1989, cliff photograph. This nest is small and appears to be new, although the sticks used are highly weathered. A photograph of the nest can be seen as Photograph No. 3. A close examination of the January 19, June 9, and August 23 cliff photographs does not resolve the question of whether the nest is new this year; not enough detail can be seen. Mr. Moretti and Mr. Grimes have observed the cliff in this vicinity very carefully, from a helicopter, each year since 1983. It is doubtful that this nest would have been overlooked.

After the 1990 nesting season, a decision will have to be made concerning the newly located cliff nest No. 189.006, since mining will take place directly beneath it in early 1991, as shown on Table 1. Because of the stress caused by observers in the area, a decision on 1991 monitoring will also have to be made.

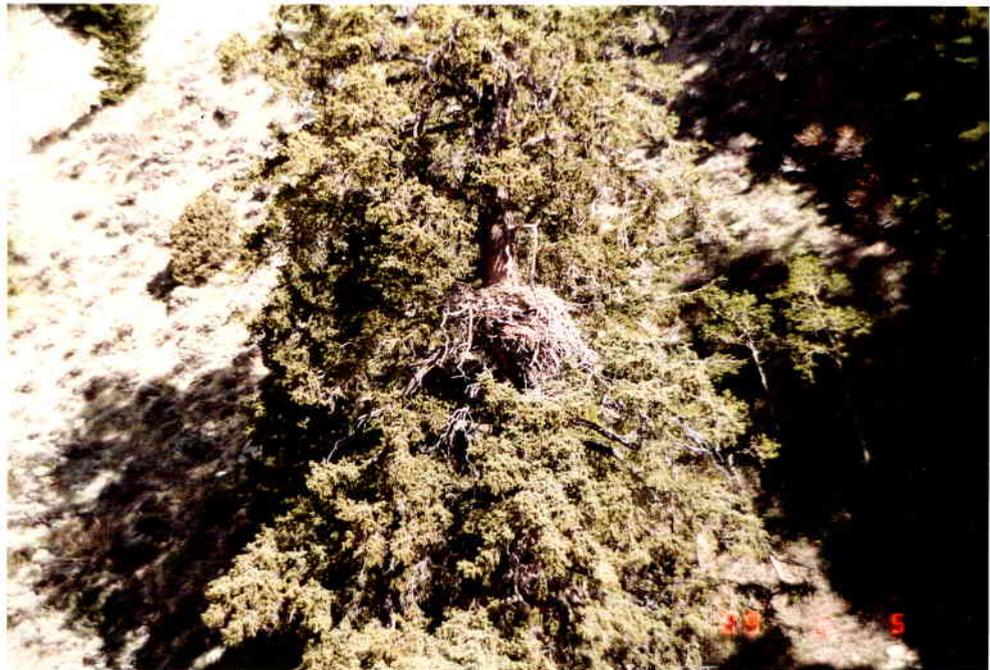
PHOTOGRAPH 4 - NEST NO. 189.002

On June 5, 1989, Mr. Miles Moretti of DWR and Mr. Ben Grimes of Cyprus Plateau Mining Corporation (CPMC) (Permittee), observed the tree nest and found it to contain some green twigs with needles. A photograph of the nest can be seen as Photograph No. 4.

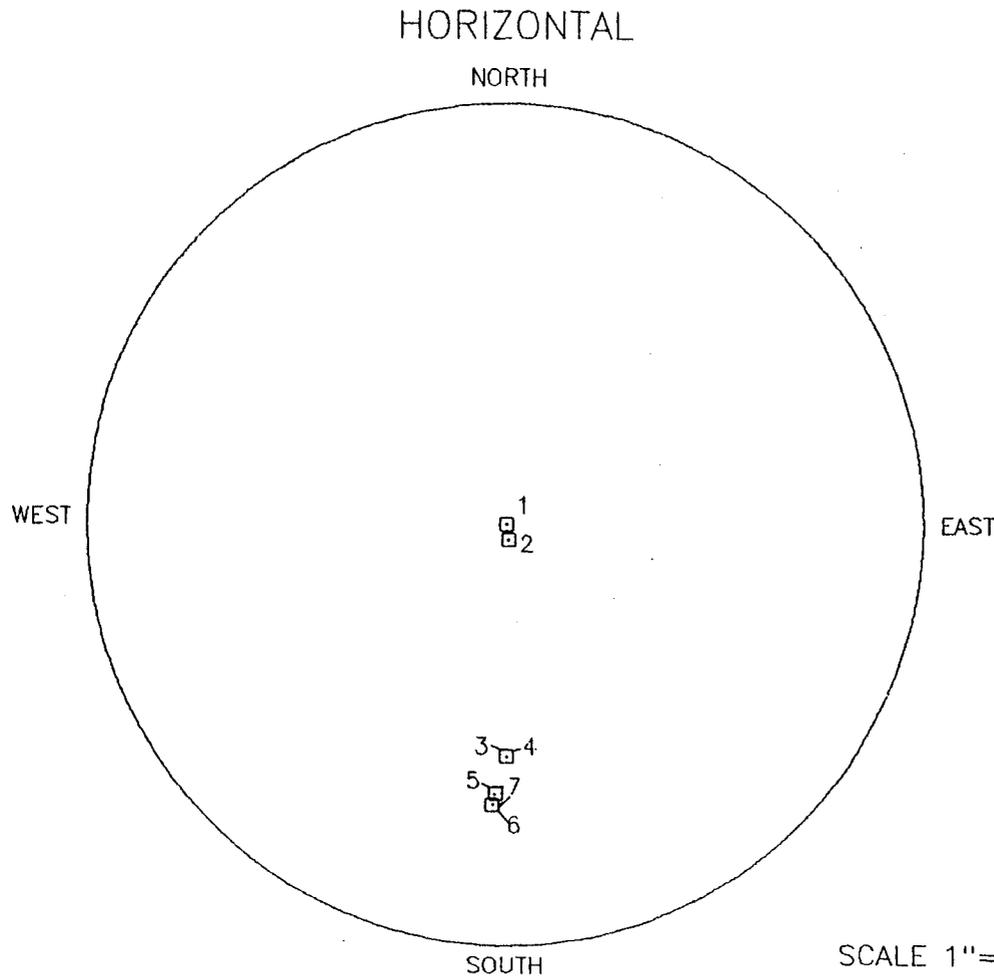
FIGURE 1
 U-NORTH SUBSIDENCE MONITORING
 STATION U1
 MOVEMENT PLOT

Movement plots were made for each point, as shown on Figures 1 through 8. As can be seen on these plots, horizontal movement has been greatest at point U1, which is closest to longwall mining, and least at point U4, which is farthest from longwall mining. Point No. 1 is the location prior to mining. Vertical movement at each point is also shown on the plots. Horizontal and vertical movement graphs have been made of all four points, as shown on Figures 2, 4, 6, and 8. As can be seen on these plots, both horizontal and vertical movement have essentially stopped.

POINT	DATE	DROP TOTAL FT.
1	JULY 7, 1988	0
2	SEPT. 23, 1988	0.53
3	NOV. 1, 1988	1.20
4	JAN. 19, 1989	1.20
5	FEB. 21, 1989	1.25
6	JUNE 6, 1989	1.48
7	AUG. 28, 1989	1.47

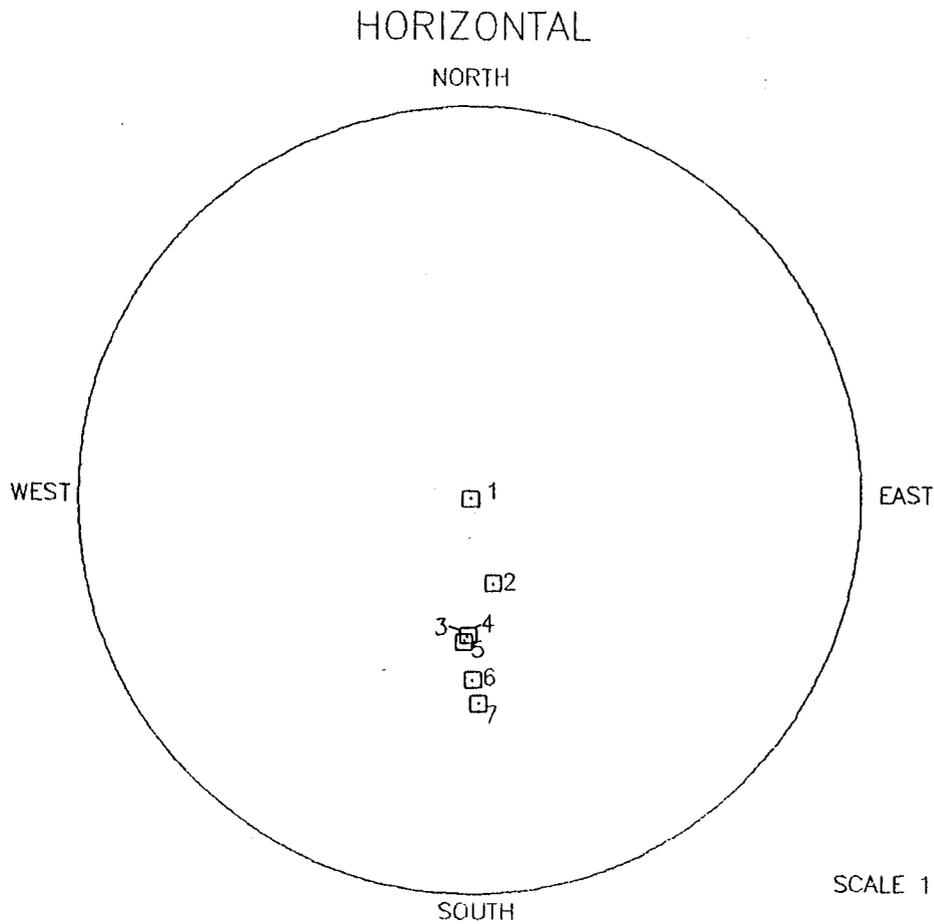
FIGURE 3
U-NORTH SUBSIDENCE MONITORING
STATION U2
MOVEMENT PLOT

POINT	DATE	DROP TOTAL FT.
1	JULY 7, 1988	0
2	SEPT. 23, 1988	0.49
3	NOV. 1, 1988	0.50
4	JAN. 19, 1989	0.50
5	FEB. 21, 1989	0.43
6	JUNE 6, 1989	0.57
7	AUG. 28, 1989	0.56

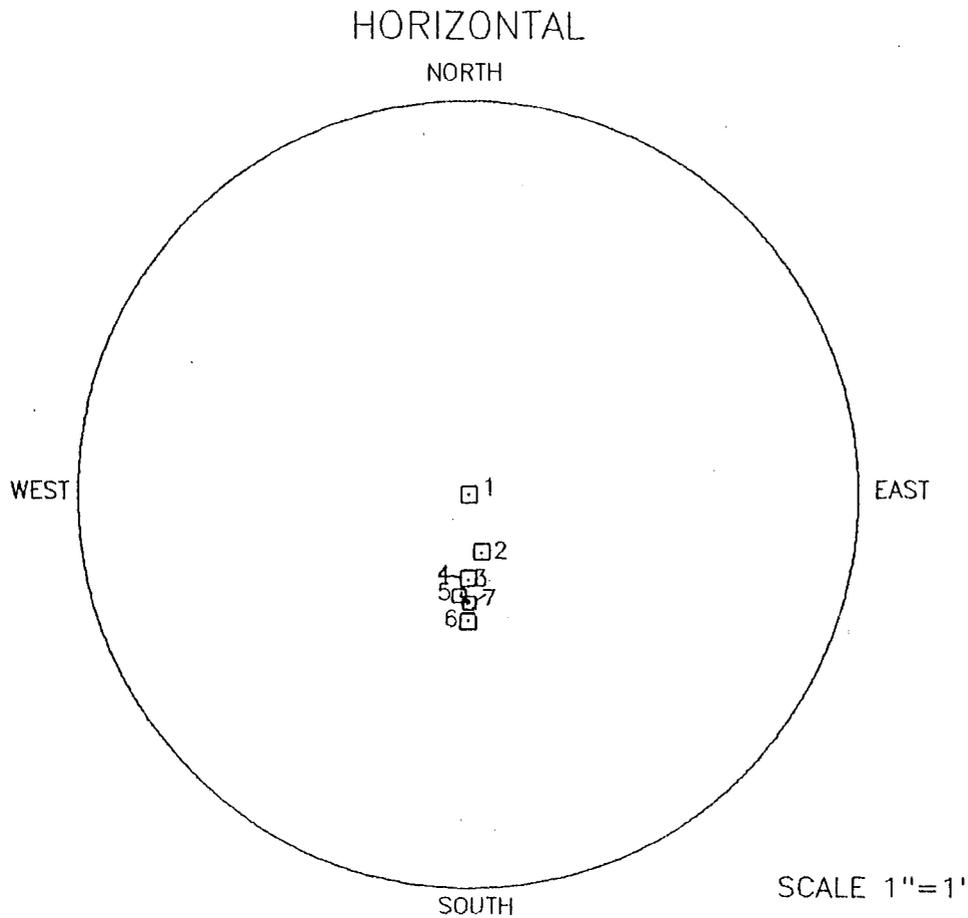
FIGURE 5
U-NORTH SUBSIDENCE MONITORING
STATION U3
MOVEMENT PLOT

POINT	DATE	DROP TOTAL FT.
1	JULY 7, 1988	0
2	SEPT. 23, 1988	0.10
3	NOV. 1, 1988	0.09
4	JAN. 19, 1989	0.09
5	FEB. 21, 1989	0.07
6	JUNE 6, 1989	0.07
7	AUG. 28, 1989	0.08

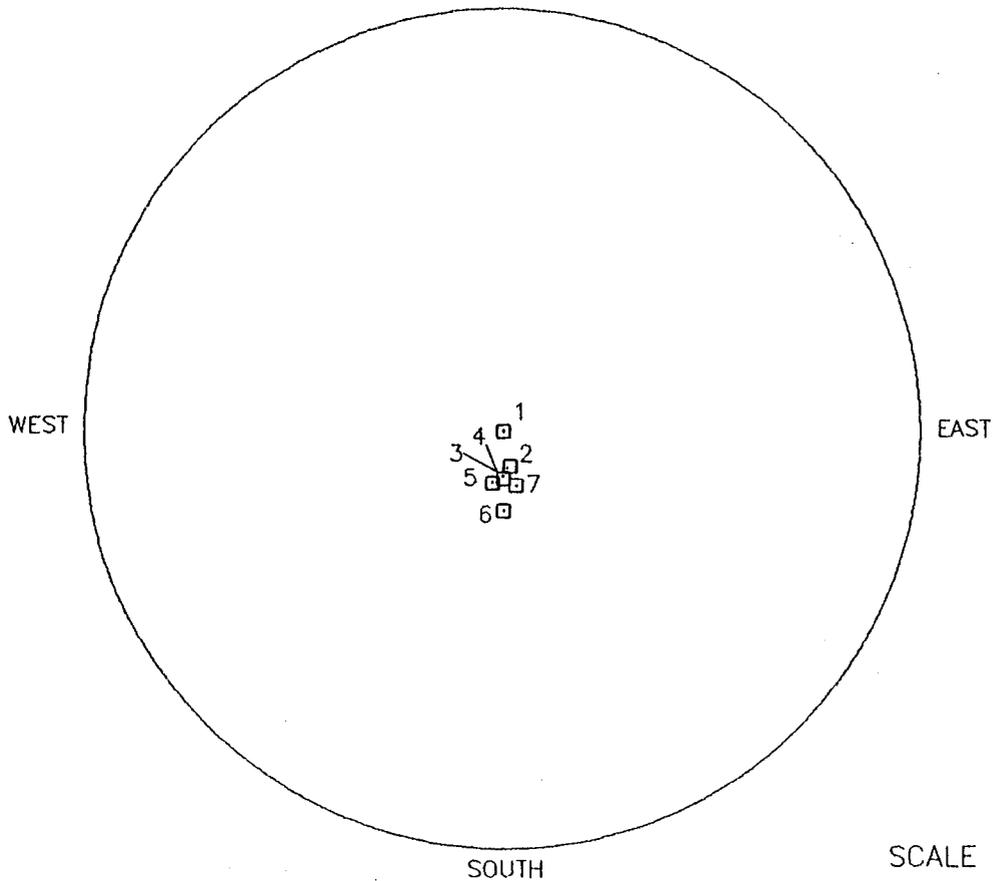
FIGURE 7
 U-NORTH SUBSIDENCE MONITORING
 STATION U4
 MOVEMENT PLOT

POINT	DATE	DROP TOTAL FT.
1	JULY 7, 1988	0
2	SEPT. 23, 1988	0.00
3	NOV. 1, 1988	+0.08
4	JAN. 19, 1989	+0.08
5	FEB. 21, 1989	0.05
6	JUNE 6, 1989	0.07
7	AUG. 28, 1989	0.05

NOTE: A + VERTICAL MOVEMENT INDICATES A RISE IN ELEVATION
