Inspection Report

Permitee: **HIAWATHA COAL CO INC**
 Operator: **HIAWATHA COAL CO INC**
 Site: **HIAWATHA MINE**
 Address: **PO BOX 1240, HUNTINGTON UT 84528**
 County: **CARBON**
 Permit Type: **PERMANENT COAL PROGRAM**
 Permit Status: **INACTIVE**

DOG M staff met with Hiawatha Mine staff to agree upon operating procedures and sources of fill for use by the Abandoned Mine Reclamation (AMR) contractor who will reclaim portals adjacent to and within the disturbed area in Fall 2018.

<p>Photo Attachment A – Hiawatha August 14, 2018</p>

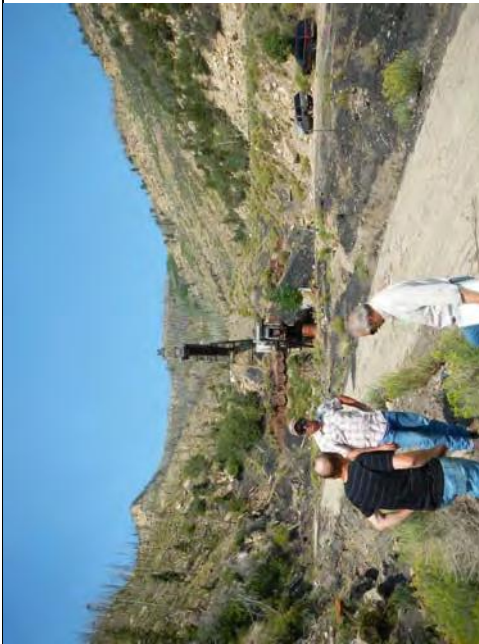
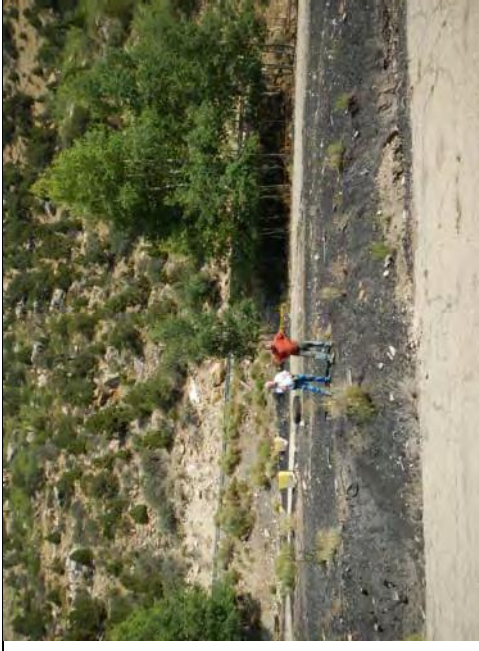
<p>Middle Fork undisturbed bypass culvert (blue) and tippie in far ground. Disturbed diversion ditch on left.</p>

Middle Fork UD drainage culvert and disturbed drainage ditch were located. The disturbed drainage ditch will be widened for equipment crossing, while still maintaining its capacity and function. The disturbed ditch will be restored to design upon completion of the work.

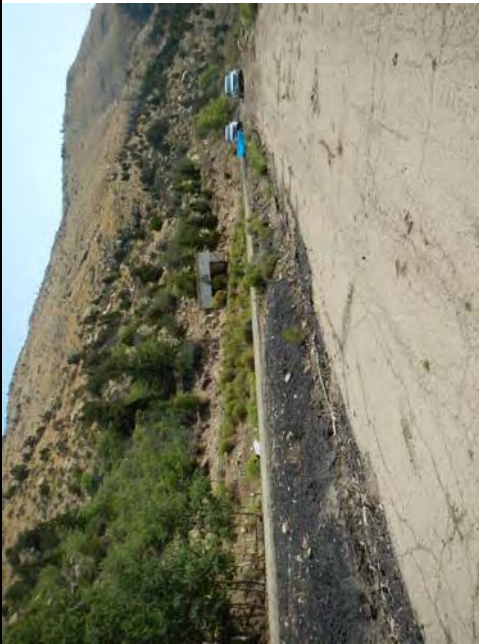
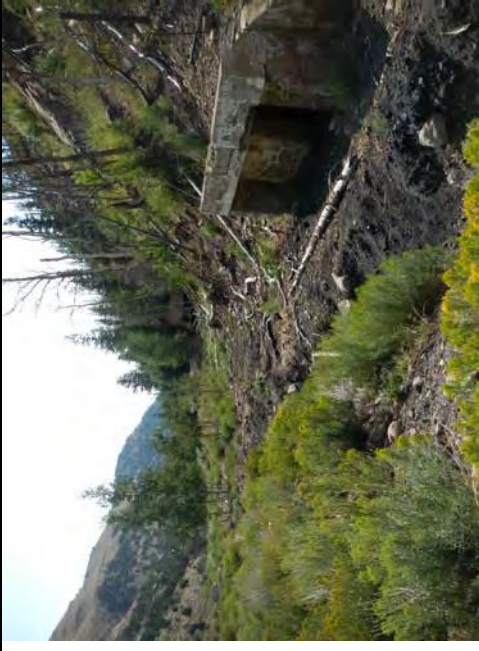
<p>Middle Fork truck turn around and AMR portal HO2 on access road to upper yard</p> <p>AMR HO1 shown as pump room on Middle Fork Ex V-5.</p> <p>AMR HC2 and HO6 on Middle Fork disturbed area boundary.</p>

The locations of 8 abandoned mine portals in Middle Fork are shown on Ex. V-5. In Middle Fork, they are along the North and South disturbed area boundary above the sediment pond, and below and above the access road leading from the truck loadout to the Middle Fork facilities yard. A 9th portal location was mapped in the same vicinity by AMR.

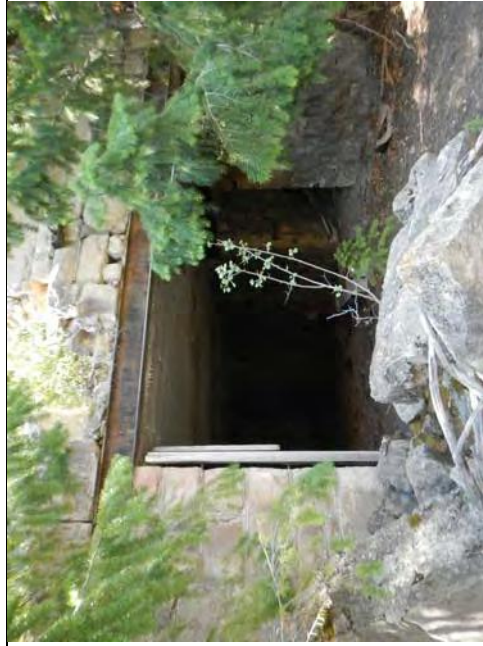
AMR portal HC3 on Middle Fork disturbed boundary

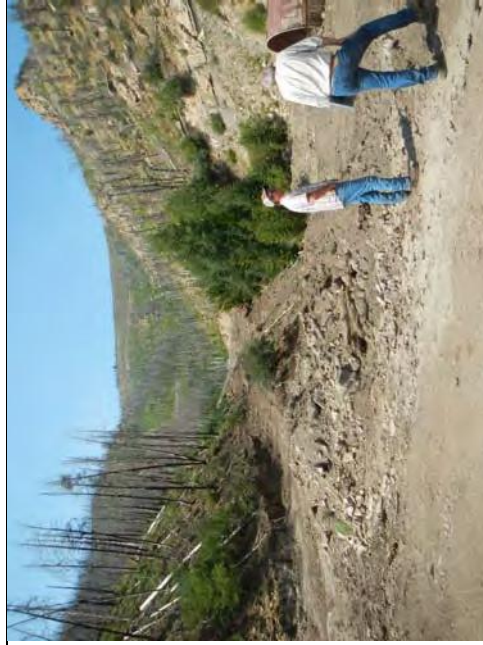
Middle Fork colluvial soil by King IV fan

Gully wash erosion from slopes above both the South and Middle Forks has brought sediments and boulders down to the pads. These sediments will be used by AML for reclamation. On the South Fork pad, these sediments lie within the King VI Mine Yard shown on Ex-V-8. In the Middle Fork these sediments are adjacent to the King IV return air fan portal and the old fan building shown on Ex V-5. Rocks and boulders may be gathered from these sediments. Loose rocks and boulders from the cut slope of the Middle Fork pad may also be collected.

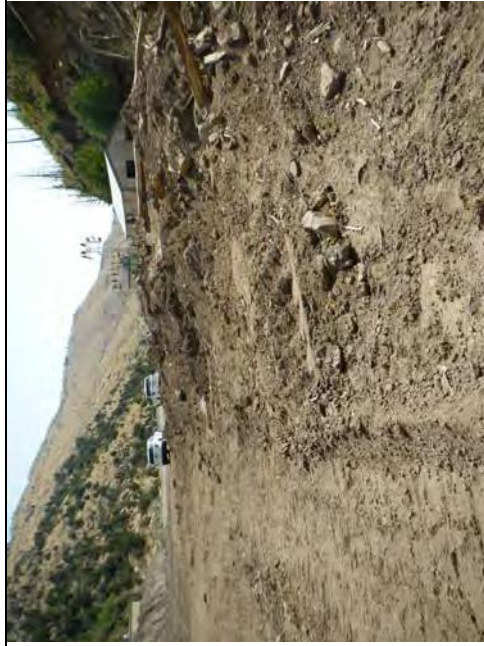
Middle Fork colluvial soil between fan and shop

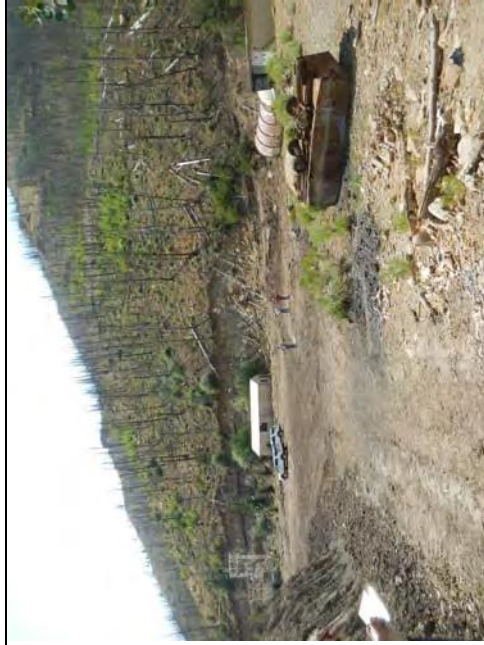
Middle Fork pad showing location of shop and fan.

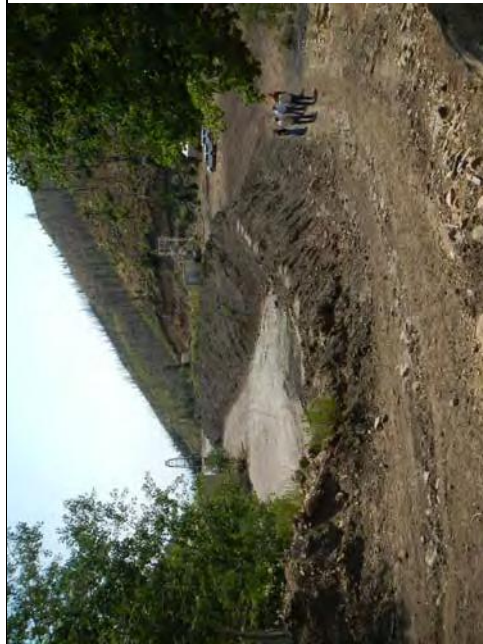
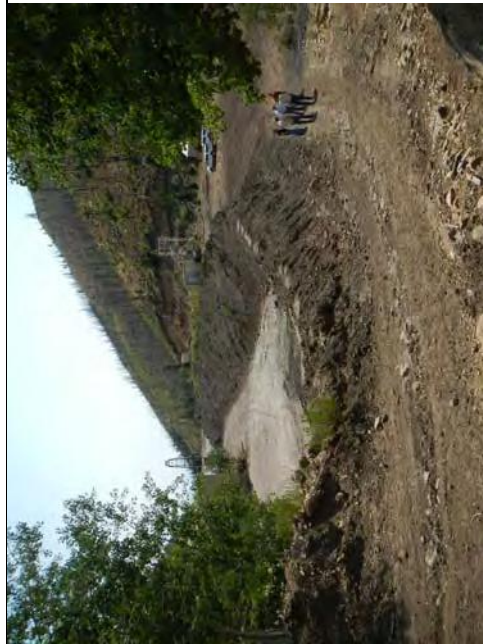
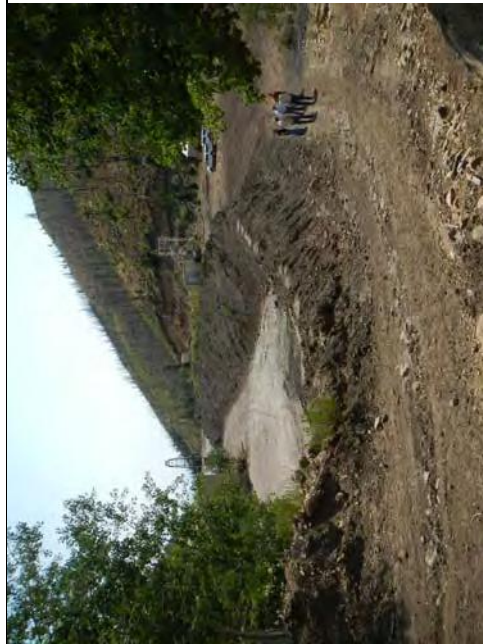
Two topsoil piles are shown on Ex. II-2. The South Fork stockpile contains 1,206 CY and the Middle Fork stockpile contains 354 CY. The attached photographs show grasses have been grazed off the Middle Fork pile which is protected by a berm. The South Fork pile is dominated by climax sagebrush.

A large stockpile of gully wash sediments has been stockpiled around the Middle Fork bathhouse. The stockpile is bermed. This stockpile is referenced on page 2-4 of the MRP as potential substitute topsoil and will not be used by AMR.

<p>Middle Fork. Colluvial soil stockpiled around bathhouse --not for use by AMR</p>	<p>Middle Fork topsoil stockpile 394 CY</p>	<p>Middle Fork topsoil stockpile 394 CY</p>

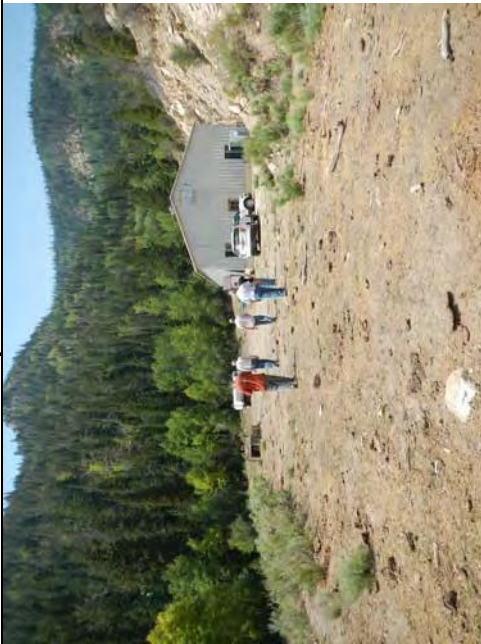
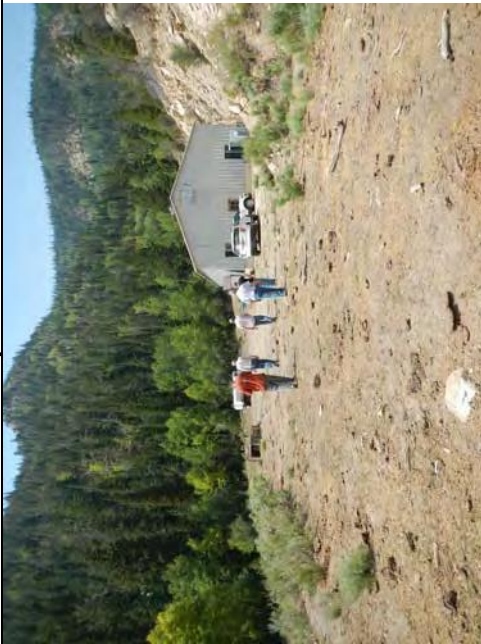
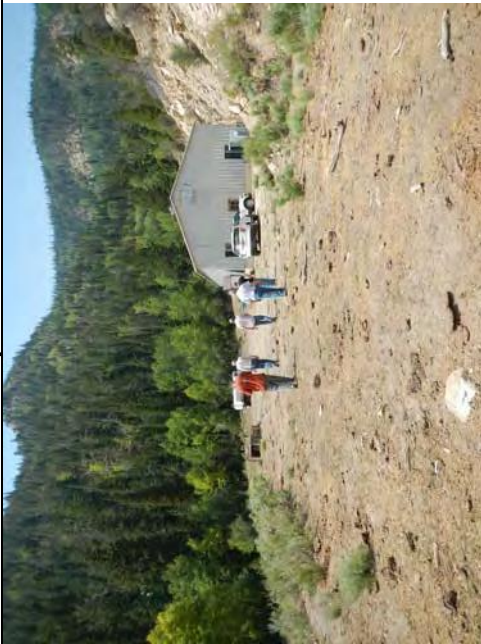
<p>South Fork looking upstream towards bathhouse from mine yard and colluvial soil pile on right is a potential source of fill for AMR.</p>	<p>South Fork looking downstream towards the shop and conveyor.</p>	<p>South Fork looking downstream towards the shop and conveyor.</p>

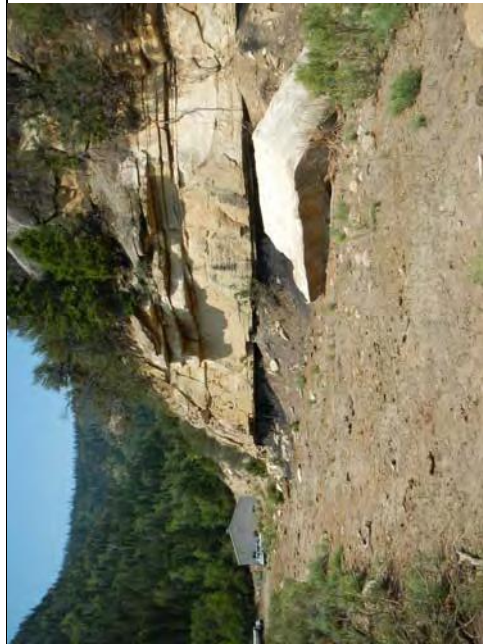
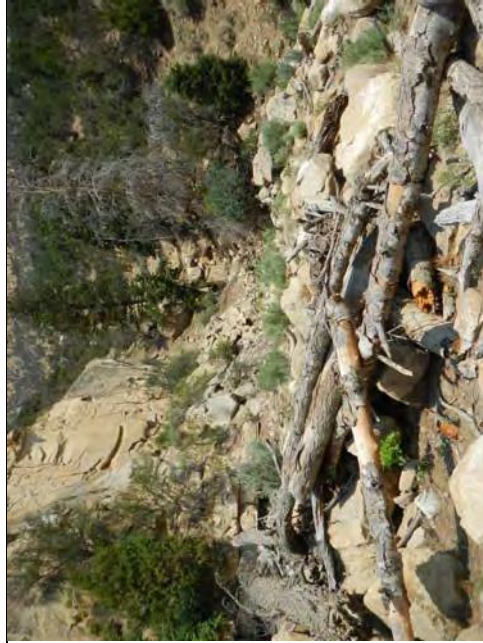
Two backfilled portals are not shown on South Fork Facilities V-8. They have been backfilled and are against the NW cutslope of the King VI mine yard.

<p>South Fork access to mine yard. AMR portals are backfilled on either side of the boulder</p>		<p>South Fork colluvial debris flow on mine yard pad is source of fill for AMR portals</p>

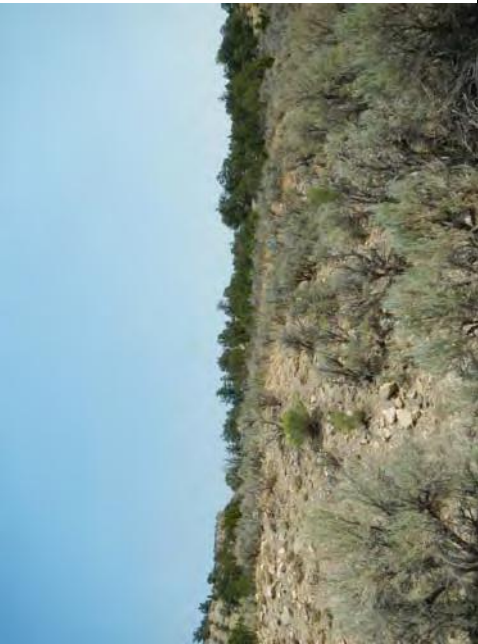
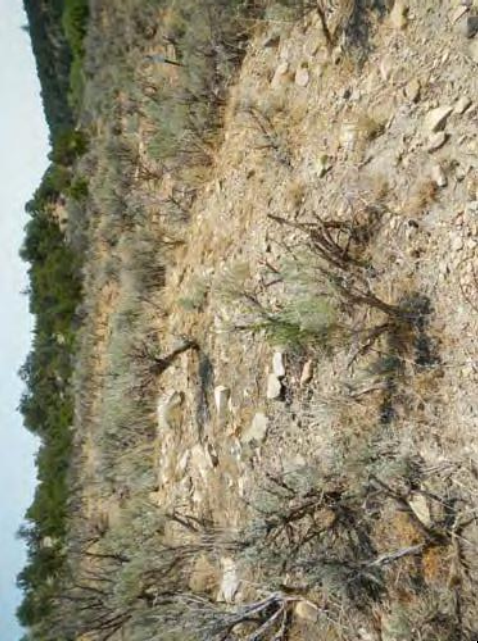
<p>South Fork topsoil stockpile</p>		<p>South Fork topsoil pile.</p>
