## OGMCOAL - Wellington Prep Plant 4.19.2012 Midterm Inspection Report

## Inspection Report

Permit Number:	C0070012
Inspection Type:	TECHNICAL
Inspection Date:	Thursday, April 19, 2012
Start Date/Time:	4/19/2012 10:30:00 AM
End Date/Time:	4/19/2012 1:30:00 PM
Last Inspection:

Permitee: **NEVADA ELECTRIC INVESTMENT CO**  
Operator: **NEVADA ELECTRIC INVESTMENT CO**  
Site: **WELLINGTON PREPARATION PLANT**  
Address: **PO BOX 337, SPRINGVILLE UT 84663**  
County: **CARBON**

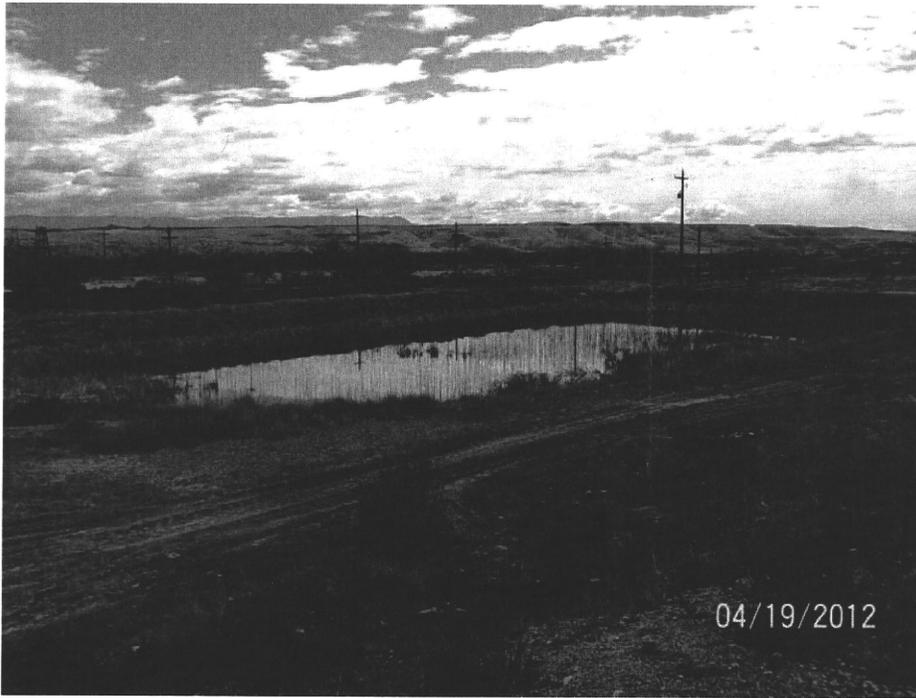
Roadside Pond, Auxillary Pond, Dryer Pond, Plant Pond and Clearwater Pond were all toured. The Dryer Pond had water in it along with wetland plants. The source of this water reportedly comes from an old now demolished pump house that had a buried pipe leading to the pond. The pond has reportedly never discharged. Significant amounts of Tamerisk were observed in the Slurry pond and Clearwater pond areas.

Figure 1. Dryer Pond wetland feature on property

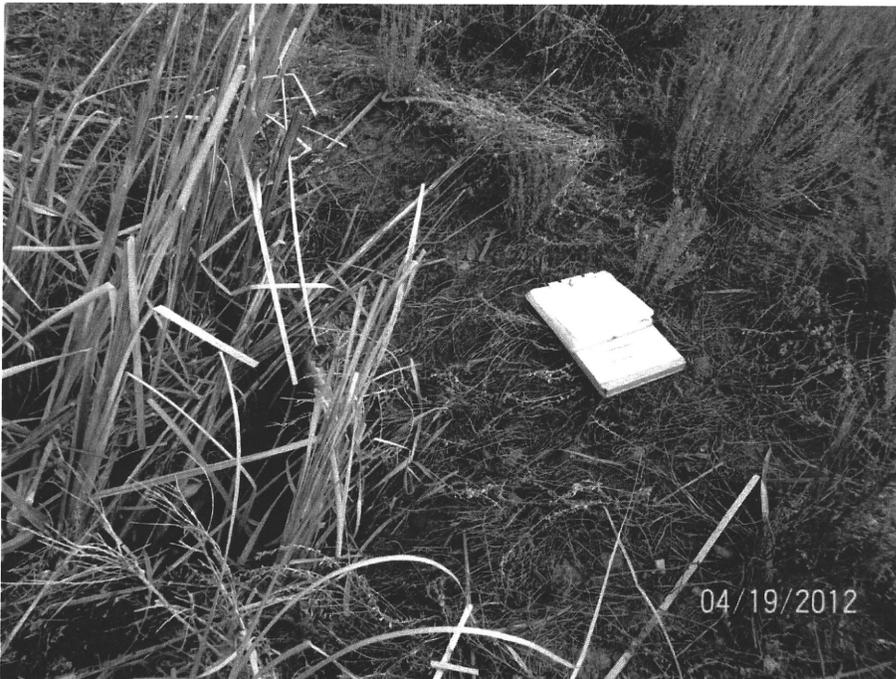
Figure 2 Culverted Inlet into Dryer Pond

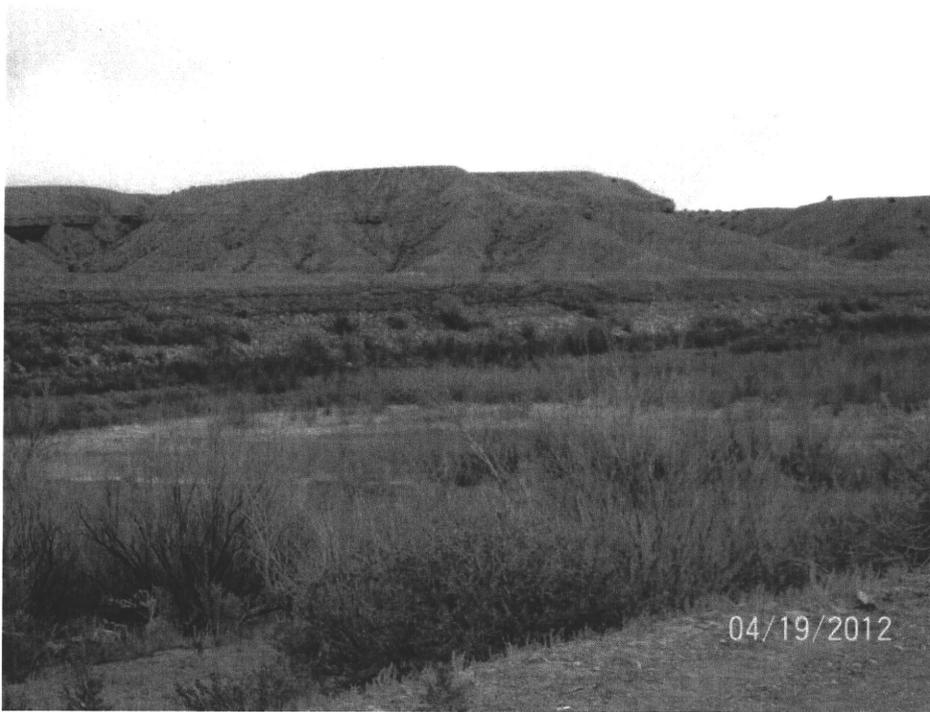
Tamarisk thrive along the Price River and in the slurry ponds. All present were uncertain as to the plant's noxious weed status. Mr. Collins was notified by email on 4/19/2012 that Tamarisk was recently added to the State's noxious weed list as a Class C species that should be controlled as noted at this website <http://ag.utah.gov/divisions/plant/noxious/documents/noxUtah.pdf>.

Figure 3 Tamerisk Growing in the Clearwater Pond

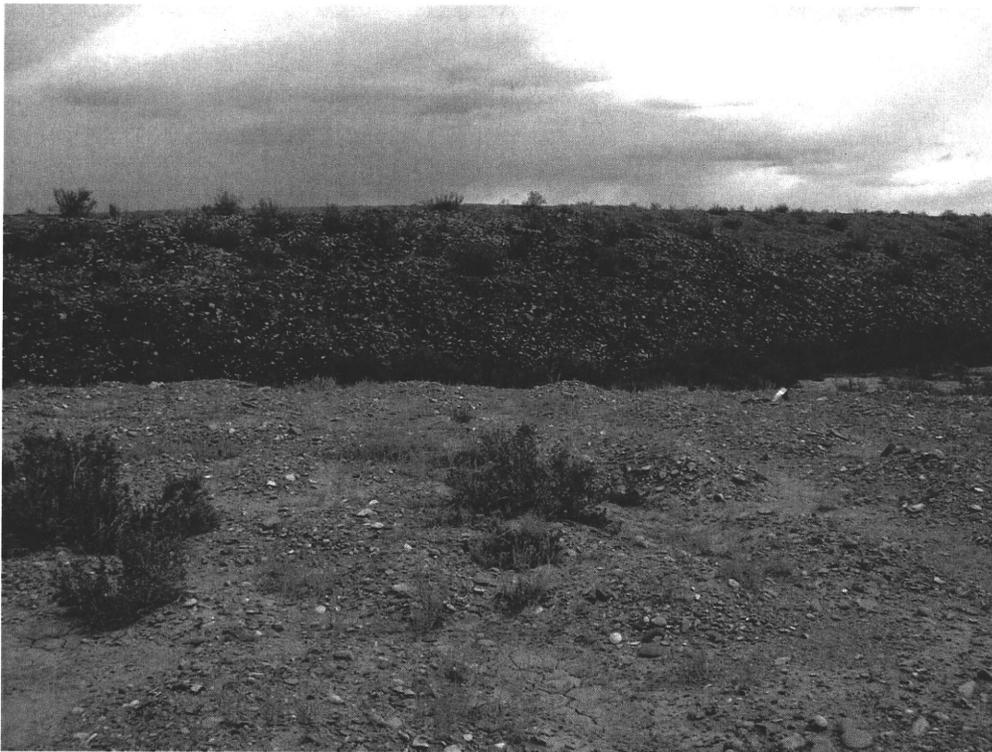
The facilities area Topsoil Pile was observed. Vegetation on the pile was sparse. Erosion is controlled by the cobbles and gravels on the surface. Pocks are still visible on the pile surface and some grasses have survived. But, the pile's compacted surface and depth above the water table work against vegetation establishment. Vegetation was thriving in the ditch surrounding the pile. Since not enough topsoil was preserved to cover the entire pre-law site, borrow areas have been identified on Map E9-3341 Facilities Map and with more detail on Map G9-3511 Potential Borrow Areas. The extensive sampling of borrow areas was reviewed prior to the site visit. At the time of sampling in 1995 depth to water in Area A was 6 ft.

Figure 4 Coarse refuse pile in background. Topsoil pile in foreground.

West side grading to be completed prior to Phase I bond release application includes asphalt removal, pond removal, grading of coal fines from surface and soil cover over the coarse refuse pile.

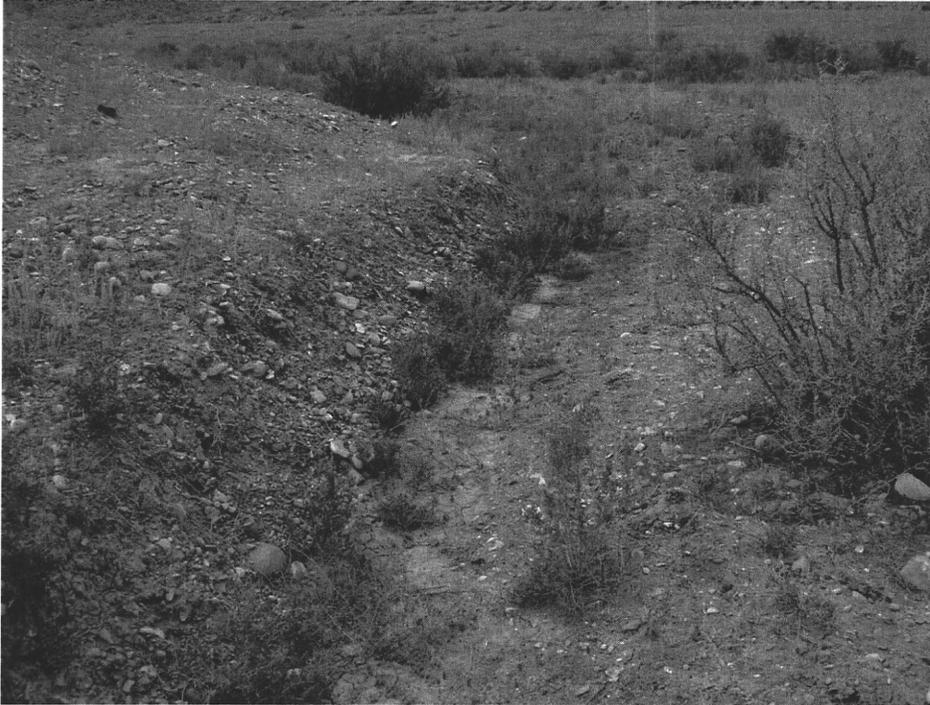
Figure 5 Ditch/Berm around the Topsoil Pile

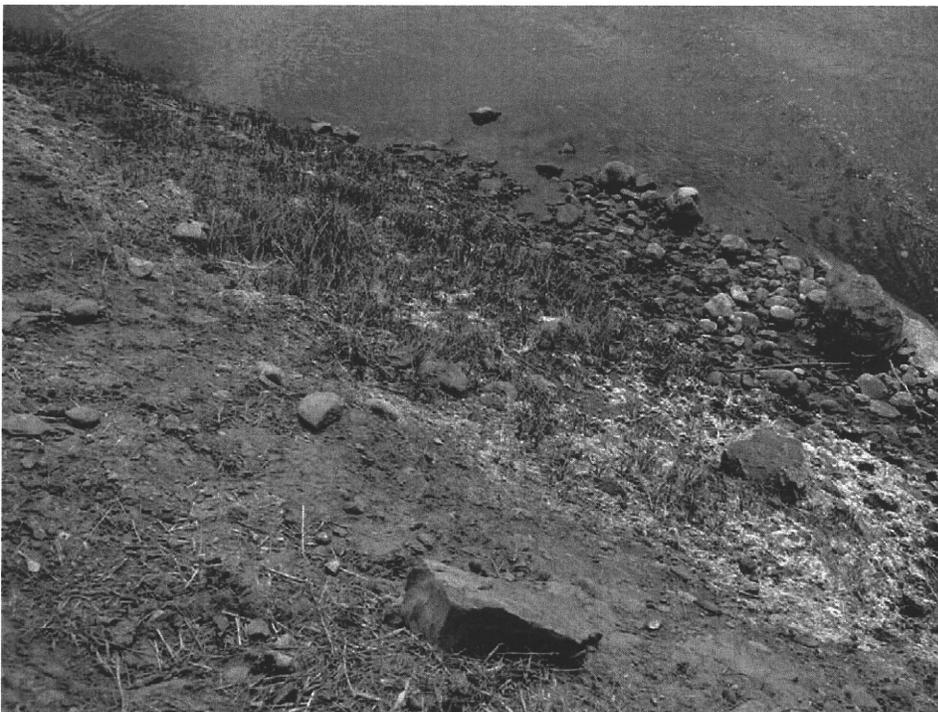
Vegetation at the reclaimed pumphouse is getting established. Juncus (volunteer species) have established on the river bank. Saltgrass (unseeded species) thrive in the salty, bog land adjacent to the river. Most successful seeded species is saltbush.

Figure 6 Volunteer *Juncus* sp. growing along riparian area of Price River at SW-2 surface sampling location

Made some recommendations for sediment control near surface water sampling location SW-2 near the bank of the river requested that additional hay bales be placed along the bank of the river to prevent erosion from the disturbed (former pumphouse area). 4/23/2012 Patrick sent an email indicating that he has complied with the request.

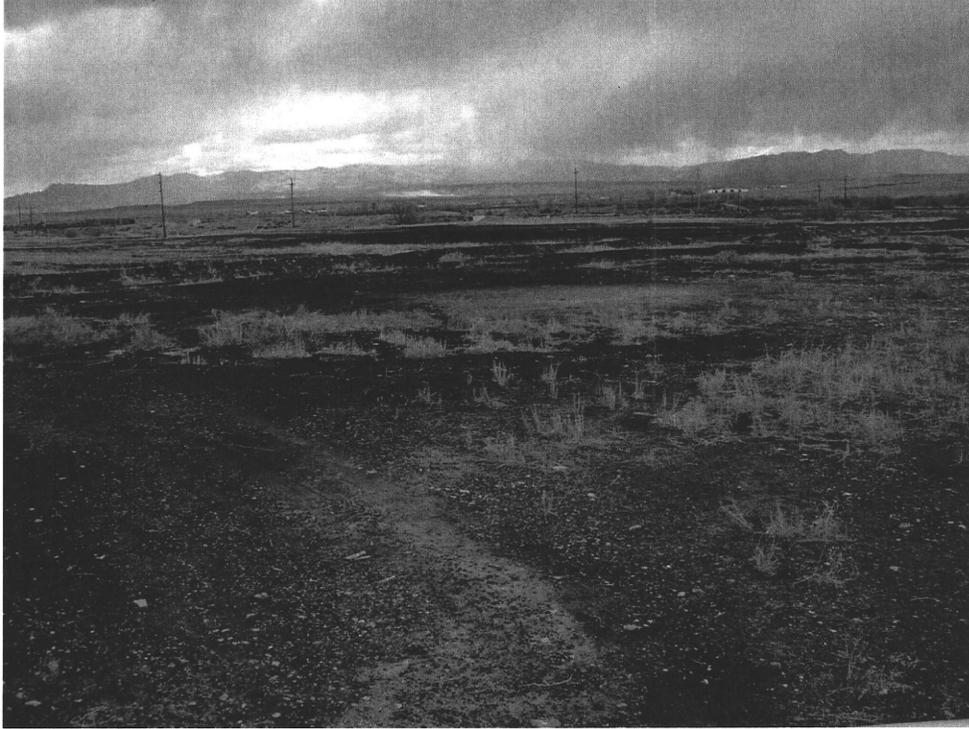
Figure 7. Former facilities stockpile location on West side of permit boundary.
