WELLINGTON PREPARATION PLANT

ANNUAL REPORT

2014

4th Quarter 2014
Refuse Pile Inspections

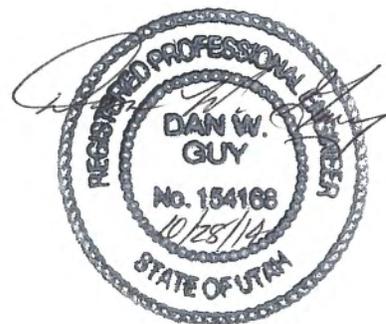
Quarter	Year
4th	2014
Refuse Pile:	
Plant Refuse Pile

Water impounding against toe:	Dry. No impounded water on top.
Fires on piles:	None.
Seepage, cracks, erosion problems or any other comments pertaining to the stability of the pile:	
Sign - OK. No erosion or other changes noted since last inspection.

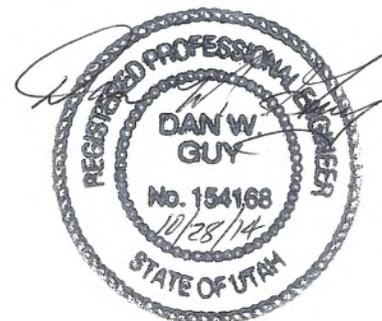
Quarter	Year
4th	2014
Refuse Pile:	
Pond Refuse Pile

Water impounding against toe:	N/A - Dry.
Fires on piles:	None.
Seepage, cracks, erosion problems or any other comments pertaining to the stability of the pile:	
Some rilling on regraded slopes. No water impoundment or significant changes to pile since last inspection.

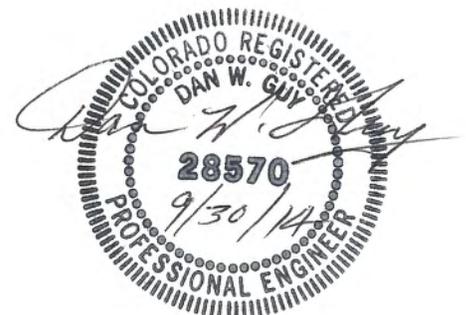
Quarter	Year
3rd	2014
Refuse Pile:	
Plant Refuse Pile

Water impounding against toe:	Damp. No impounded water on top.
Fires on piles:	None.
Seepage, cracks, erosion problems or any other comments pertaining to the stability of the pile:	
Sign - OK. No erosion or other changes noted since last inspection. Large storm on 9/27/14.

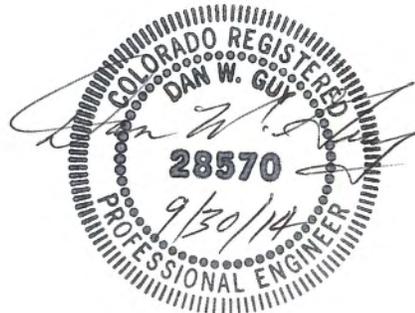
Quarter	Year
3rd	2014
Refuse Pile:	
Pond Refuse Pile

Water impounding against toe:	N/A - Damp.
Fires on piles:	None.
Seepage, cracks, erosion problems or any other comments pertaining to the stability of the pile:	
Large storm on 9/27/14. Some rilling on regraded slopes. No water impoundment or significant changes to pile since last inspection.

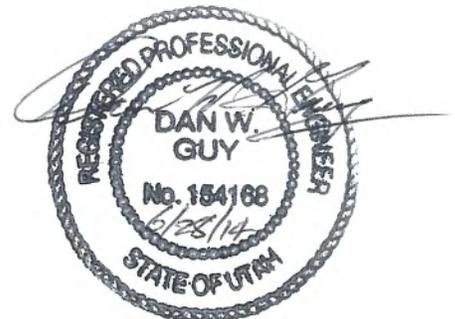
Quarter	Year
2nd	2014
Refuse Pile:	
Plant Refuse Pile

Water impounding against toe:	Dry. No water on top.
Fires on piles:	None.
Seepage, cracks, erosion problems or any other comments pertaining to the stability of the pile:	
Sign - OK. No erosion or other changes noted since last inspection.

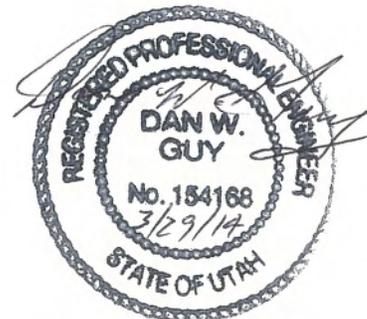
Quarter	Year
1st	2014
Refuse Pile:	
Plant Refuse Pile

Water impounding against toe:	Dry. No water on top.
Fires on piles:	None.
Seepage, cracks, erosion problems or any other comments pertaining to the stability of the pile:	
Sign - OK. No erosion or other changes noted since last inspection.

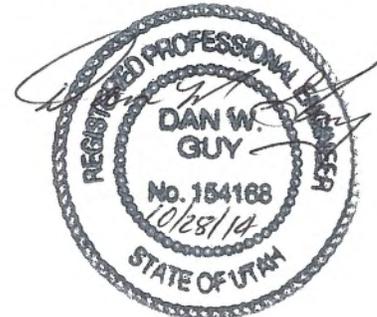
POND: Upper Refuse Pond

IMPOUNDMENTS	
(1) Changes in Geometry of Structure	N/A - None
(2) Instrumentation	N/A - None
(3) Depth of Impounded Water (Minimum)	N/A - Dry
Depth of Impounded Water (Maximum)	N/A - Dry
Depth of Impounded Water (Present)	N/A - Dry
(4) Existing Storage Capacity	136.00 acre feet
(5) Volume of Impounded Water	N/A - Dry
(6) Changes Affecting Stability or Operation of the Structure	N/A - None
(7) Stability	Slopes Stable
(8) Structural Weakness/Erosion	None Noted
(9) Potential Safety Hazards	None Noted
(10) Monitoring Procedures	Quarterly/Annual Inspection
SEDIMENT PONDS ONLY	
(11) Sediment Accumulation (Elevation)	N/A
(12) Sediment Cleanout Level (Elevation)	N/A
(13) Principle Spillway (Elevation)	N/A
(14) Emergency Spillway (Elevation)	N/A
(15) Existing Sediment Capacity (To Cleanout)	N/A
GENERAL	
(16) Comments/Recommendations	MSHA Pond. Divided into 3 cells. 1211-UT-09-00099-04

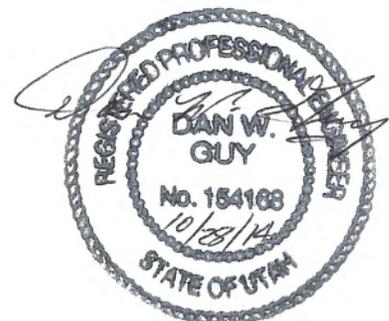
POND: Lower Refuse Pond

IMPOUNDMENTS	
(1) Changes in Geometry of Structure	N/A - None
(2) Instrumentation	N/A - None
(3) Depth of Impounded Water (Minimum)	N/A - Dry
Depth of Impounded Water (Maximum)	N/A - Dry
Depth of Impounded Water (Present)	Damp

(4) Existing Storage Capacity	765.00 acre feet
(5) Volume of Impounded Water	Minor Water in East Perimeter Ditch.
(6) Changes Affecting Stability or Operation of the Structure	N/A - None

(7) Stability	Slopes Stable
(8) Structural Weakness/Erosion	None Noted
(9) Potential Safety Hazards	None Noted
(10) Monitoring Procedures	Quarterly/Annual Inspection
SEDIMENT PONDS ONLY

(11) Sediment Accumulation (Elevation)	5370.4 (Average)
(12) Sediment Cleanout Level (Elevation)	5372.0
(13) Principle Spillway (Elevation)	5382.7
(14) Emergency Spillway (Elevation)	5382.7

(15) Existing Sediment Capacity (To Cleanout)	53.72 acre feet
GENERAL	
(16) Comments/Recommendations	MSHA Pond. Ditch cut around perimeter & through middle. 1211-UT-09-00099-03

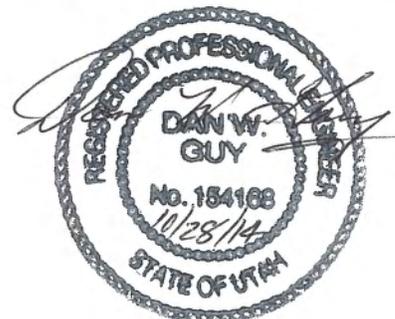
POND: Auxillary Pond

IMPOUNDMENTS	
(1) Stability	Slopes Stable. Incised Pond.
(2) Structural Weakness/Erosion	Minor Erosion on East Inlet.
(3) Potential Safety Hazards	None Noted.
(4) Depth of Impounded Water	Upper – 1'; Lower – 3'.
(5) Existing Storage Capacity	0.493 acre feet.
(6) Monitoring Procedures	Quarterly Inspection.

SEDIMENT PONDS ONLY	
(7) Sediment Accumulation (Elevation)	5336.0 (Avg.)
(8) Sediment Cleanout Level (Elevation)	5336.6
(9) Principle Spillway (Elevation)	5340.0
(10) Emergency Spillway (Elevation)	5340.0
(11) Existing Sediment Capacity (To Cleanout)	0.152 acre feet.

GENERAL	
(12) Comments/Recommendations	Pond cleaned in 1998. New Oil Skimmer Installed on Lower Pond.

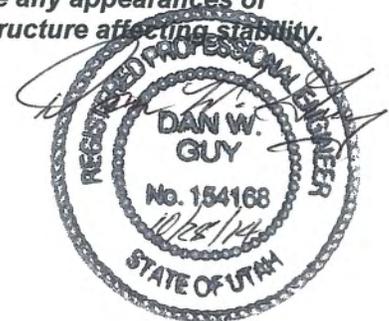
POND: Pipeline Pond

IMPOUNDMENTS	
(1) Stability	<i>Slopes Stable. Incised Pond</i>
(2) Structural Weakness/Erosion	<i>None Noted.</i>
(3) Potential Safety Hazards	<i>None Noted.</i>
(4) Depth of Impounded Water	<i>N/A - Damp.</i>
(5) Existing Storage Capacity	<i>0.933 acre feet.</i>
(6) Monitoring Procedures	<i>Quarterly Inspection. U.P.D.E.S.</i>

SEDIMENT PONDS ONLY	
(7) Sediment Accumulation (Elevation)	<i>5355.5</i>
(8) Sediment Cleanout Level (Elevation)	<i>5358.0</i>
(9) Principle Spillway (Elevation)	<i>5362.6</i>
(10) Emergency Spillway (Elevation)	<i>5362.6</i>
(11) Existing Sediment Capacity (To Cleanout)	<i>0.203 acre feet.</i>

GENERAL	
(12) Comments/Recommendations	<i>Pond O.K.</i>
