WELLINGTON PREPARATION PLANT

ANNUAL REPORT

2019

Quarterly
Refuse Pile Inspections
2019

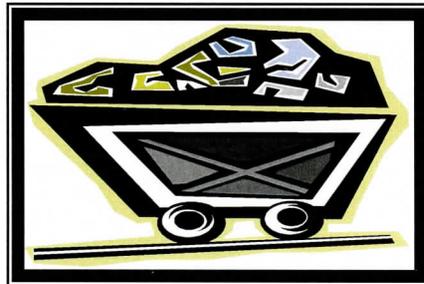
1st Quarter 2019
Refuse Pile Inspections

Water impounding against toe:	Dry
Fires on piles:	None.
Seepage, cracks, erosion problems or any other comments pertaining to the stability of the pile: No	
Sign - OK. No erosion or other changes noted since last inspection.

Water impounding against toe:	N/A - Dry.
Fires on piles:	None.
Seepage, cracks, erosion problems or any other comments pertaining to the stability of the pile:	
Portions of SE toe of the pile have been removed along with the fines from the Upper Slurry Pond for reclamation and power generation . No fines have been removed during this winter season.

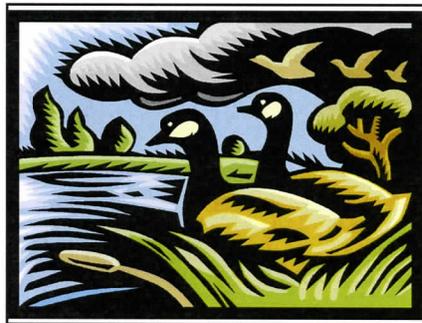
**PRICE RIVER TERMINAL
2019 ANNUAL POND INSPECTION REPORT**

POND: Roadside Pond

IMPOUNDMENTS	
(1) Stability	Slopes Stable. Incised Pond
(2) Structural Weakness/Erosion	Minor erosion on slopes near road inlet.
(3) Potential Safety Hazards	None Noted.
(4) Depth of Impounded Water	N/A – Dry.
(5) Existing Storage Capacity	0.27 acre feet.
(6) Monitoring Procedures	Quarterly Inspection.

GENERAL	
(12) Comments/Recommendations	Flows to Auxiliary Pond to Dryer Pond.
