From: "Marshall, Jay" <jmarshall@coalsource.com>
To: <jerriannernstsen@utah.gov>
Date: 5/25/2006 11:02:41 AM
Subject: Phase II pond & culvert information

Sorry I was so slow getting this to you. Attached you will find a small write up and photos that may help sort out the required reclamation done at Phase II bond release as well as reclaimed channel repair.

**Phase II
Bond Release Work
And
Subsequent Repairs**

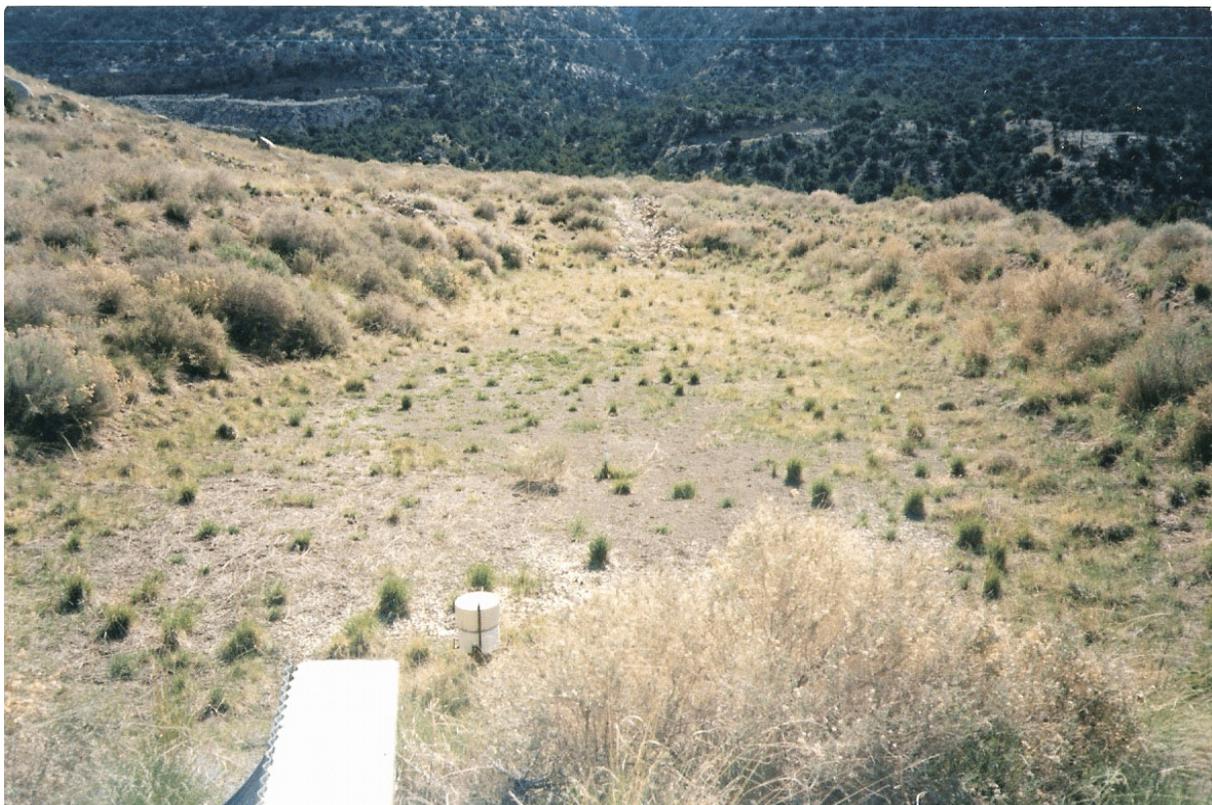
POND PRIOR TO REQUIRED PHASE II RECLAMATION

Phase II bond release was conditionally approved on October 10, 1999 with stipulations. Prior to final approval UEI was required to remove the culvert on the landfill area and to realign the channel and also to remove sediment pond #2. In the fall of 2001 an amendment was filed with DOGM requesting that the pond be breached but otherwise left in place. The approved MRP at that time allowed for breaching or total reclamation of the pond. The request to breach was denied by DOGM, and the pond was reclaimed. The pond and culvert work was completed in the fall of 2001 with the understanding that the reclamation time clock would not restart. On January 24, 2002 Phase II bond release was approved.

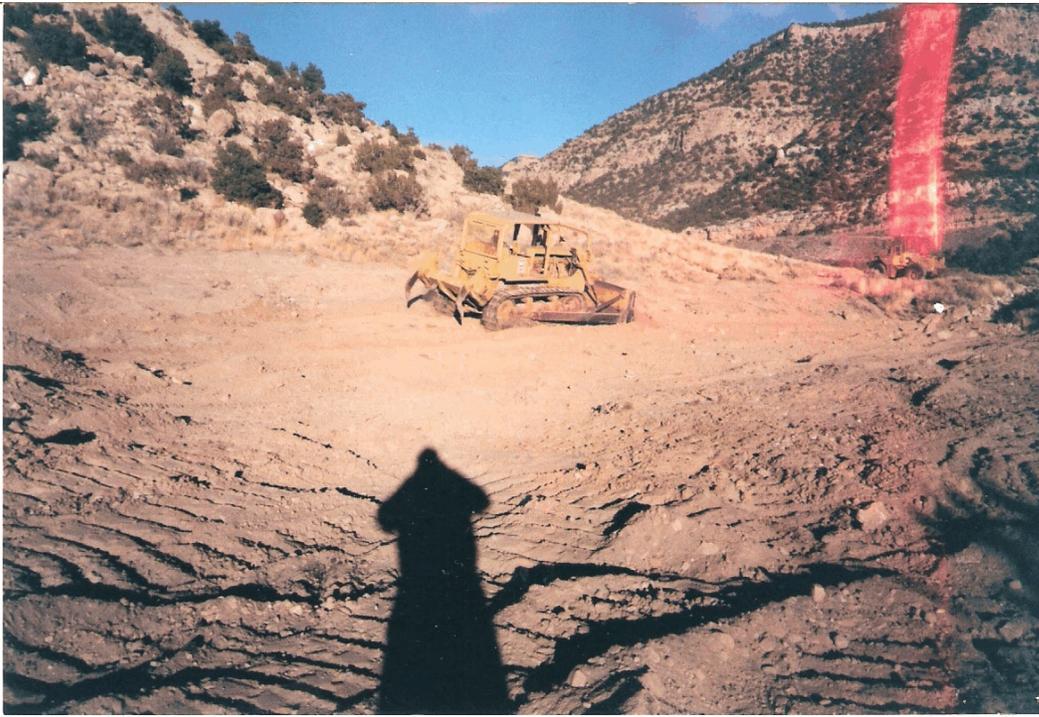
POND DURING REQUIRED PHASE II RECLAMATION

Fall of 2001 Total Disturbance .88 Acres

Reclamation Clock NOT Restarted

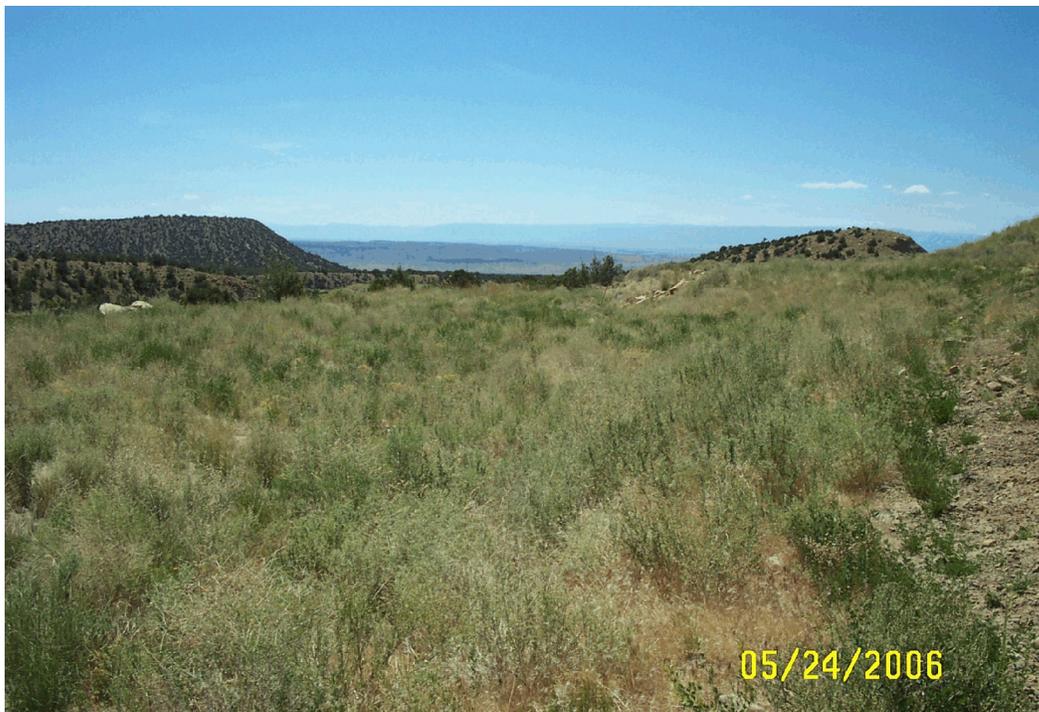
POND AFTER REQUIRED PHASE II RECLAMATION

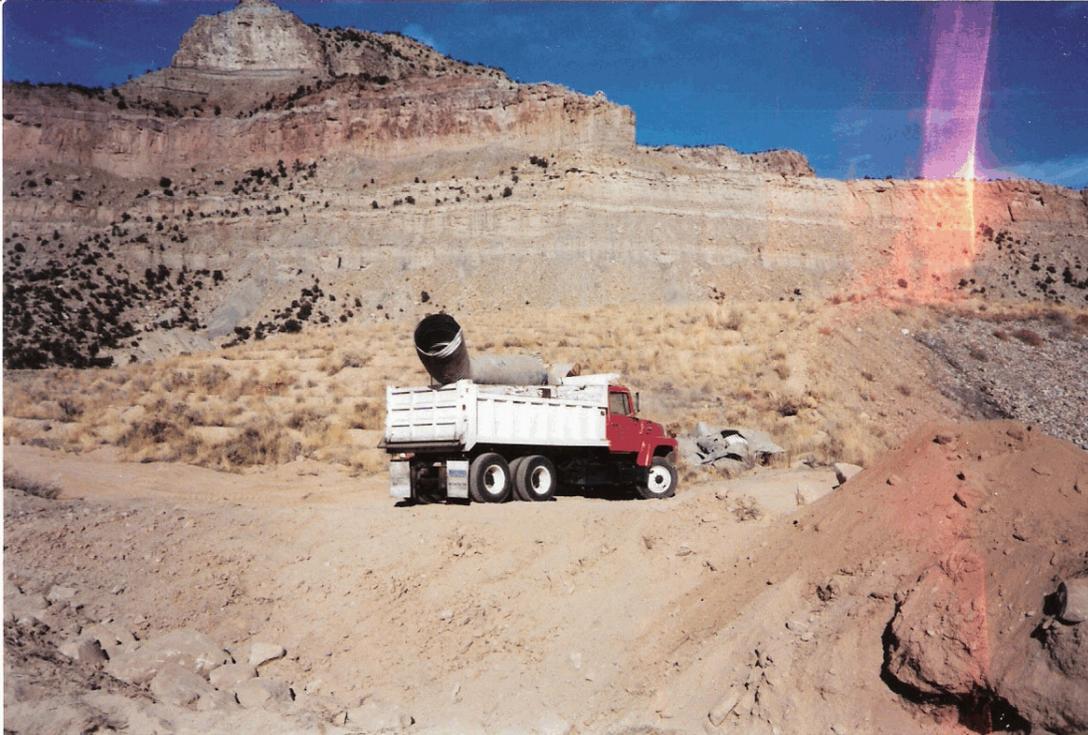
CULVERT REMOVAL REQUIRED PHASE II RECLAMATION

Fall of 2001 Total Disturbance .49 Acres

Reclamation Clock NOT Restarted

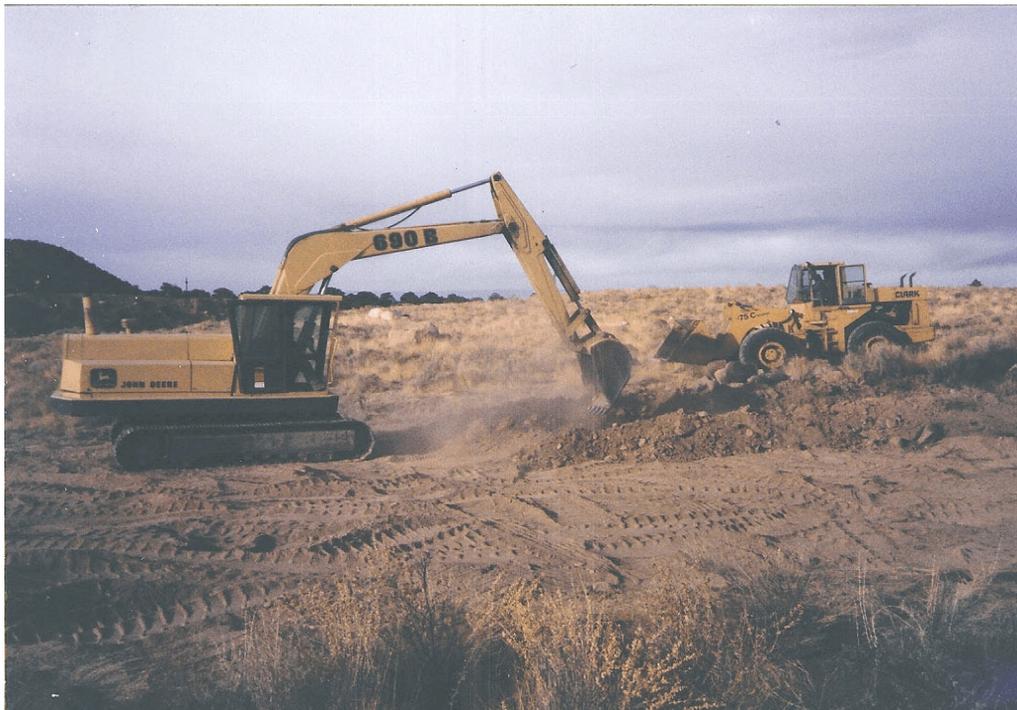
CHANNEL RESTORATION REQUIRED PHASE II RECLAMATION

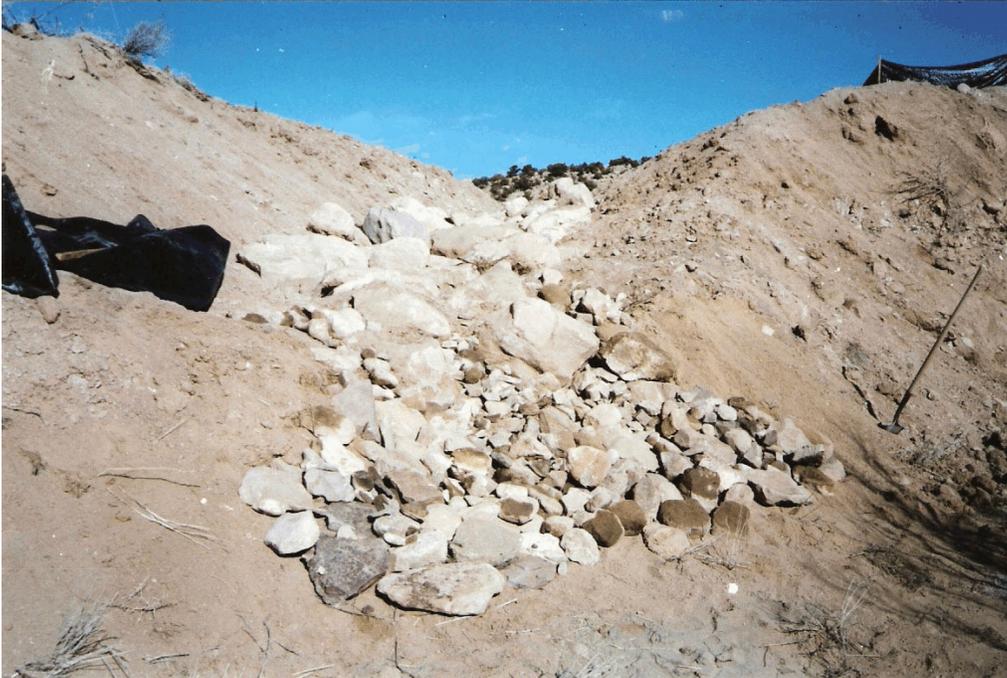
REQUIRED CHANNEL RESTORATION PHASE II RECLAMATION

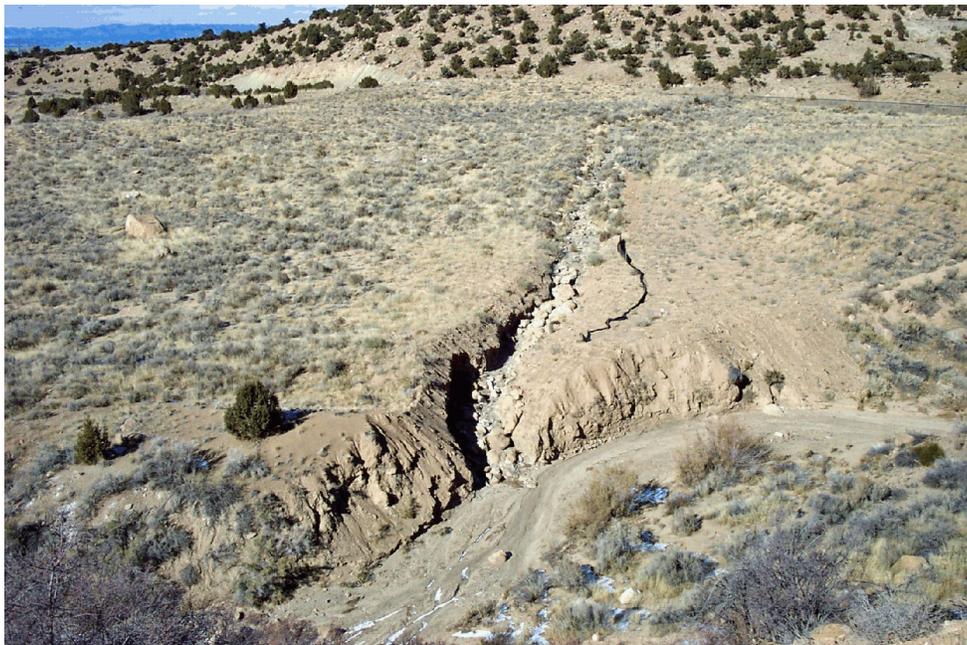
In November of 2003 a thunderstorm event resulted in severe damage to the channel established in the fall of 2001. Below are photos of the damage and repairs. The repairs did not restart the bond clock. Total disturbance for repairs did not exceed .49 acres.

DAMAGE FROM NOVEMBER 03 STORM EVENT

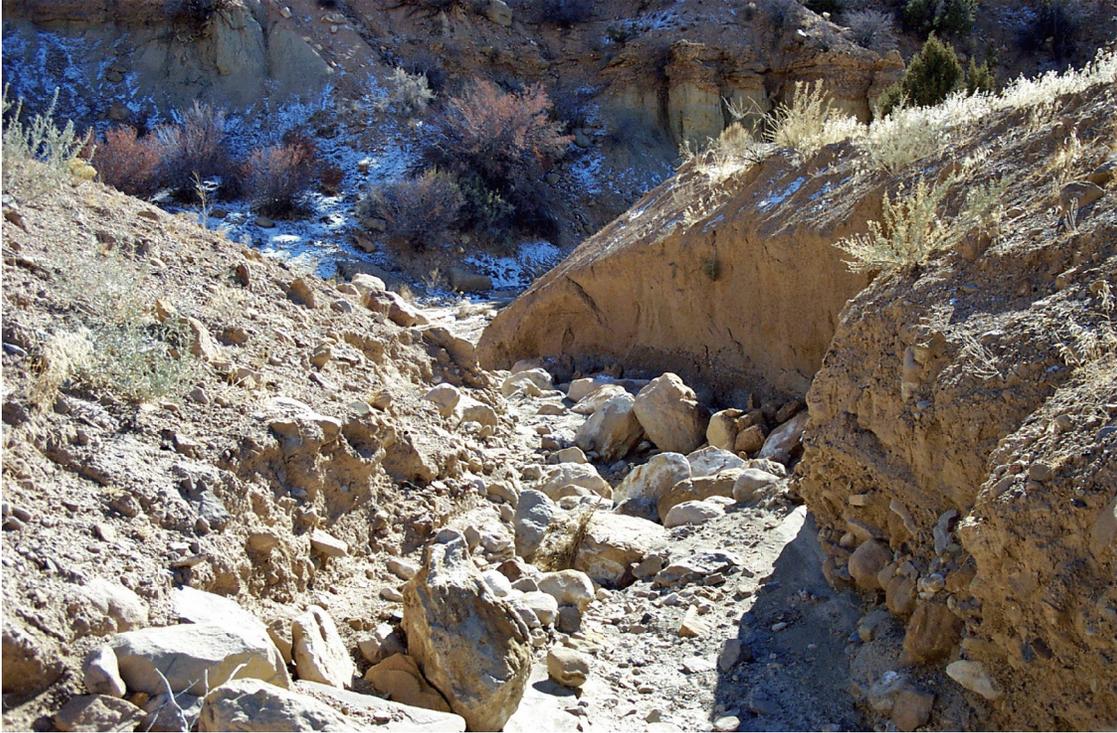
CLOSEUP OF DAMAGE FROM NOVEMBER 03 STORM EVENT

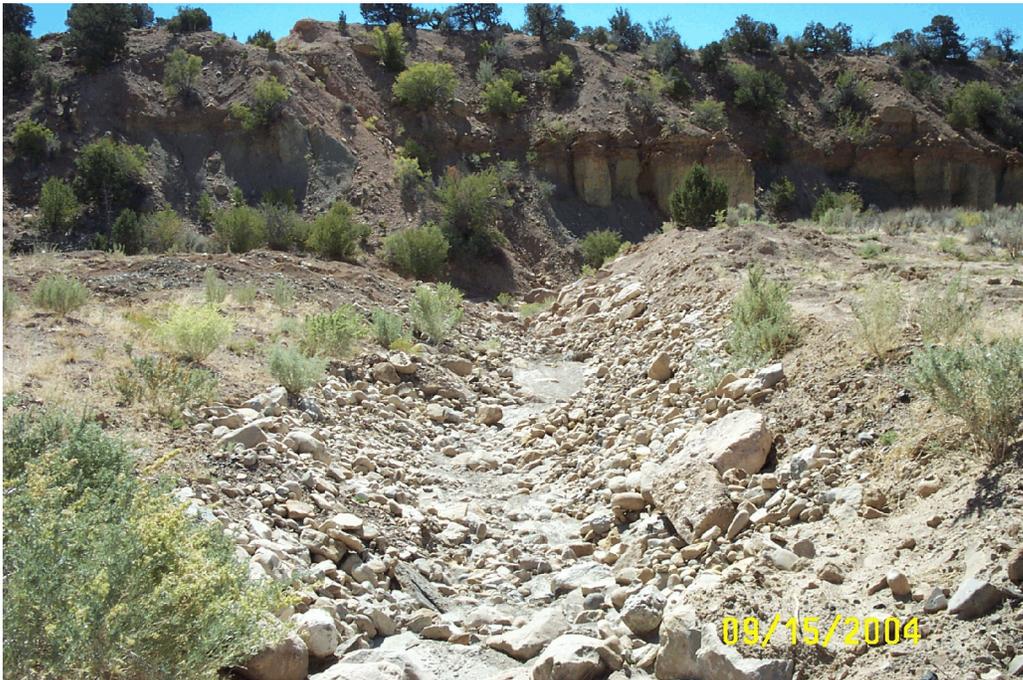
DAMAGE FROM NOVEMBER 03 STORM EVENT REPAIRED AUGUST 04
Repairs in August 2004 DID NOT Restart The Bond Clock

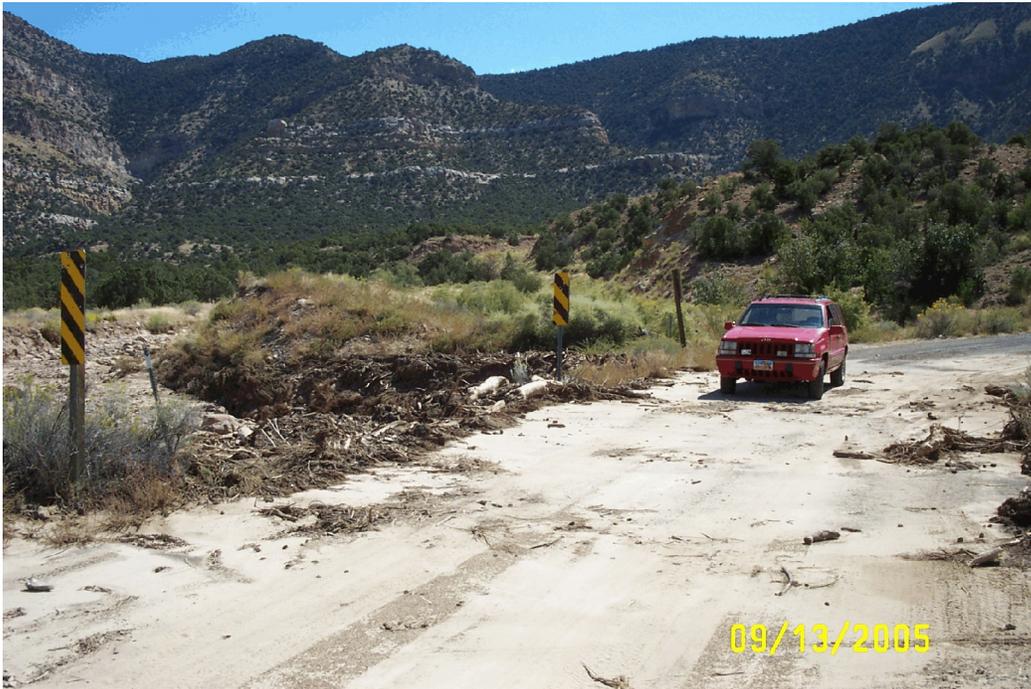
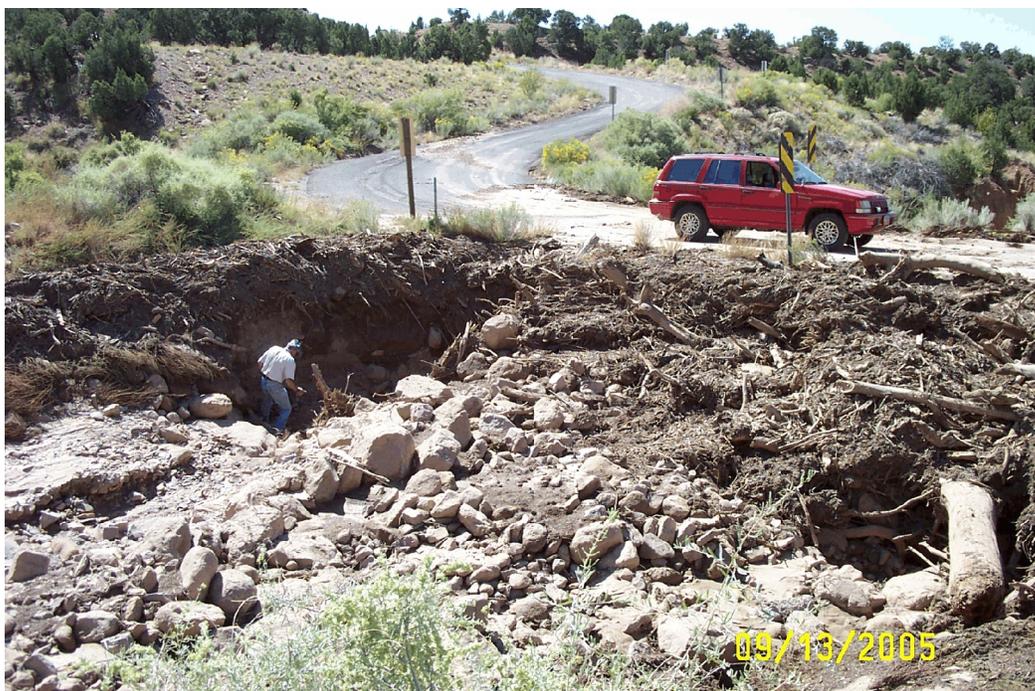
In September of 05 a very significant storm event slightly damaged for the second time the channel established in the fall of 2001

STORM EVENT SEPTEMBER 2005
Photo taken at the Horse Canyon Culverts
Note Plugged Culverts Water Flowing Over The Road

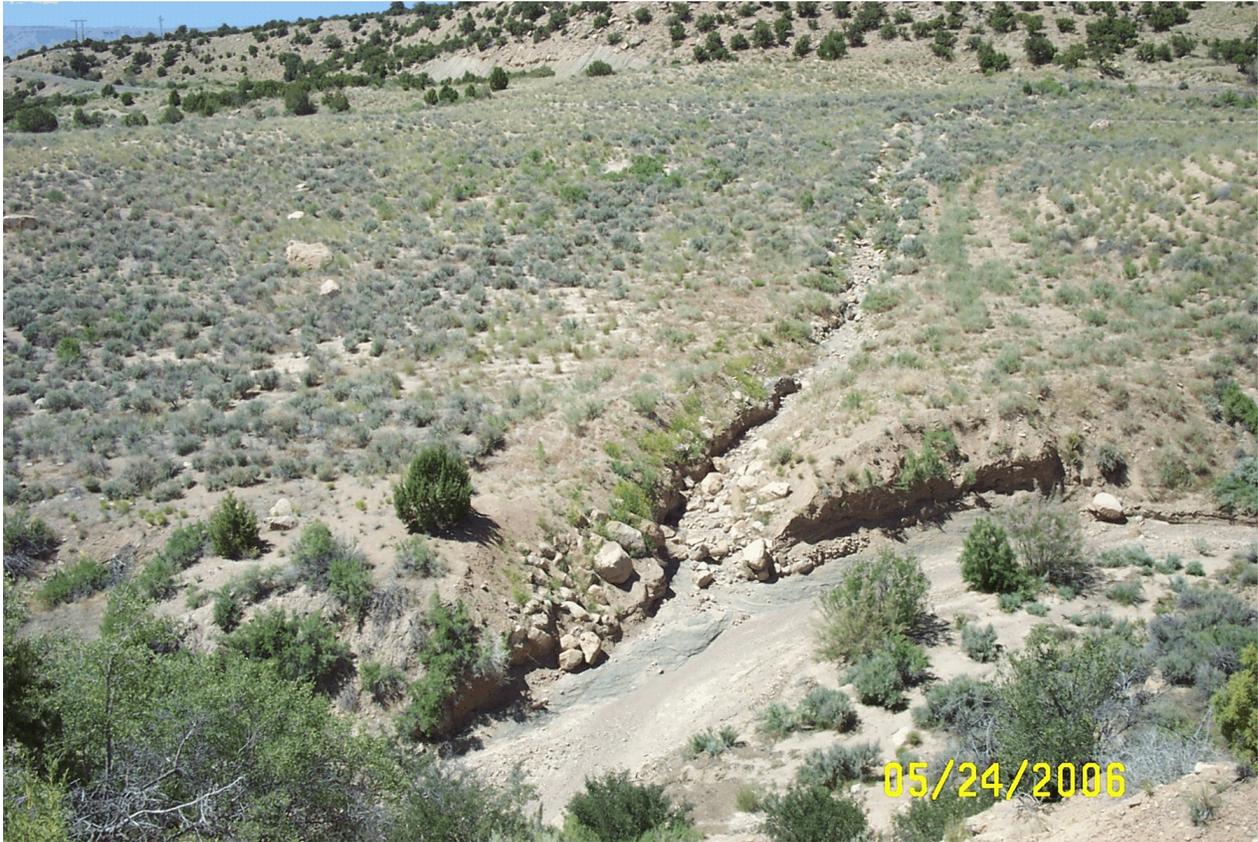
DAMAGE RESULTING FROM SIGNIFICANT SEPTEMBER 05 EVENT

The damage in the photo above appears worse than it really is due to the shadows. However the geometry of the reclaimed channel is no different than the main channel shown above nor in the channels immediately above and below shown in the photos below. Minor repairs to the channel, if required, should not restart the bond clock. Keep in mind at Phase II bond release the total disturbance for the culvert removal and for establishing the channel was less than .49 acres. Repairs to the above channel, if required would result in less than .25 acres of disturbance. The photos below show that the cutting in the established channel is the same or even less than the cutting in the main channel and in the channel above the reclaimed area. The established channel carries water from undisturbed across the disturbed area to the undisturbed Horse Canyon drainage.

It is the operators opinion that the reestablished channel does not need to be repaired since it does meet AOC and is not different than the undisturbed drainage above and below the reclaimed site.

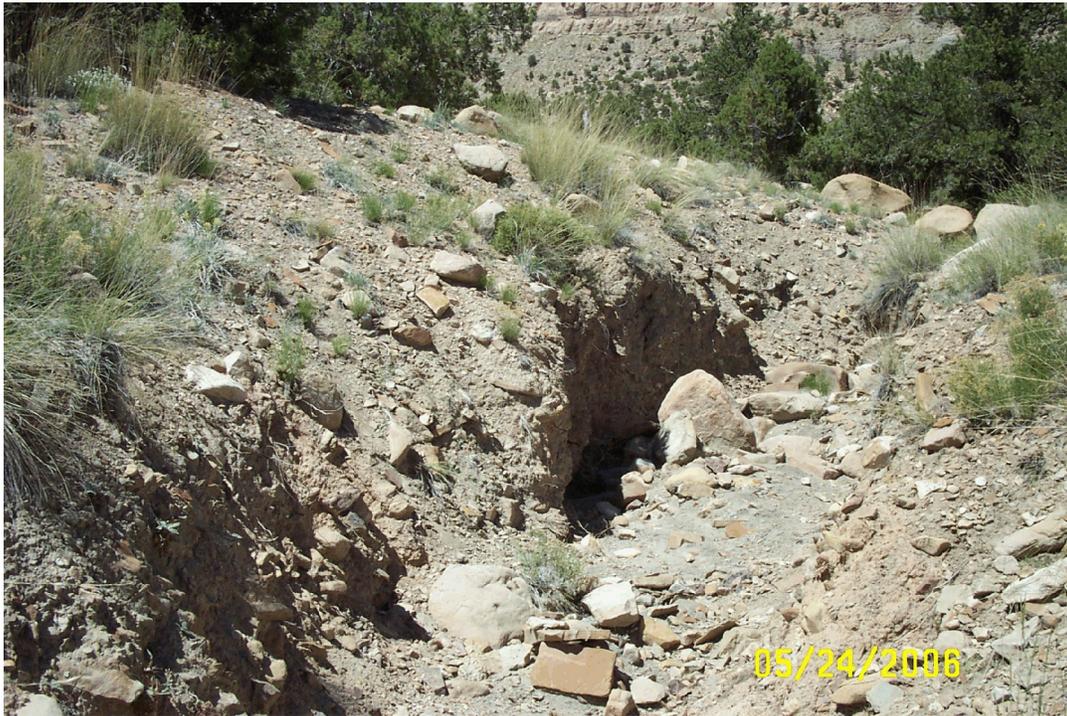
Cutting in the same drainage above the reclaimed site. This area has never been disturbed and has the same characteristics as the area of potential repairs. The reclaimed channel is at AOC.

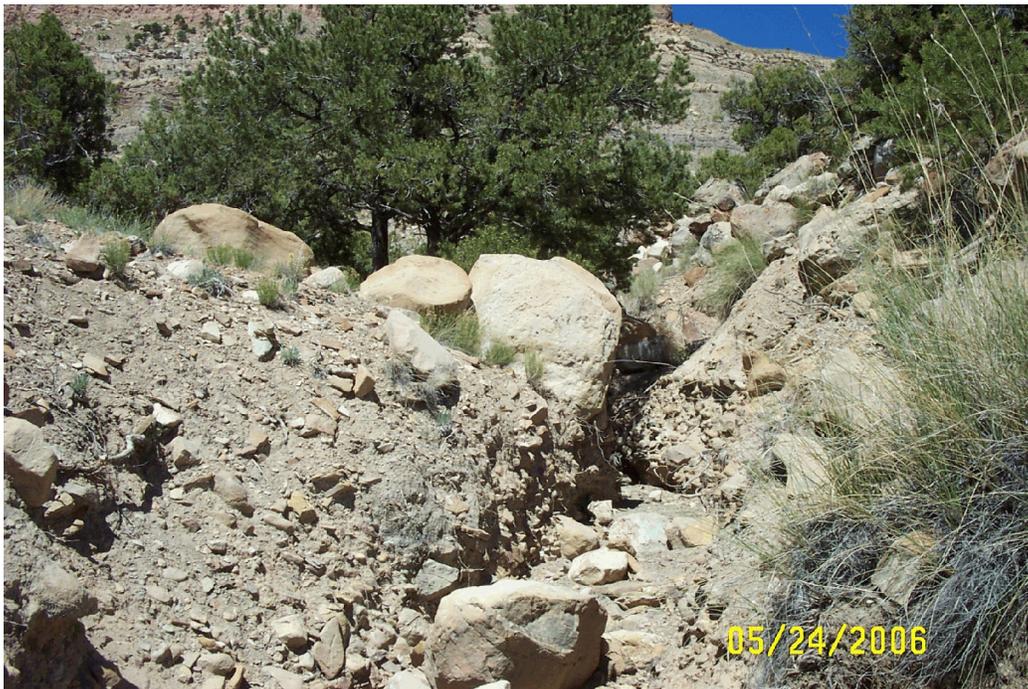
The below Photo is also in the same channel, immediately above the reclaimed channel, and shows natural cutting similar to that found in the reclaimed channel.

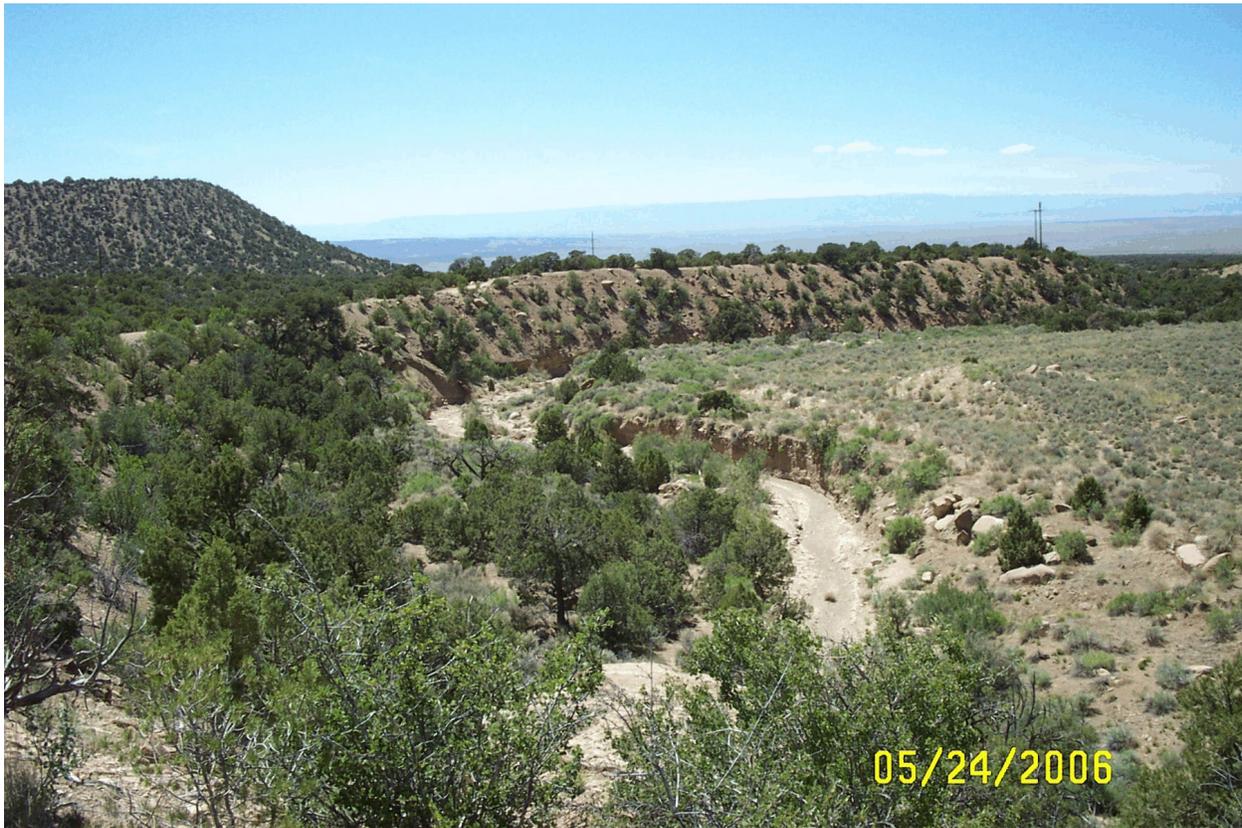
The Photo below shows cutting in the Main Horse Canyon Creek, undisturbed, which is much more significant than is the cutting found in the reestablished channel. The photo was taken immediately below the confluence of the reestablished channel and Horse Canyon.
