## **APPENDIX 7-8**

# **Water Monitoring Location Descriptions**

Last updated January 2006

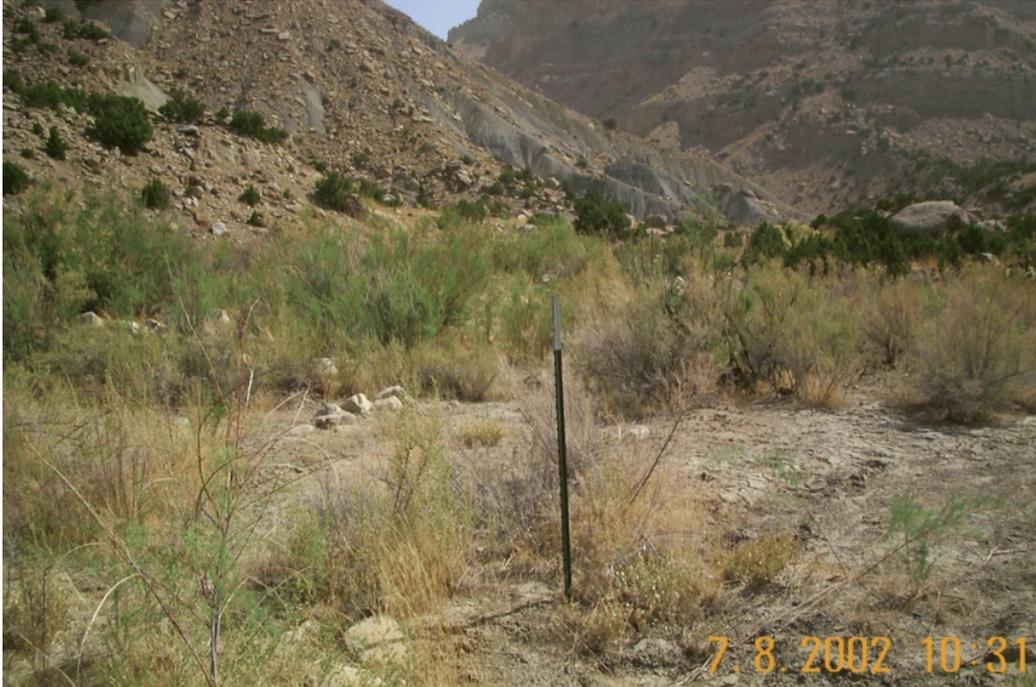
**L-1-S**

- Location:** In Lila Canyon wash North of the permit area. Stream reach is intermittent by definition but ephemeral acting (See Appendix 7-7 & Plate 7-4). The wash above and below flows only as a result of spring run-off or storm events. Located in the Mancos Shale at an elevation of 5,830 feet.
- General:** The Sunnyside coal seam does not exist at this location. Since L-1-S is located off the permit area and subsidence is not a possibility, there is no potential for Lila Canyon Mine to negatively affect this monitoring location. The permittee has never observed amphibians at or near this location.
- Vegetation description:** Habitat within this Mancos substrate out wash area is predominately a mix of salt desert shrub, greasewood, and invasive tamarisk and cheatgrass.

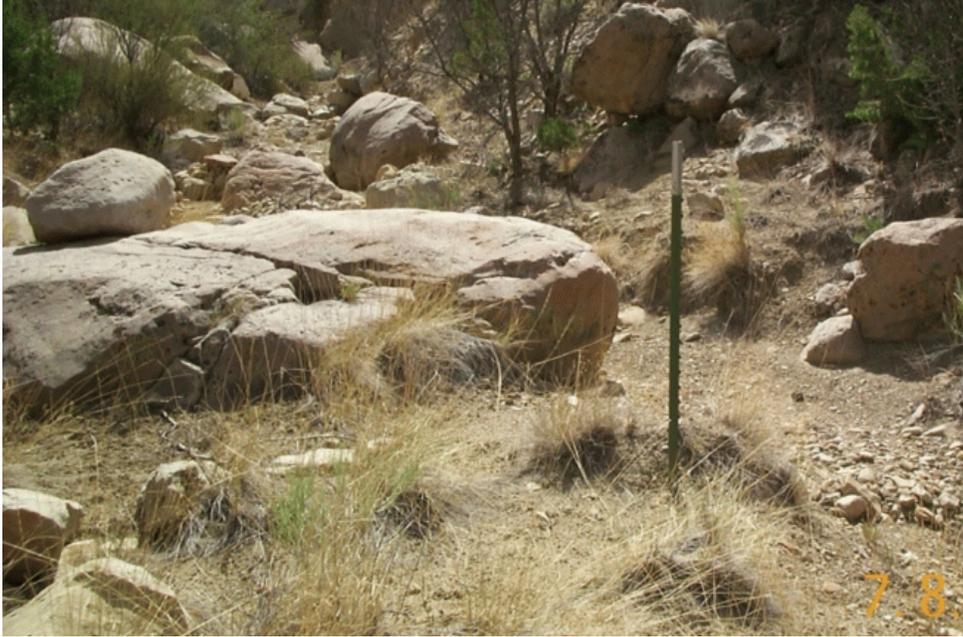
**L-2-S**

**Location:** L-2-S is located In the Right Fork of Lila Canyon wash South of and upstream of the permit area. Stream reach is ephemeral by definition (See Appendix 7-7& Plate 7-4). The wash above and below flows only as a result of spring run-off or storm events. Located in the Mancos Shale at an elevation of 5,950 feet.

**General:** The Sunnyside coal seam does not exist at this location. Since L-2-S is located off the permit area and subsidence is not a possibility, there is no potential for Lila Canyon Mine to negatively affect this monitoring location. The permittee has never observed amphibians at or near this location.

**Vegetation description:** Habitat overstory adjacent to the dry streambed monitoring location is Pinyon-Juniper, isolated sagebrush, and needle and thread grass.

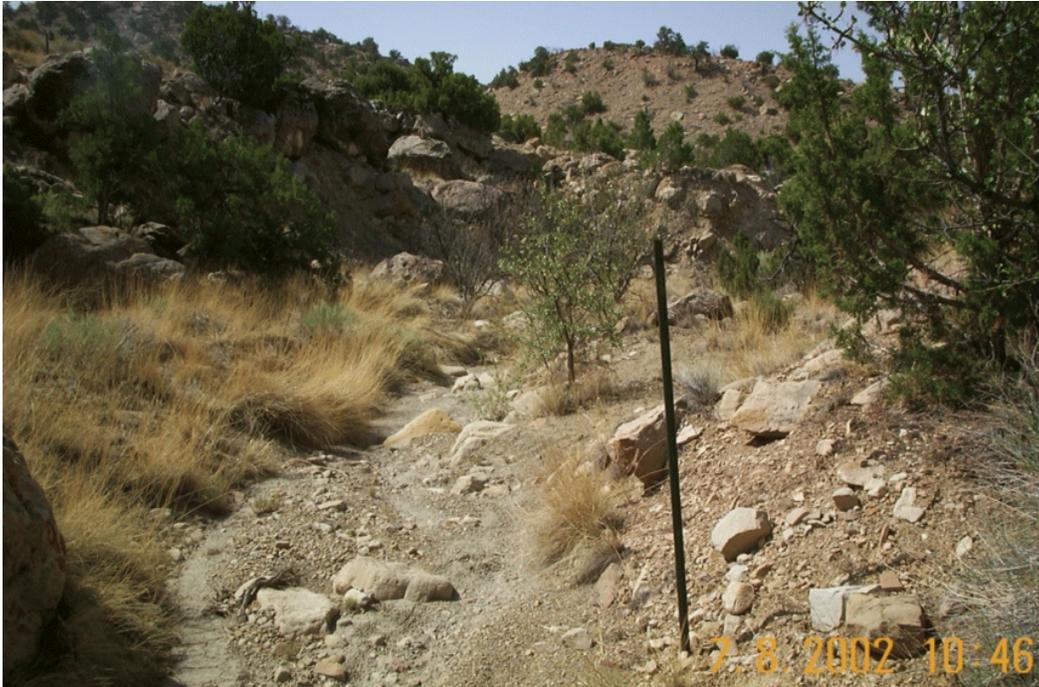
**L-3-S**

**Location:** Located in the Right Fork of Lila Canyon wash South of and down stream of the permit area. Stream reach is ephemeral by definition (See Appendix 7-7& Plate 7-4). The wash above and below flows only as a result of spring run-off or storm events. The Sunnyside coal seam does not exist in this location. Located in the Mancos Shale at an elevation of 5,750 feet.

**General:** Since L-3-S is located off the permit area and subsidence is not a possibility, there is no potential for the Lila Canyon Mine to negatively affect this monitoring location. The permittee has never observed amphibians at or near this location.

**Vegetation description:** Habitat overstory is a Pinyon-Juniper habitat similar to L-2-S.

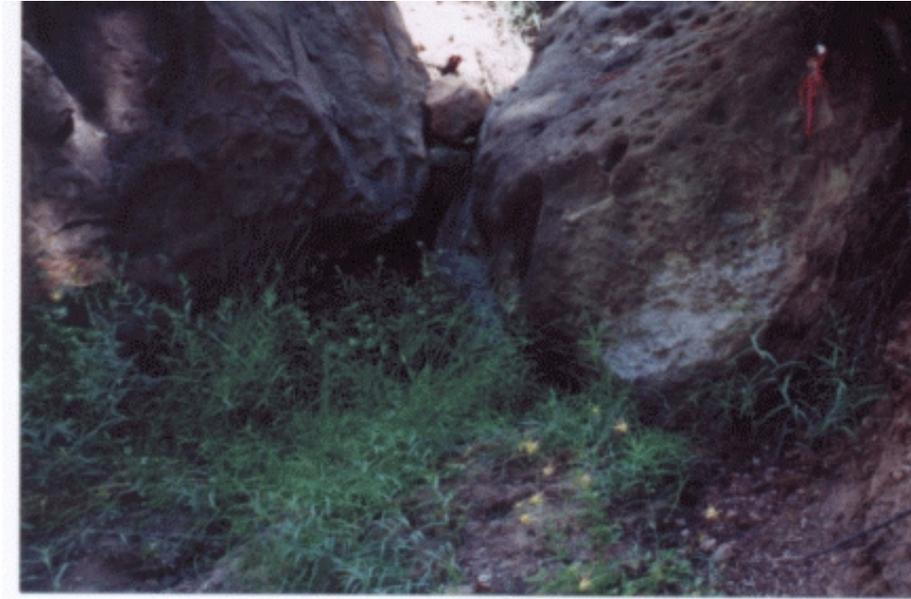
**L-6-G**  
**(H-18) Lila Canyon**

**Location:** Located in Lila Canyon within the Permit area. The old Horse Canyon Mine has already undermined this monitoring location with no impact. Stream reach is intermittent by definition but is ephemeral acting (See Appendix 7-7 & Plate 7-4). The wash above and below the spring flows only as a result of spring run-off or storm events. Located in the Upper Price River near the contact of the Flagstaff/ North Horn and the Upper Price River Formations at an elevation of 7280 feet.

**General:** The coal seam has been previously mined under this location. The spring lies approximately 1,800 feet above the mined out Sunnyside coal seam. There is no potential for Lila Canyon Mine to negatively impact this monitoring location. The permittee has never observed amphibians at or near this location.

**Vegetation description:** Habitat overstory is Douglas Fir-Mountain Brush association.

Since the operator has never observed flow at this location, and a new location upstream has been determined to be more suitable for monitoring, this site will be terminated. L-11-G has been established to replace L-6-G as a monitoring location.

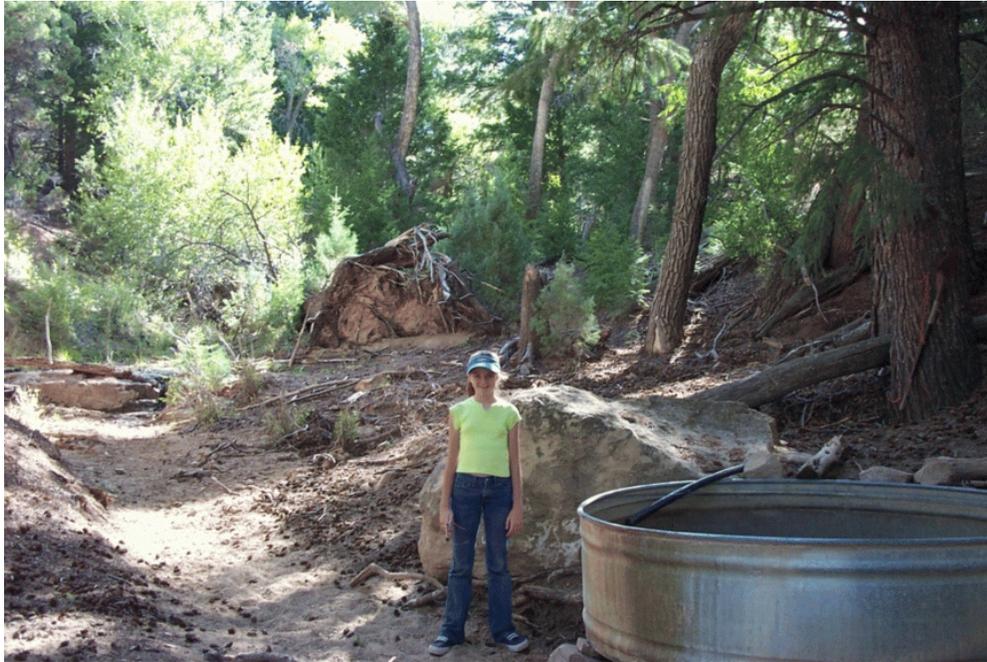
## L-7-G Cottonwood Spring

**Location:** Located in Cottonwood Canyon approximately .5 miles from the intersection of Cottonwood Canyon with Little Park Wash. This spring is located approximately .25 miles inside the permit area. Located in the Flagstaff/ North Horn Formation at an elevation of 7360 feet. Stream reach is intermittent by definition but is ephemeral acting (See Appendix 7-7 & Plate 7-4). Flow from the spring flows approximately 200 feet down stream where it evaporates or is absorbed. The drainage above and below Cottonwood spring flows only as a result of spring run-off or storm events.

**General:** The coal seam at this location lies approximately 2,500 feet below the spring. Due to the depth of the coal and the tendency for the overlying formations to swell and seal, there is little potential for Lila Canyon Mine to negatively impact this spring or recharge sources. The permittee has never observed amphibians at or near this location.

**Vegetation description:** Habitat overstory is Douglas fir-mountain brush association.

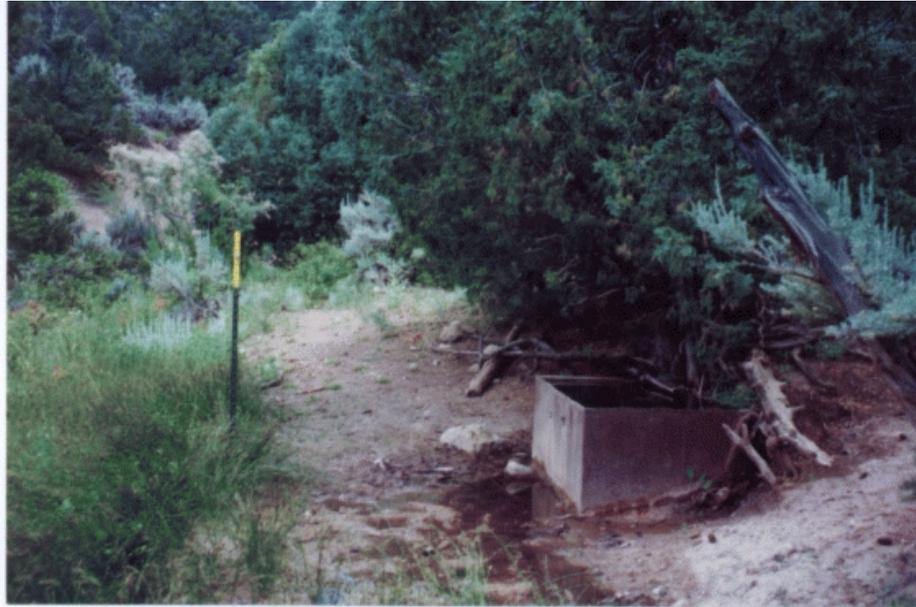
**L-8-G**  
**Above IPA #1**

**Location:** L-8-G is located in an unnamed canyon that the operator refers to as IPA #1, approximately 1 mile above Piezometer IPA #1. Located in the Flagstaff/ North Horn Formation at an elevation of 7360 feet. Stream reach is intermittent by definition but is ephemeral acting (See Appendix 7-7 & Plate 7-4). Flow from the spring flows approximately 200 feet down stream where it evaporates or is absorbed. The drainage above and below this spring flows only as a result of spring run-off or storm events.

**General:** The coal seam at this location lies approximately 2,400 feet below the spring. The spring is located .5 miles to the East and off of, the permit area. Due to its location, .5 miles outside of the limit of subsidence, depth of the coal, and the tendency for the overlying formations to swell and seal, there is no potential for Lila Canyon Mine to negatively impact this spring or recharge sources. The permittee has never observed amphibians at or near this location.

**Vegetation description:** Habitat is predominantly Pinyon - Juniper and sagebrush grass associations.

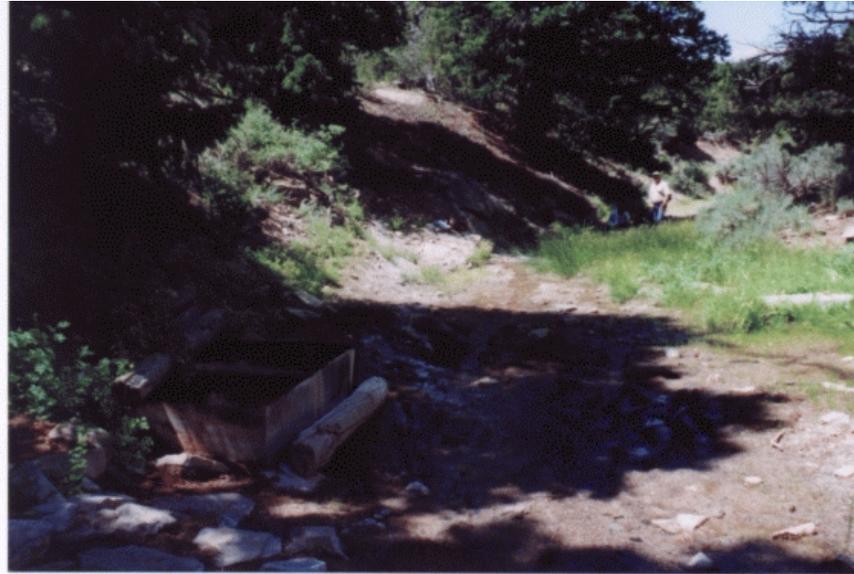
## L-9-G Pine Spring

**Location:** L-9-G is located in an unnamed side canyon approximately 1.25 miles from Little Park Wash. Located in the Flagstaff/ North Horn Formation at an elevation of 7200 feet. Stream reach is intermittent by definition but is ephemeral acting (See Appendix 7-7 & Plate 7-4). Flow from the spring flows approximately 400 feet down stream where it evaporates or is absorbed. The drainage above and below this spring flows only as a result of spring run-off or storm events.

**General:** The coal seam at this location lies approximately 2,300 feet below the spring. The spring is located slightly to the East of and off of the permit area outside of the limit of subsidence. Due to its location, outside the limit of subsidence, depth of the coal, and the tendency for the overlying formations to swell and seal, there is no potential for Lila Canyon Mine to negatively impact this spring or recharge sources. The permittee has never observed amphibians at or near this location.

**Vegetation description:** A wet meadow habitat is present within the area of the monitoring site. An overstory of Pinyon-Juniper and sagebrush grass lies immediately adjacent along each side of this site. The wet meadow habitat was washed out or covered with sand and gravel as a result of storm events in Aug 2003.

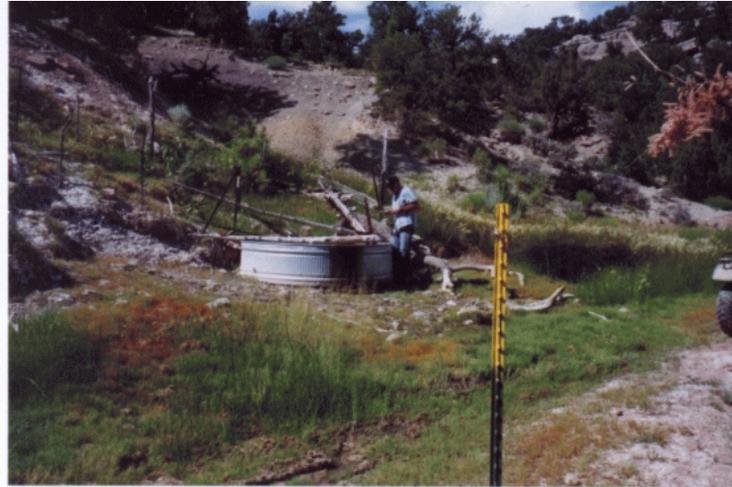
## L-10-G

**Location:** L-10-G is located in Williams Draw approximately 1.25 miles South and East of the permit area. Located in the Upper Price River near the contact of the Flagstaff/ North Horn and the Upper Price River Formations at an elevation of 6720 feet. Stream reach is intermittent by definition but is ephemeral acting (See Appendix 7-7 & Plate 7-4). Flow from the spring flows approximately 200 feet down stream where it evaporates or is absorbed. The drainage above and below this spring flows only as a result of spring run-off or storm events.

**General:** The coal seam at this location lies approximately 1250 feet below the spring. The spring is located over a mile outside of the limit of subsidence. Due to its location, outside the limit of subsidence, depth of the coal, and the tendency for the overlying formations to swell and seal, there is no potential for Lila Canyon Mine to negatively impact this spring or recharge sources. The permittee has never observed amphibians at or near this location.

**Vegetation description:** A wet meadow habitat is present within the area of the monitoring site. An overstory of Pinyon-Juniper and sagebrush grass lies immediately adjacent along each side of this site.

Since this spring location is so far off the permit area a better site was identified where the information gathered would be more valuable. This site will be replaced by L-12-G.

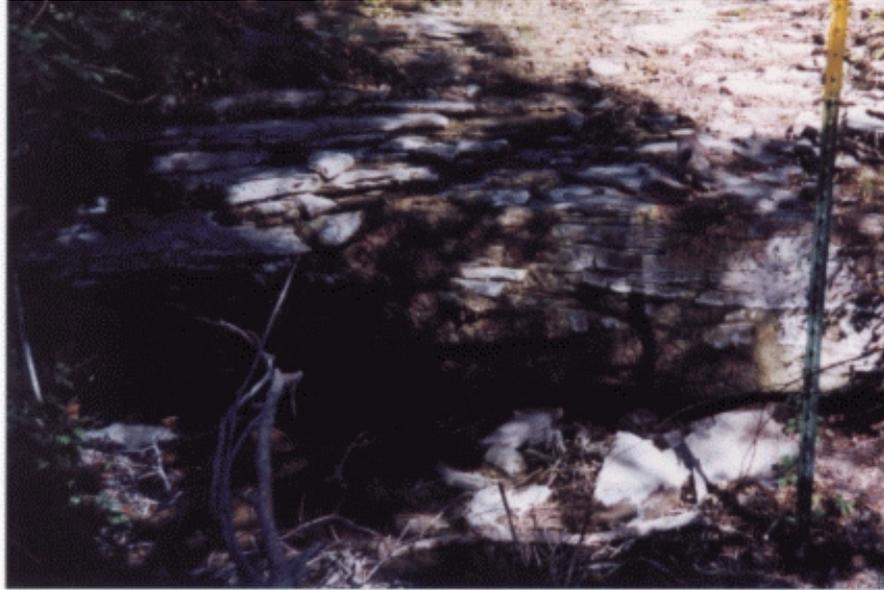
**L-11-G**  
**Mont/Leslie Spring**  
**Will Replace L-6-G**

**Location:** L-11-G is located in Lila Canyon within the Permit area. Located in the Upper Price River near the contact of the Flagstaff/ North Horn and the Upper Price River Formations at an elevation of 7360 feet. The old Horse Canyon Mine has already undermined this monitoring location with no impact. The spring flows for approximately 50 feet where it either evaporates or is absorbed. Stream reach is intermittent by definition but is ephemeral acting (See Appendix 7-7 & Plate 7-4). The wash flows only as a result of spring run-off or storm events.

**General:** The coal seam has been previously mined at this location. The spring lies approximately 1,900 feet above the mined out Sunnyside coal seam. There is no potential for Lila Canyon Mine to negatively impact this monitoring location. The permittee has never observed amphibians at or near this location.

**Vegetation description:** Habitat overstory is Douglas fir-mountain brush association.

This monitoring location will replace L-6-G.

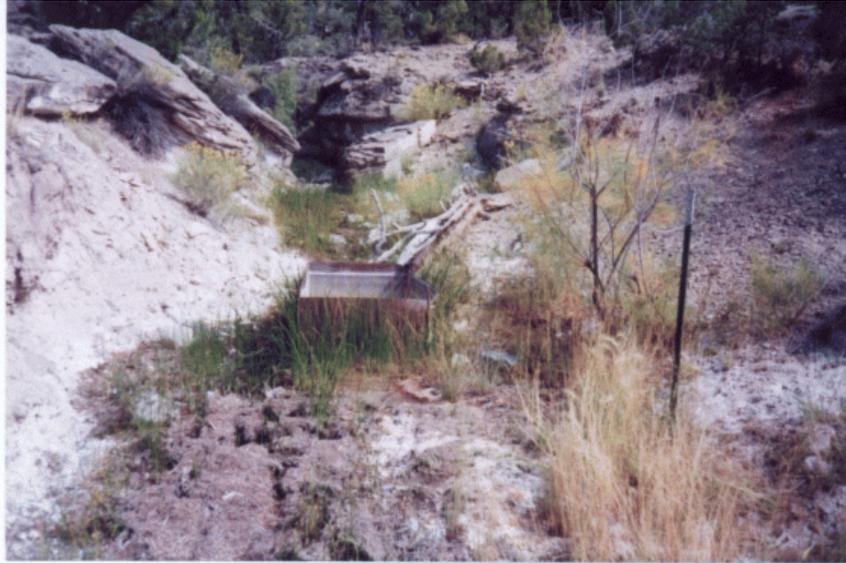
**L-12-G**  
**Will Replace L-10-G**

**Location:** L-12-G is located in an unnamed drainage on the south end of the permit area. Located in the Upper Price River at an elevation of 6800 feet. Stream reach is intermittent by definition but is ephemeral acting (See Appendix 7-7 & Plate 7-4). Flow from the spring flows approximately 100 feet down stream where it evaporates or is absorbed. The drainage above and below this spring flows only as a result of spring run-off or storm events.

**General:** The coal seam at this location lies approximately 1100 feet below the spring. The spring is located just outside of the limit of subsidence. Due to its location, outside the limit of subsidence, depth of the coal, and the tendency for the overlying formations to swell and seal, there is no potential for Lila Canyon Mine to negatively impact this spring or recharge sources. The permittee has never observed amphibians at or near this location.

**Vegetation description:** A small wet meadow habitat is present within the area of the monitoring site. An overstory of Pinyon-Juniper and sagebrush grass lies immediately adjacent along each side of this site.

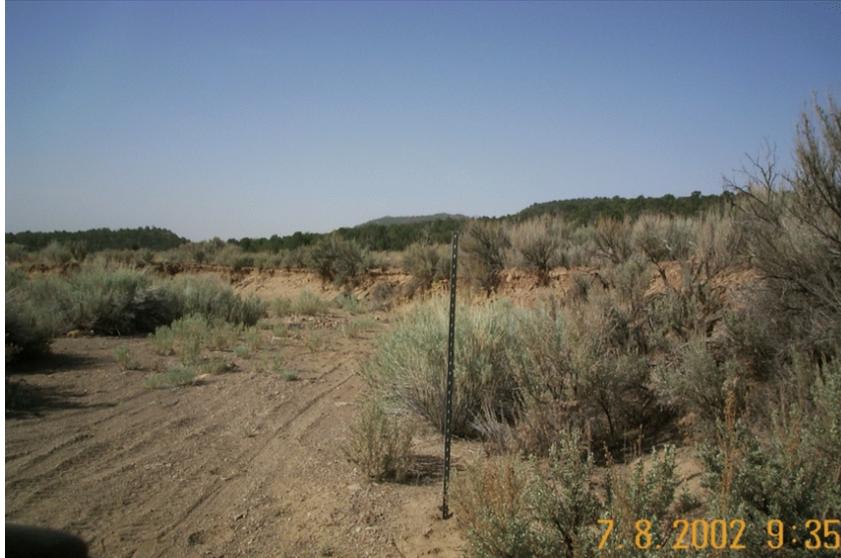
## L-13-S

**Location:** L-13-S is located in Little Park Wash at the road intersection. Located in Alluvium adjacent to the Upper Price River Formation at an elevation of 6840 feet. Stream reach is intermittent by definition but is ephemeral acting (See Appendix 7-7 & Plate 7-4). The drainage above and below this monitoring location flows only as a result of spring run-off or storm events.

**General:** The coal seam at this location lies approximately 1400 feet below the monitoring location. Due to its location, depth of the coal, and the tendency for the overlying formations to swell and seal, there is no potential for Lila Canyon Mine to negatively impact this monitoring location. The permittee has never observed amphibians at or near this location.

**Vegetation description:** The area surrounding the dry wash monitoring site consists primarily of mature sagebrush habitat.

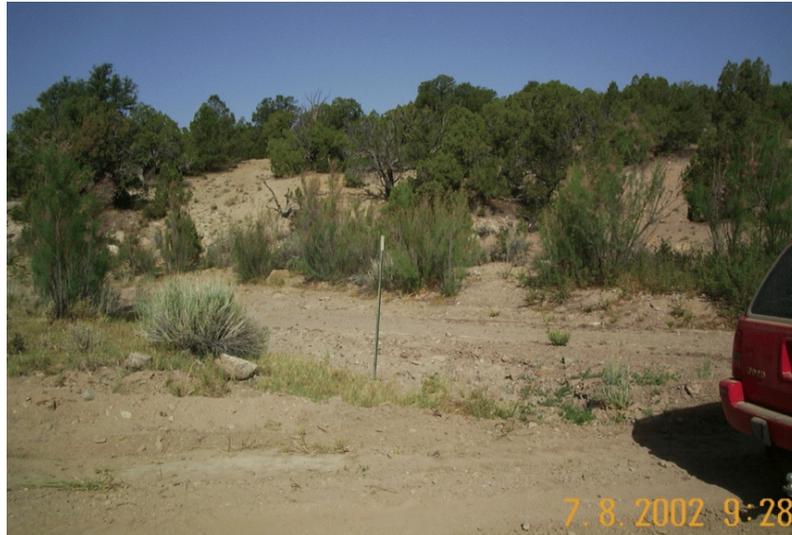
**L-14-S**  
**Wash Below L-12-G**

**Location:** L-14-S is located at the road intersection of the unnamed drainage below L-12-G. Located in the Upper Price River Formation at an elevation of 6690 feet. Stream reach is intermittent by definition but is ephemeral acting (See Appendix 7-7 & Plate 7-4). The drainage above and below this monitoring location flows only as a result of spring run-off or storm events.

**General:** The coal seam at this location lies approximately 1000 feet below the monitoring location. Due to the faulting this monitoring location is outside the mine projections and the projected limit of subsidence. As a result of its location, depth of the coal, and the tendency for the overlying formations to swell and seal, there is no potential for Lila Canyon Mine to negatively impact this monitoring location. The permittee has never observed amphibians at or near this location.

**Vegetation description:** The area surrounding the dry wash monitoring site consists primarily of mature sagebrush habitat with a bordering overstory of Pinyon-Juniper and invasive tamarisk..

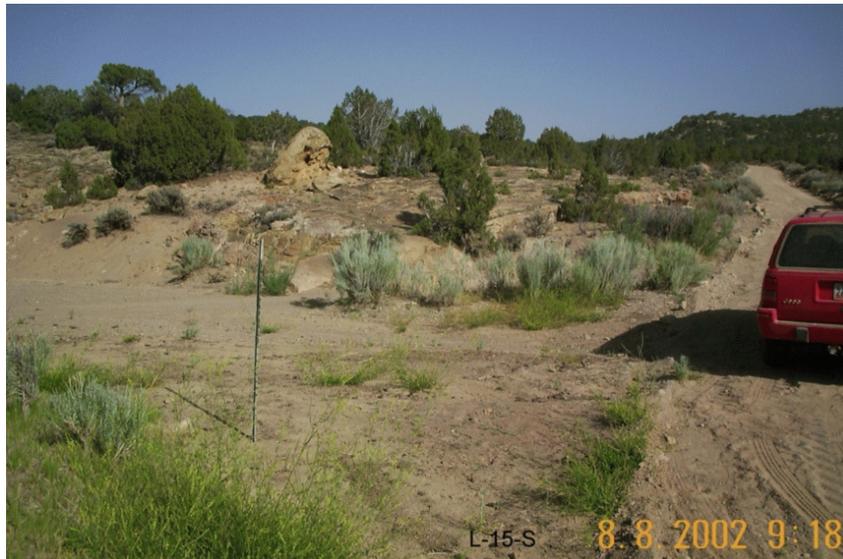
## L-15-S

**Location:** L-15-S is located at the road intersection of Williams Draw. Located in Alluvium adjacent to the Upper Price River Formation at an elevation of 6560 feet. The stream reach is intermittent by definition but is ephemeral acting (See Appendix 7-7 & Plate 7-4). The drainage above and below this monitoring location flows only as a result of spring run-off or storm events.

**General:** The coal seam at this location lies approximately 900 feet below the monitoring location. This site is located 1.25 miles South of the permit boundary. As a result of its location, there is no potential for Lila Canyon Mine to negatively impact this monitoring location. The permittee has never observed amphibians at or near this location.

**Vegetation description:** The area surrounding the dry wash monitoring site consists primarily of mature sagebrush and Pinyon-Juniper habitat.

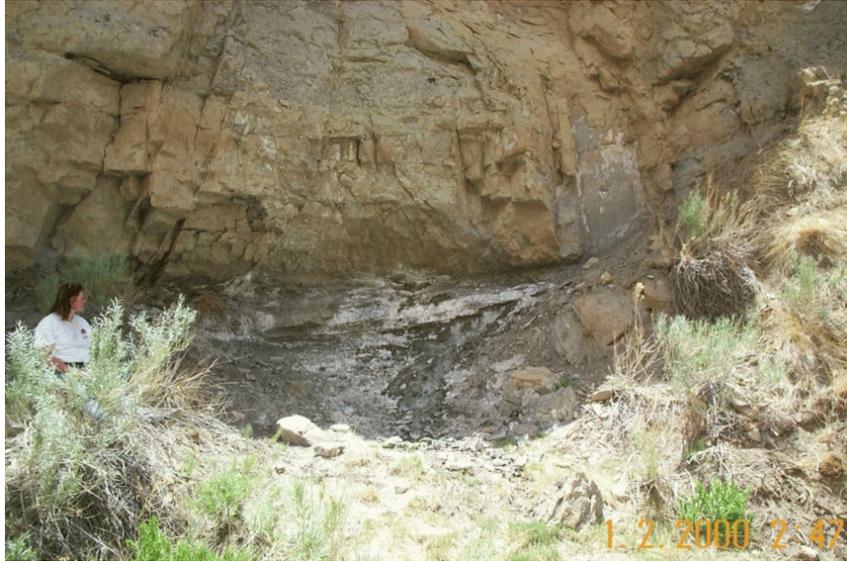
## L-16-G Little Stink

**Location:** Located in what has recently been named Stinky Spring Canyon by the Operator. The seep is located approximately .25 miles to the West of the permit area and within the Central Graben. The seep is located at the top of the Mancos Shale approximately 600 feet below the coal seam in a highly faulted area at an elevation of 5840 feet. The stream reach is intermittent by definition but is ephemeral acting (See Appendix 7-7 & Plate 7-4). The drainage above and below this monitoring location flows only as a result of spring run-off or storm events.

**General:** Due to its location, outside the permit area, outside the limit of subsidence, within the Central Graben, and being 600 feet below the coal seam, there is no potential for Lila Canyon Mine to negatively impact this spring or recharge sources. This location is used by Rocky Mountain Bighorn Sheep; however, no evidence of the sheep using the poor quality water has been documented. The permittee has never observed amphibians at or near this location.

**Vegetation description:** Habitat immediately below this wet seep monitoring site is a mix of grasses and salt desert shrub habitat.

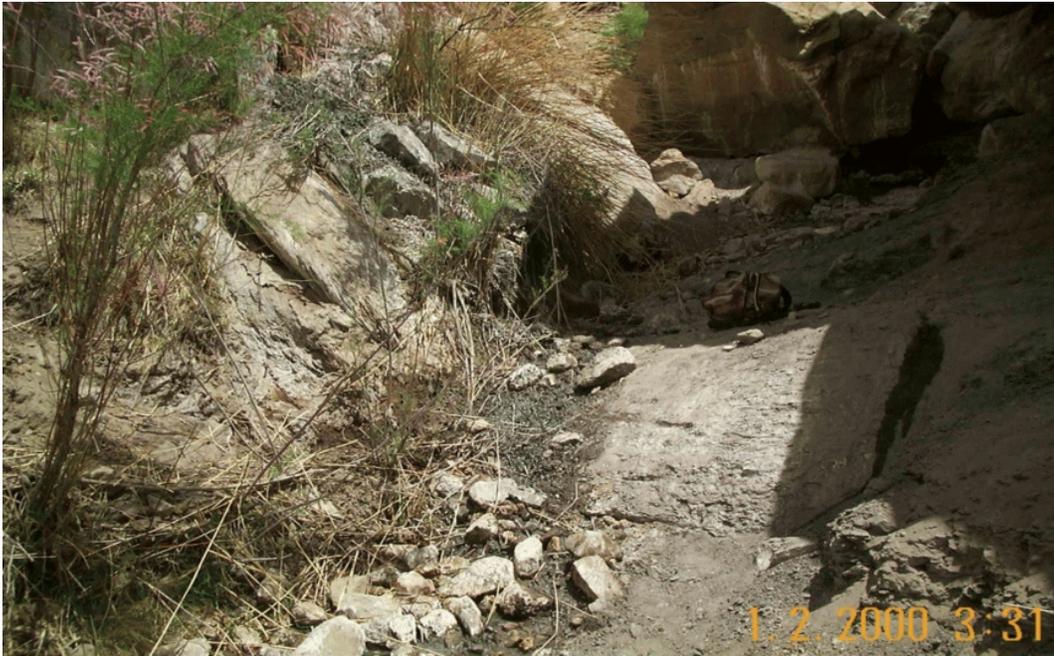
## L-17-G Big Stink

- Location:** Located in what has recently been named Stinky Spring Canyon. The seep is located approximately .25 miles to the West of the permit area, .1 mile above L-16-S, and within the Central Graben. The seep is located at the top of the Mancos Shale approximately 500 feet below the coal seam in a highly faulted area at an elevation of 5920 feet. The stream reach is intermittent by definition but is ephemeral acting (See Appendix 7-7 & Plate 7-4). The drainage above and below this monitoring location flows only as a result of spring run-off or storm events.

- General:** Due to its location, outside the permit area, outside the limit of subsidence, and being 500 feet below the coal seam, there is no potential for Lila Canyon Mine to negatively impact this spring or recharge sources. This location is used by Rocky Mountain Bighorn Sheep; however, no evidence of the sheep drinking the poor quality water has been documented. The permittee has never observed amphibians at or near this location.

- Vegetation description:** Habitat immediately below this wet seep monitoring site is a mix of grasses and salt desert shrub habitat and invasive tamarisk.

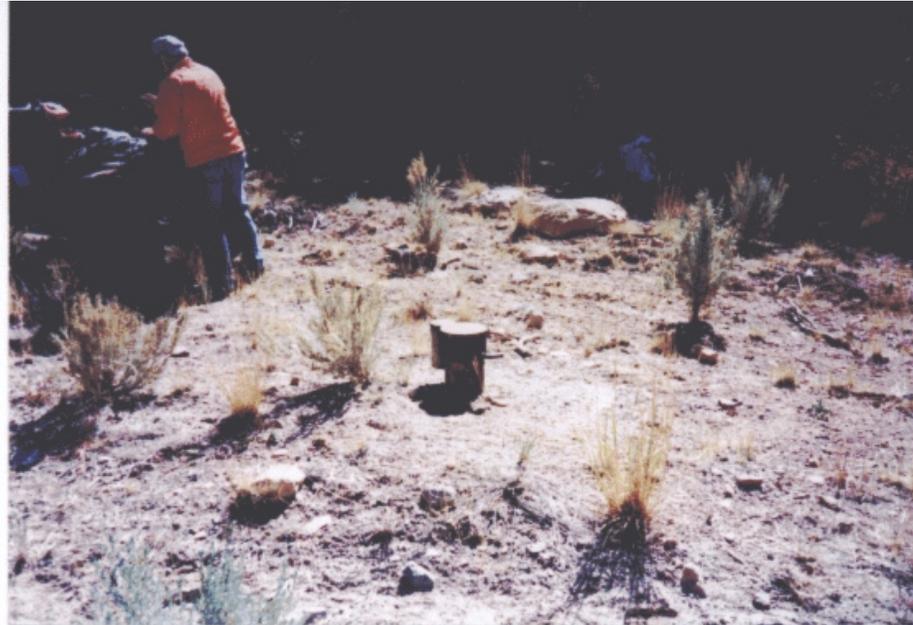
**IPA #1  
Piezometer**

**Location:** Located in an unnamed canyon that is a branch of Little Park Wash. Located in the Upper Price River Formation at an elevation of 7034 feet. See Plate 7-4 for location.

**General:** This site is used as a Piezometer measuring location only. The depth of water is measured quarterly.

**Vegetation description:** Habitat surrounding this Piezometer site is sagebrush-grass.

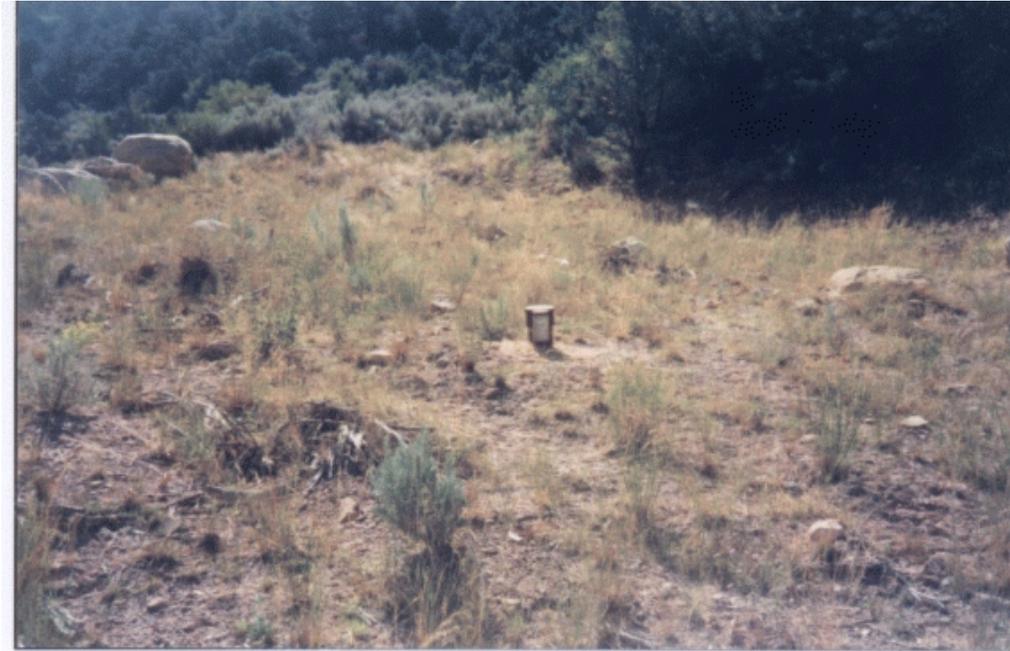
**IPA #2**  
**Piezometer**

**Location:** Located on the Little Park Wash road near the Little Park Wash crossing. See Plate 7-4 for location. Located in the Upper Price River Formation at an elevation of 6865 feet.

**General:** This site is used as a Piezometer measuring location only. The depth of water is measured quarterly.

**Vegetation description:** Habitat surrounding this Piezometer site is sagebrush-grass.

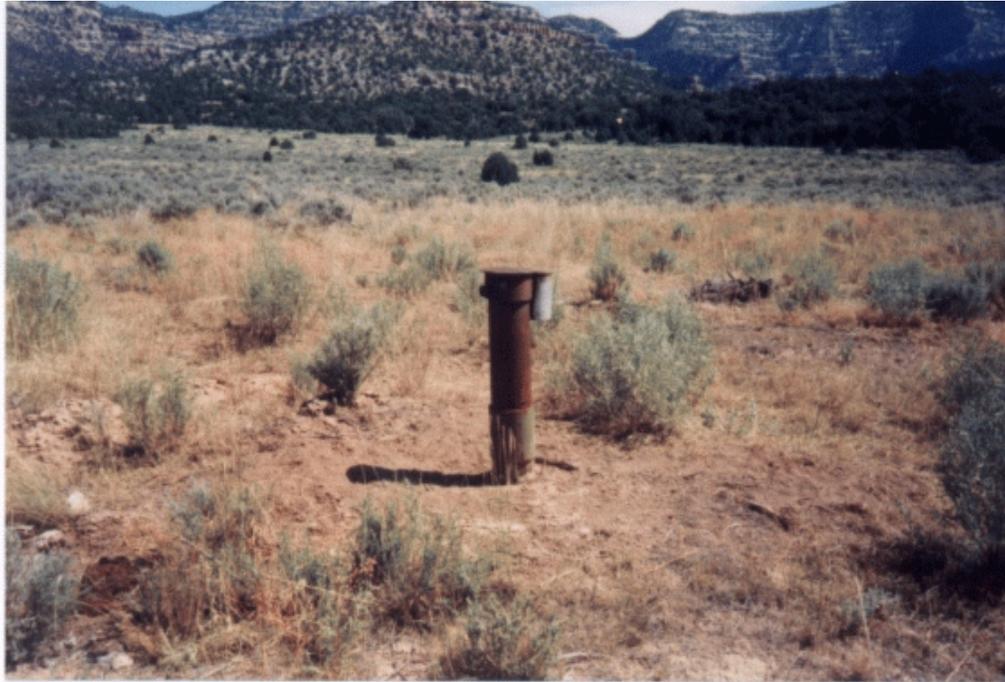
**IPA #3  
Piezometer**

**Location:** Located on the Little Park Wash road. See Plate 7-4 for location. Located in the Upper Price River Formation at an elevation of 6810 feet.

**General:** This site is used as a Piezometer measuring location only. The depth of water is measured quarterly.

**Vegetation description:** Habitat surrounding this Piezometer site is sagebrush-grass.

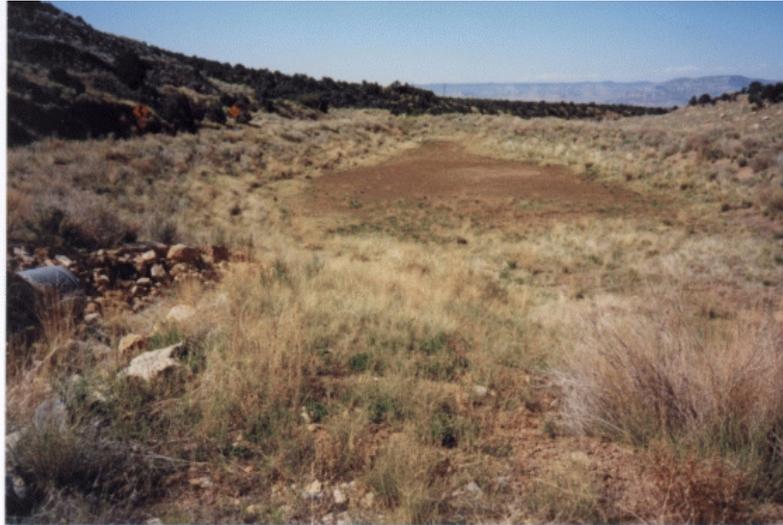
**Horse Canyon  
Sediment Pond #2  
UPDES #002A**

**Location:** Located in Horse Canyon above and to the North of the bridge on County highway 124. Located in an alluvial fan on the Mancos Shale at an elevation of 6190 feet.

**General:** This is UPDES site #002A of the Horse Canyon UPDES permit. The Sunnyside coal seam does not exist in this location. There is no potential for Lila Canyon Mine to negatively affect this monitoring site. The permittee has never observed amphibians at or near this location.

**Vegetation description:** This reseeded sediment pond is covered by a reclamation vegetation cover consistent with a sagebrush-grass habitat.

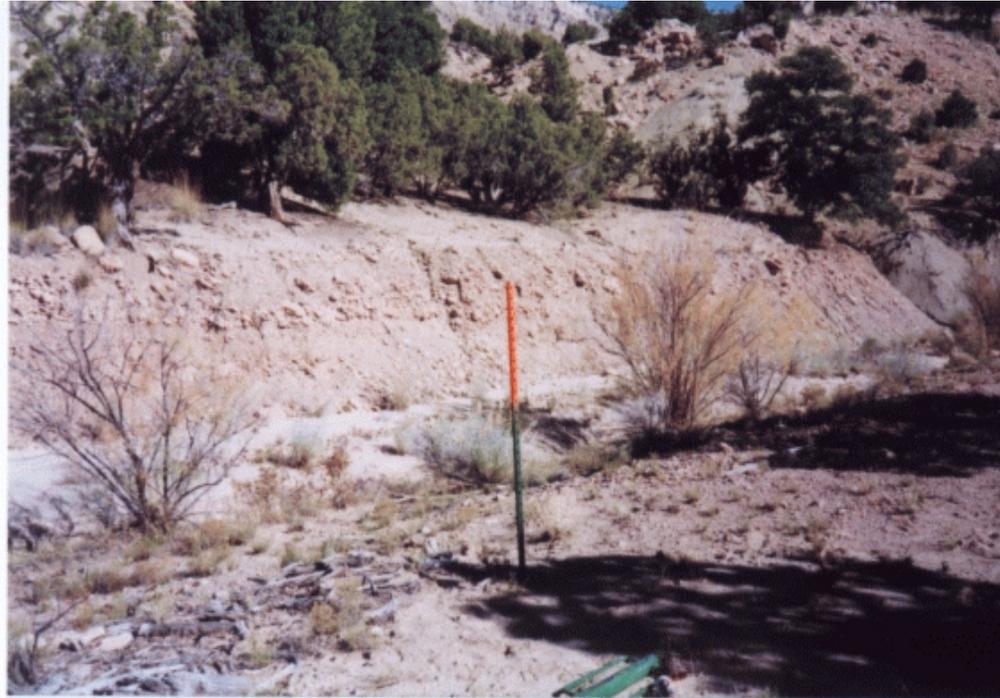
## HC-2 (B-1)

**Location:** HC-2 is located in Horse Canyon Wash West and downstream of the permit area. Located in an alluvial fan on the Mancos Shale at an elevation of approximately 6100 feet. Stream reach is ephemeral by definition (See Appendix 7-7& Plate 7-4). The wash above and below flows only as a result of spring run-off or storm events.

**General:** The Sunnyside coal seam does not exist in this location. Since this site is located off the permit area and subsidence is not a possibility, there is no potential for Lila Canyon Mine to negatively affect this monitoring location. The permittee has never observed amphibians at or near this location.

**Vegetation description:** This dry channel monitoring location is surrounded by a Pinyon-Juniper overstory. Vegetation within the ephemeral acting channel is a mix of sagebrush, salt desert shrub and invasive tamarisk habitats.

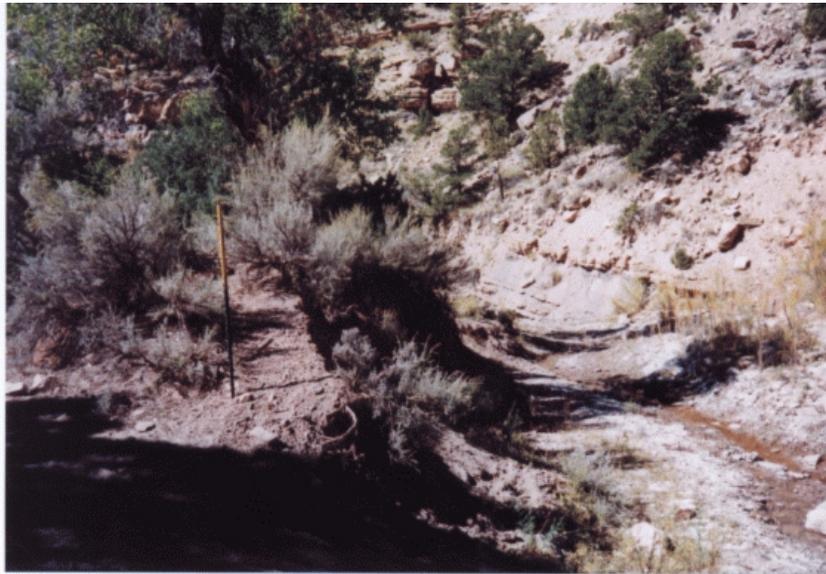
## HC-1 Horse Canyon Above Permit Area

**Location:** HC-1 is located in Horse Canyon Wash within the permit area, near the Carbon Emery county lines. Located in the Upper Price River Formation at an elevation of 6480 feet. Flow appears to be perennial due to spring inflow in the immediate area. Stream reach below this monitoring point is intermittent by definition but exhibits ephemeral flow patterns. The wash above and below flows only as a result of spring run-off or storm events.

**General:** The coal seam has been previously mined at this location. The monitoring location lies approximately 300 feet above the mined out Sunnyside coal seam. There is no potential for Lila Canyon Mine to negatively impact this monitoring location. The permittee has never observed amphibians at or near this location.

**Vegetation description:** This wet channel monitoring location is surrounded by mature sagebrush and Pinyon-Juniper habitats. Invasive tamarisk is present within the channel.

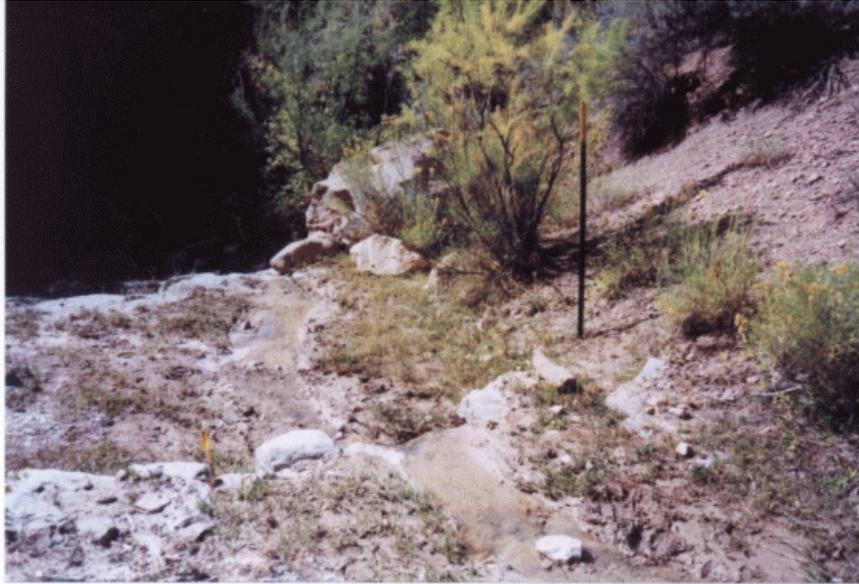
## RF-1 Right Fork

**Location:** RF-1 is located In the right fork of Horse Canyon Wash near the road forks but within the permit area. Located in the Upper Price River Formation at an elevation of 6480 feet. Flow appears to be perennial due to Redden Spring inflow. Flow continues for approximately 300 feet below the monitoring location where the stream reach becomes ephemeral. The wash 700 feet below flows only as a result of spring run-off or storm events.

**General:** The coal seam has been previously mined at this location. The monitoring location lies approximately 300 feet above the mined out Sunnyside coal seam. There is no potential for Lila Canyon Mine to negatively impact this monitoring location. The permittee has never observed amphibians at or near this location

**Vegetation description:** This wet channel monitoring location is surrounded by mature sagebrush and Pinyon-Juniper habitats. Invasive tamarisk is present within the channel.

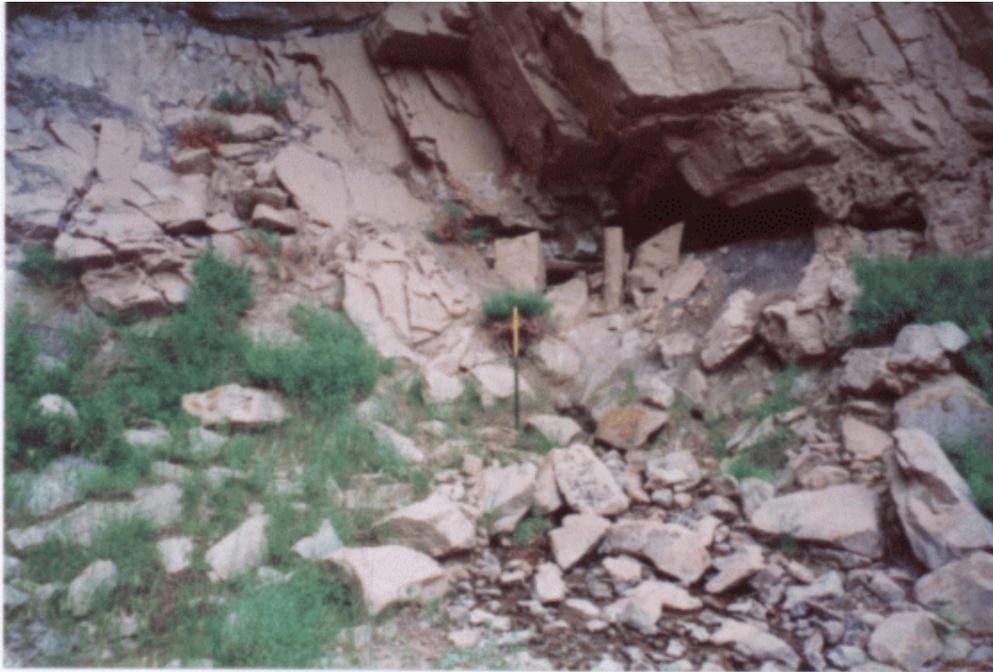
**RS-2**  
**Redden Spring**

**Location:** Redden Spring is located in the right fork of Horse Canyon Wash near the road forks but within the permit area. Located at the base of the Flagstaff/North Horn Formation at an elevation of 6592 feet. The wash above flows only as a result of spring run-off or storm events.

**General:** The coal seam has been previously mined at this location. The monitoring location lies approximately 800 feet above the mined out Sunnyside coal seam. There is no potential for Lila Canyon Mine to negatively impact this monitoring location. The permittee has never observed amphibians at or near this location.

**Vegetation description:** Habitat immediately below this wet seep monitoring site is a mix of grasses and salt desert shrub habitat.
