APPENDIX 7-7

Surface Water Characterizations

UtahAmerican Energy, Inc.

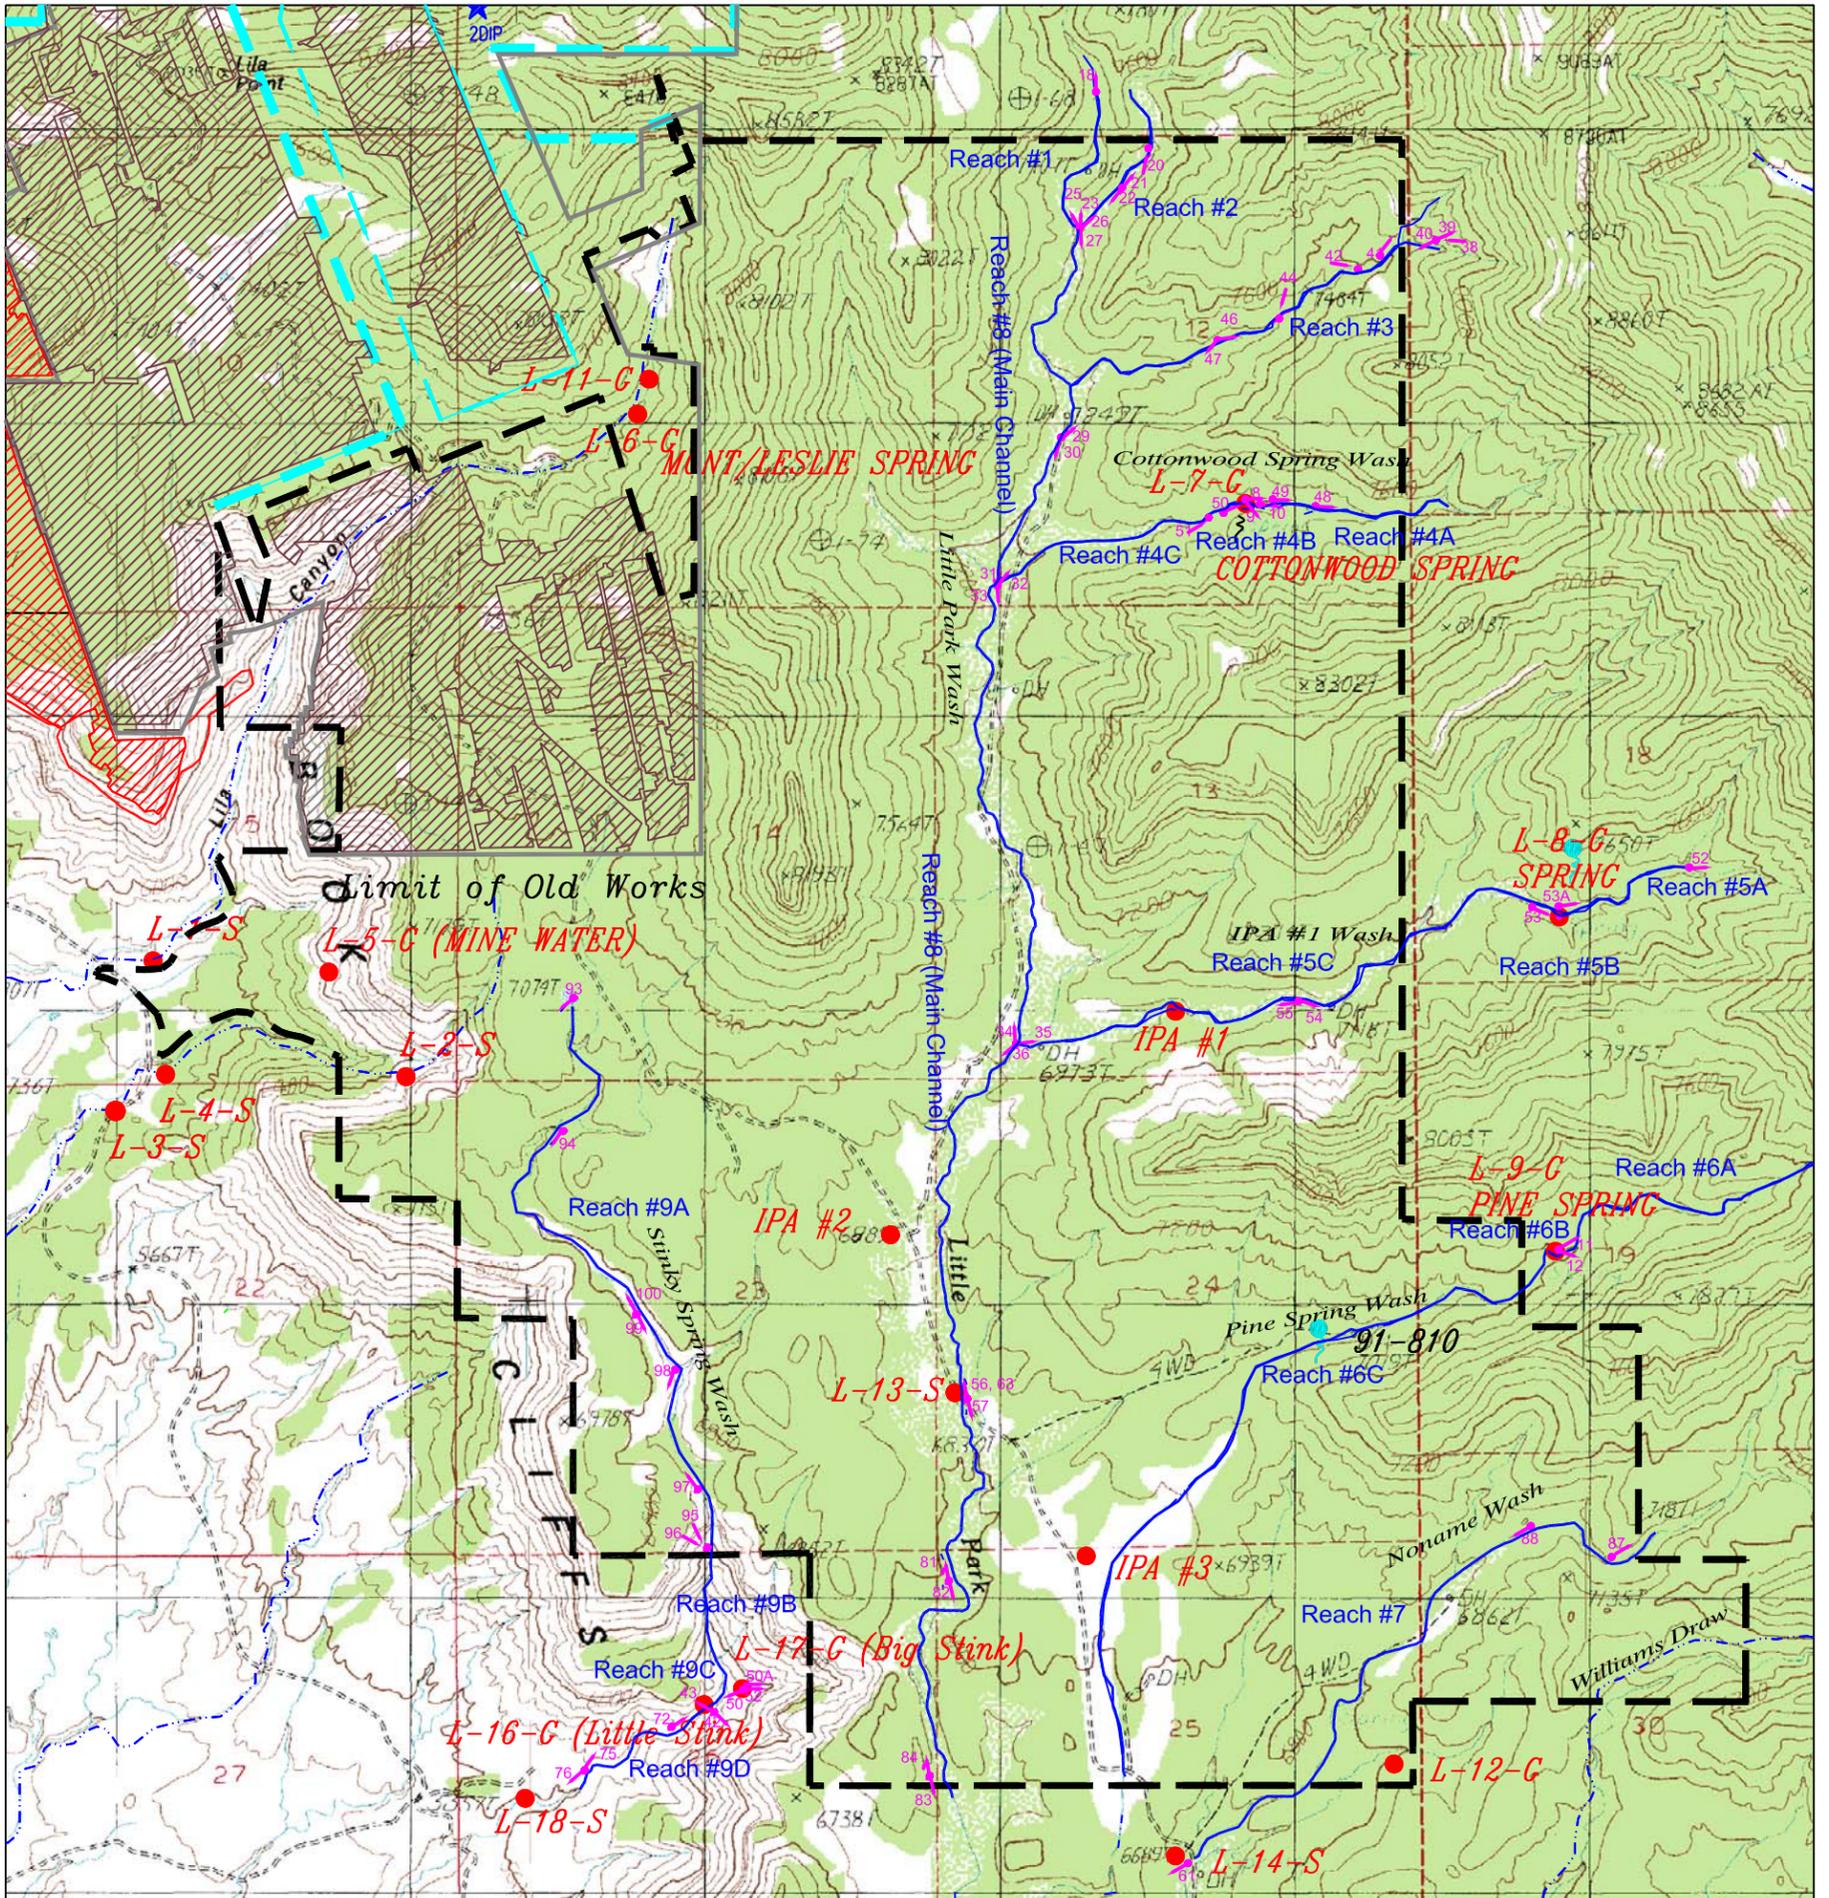
Appendix 7-7
Figure 1
All Stream Reaches

Photo Locations in Magenta

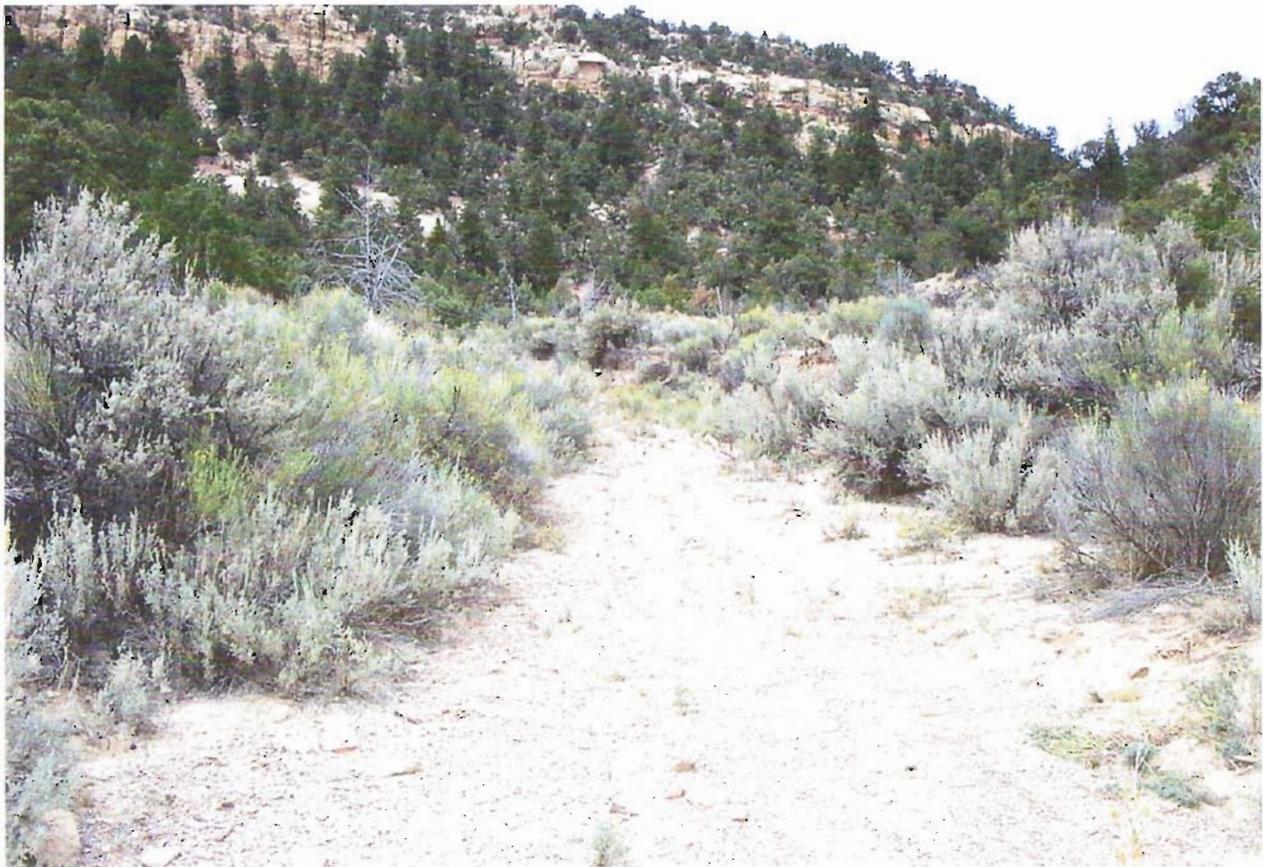
Reach #1 can be described as being the Left Fork of the Left Fork of Little Park Wash. Reach #1 starts at the north boundary of the permit area at an elevation of 7480 feet and drops at a grade of 6.58 % to an elevation of 7,360 feet where it converges with Reach #2 forming the Main Little Park Wash. The 1,800 foot long channel is comprised mostly of sand and gravel with the sides being pinyon-juniper and sagebrush grass associations, with no riparian vegetation present. The full 1,800 feet has been classified as ephemeral acting. Fish and macro invertebrates are non existing within this reach.

Photographs 18 and 25, found in Attachment #1, depict the conditions found in reach #1.

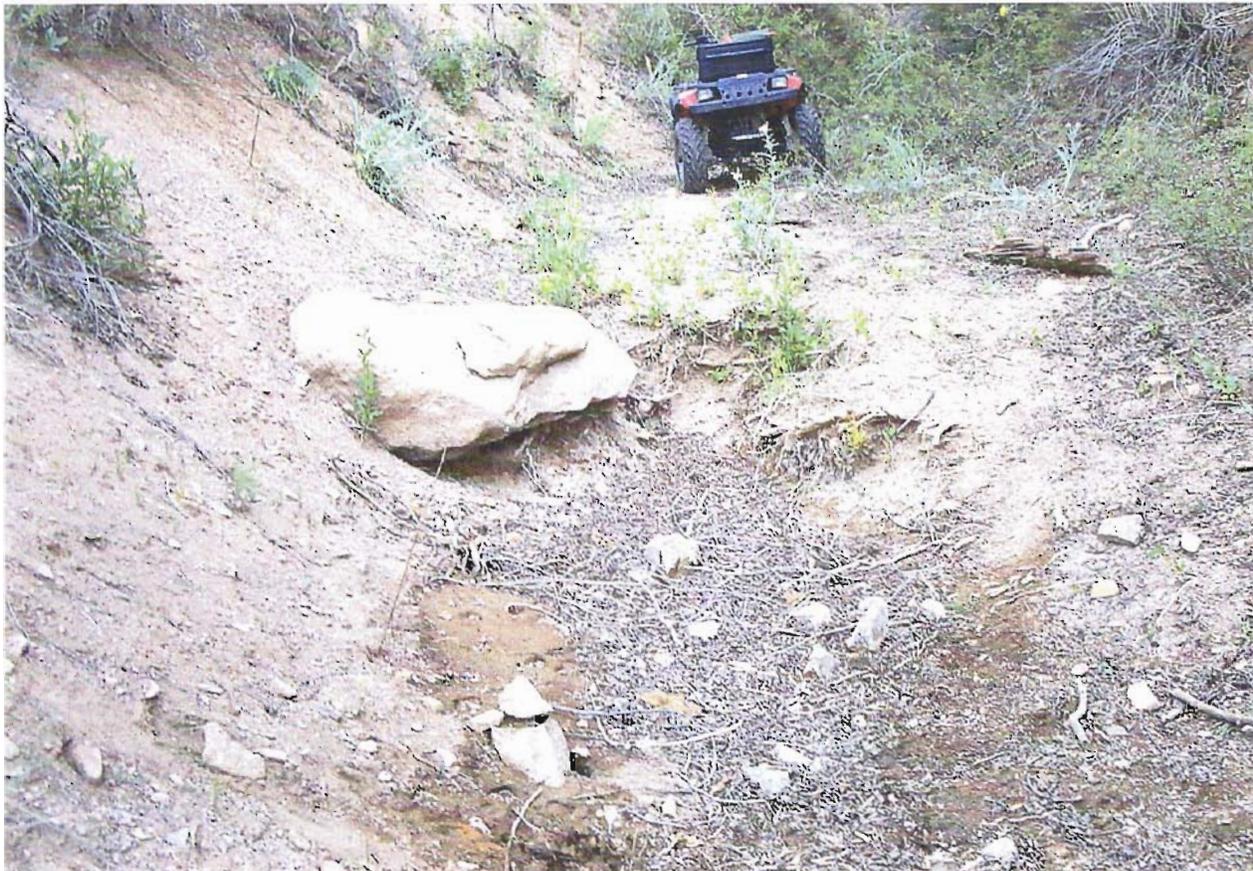
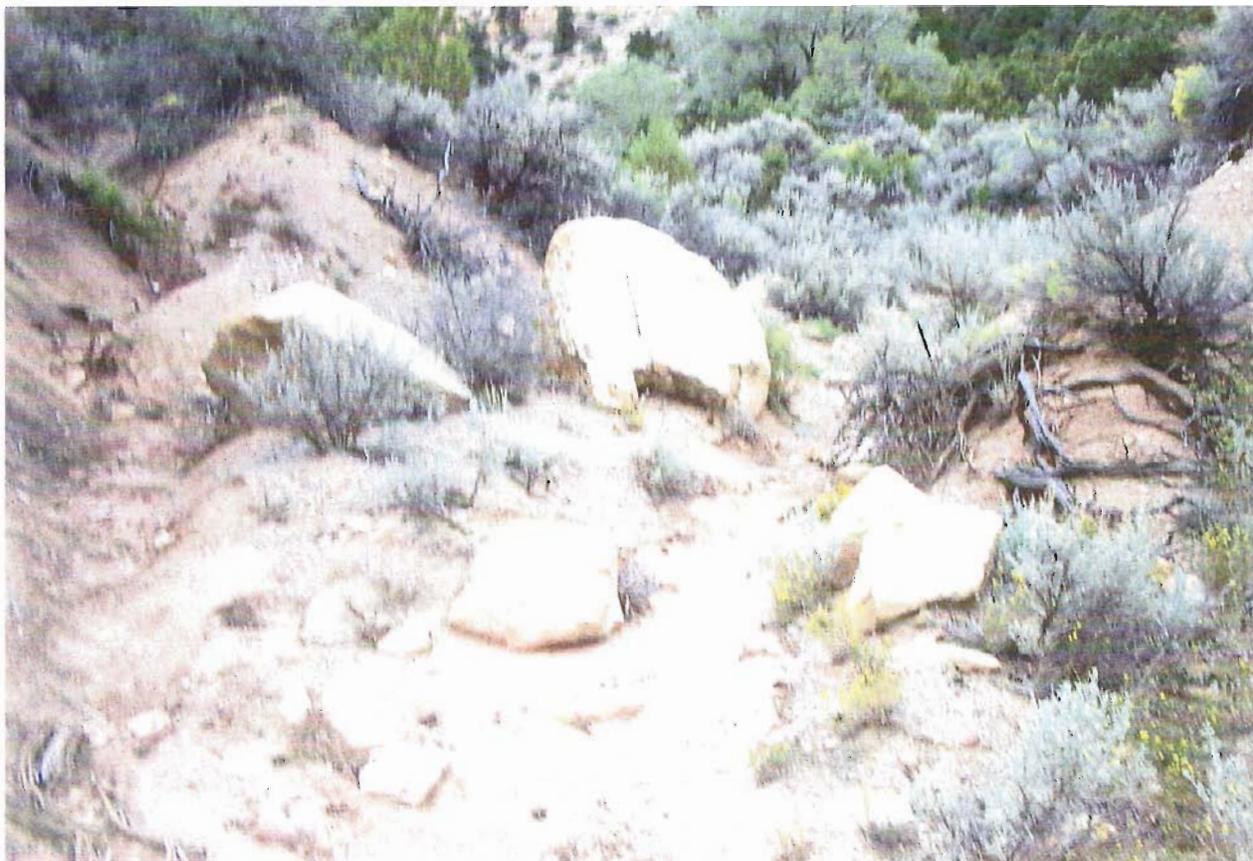
Reach #2, identified by the Operator, can be described as being the Right Fork of the Left Fork of Little Park Wash (Figure 1). Reach #2 starts at the north boundary of the permit area at an elevation of 7,500 feet and flows at a grade of 7.56 % to an elevation of 7360 feet where it converges with Reach #1 forming the Main Little Park Wash. The 1,900 foot long channel is comprised mostly of sand and gravel with the vegetation being mostly pinyon-juniper and sagebrush grass associations, with no riparian vegetation present. The full 1,900 feet has been classified as ephemeral acting. Fish and macro invertebrates are non existing within this reach.

Photographs 20,21,22, and 26, found in Attachment #1, depict the conditions found in Reach #2.

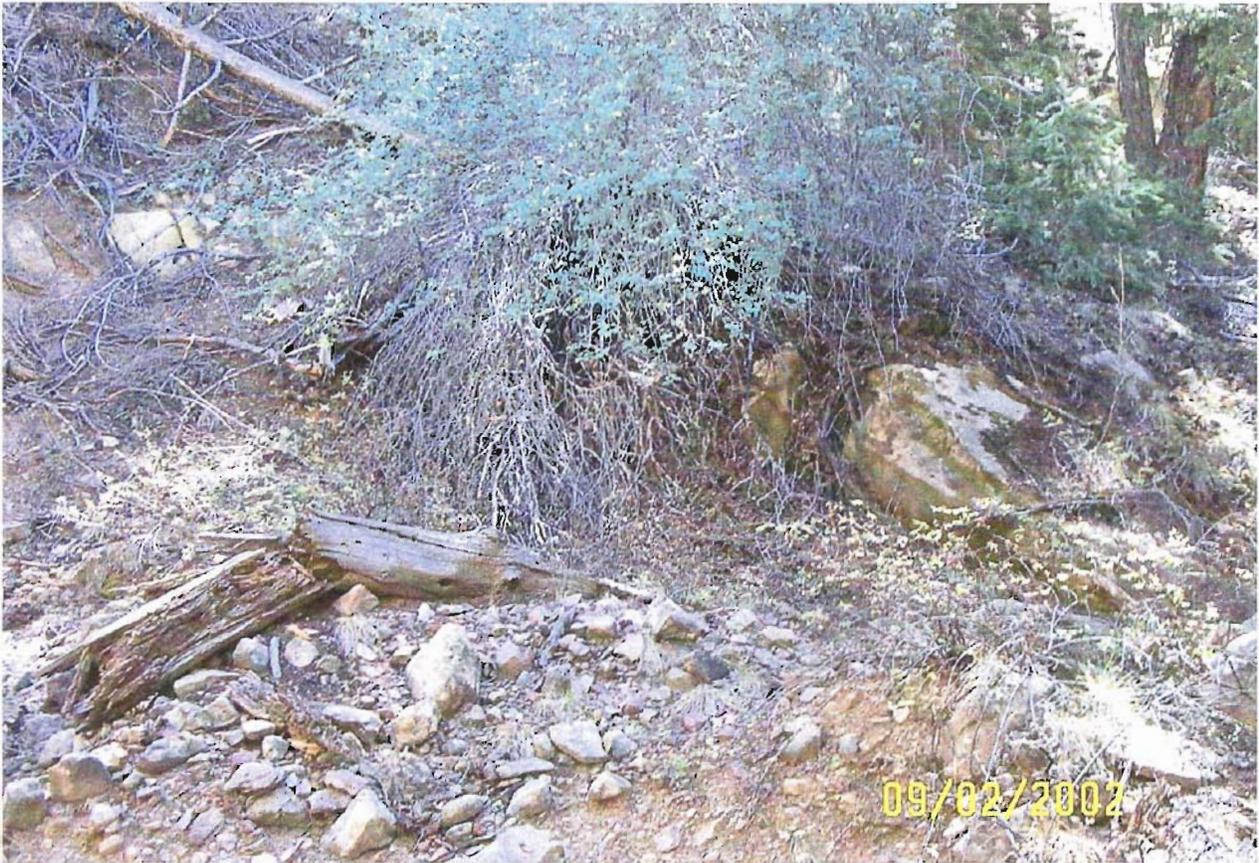
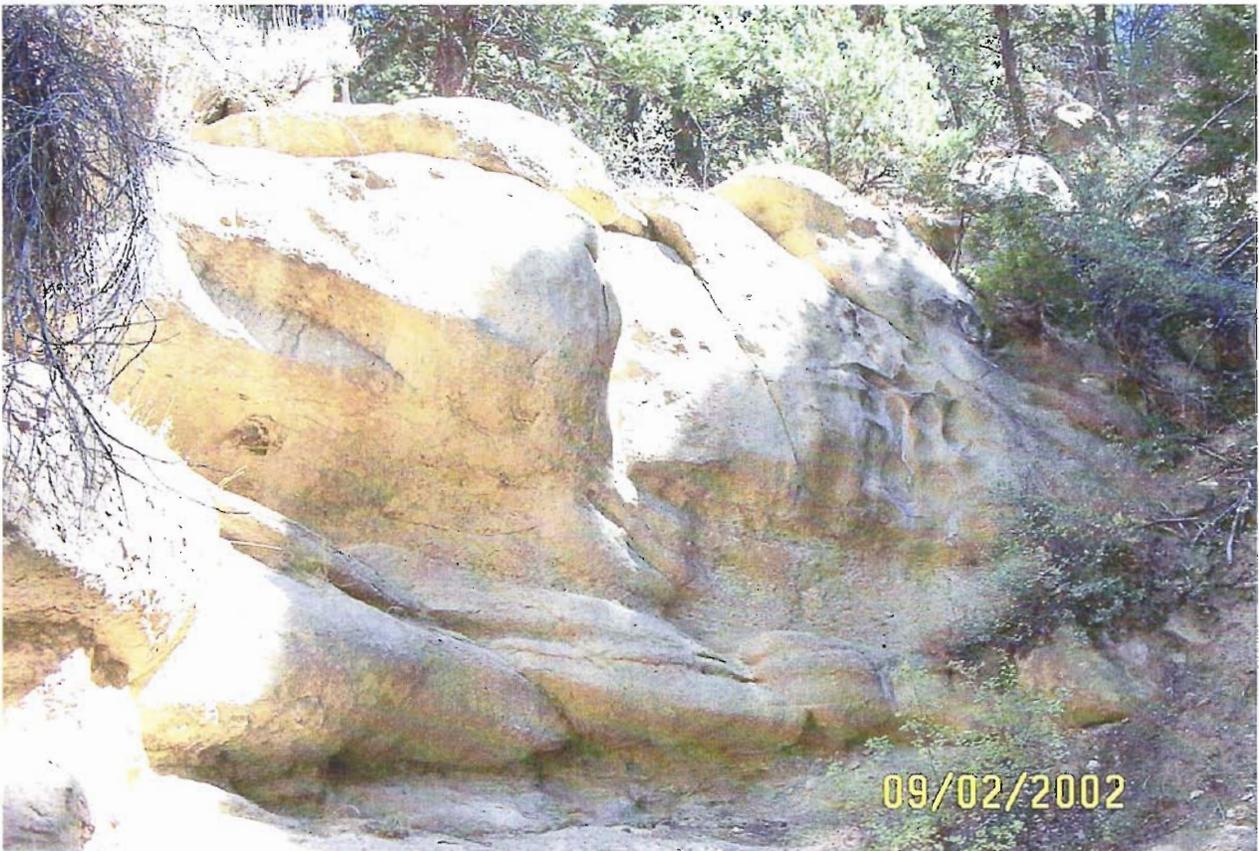
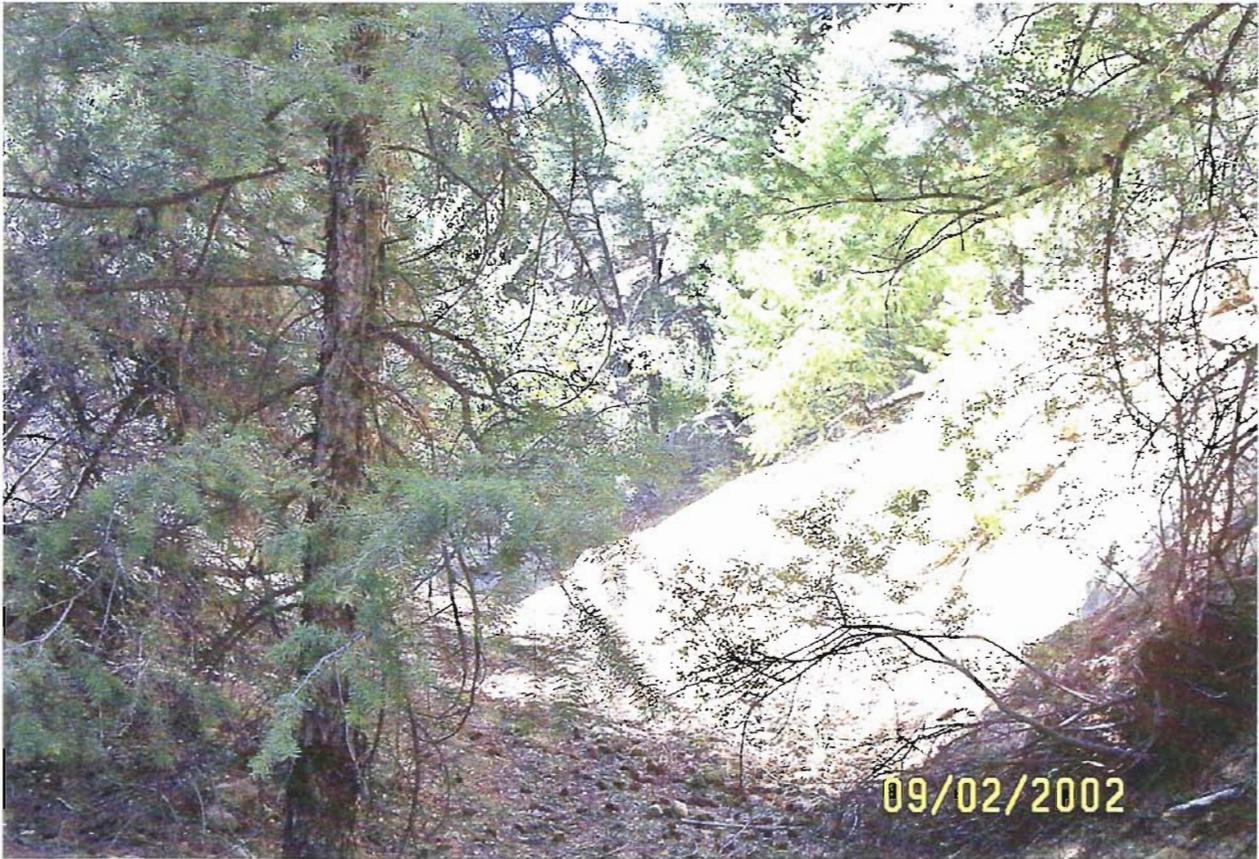
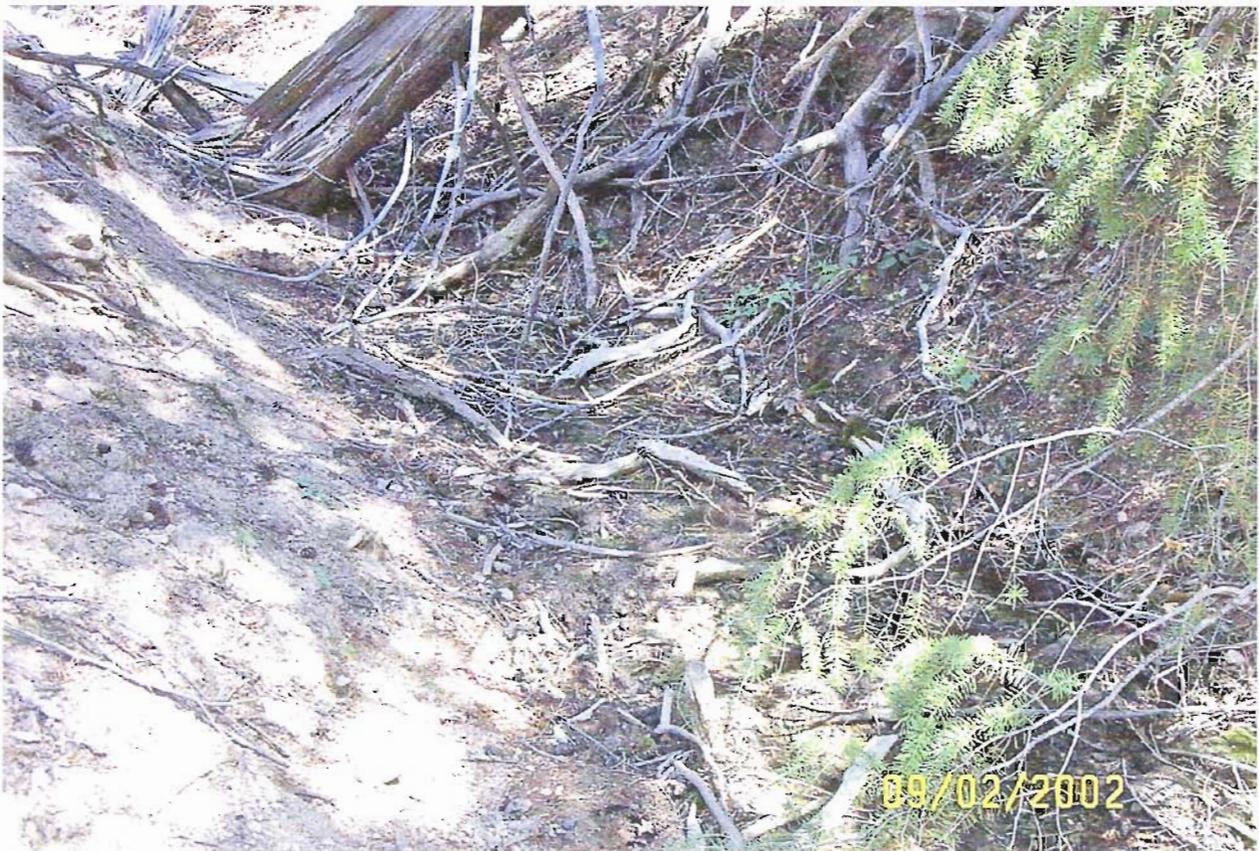
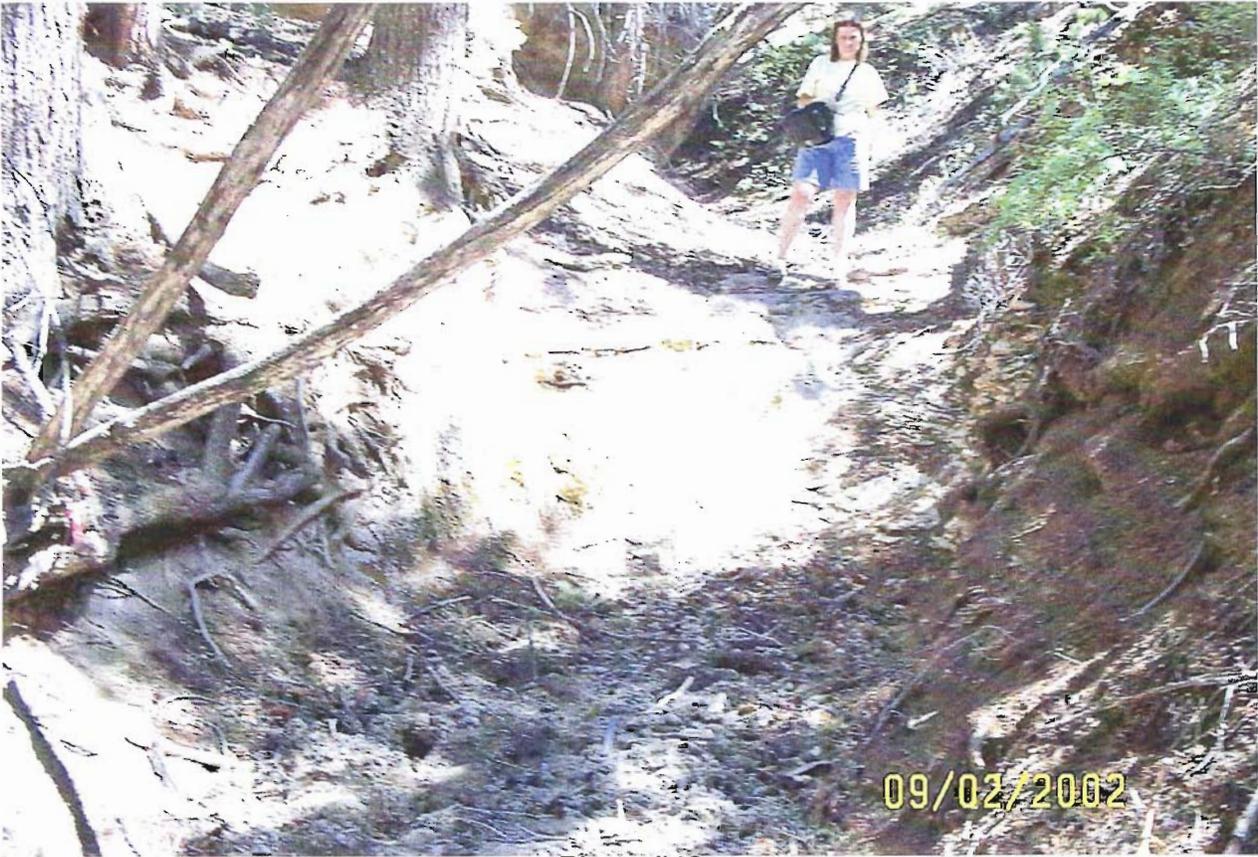
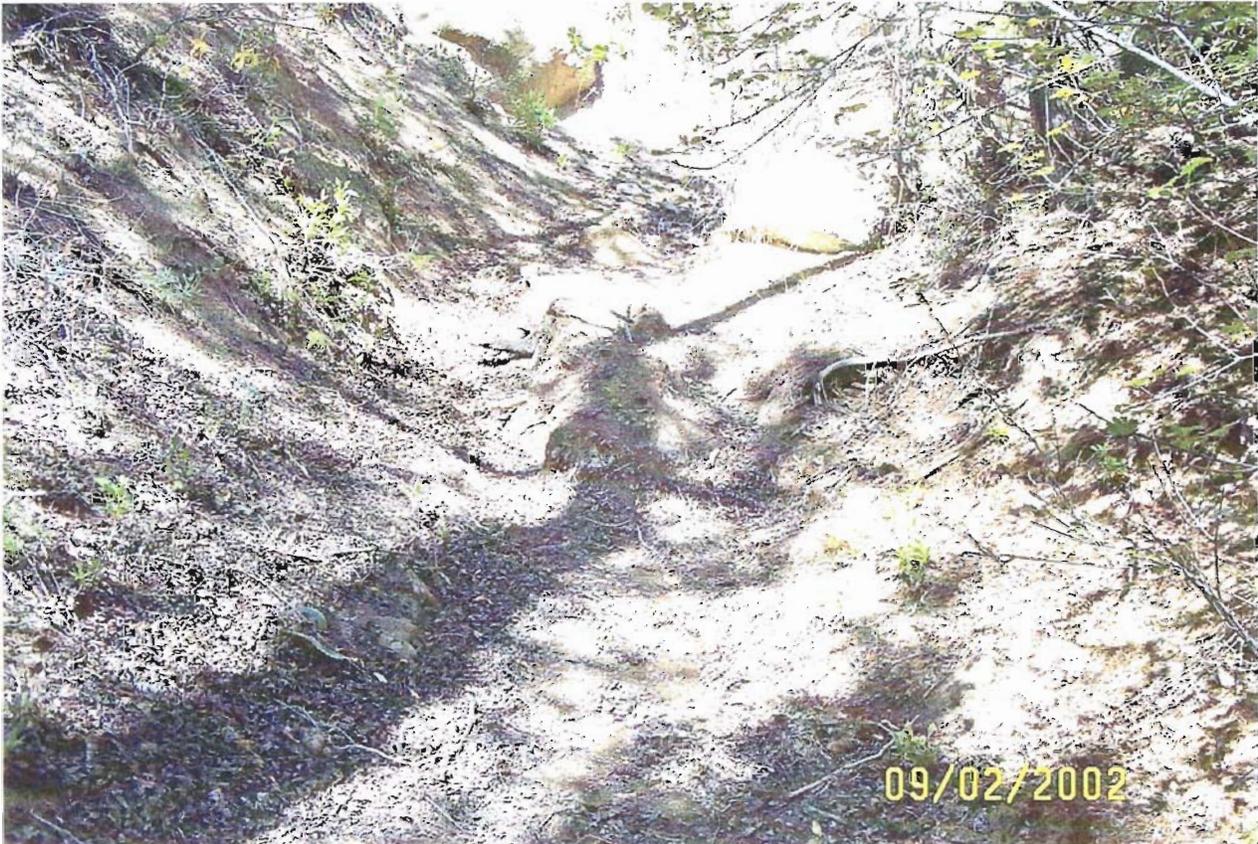
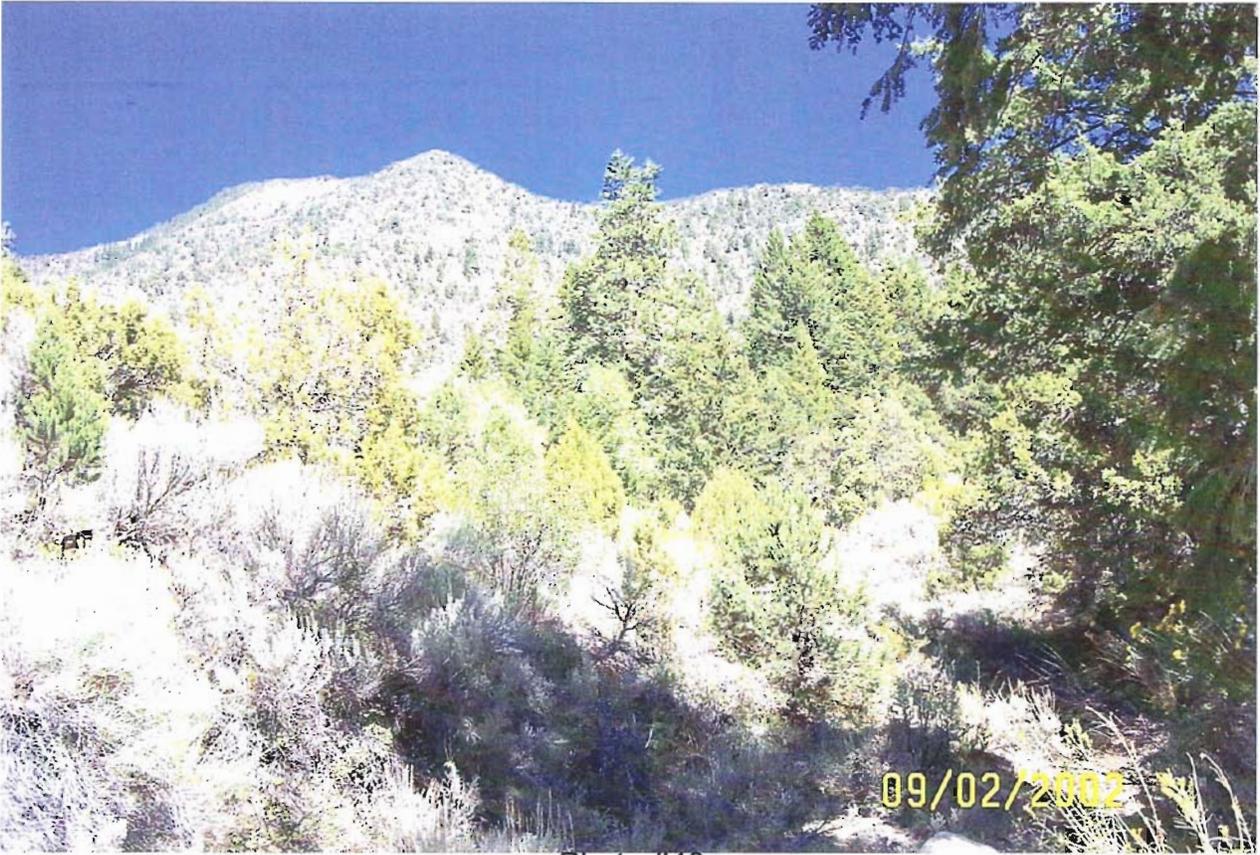
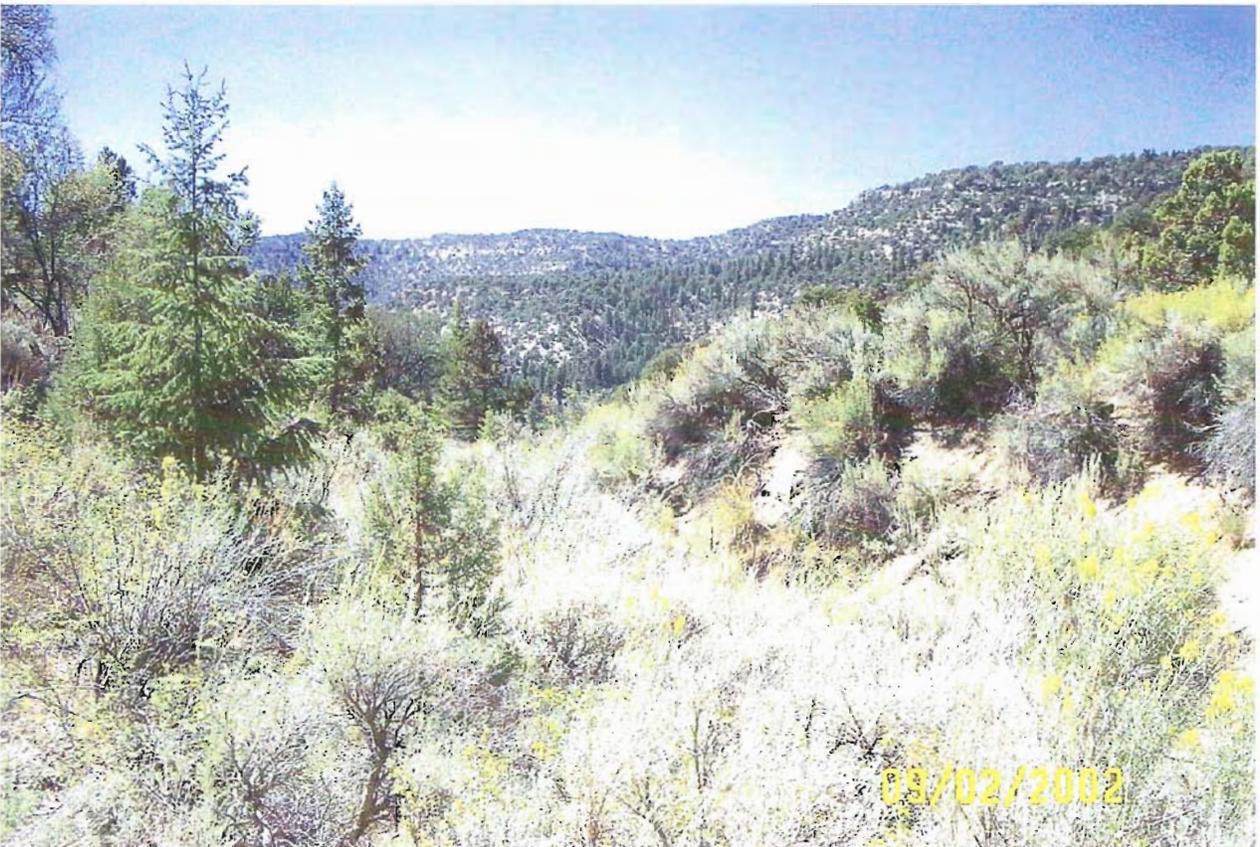
Reach #3, identified by the Operator, can be described as being the Right Fork of Little Park Wash. Reach #3 starts at the north east boundary of the permit area at an elevation of 7,750 feet and flows at a grade of 10.2% to an elevation of 7,270 feet where it converges with the Main Little Park Wash, Reach #8 (Table 2). The 4,800 foot long channel is comprised mostly of sand and gravel with the upper sections being Douglas Fir and transgressing into pinyon-juniper and sagebrush grass associations, with no riparian vegetation present. The full 4,800 feet has been classified as ephemeral acting. Fish and macro invertebrates are non existing within this reach.

Photographs 38, 39, 40, 41, 42, 44, 46, and 47, found in Attachment #1, depict the conditions found in Reach #3.
