APPENDIX 7-7

Surface Water Characterizations

UtahAmerican Energy, Inc.

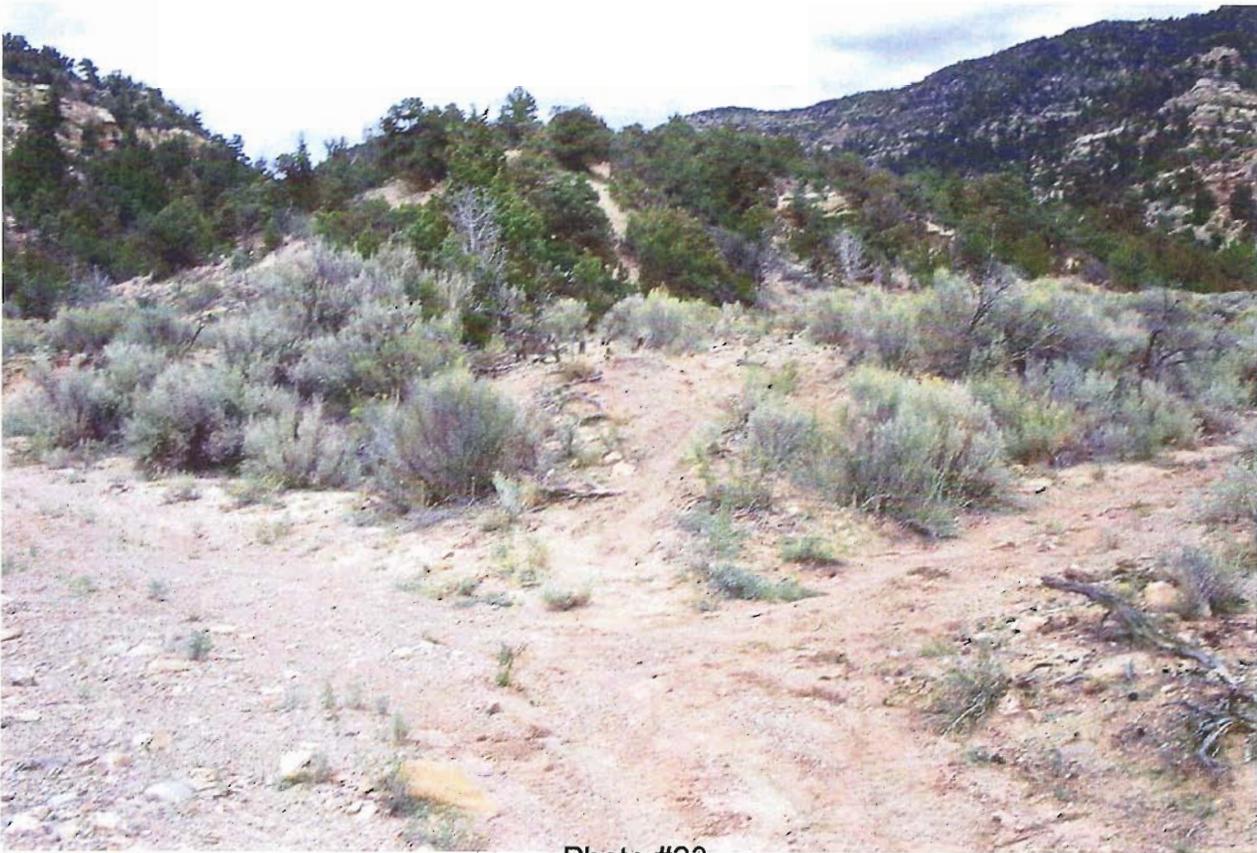
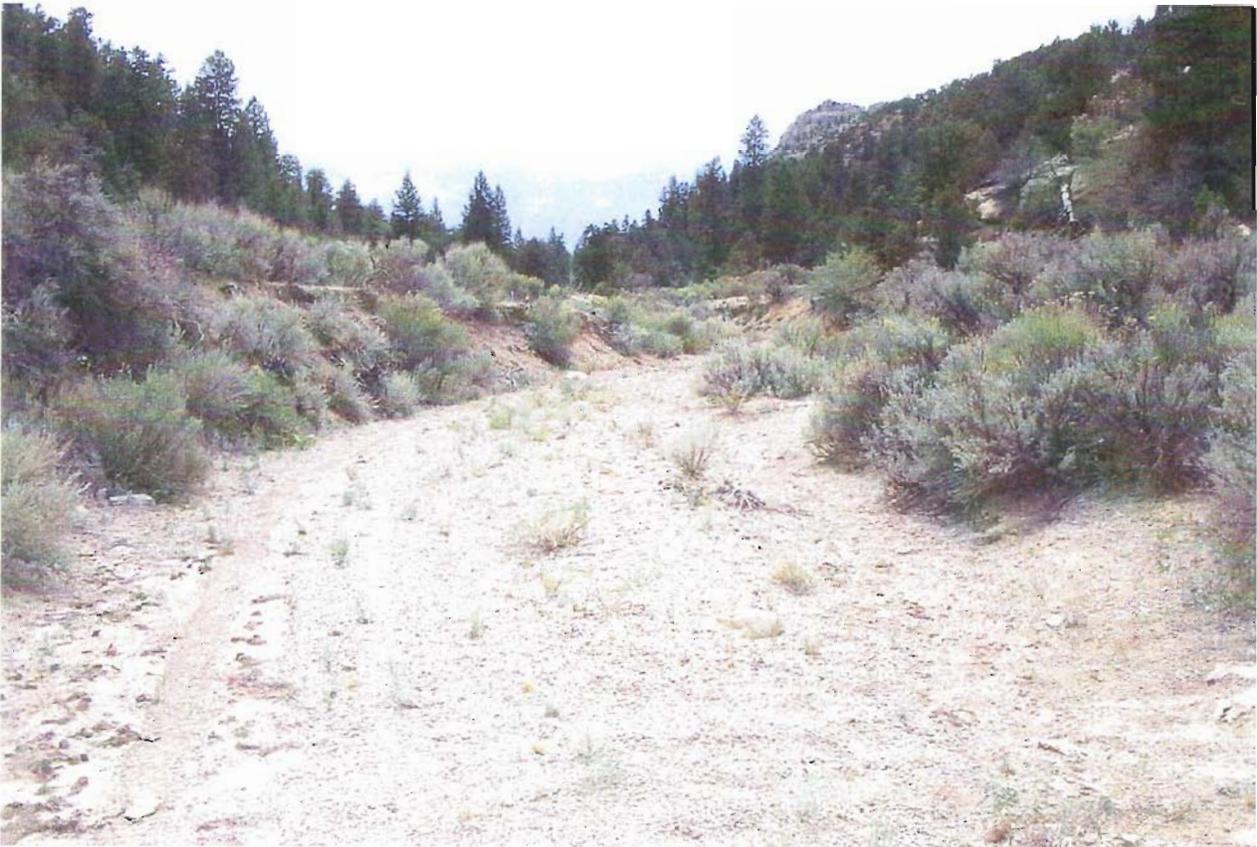
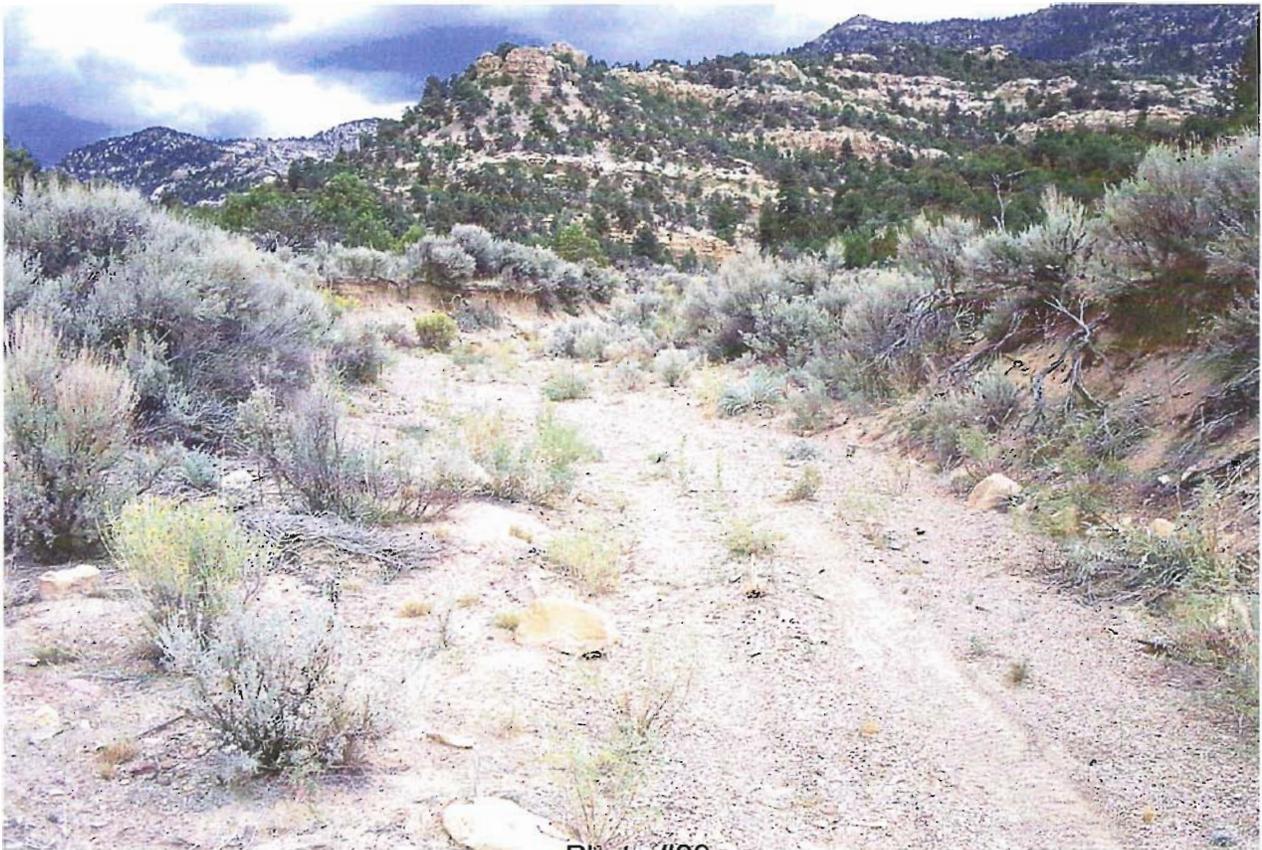
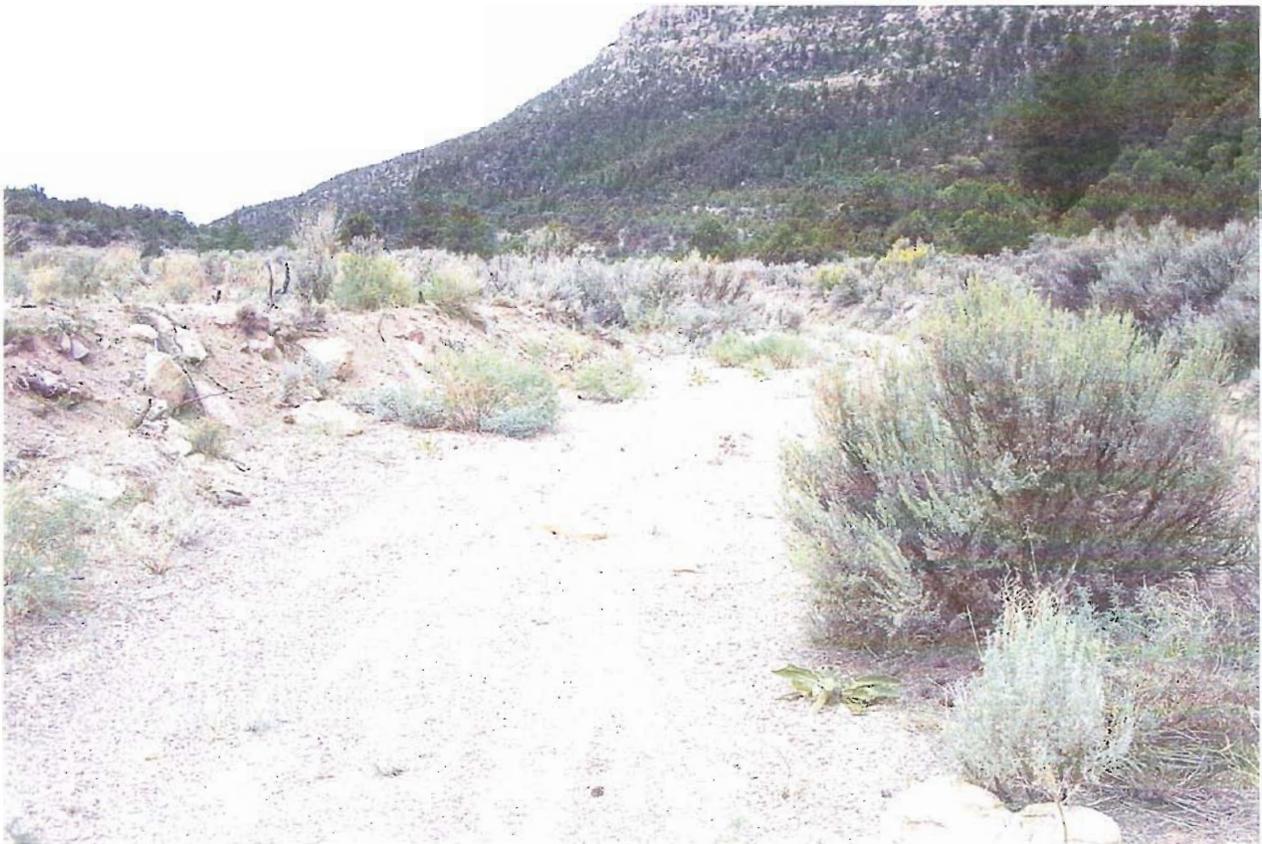
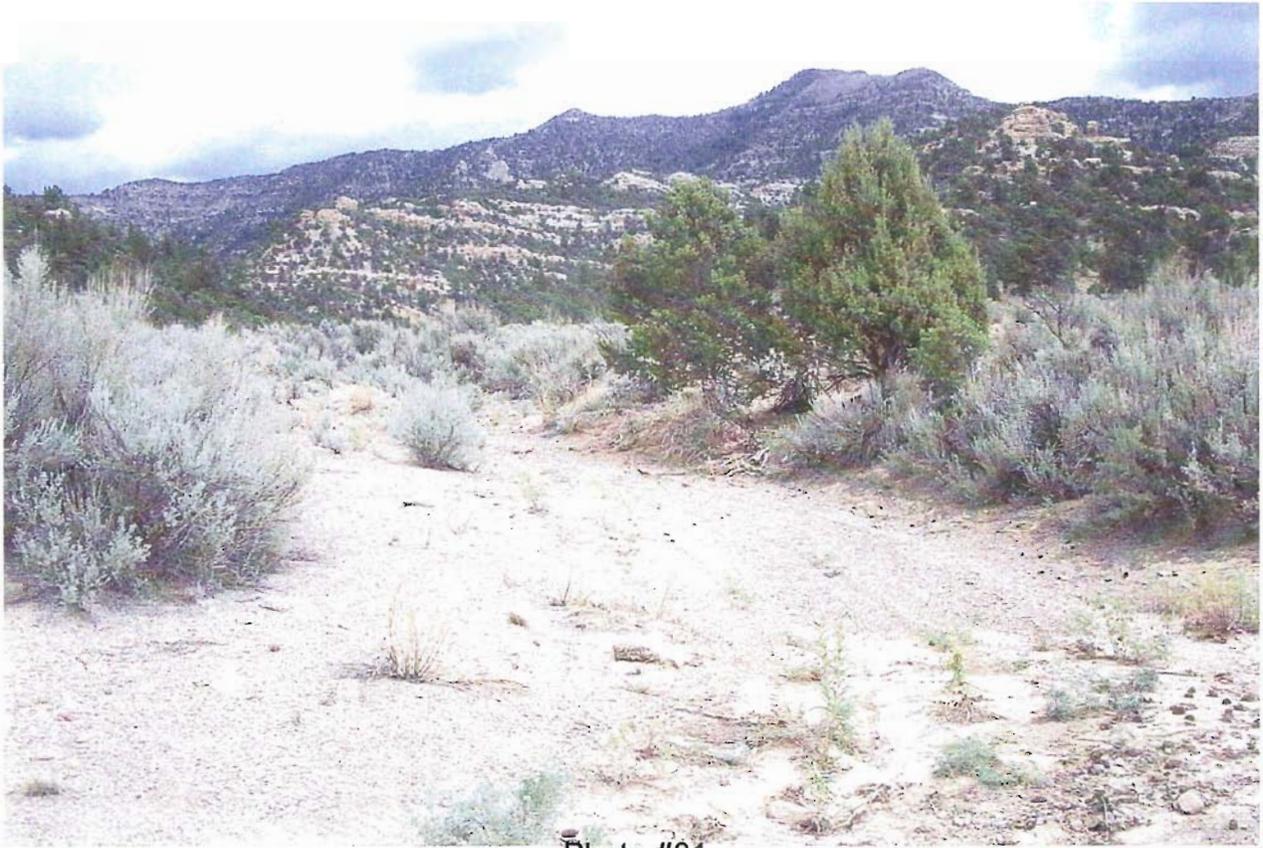
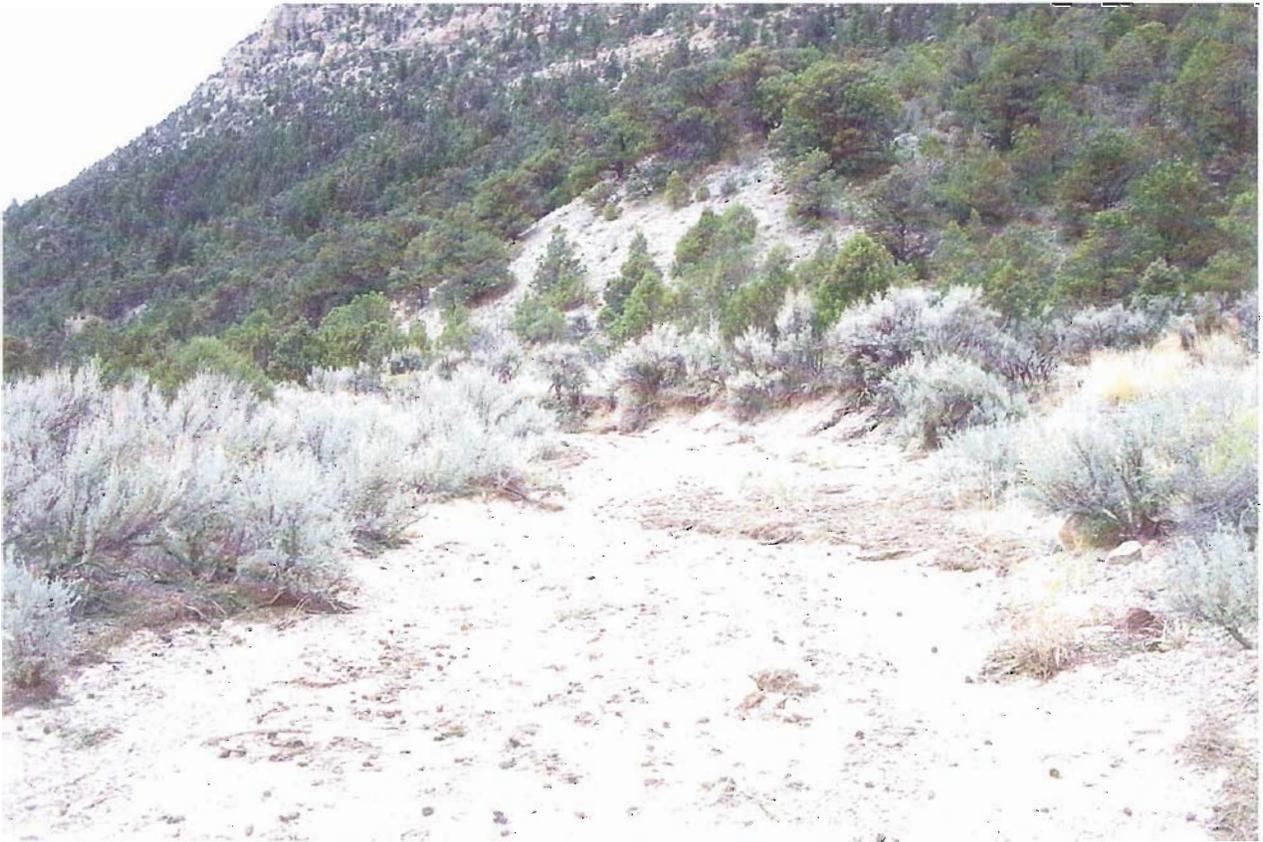
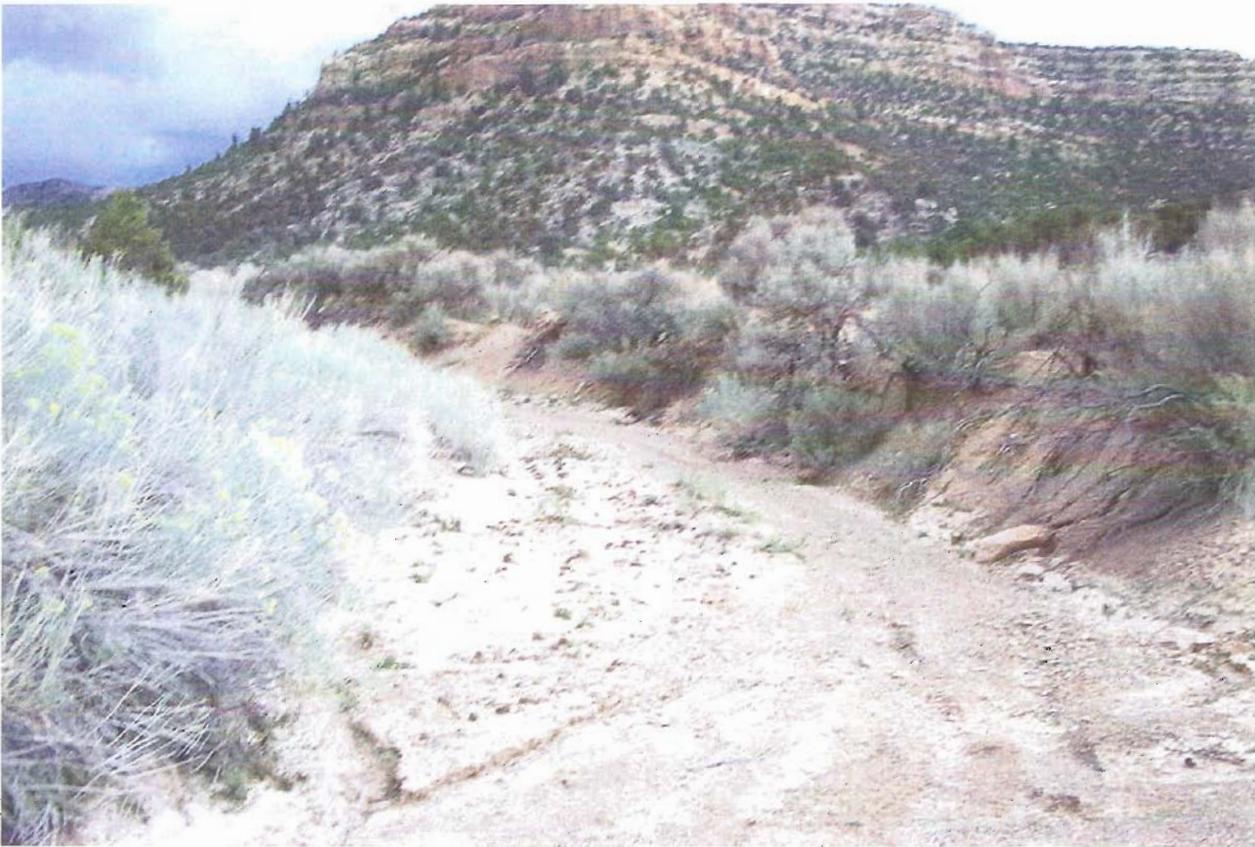
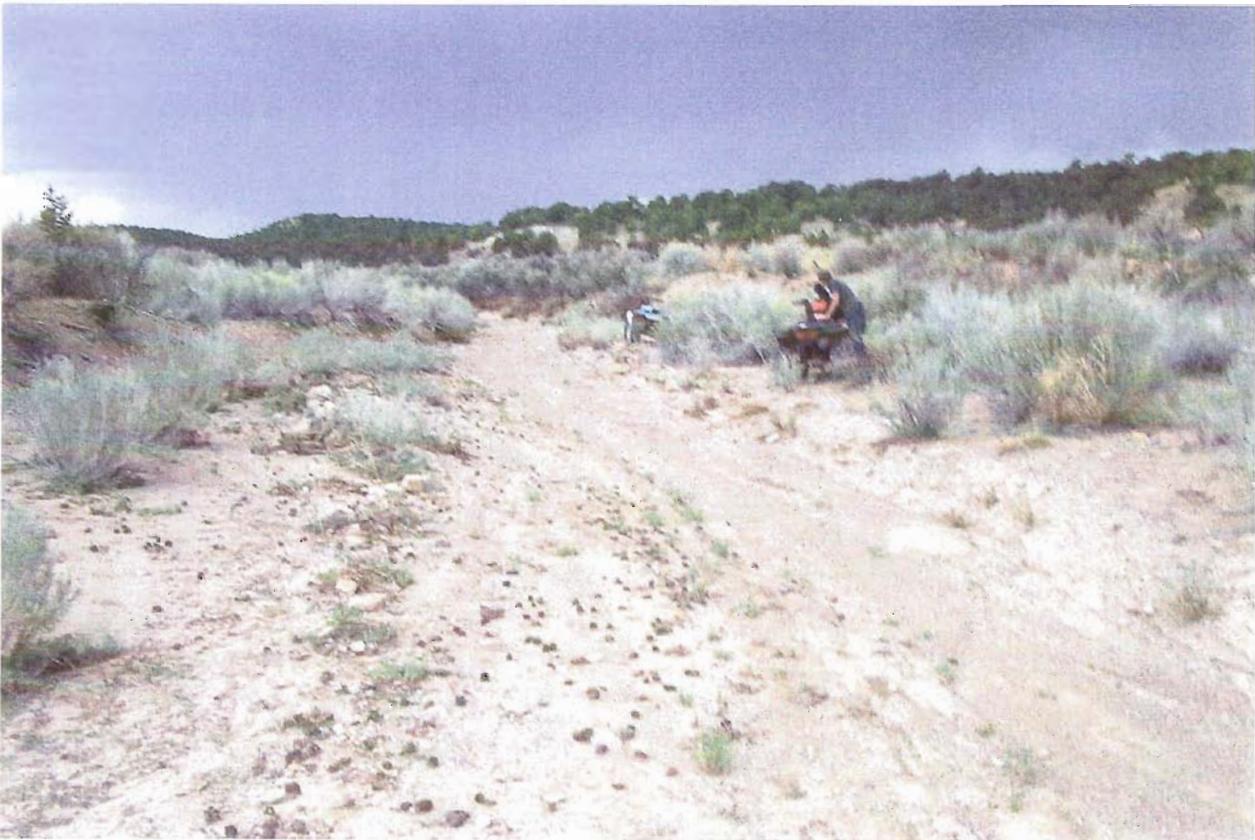
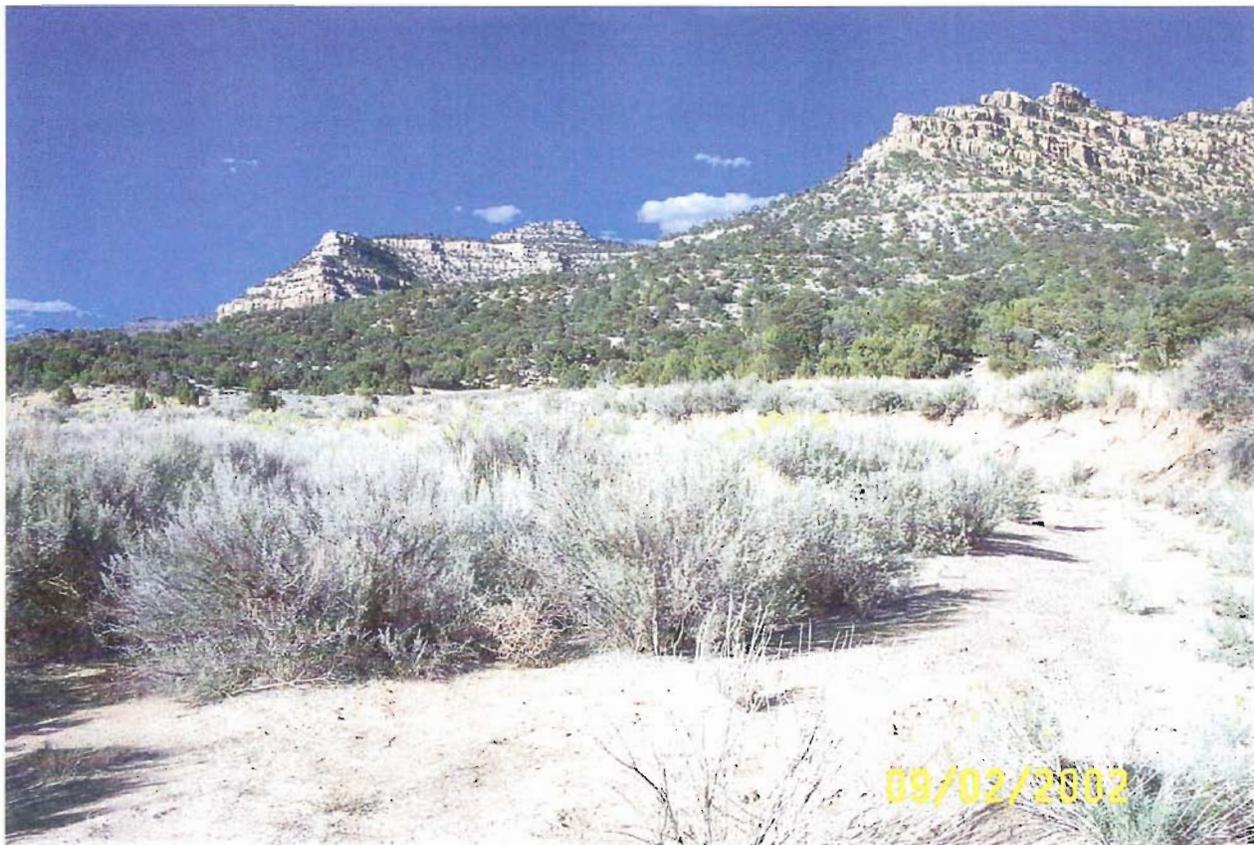
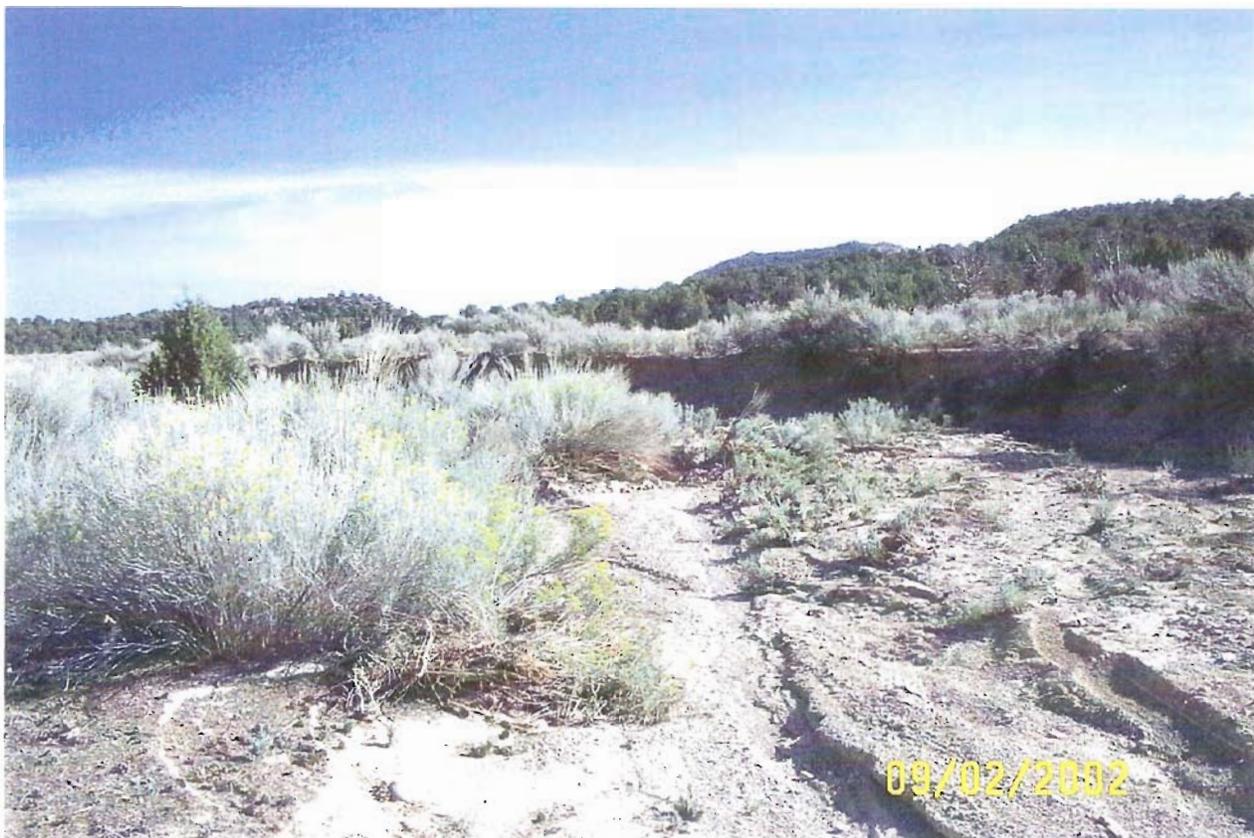
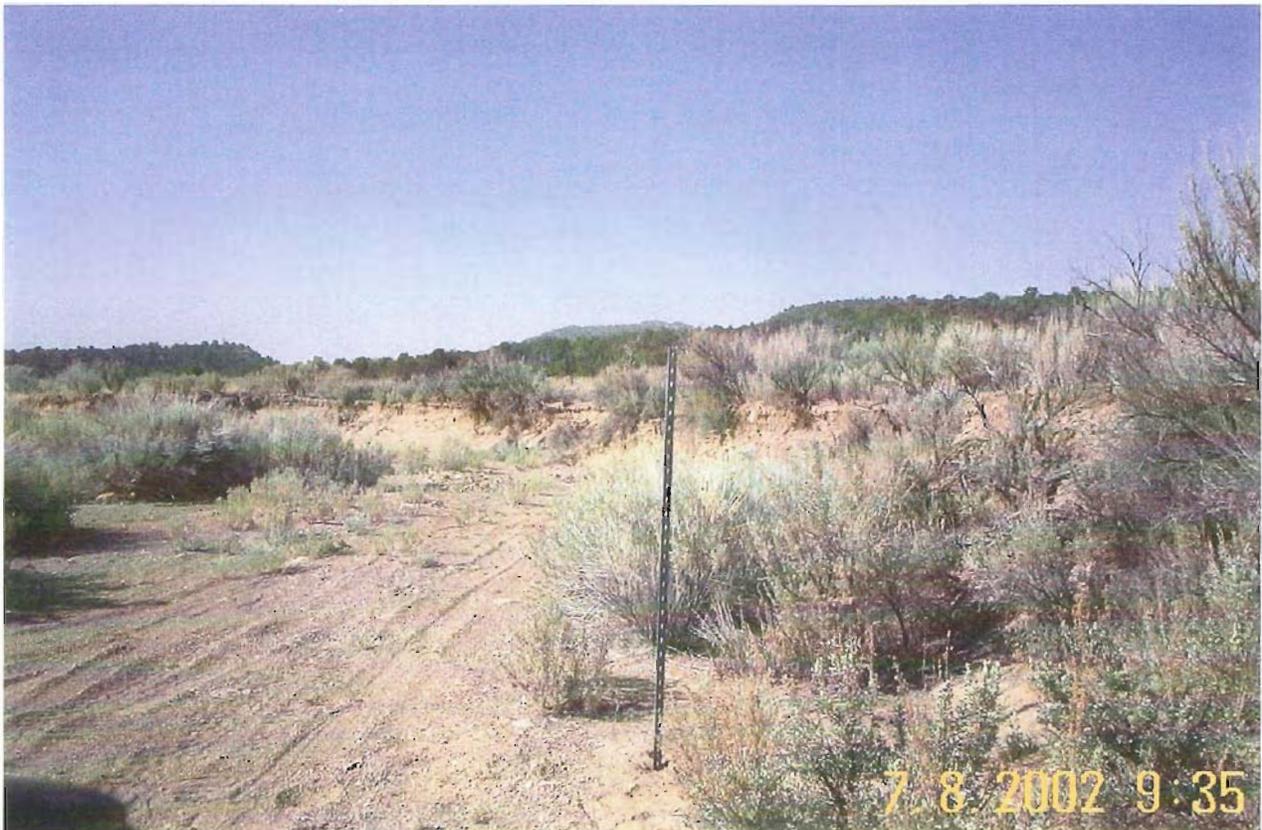
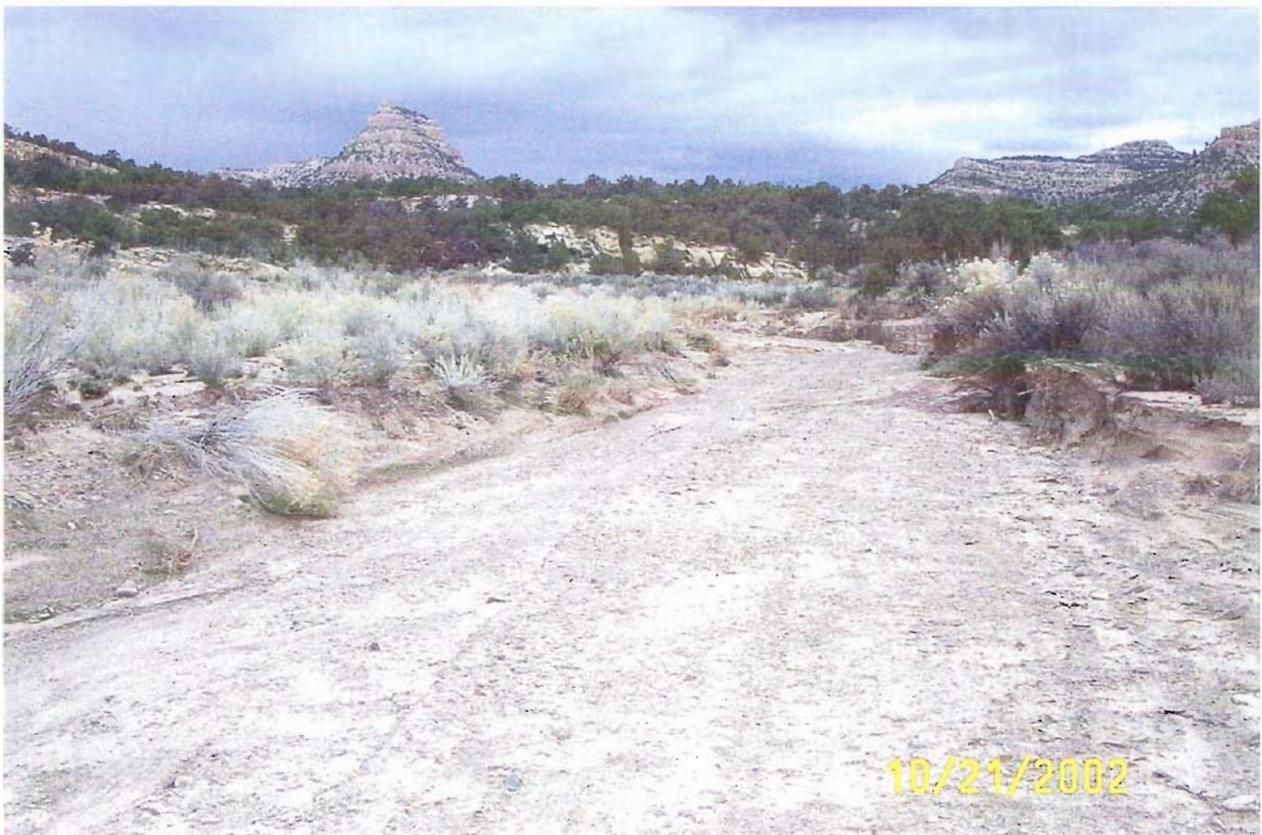
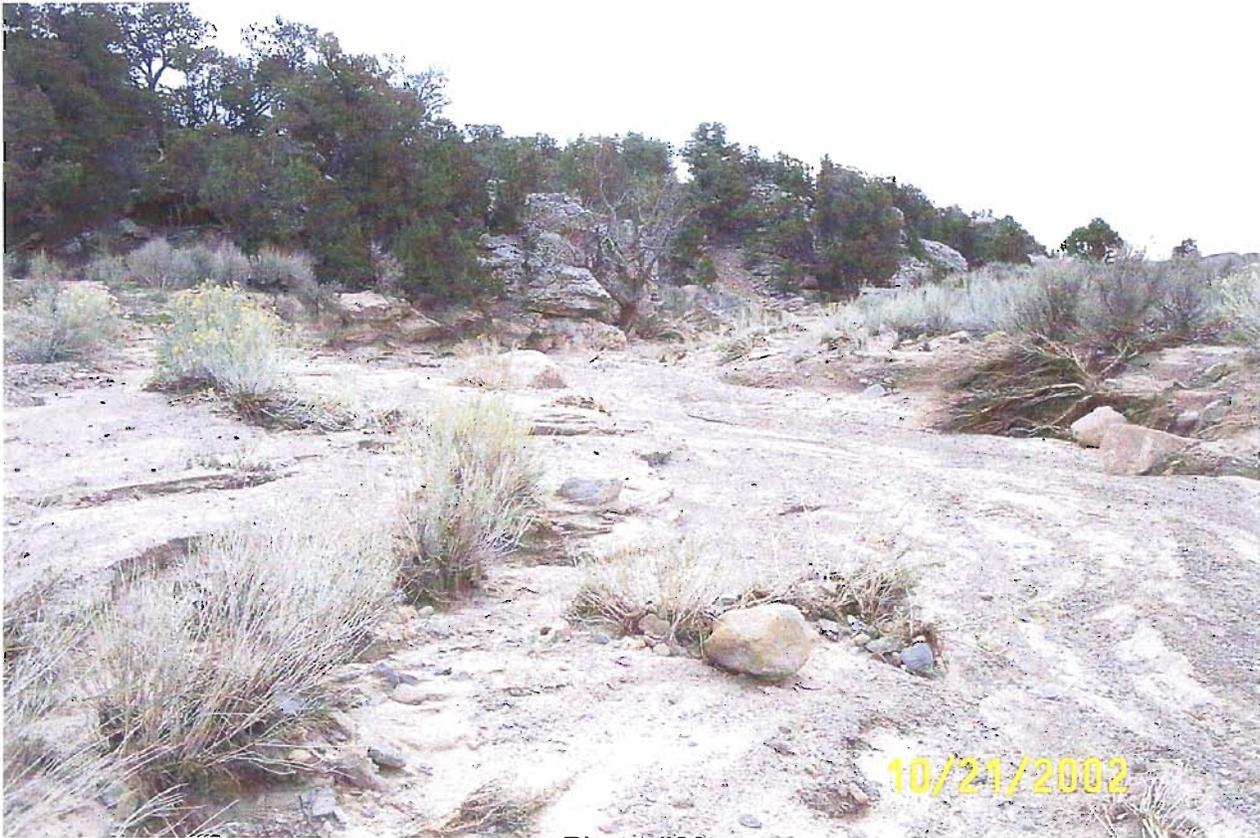
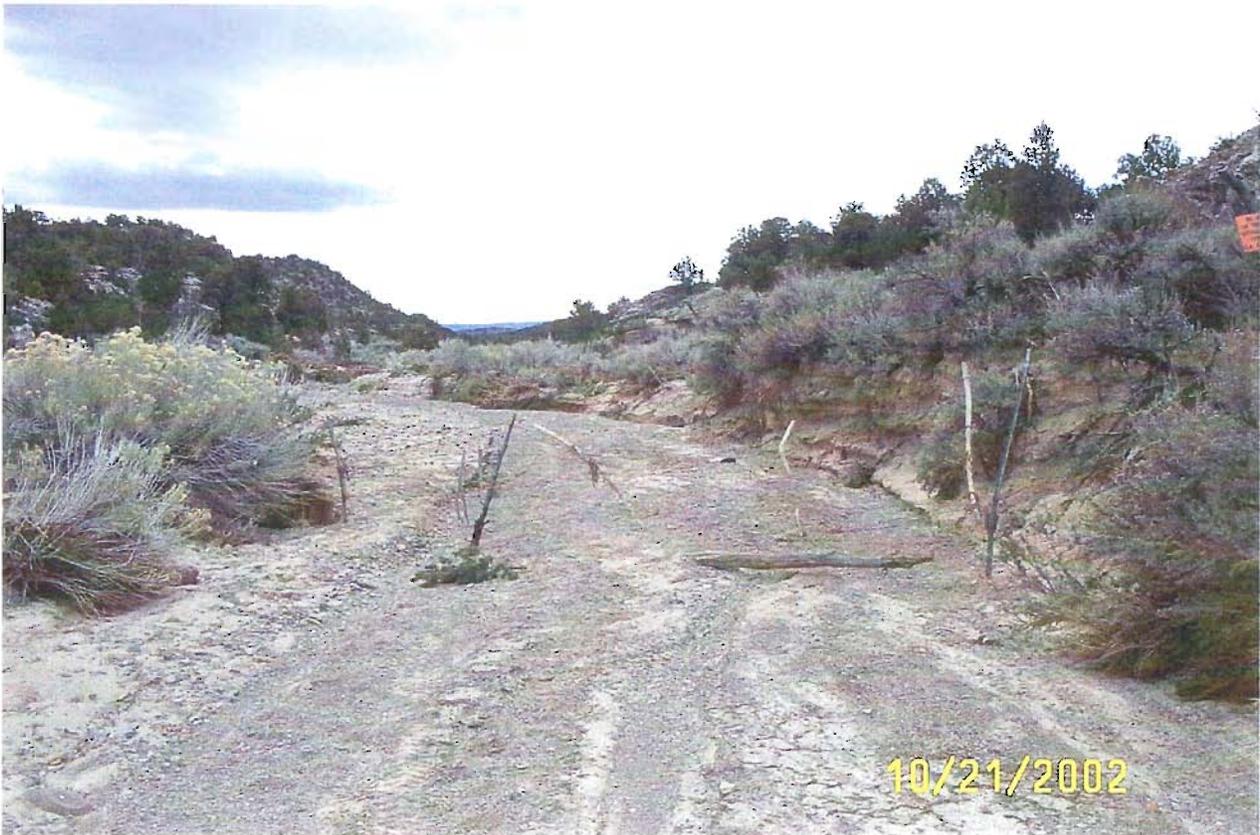
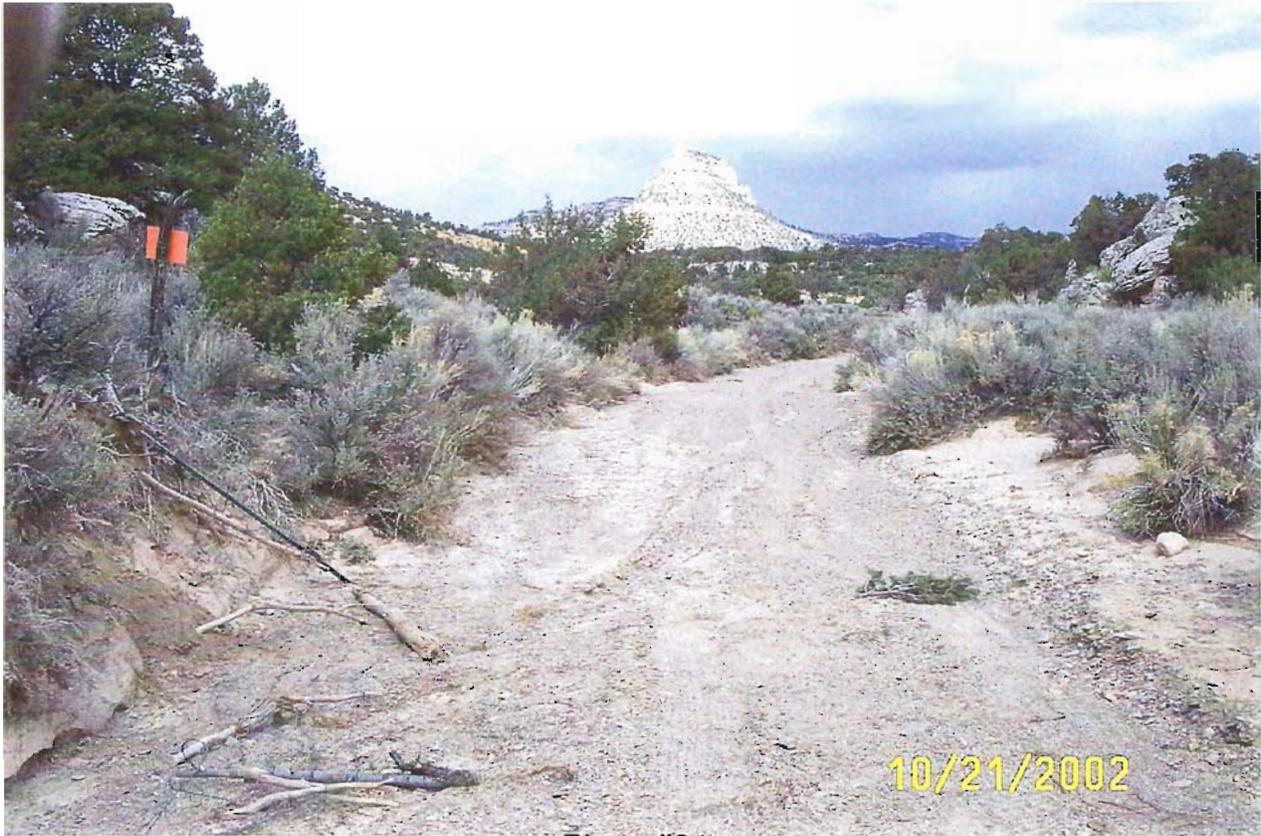
The Permittee has classified this drainage or stream reach as “Ephemeral” because of its vegetation types, tendency to flow only in response to storm events, and location above the local water table. Fish and macro invertebrates are non existing within this reach, with no riparian vegetation present.

Photographs 23, 27, 29, 30, 31, 33, 34, 36, 56, 57, 63, 81, 82, 83, and 84, found in Attachment #1, depict the conditions found in Reach #8.

The chance of subsidence negatively effecting this ephemeral channel is minimal. However, in the unlikely event that cracks, fissures or sink holes are observed as a result of subsidence the channel will be regraded, filling in the cracks, fissures or sinkholes by hand methods or light equipment depending upon inaccessibility. UEI will use the best available techniques available at the time of repair. Significant repairs may require seeding. UEI will notify the Division prior to any repair of seeps, springs, or drainages.

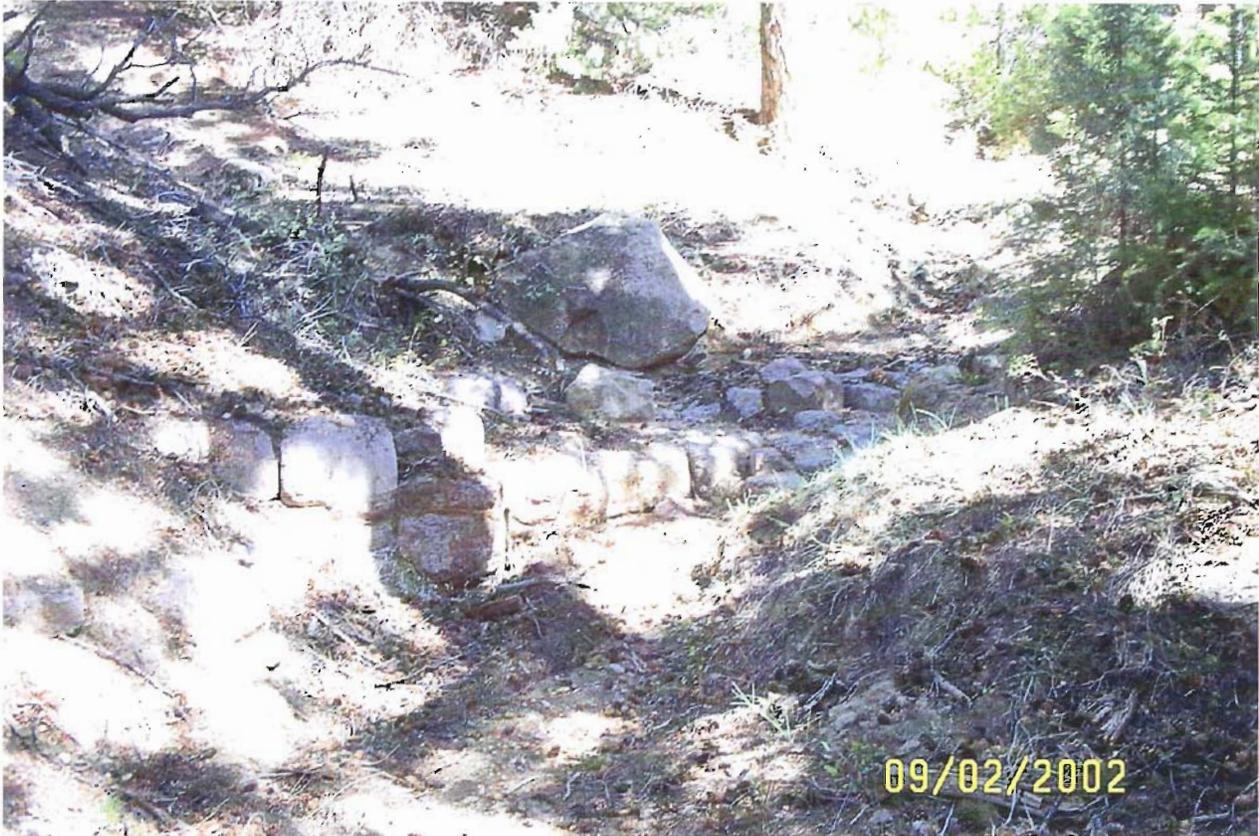
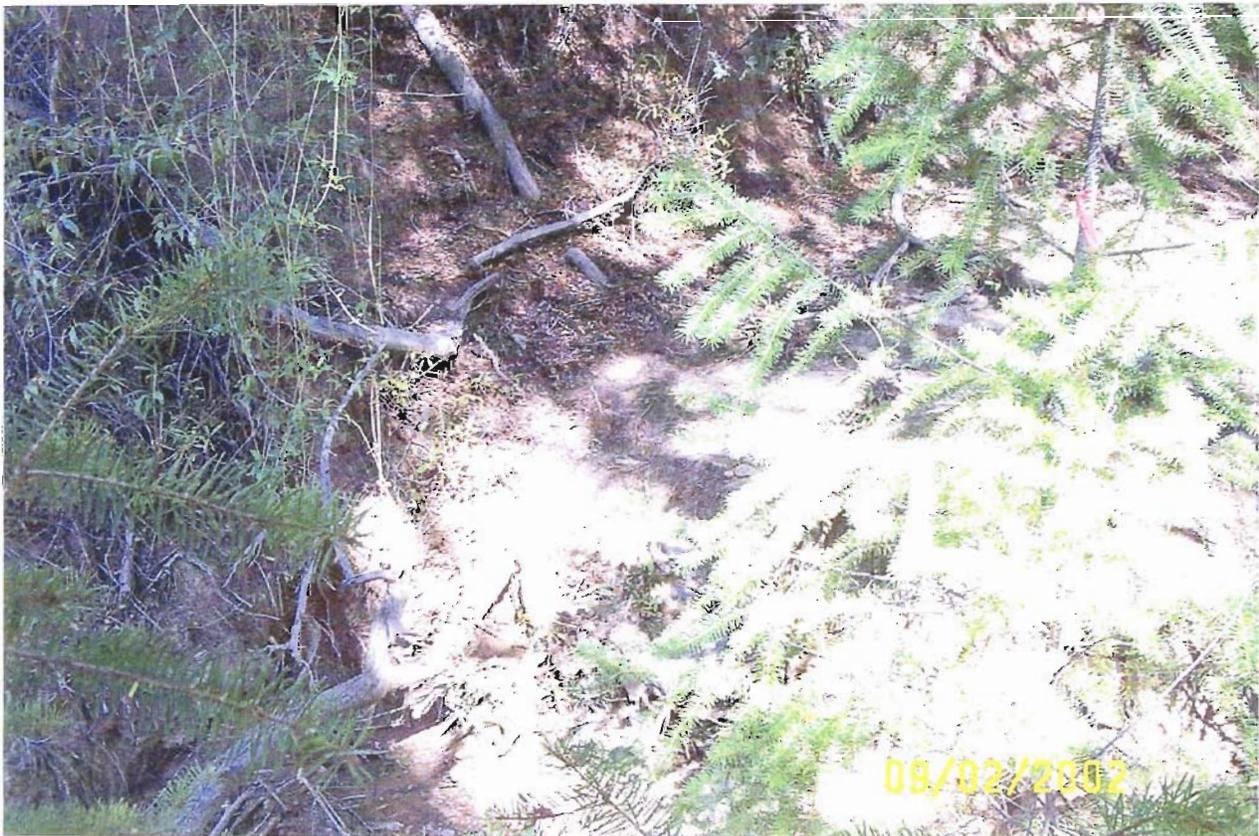
Reach #4A starts at an elevation of 7,500 feet near the eastern edge of the permit area and drops to an elevation of 7,350 feet near L-7-G. The average grade for the 2,400 foot reach is 6.6%. The reach runs mostly through spruce-fir and contains no riparian vegetation. The channel bed is mostly sand and gravel.

Photographs 48 and 49 depict the conditions found in Reach #4A.
