APPENDIX 7-7

Surface Water Characterizations

UtahAmerican Energy, Inc.

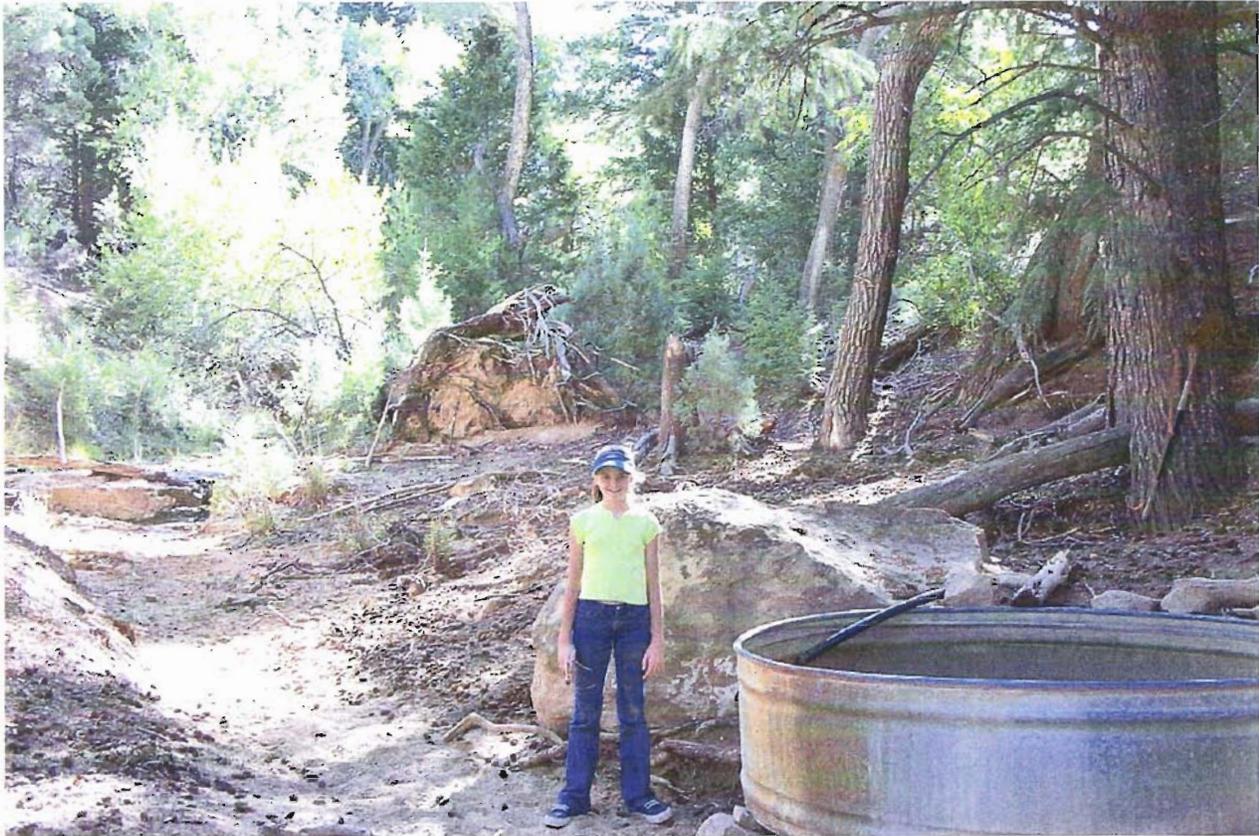
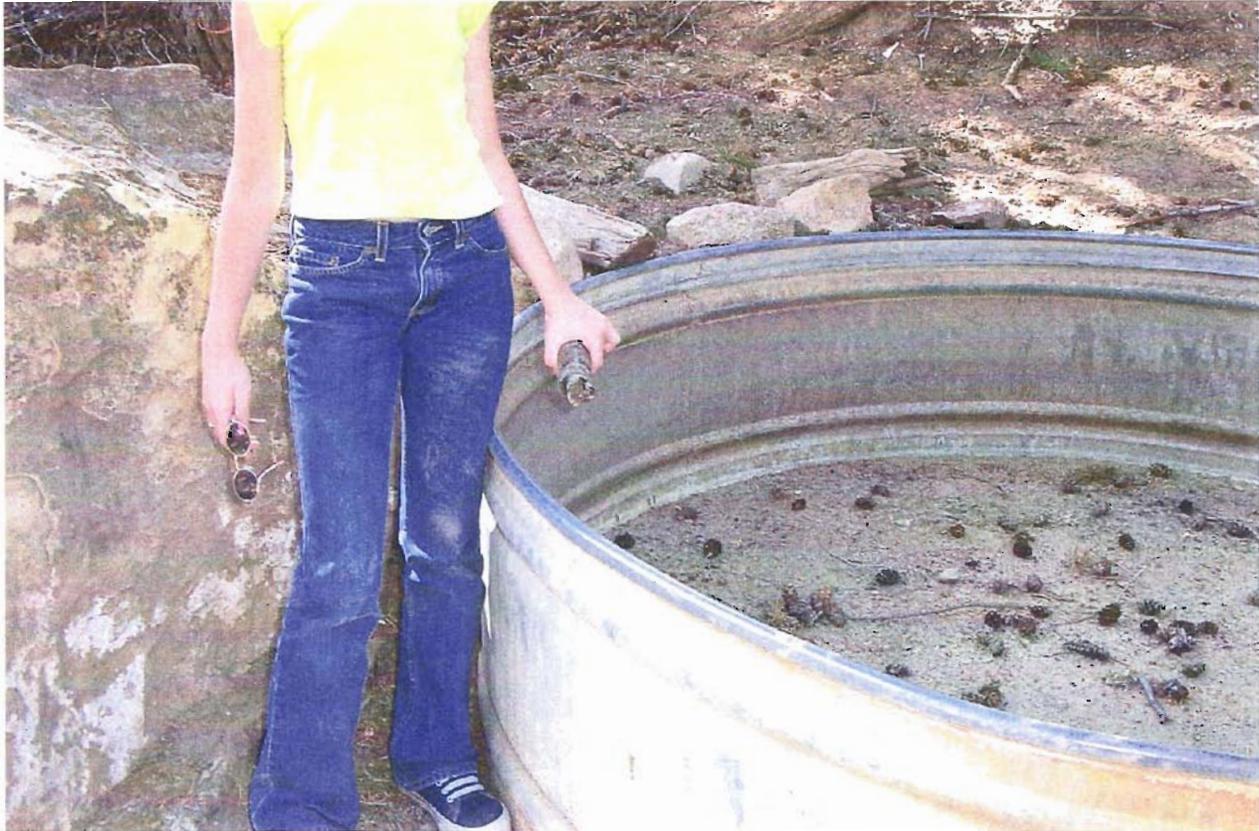
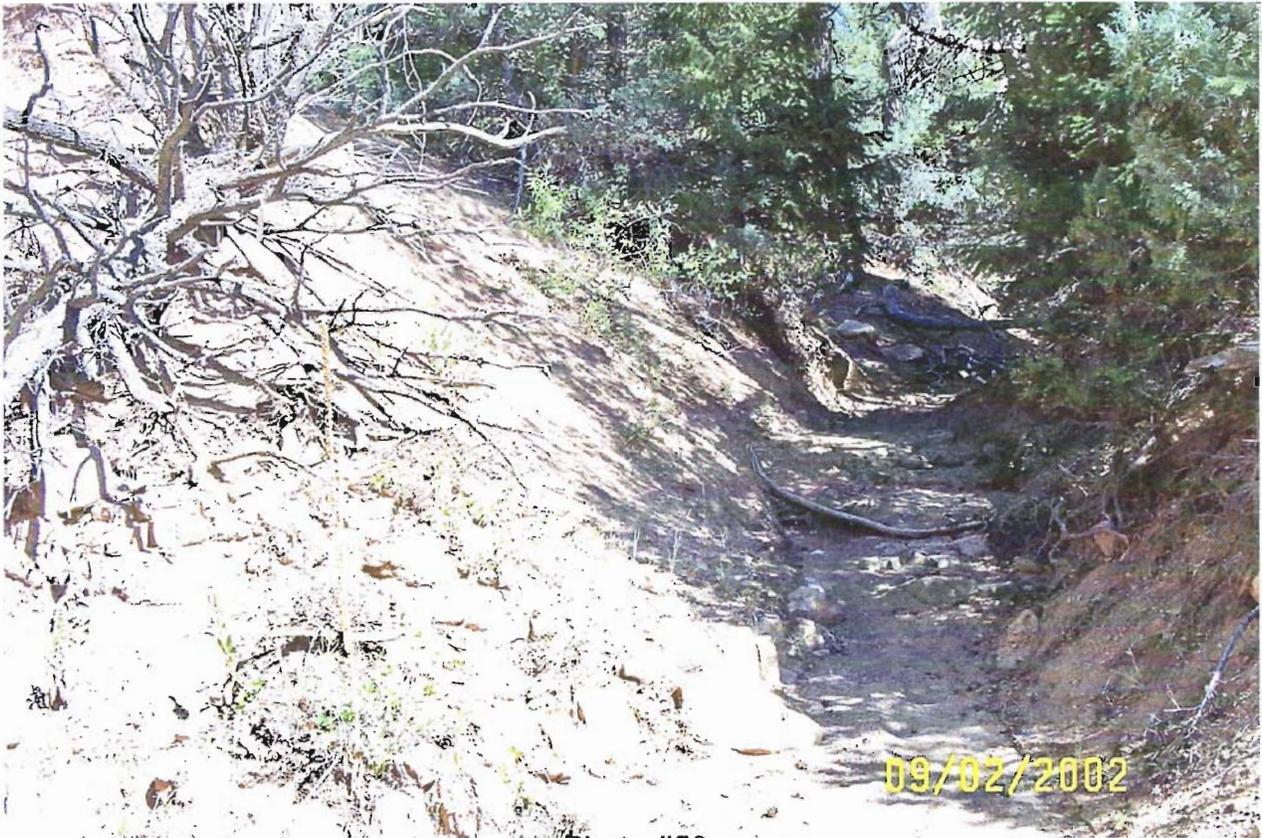
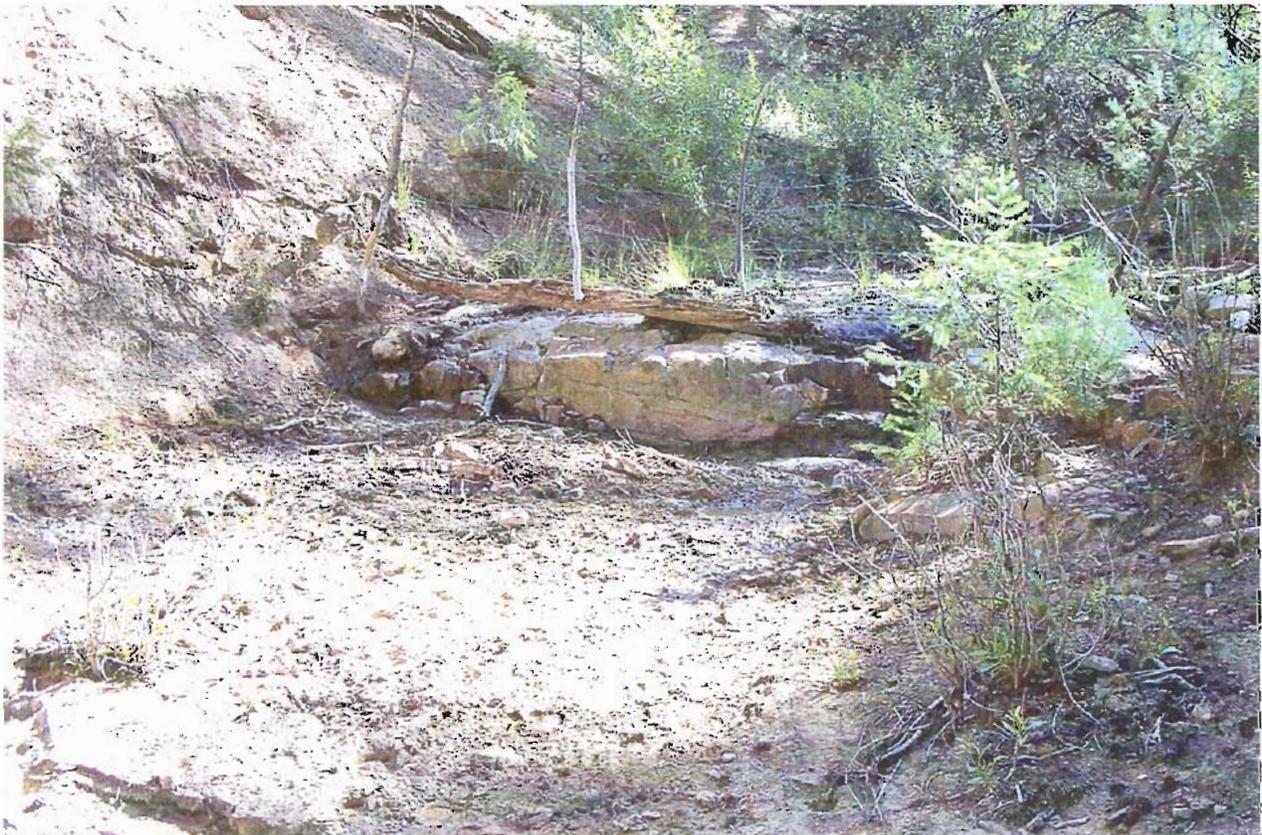
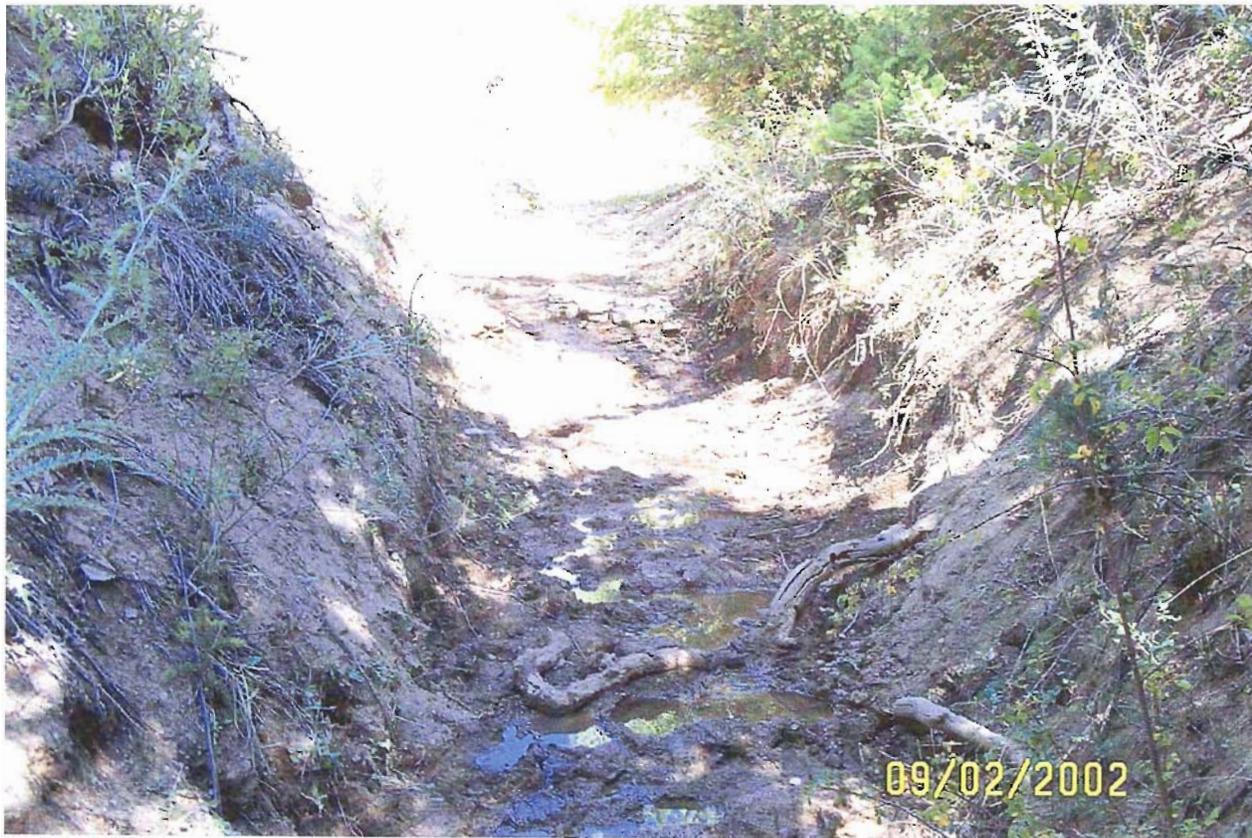
Reach #4B starts at an elevation of 7,350 feet and has a minor slope over the 450 feet to where the next reach begins. The reach runs mostly through Douglas Fir with some pinyon juniper. The reach does not contain any riparian vegetation. The channel bed is mostly sand and gravel. Fish and macro invertebrates are non existing within this reach.

Photographs 8, 9, 10, 50, and 51, found in Attachment #1, depict the conditions found in Reach #4B.

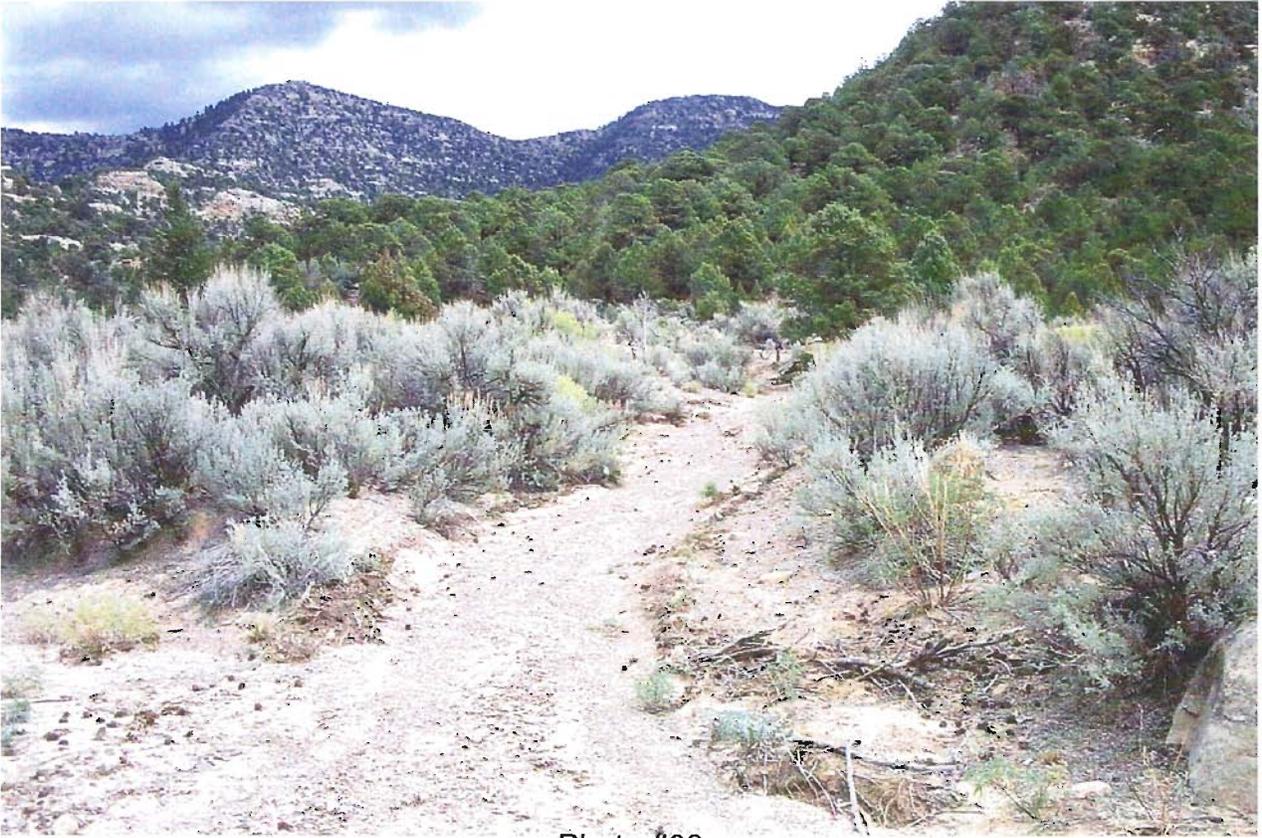
Photo #32

Reach #4C starts near photo 51 at an elevation of 7,300 feet and drops to an elevations of 7,180 feet and has a minor slope (4.5%) over its 2,575 foot length. The reach runs mostly through pinyon juniper transgressing a sagebrush grass type vegetation at the confluence with Little Park Wash. The reach does not contain any riparian vegetarian. The channel bed is mostly sand and gravel. Fish and macro invertebrates are non existing within this reach.

Photograph 32, found in Attachment #1, depicts the conditions found in Reach #4C.

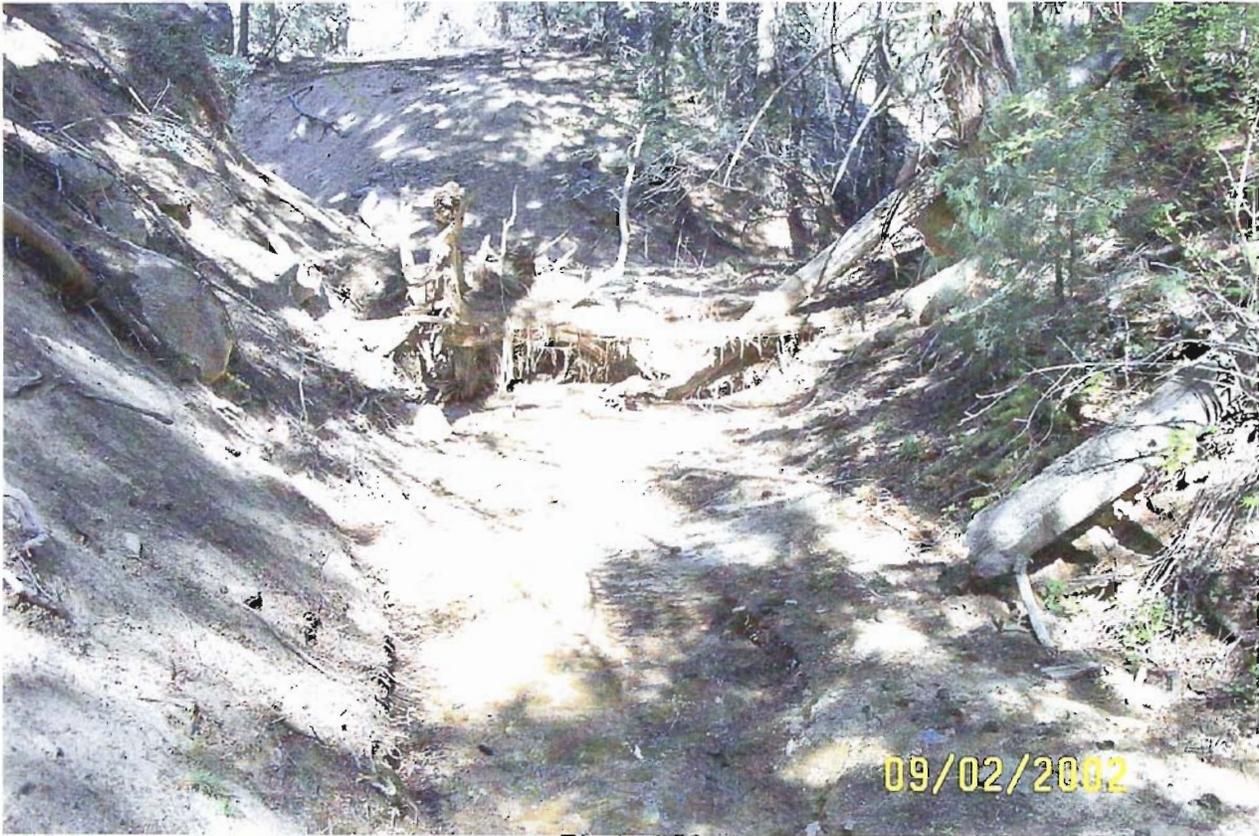
Photo #52

Reach #5A starts at an elevation of 7,450 feet and drops to an elevations of 7,300 feet and has a minor slope (7.8%) over its 1729 foot length. The reach runs mostly through Douglas Fir in the upper sections and transgresses to pinyon juniper. The reach does not contain any riparian vegetarian. The channel bed is mostly sand and gravel. Fish and macro invertebrates are non existing within this reach.

Photograph 52, found in Attachment #1, depicts the conditions found in Reach #5A.

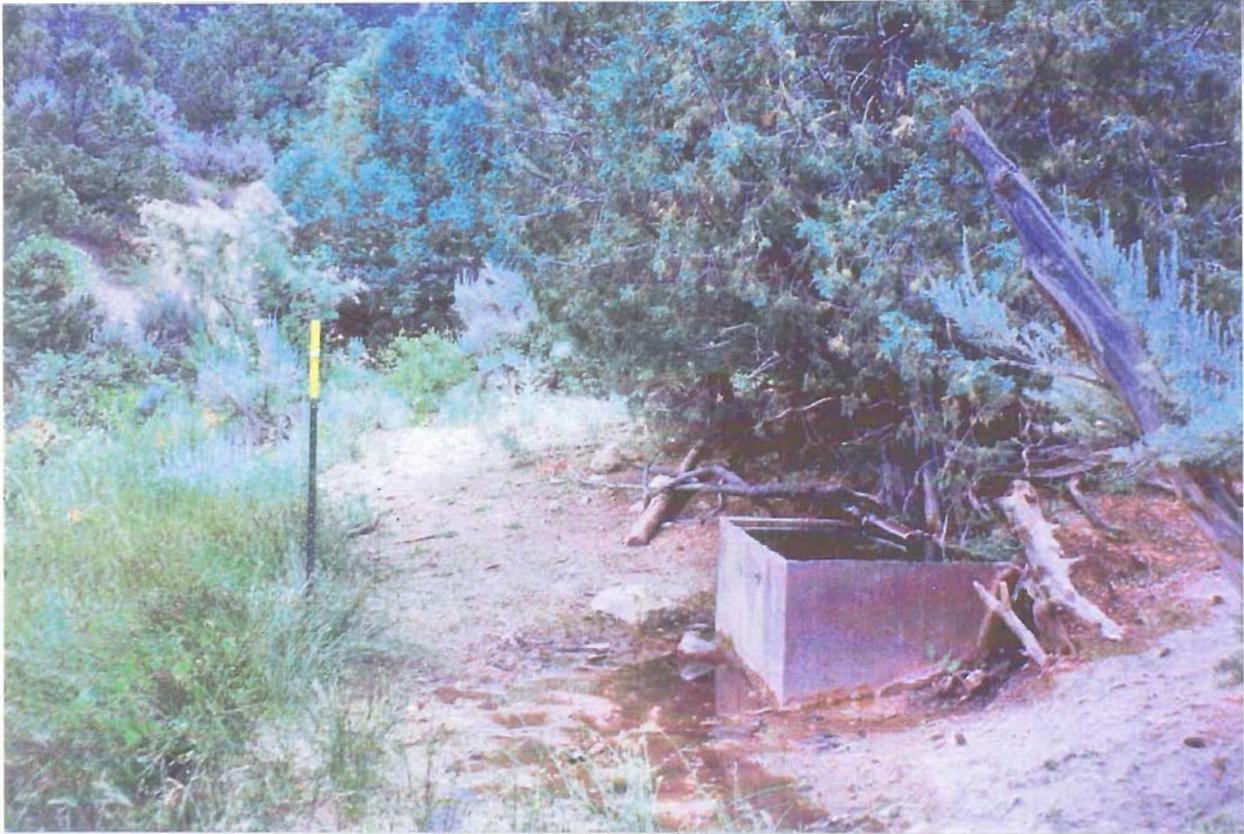
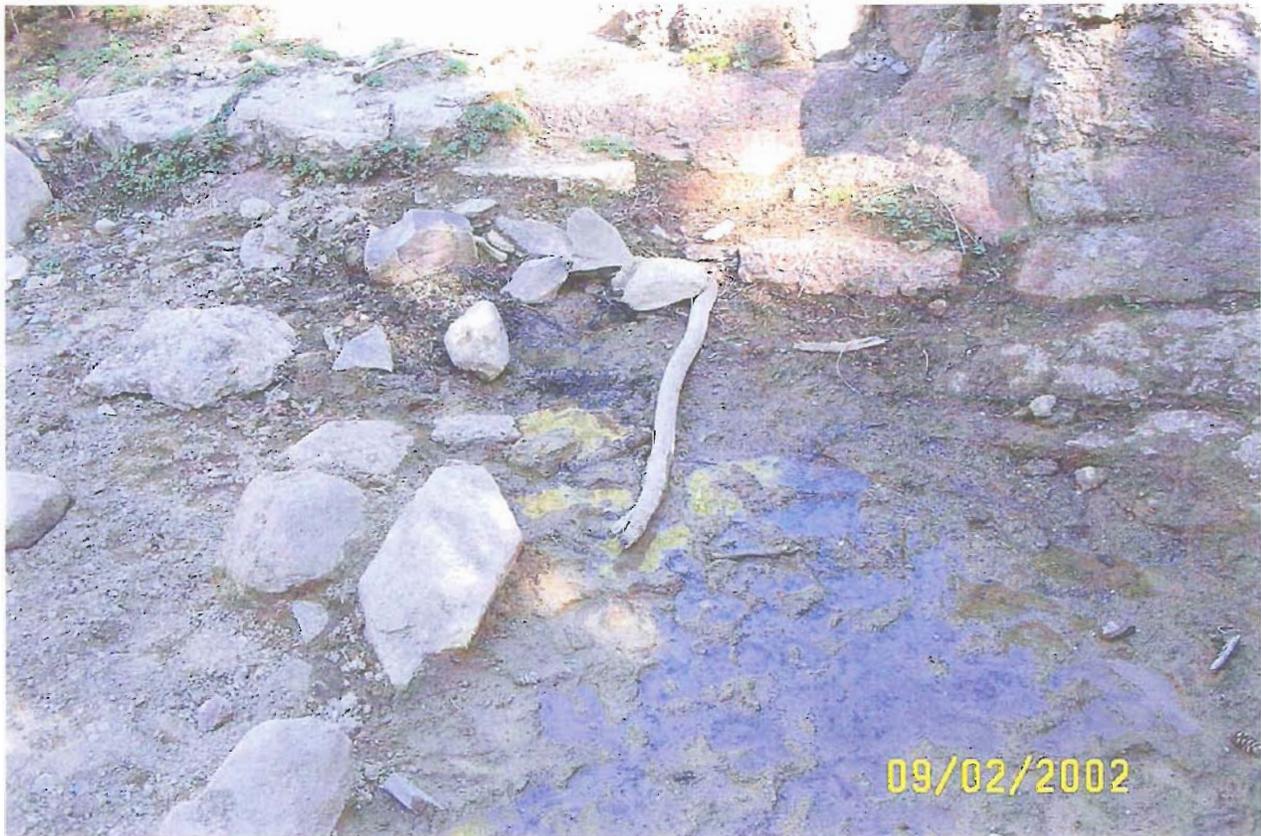
Reach #5B starts at an elevation of 7,300 feet and drops to an elevations of 7,270 feet and has a minor slope (10.4%) over its 300 foot length. L-8-G is located in Douglas Fir. It flows off and on for approximately 300 feet where it either evaporates or is absorbed into the alluvium. The intermittent flow of water from the spring probably never reaches the main channel of Little Park Wash even in years of high precipitation. The reach does not contain any riparian vegetation. The channel bed is mostly sand and gravel. Fish and macro invertebrates are non existing within this reach.

Photographs 53 and 53A found in Attachment #1, depicts the conditions found in Reach #5B.

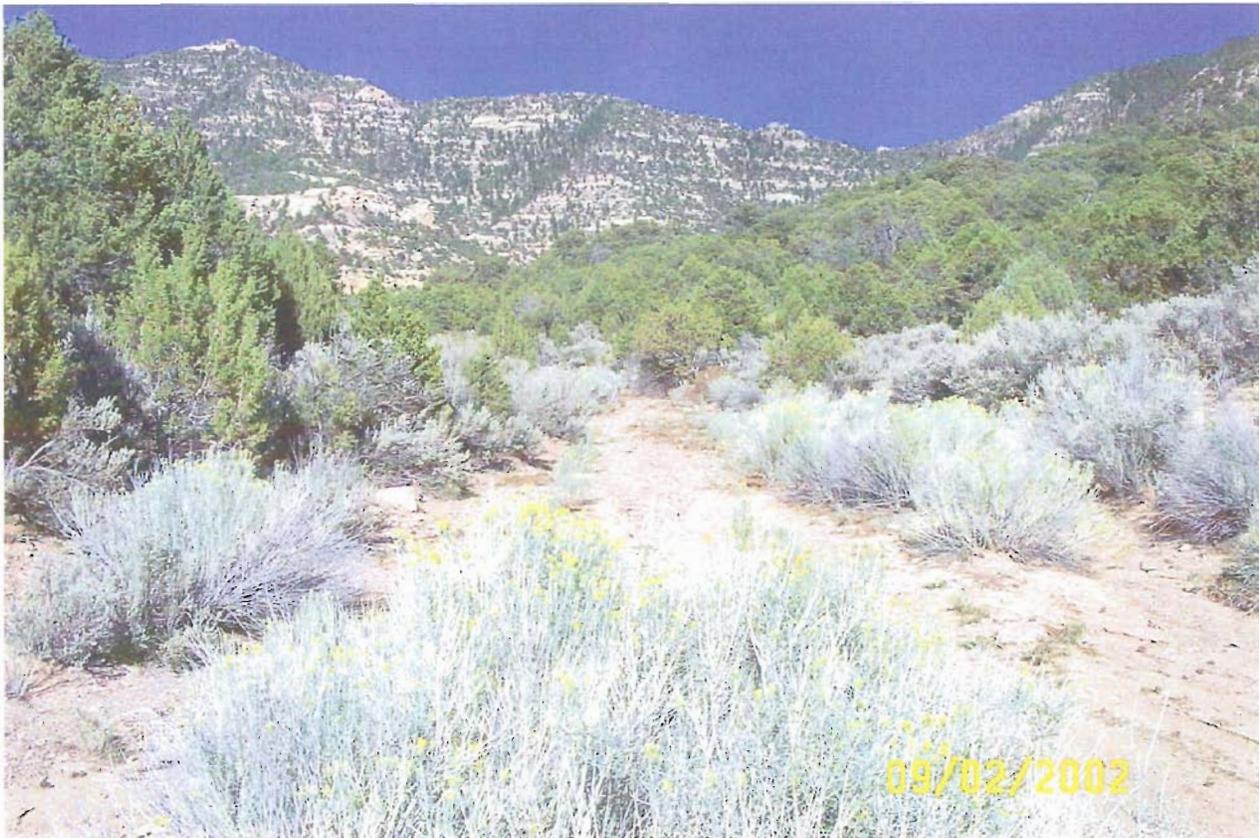
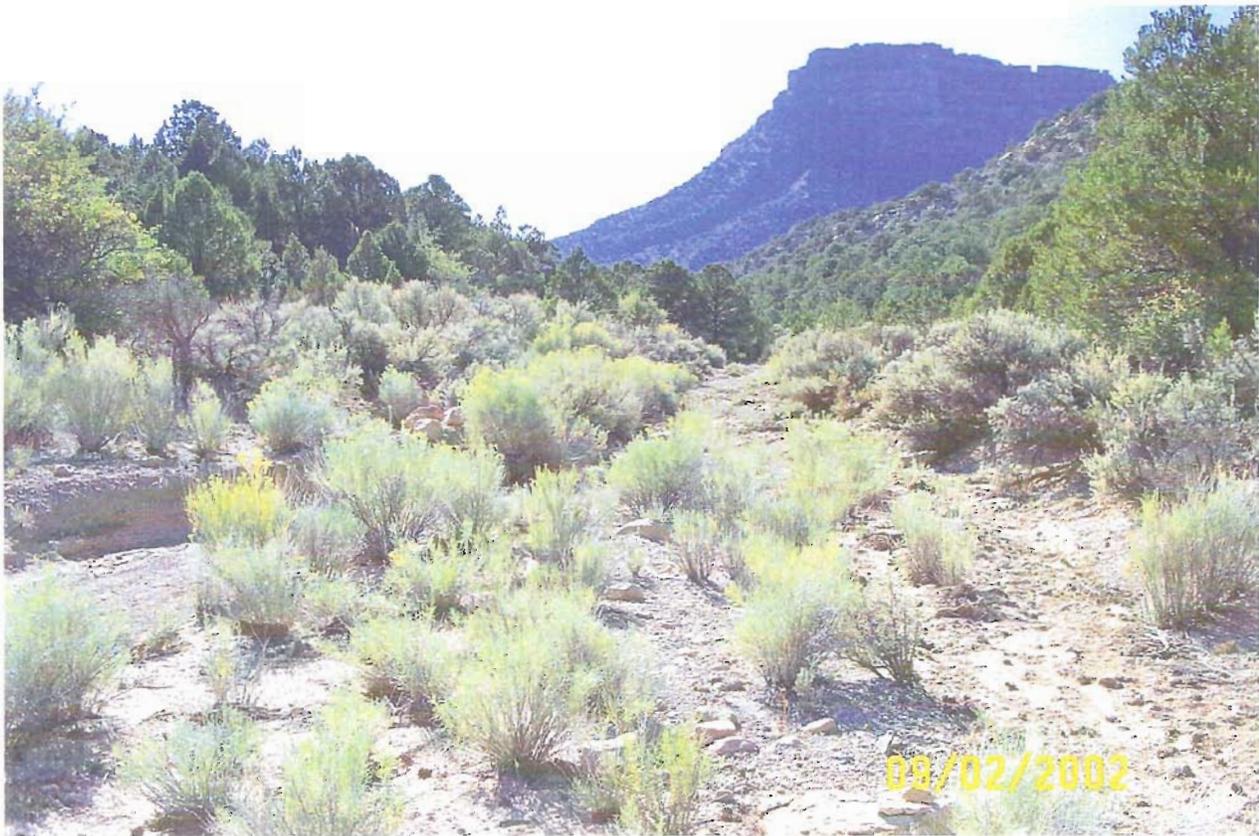
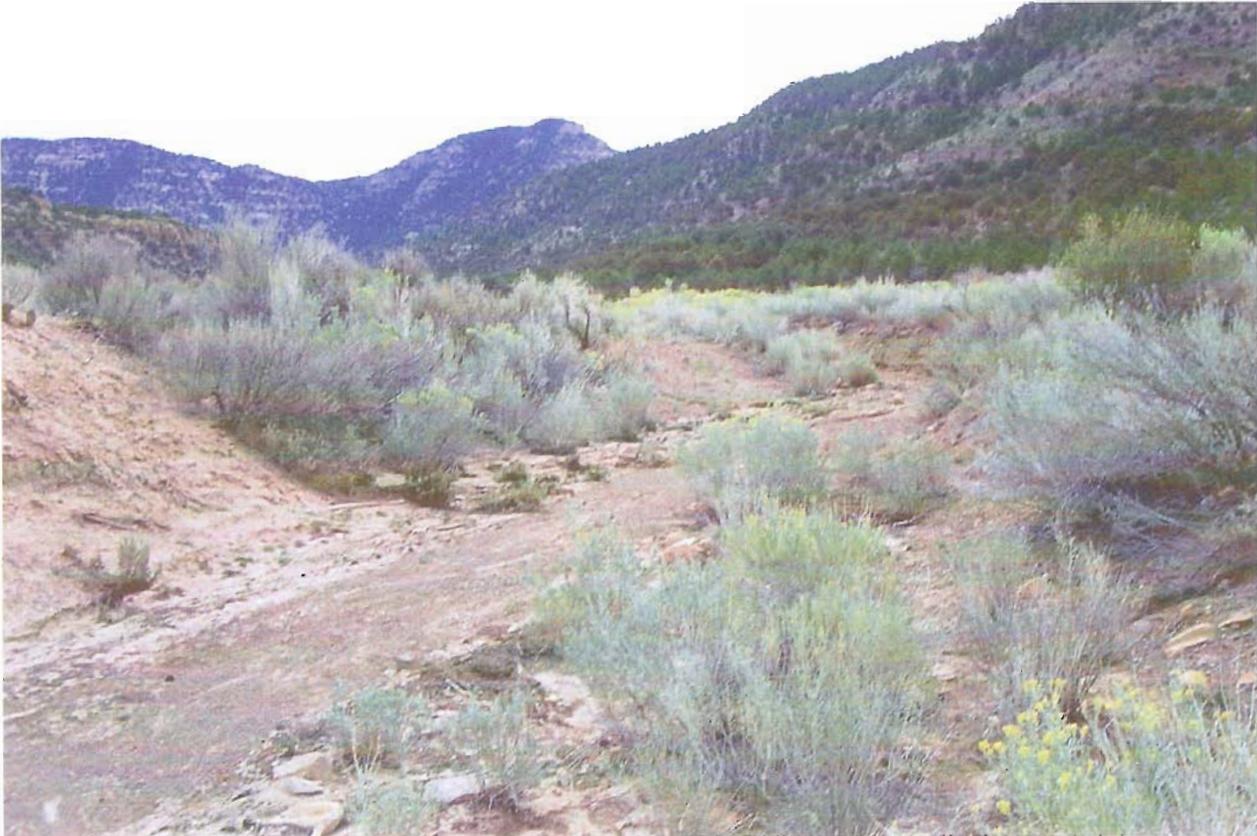
Reach #5C starts at an elevation of 7,270 feet and drops to an elevations of 6,970 feet and has a minor slope (4.5%) over its 6,700 foot length. The reach does not contain any riparian vegetation. The channel bed is mostly sand and gravel. Vegetation transgresses pinion-juniper, to a sagebrush grass type vegetation at the confluence with Little Park Wash.

Photographs 54, 55, and 35 found in Attachment #1, depicts the conditions found in Reach #5C.

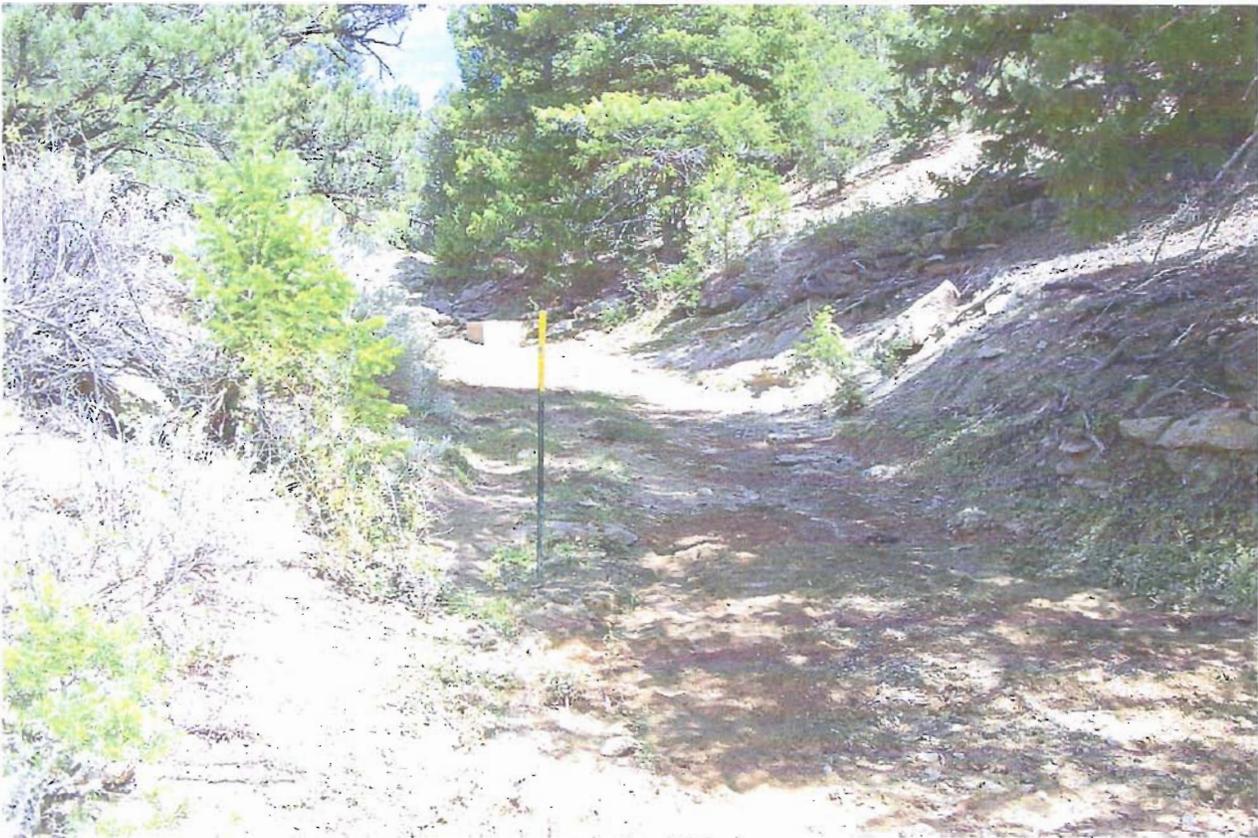
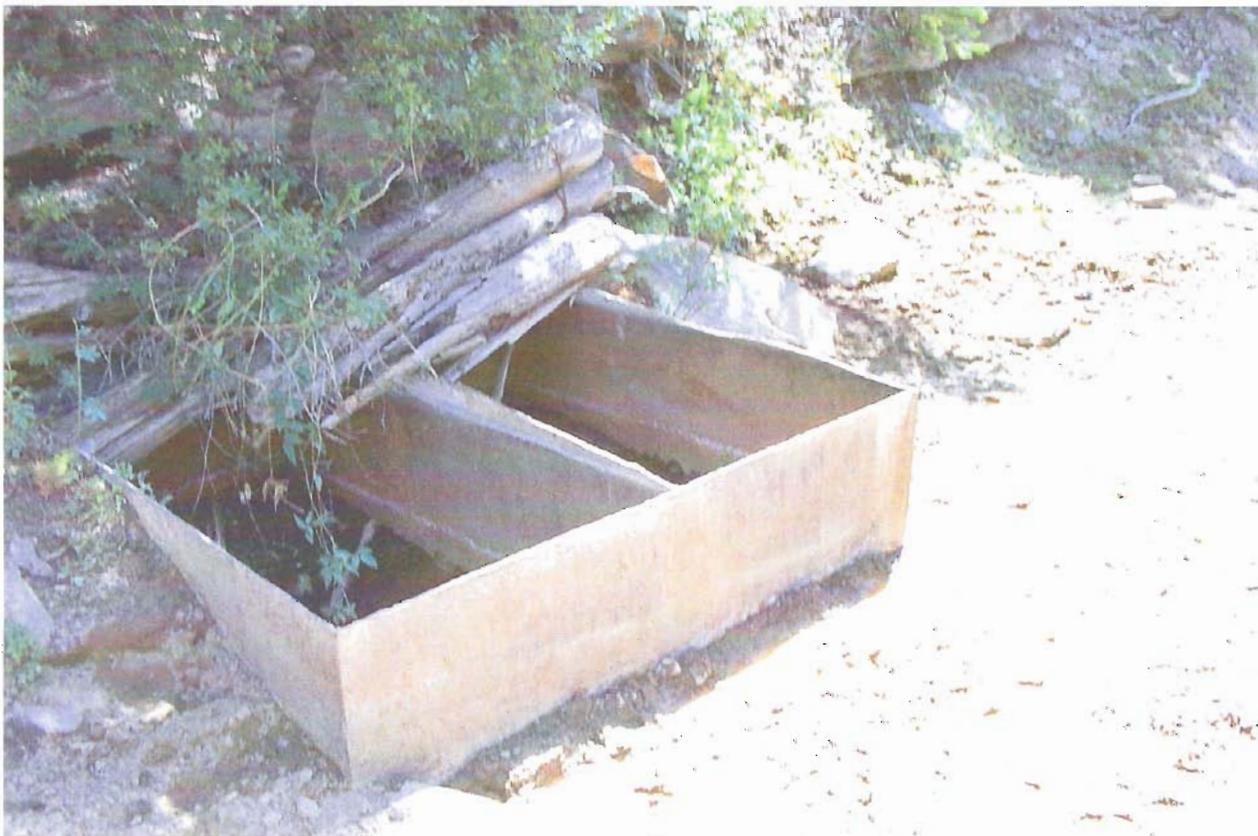
Photographs 11 and 12 found in Attachment #1, depicts the conditions found in Reach #6B.

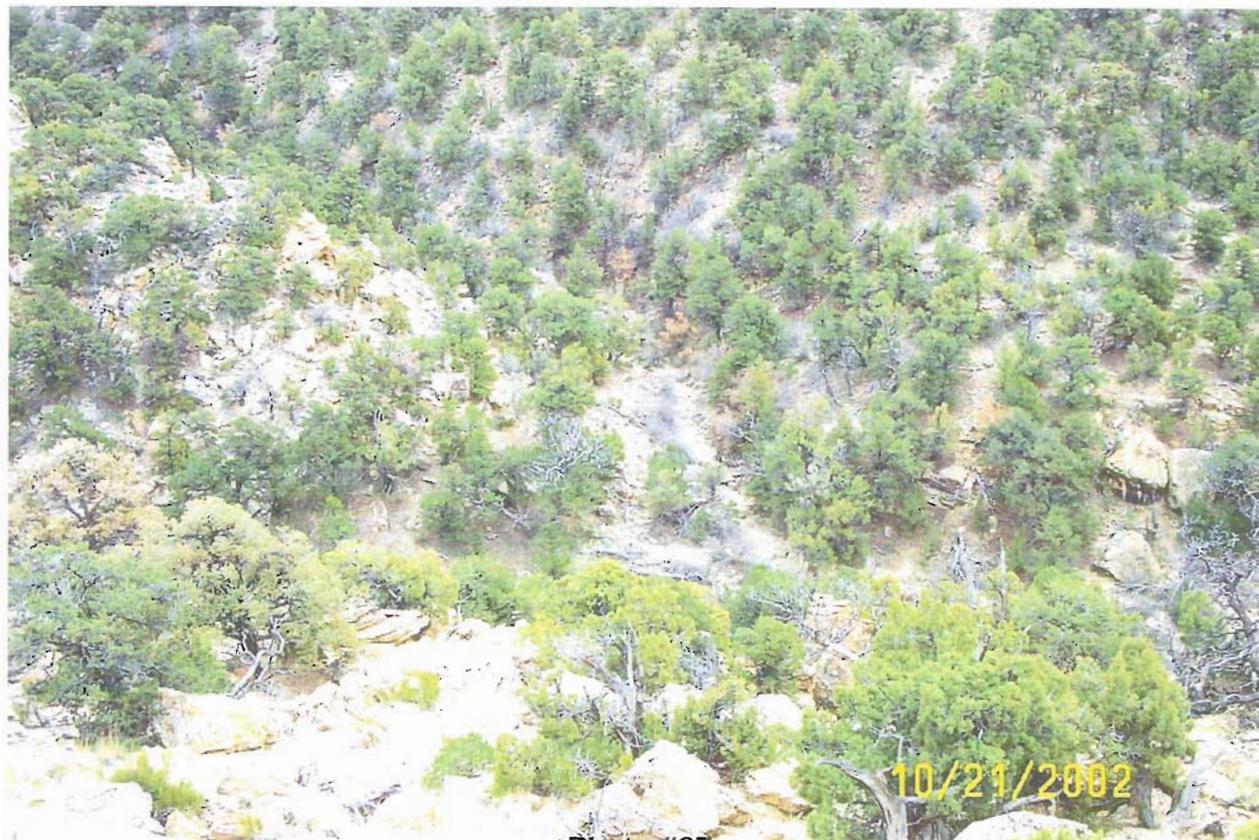
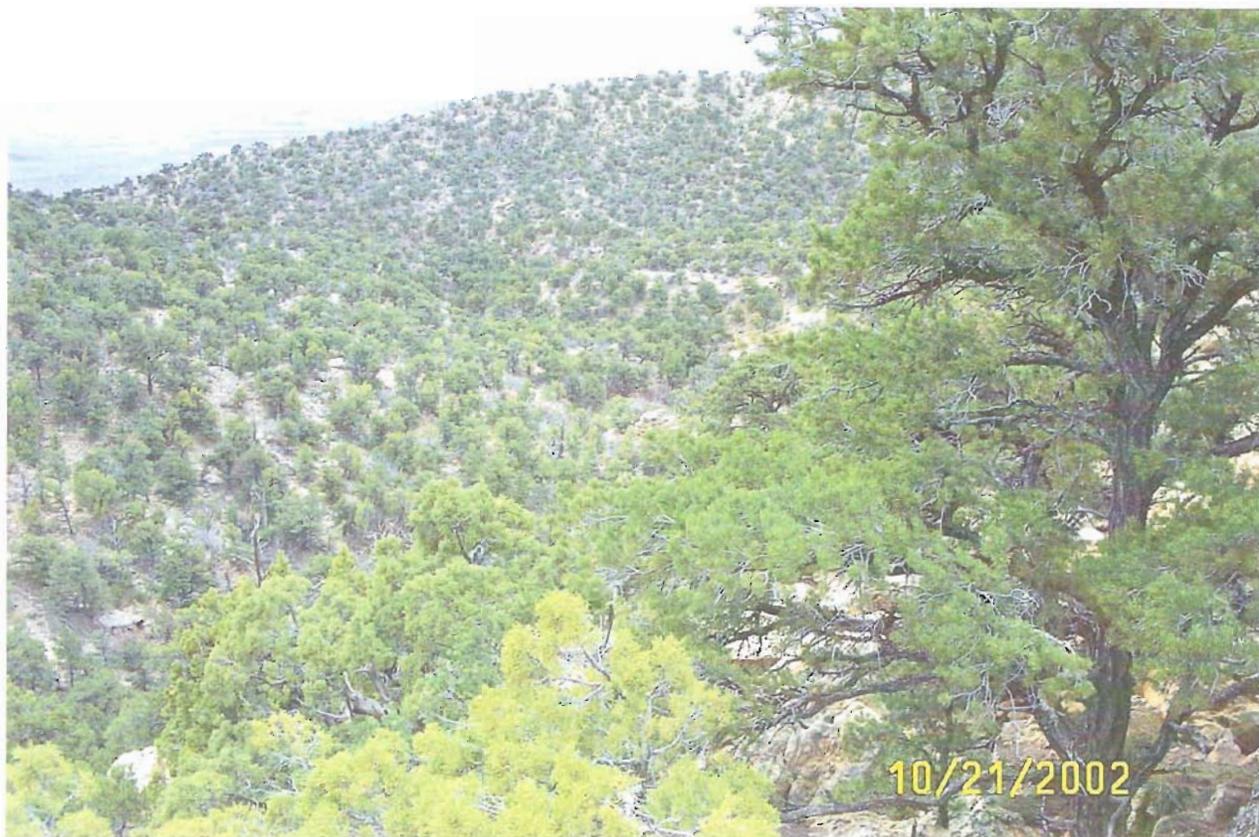
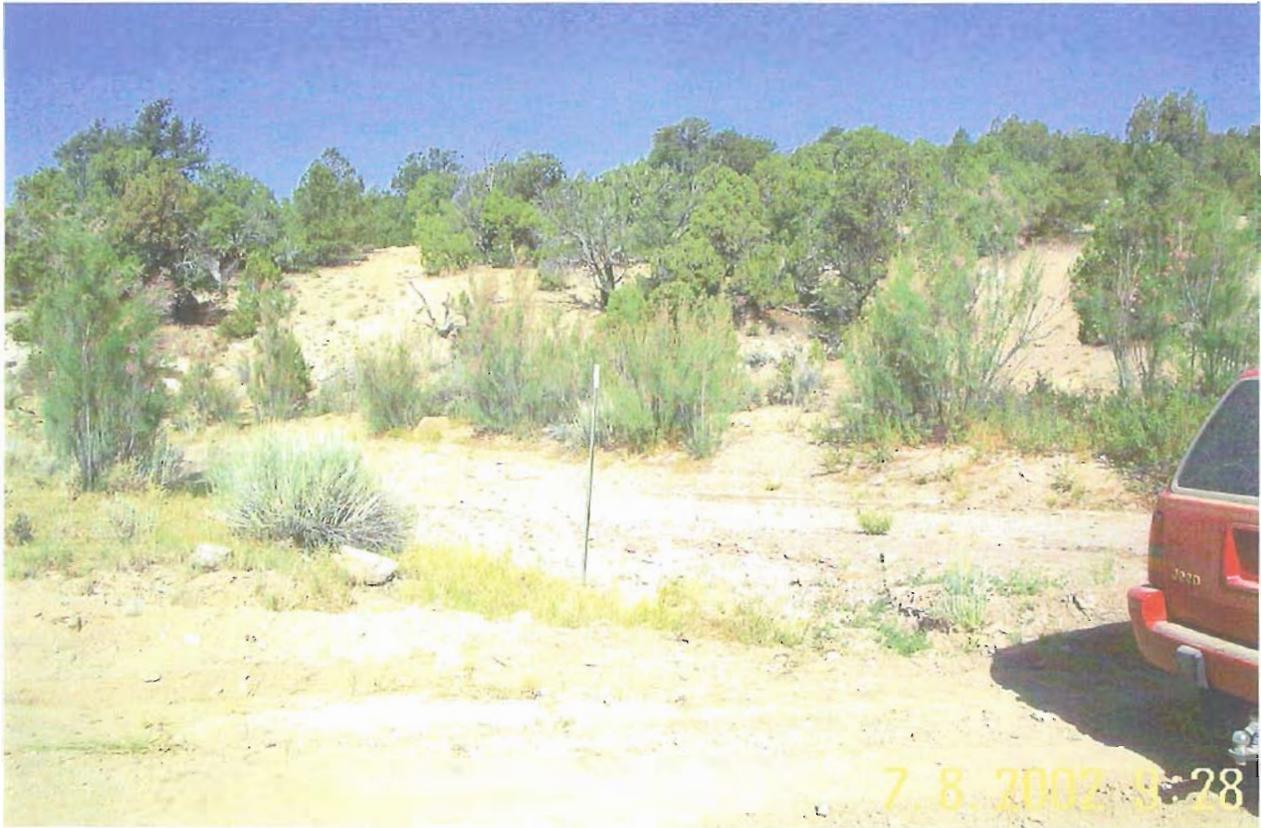
hundred feet below L-12-G is where the channel changes from intermittent to ephemeral. From this point downstream there are several wet spots but no flow. The water table, with respect to the channel surface, could not be located using an 18" spade in most places. Flow has been observed at the road crossing, L-14-S, in some wet years but it is currently dry. The intermittent flow of water from the springs probably never reaches the main channel of Little Park Wash even in years of high precipitation.

Photographs 61, 87, and 88 found in Attachment #1, depicts the conditions found in Reach #7.
