APPENDIX 7-7

Surface Water Characterizations

UtahAmerican Energy, Inc.

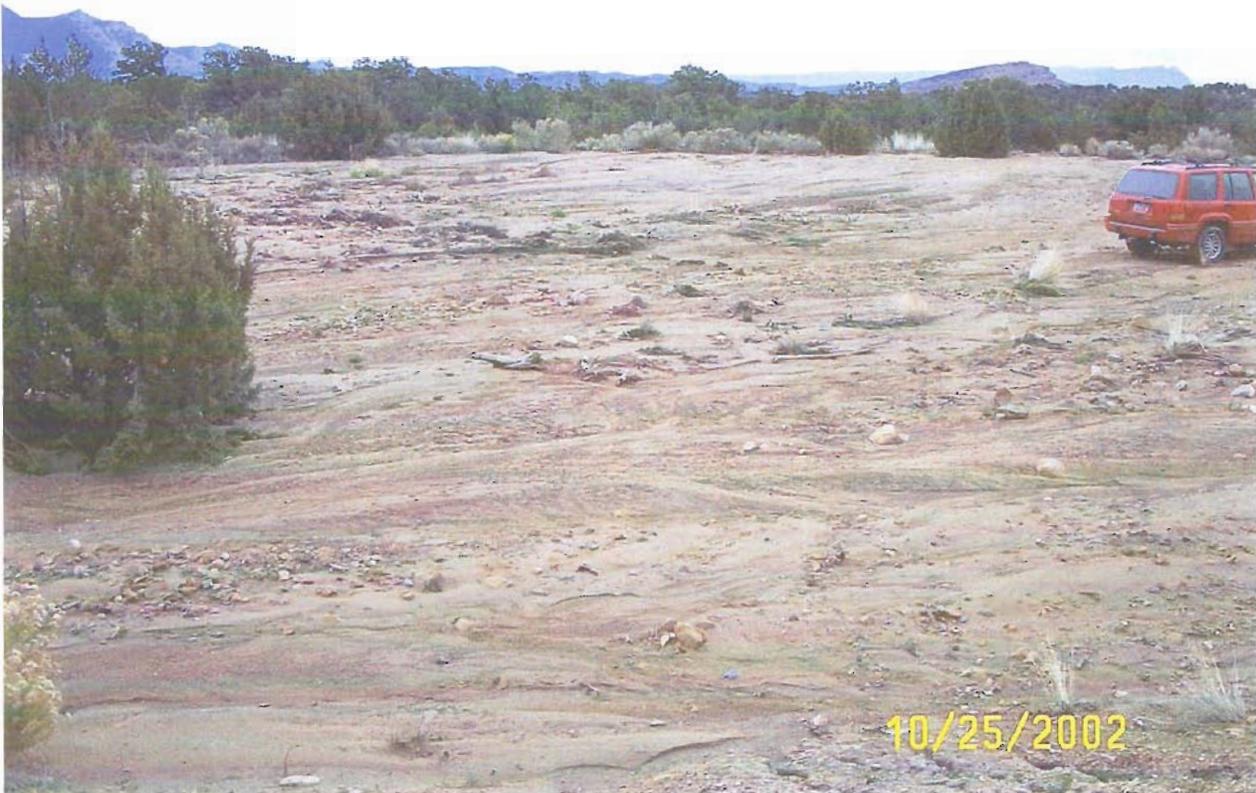
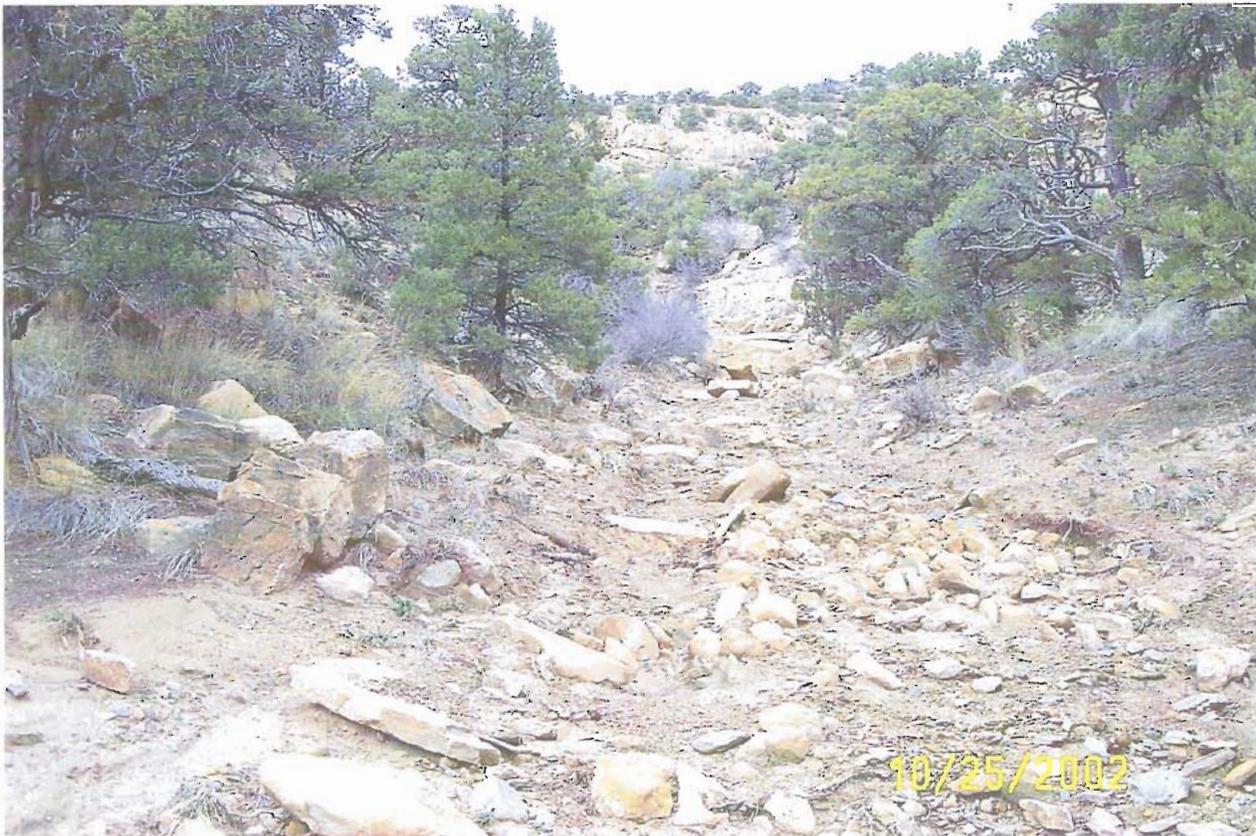
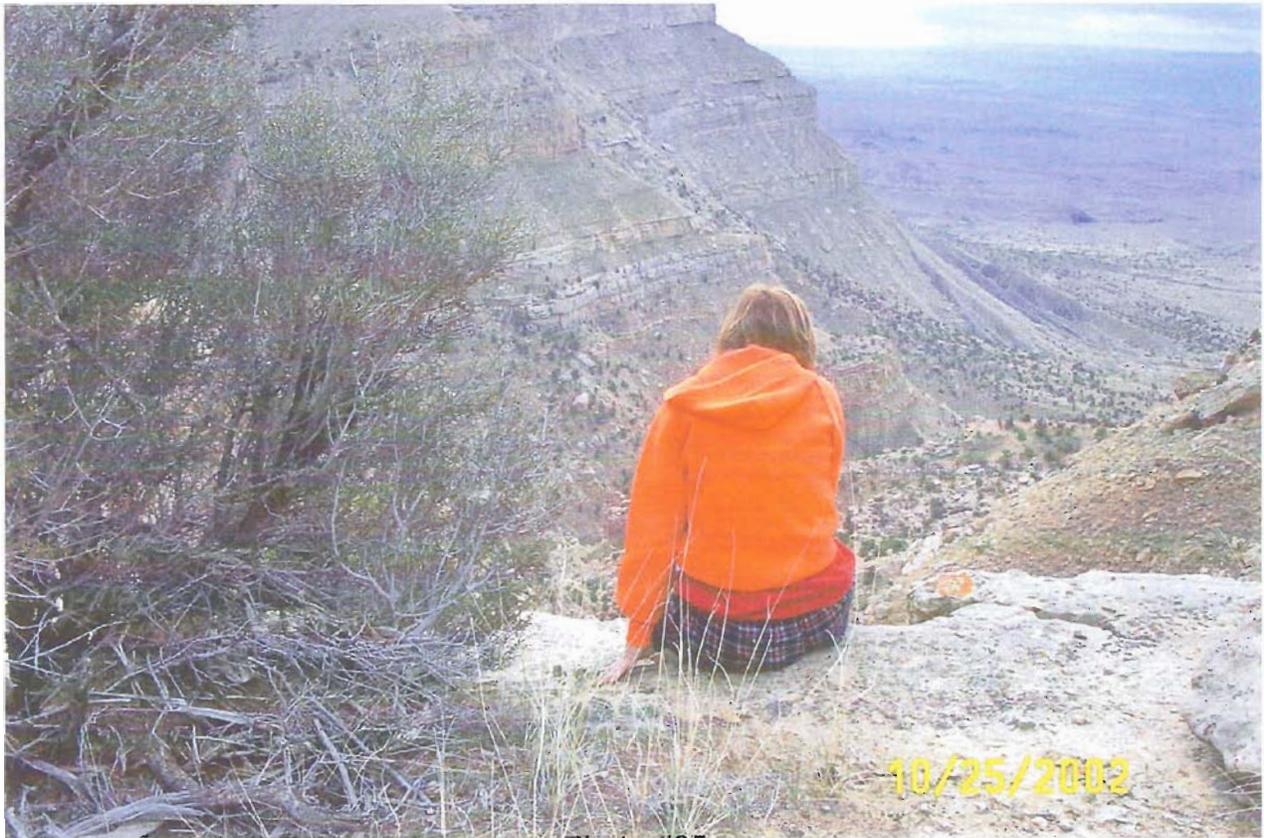
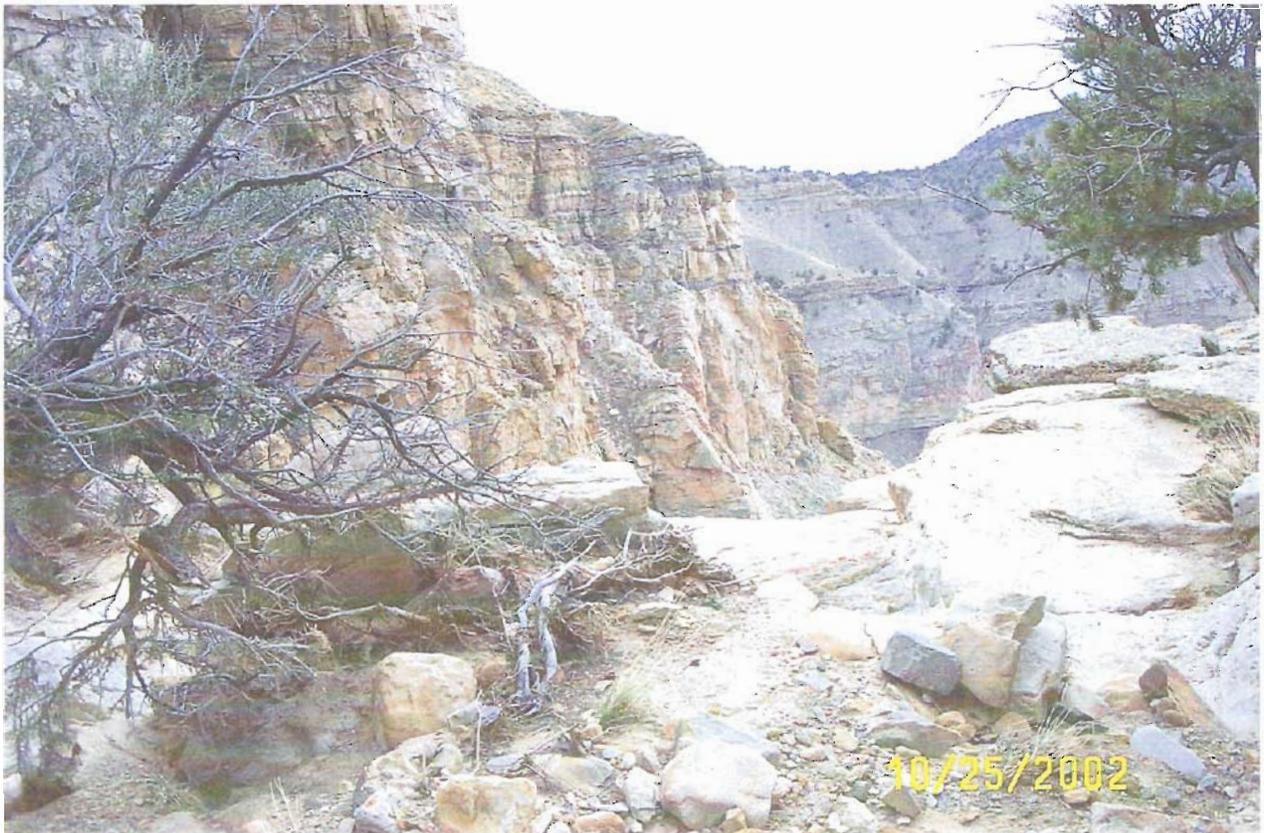
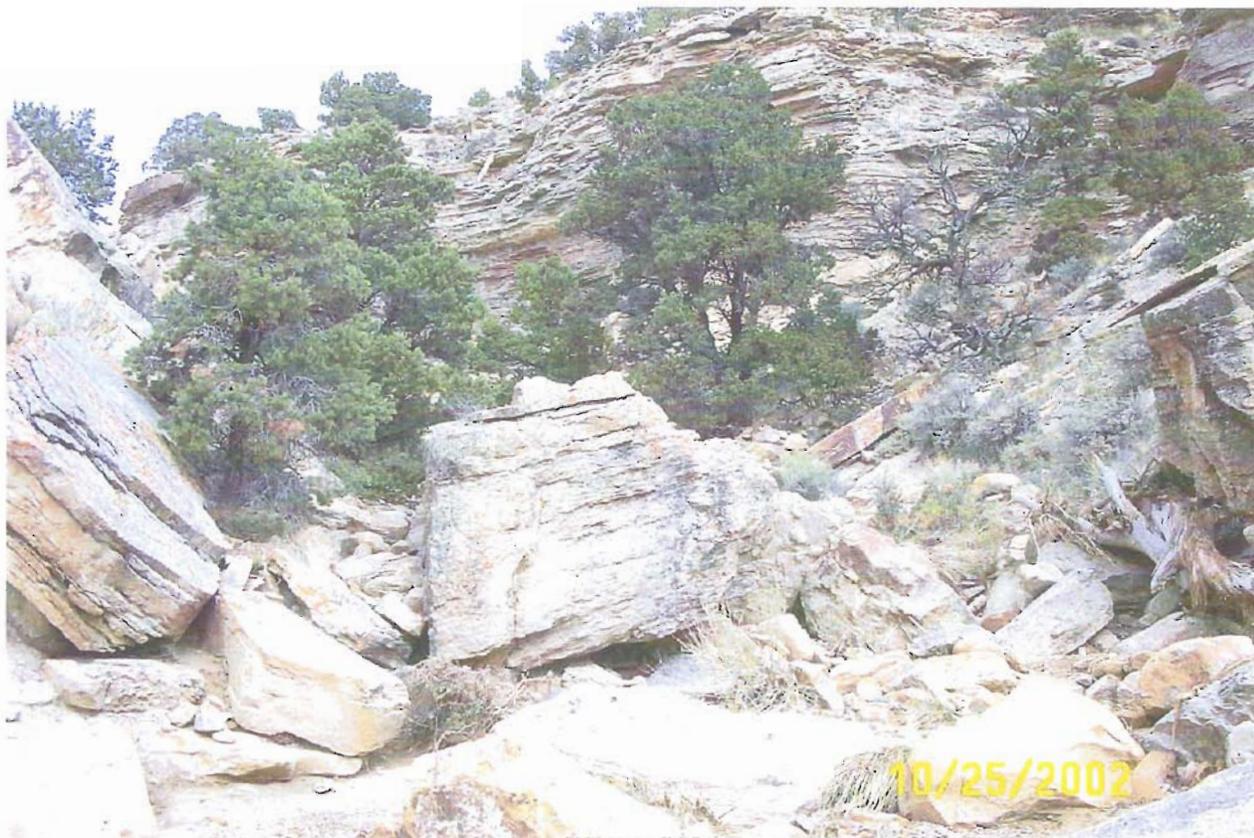
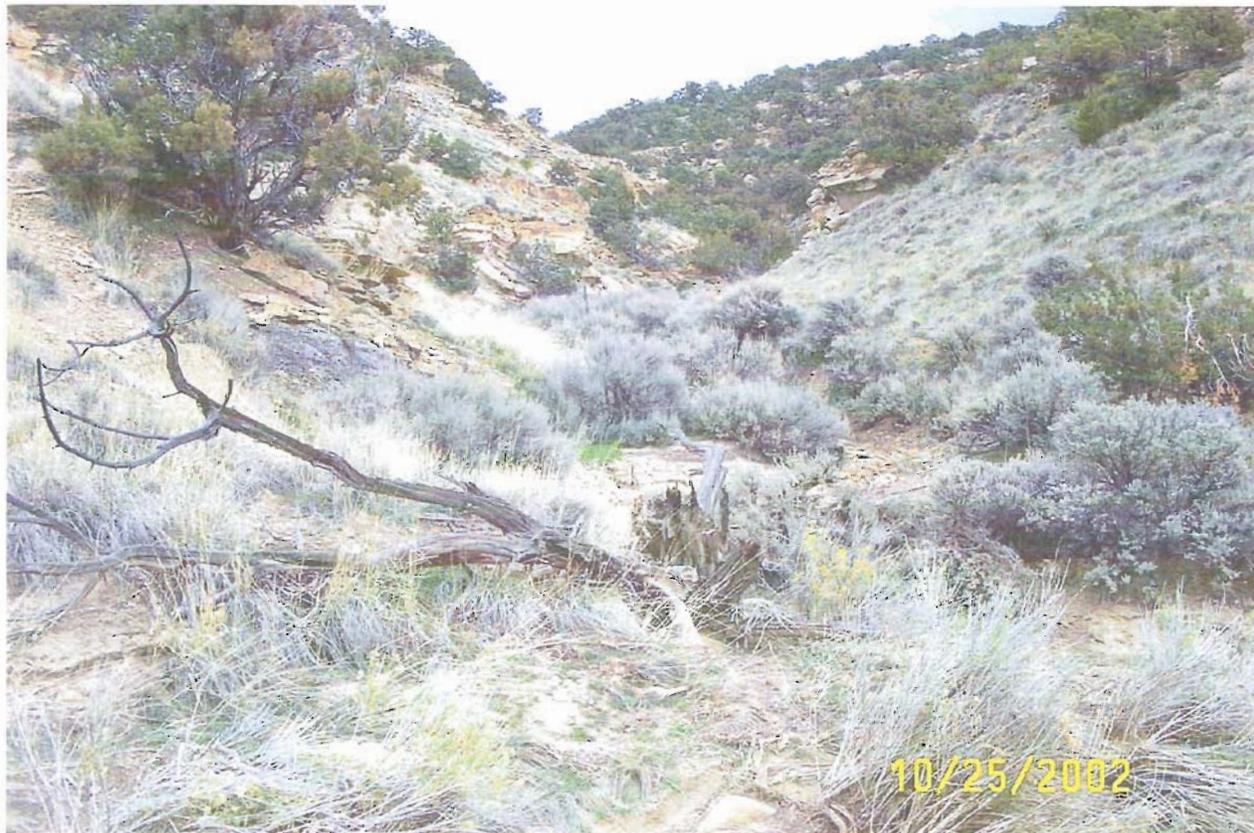
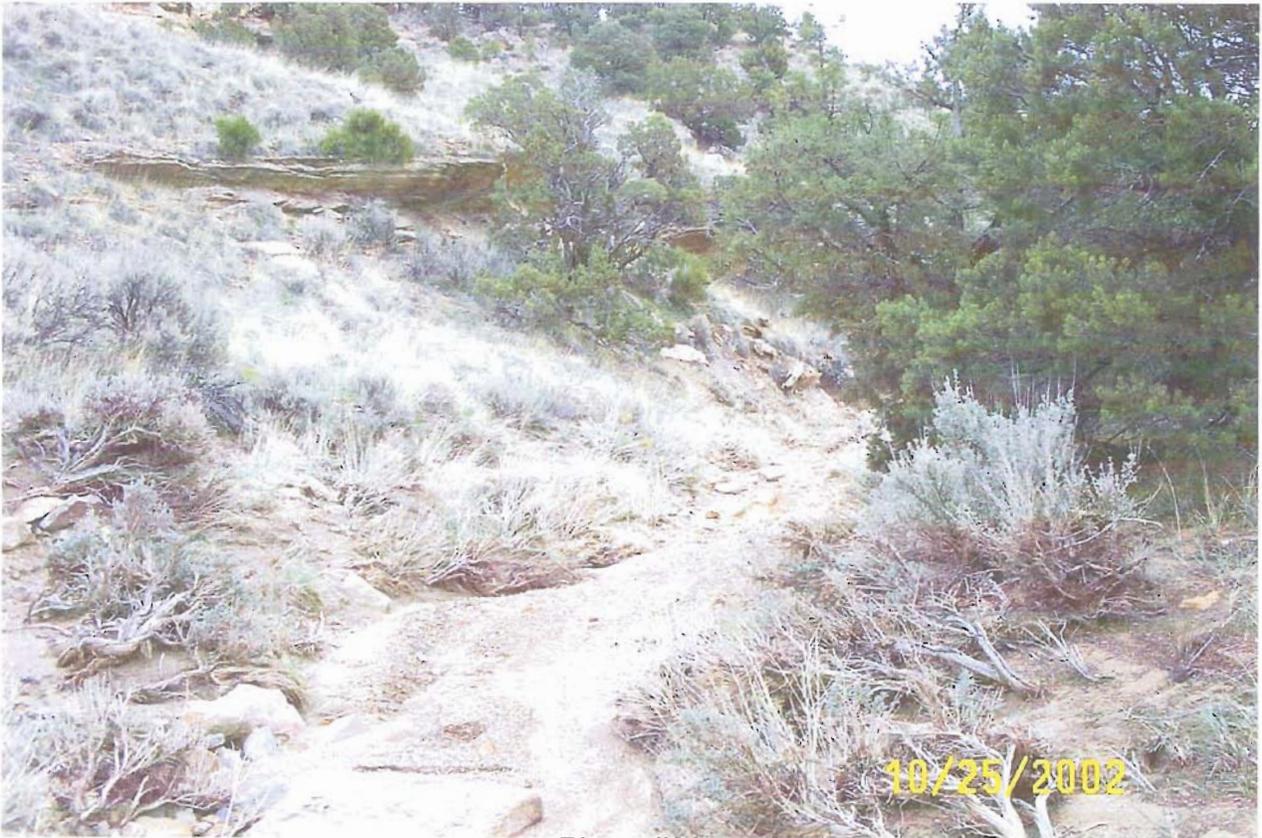
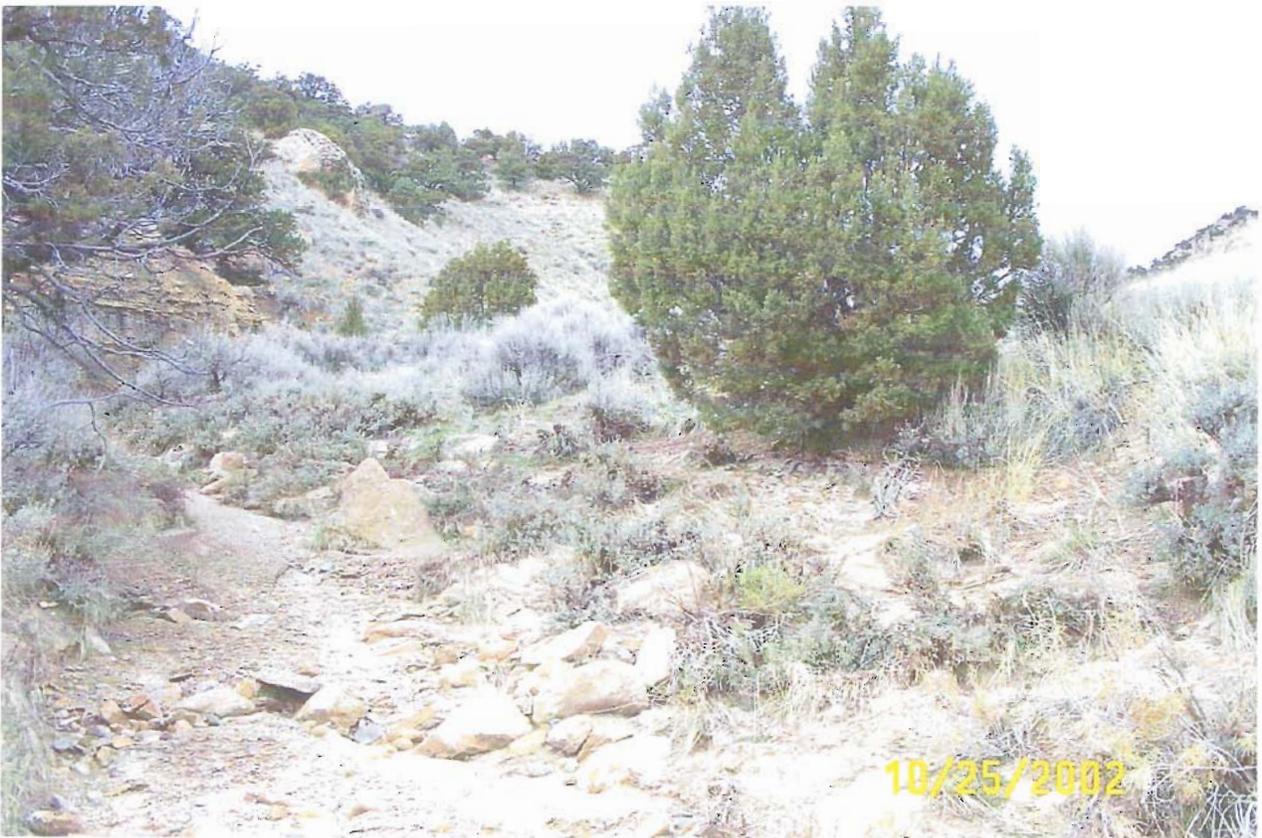
Photograph 93, 94, 95, 96, 97, 98, 99, and 100, found in Attachment #1, depicts the conditions found in Reach #9A.

The chance of subsidence negatively effecting this ephemeral channel is minimal. However, in the unlikely event that cracks, fissures or sink holes are observed as a result of subsidence the channel will be regraded, filling in the cracks, fissures or sinkholes by hand methods due to its inaccessibility. UEI will use the best available techniques available at the time of repair. Significant repairs may require seeding. UEI will notify the Division prior to any repair of seeps, springs, or drainages.

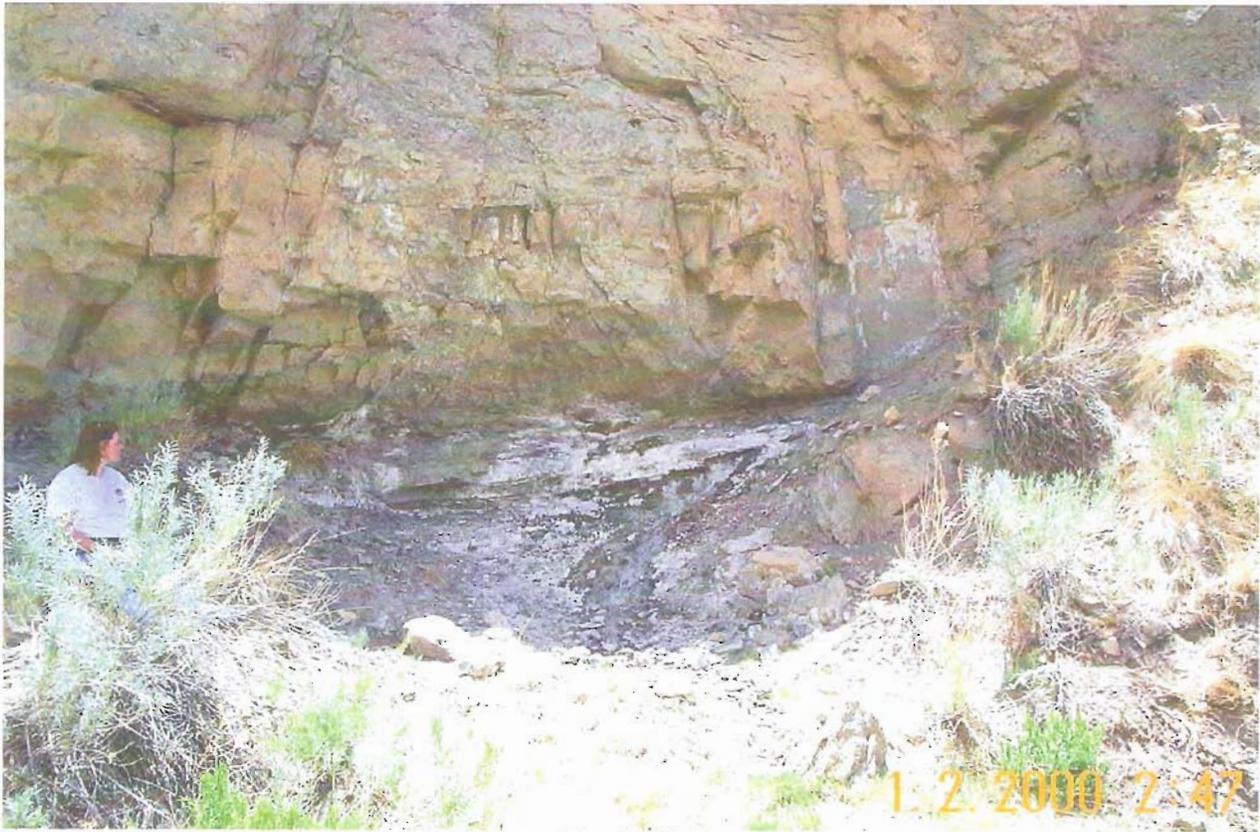
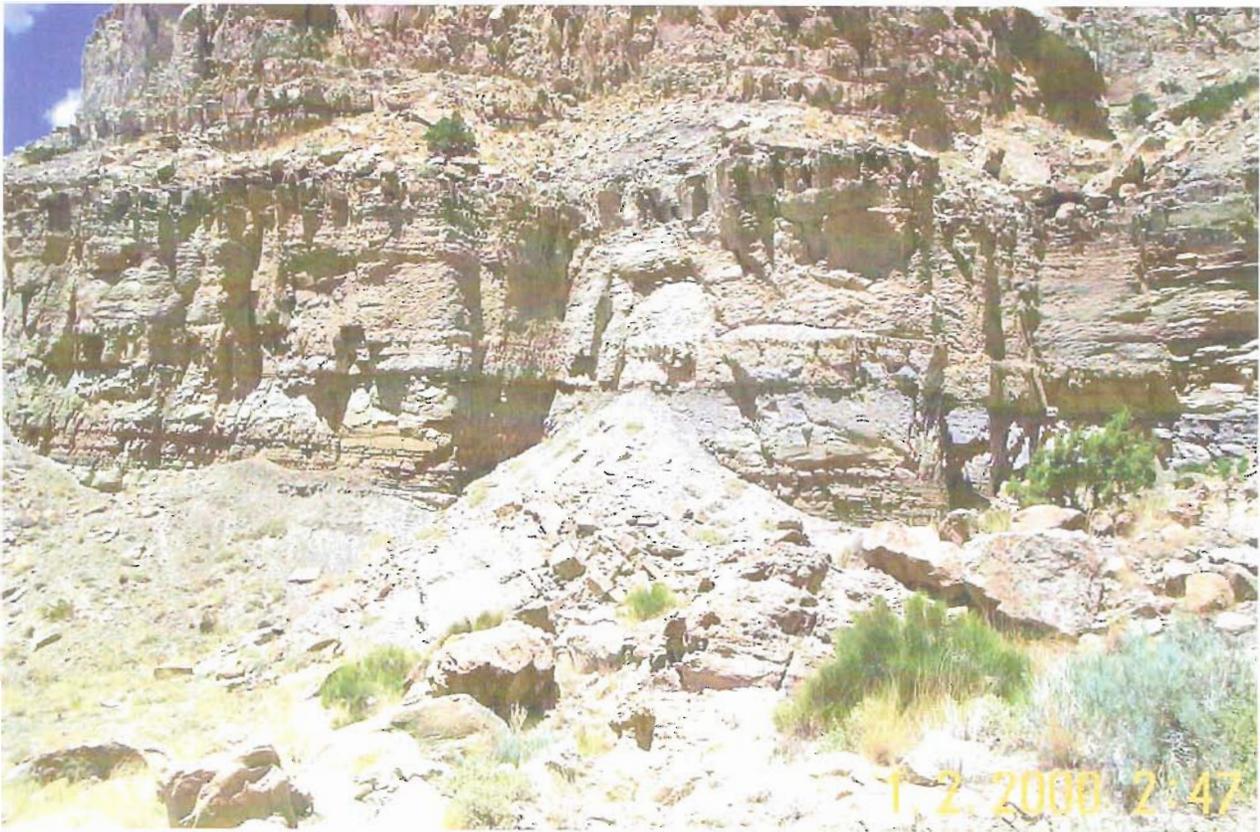
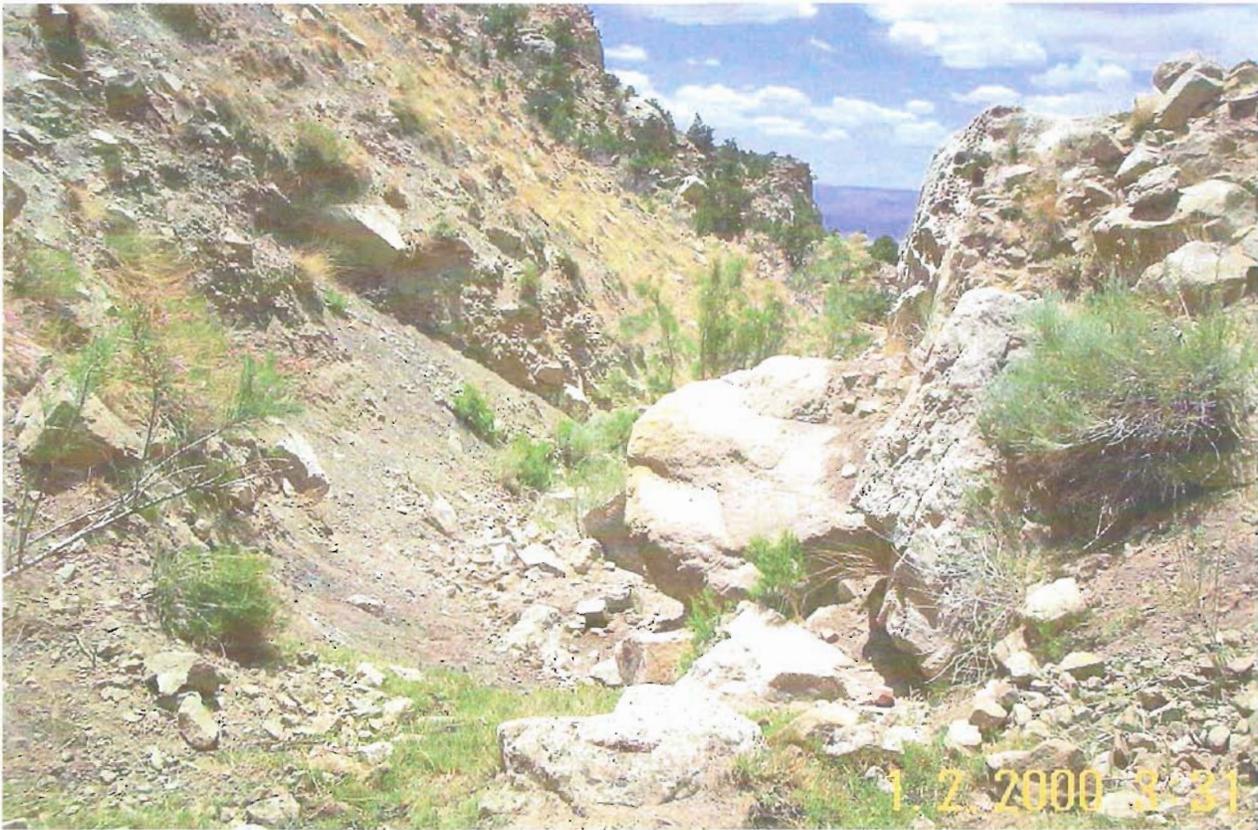
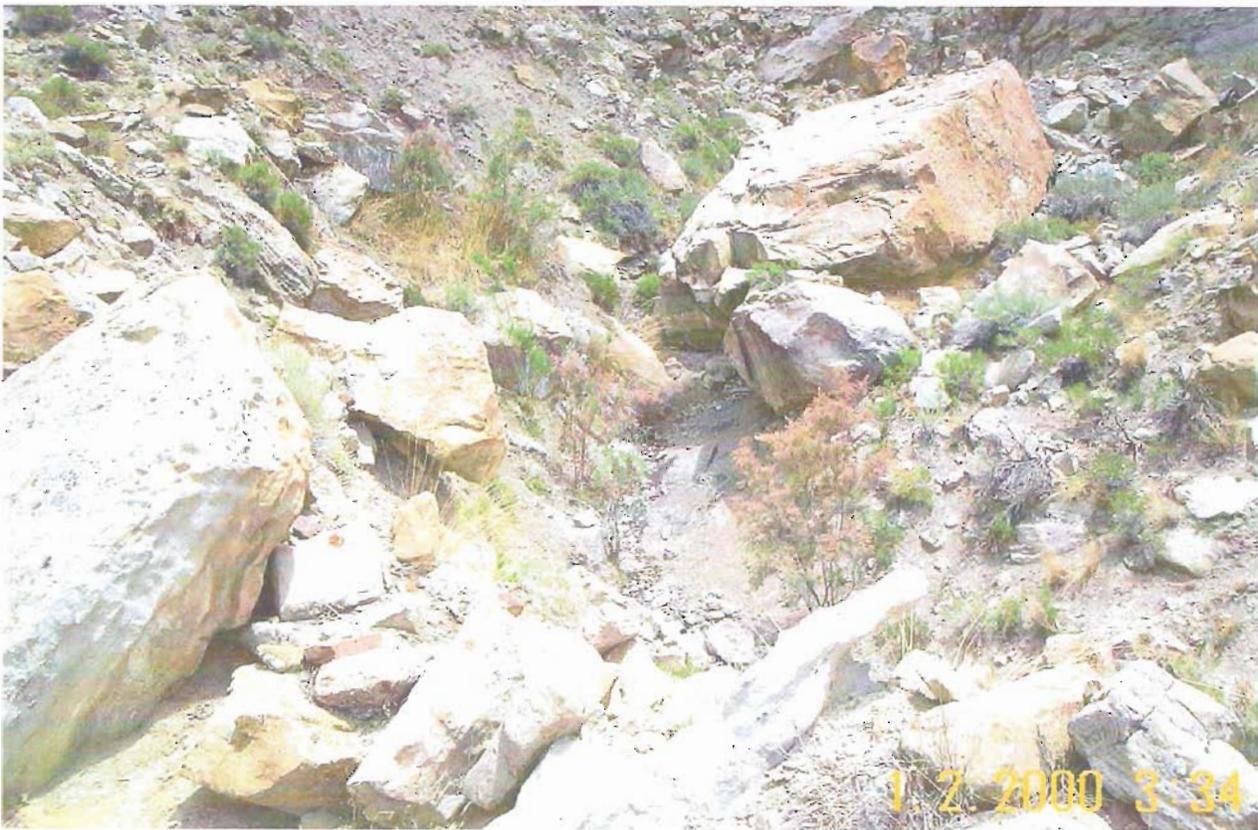
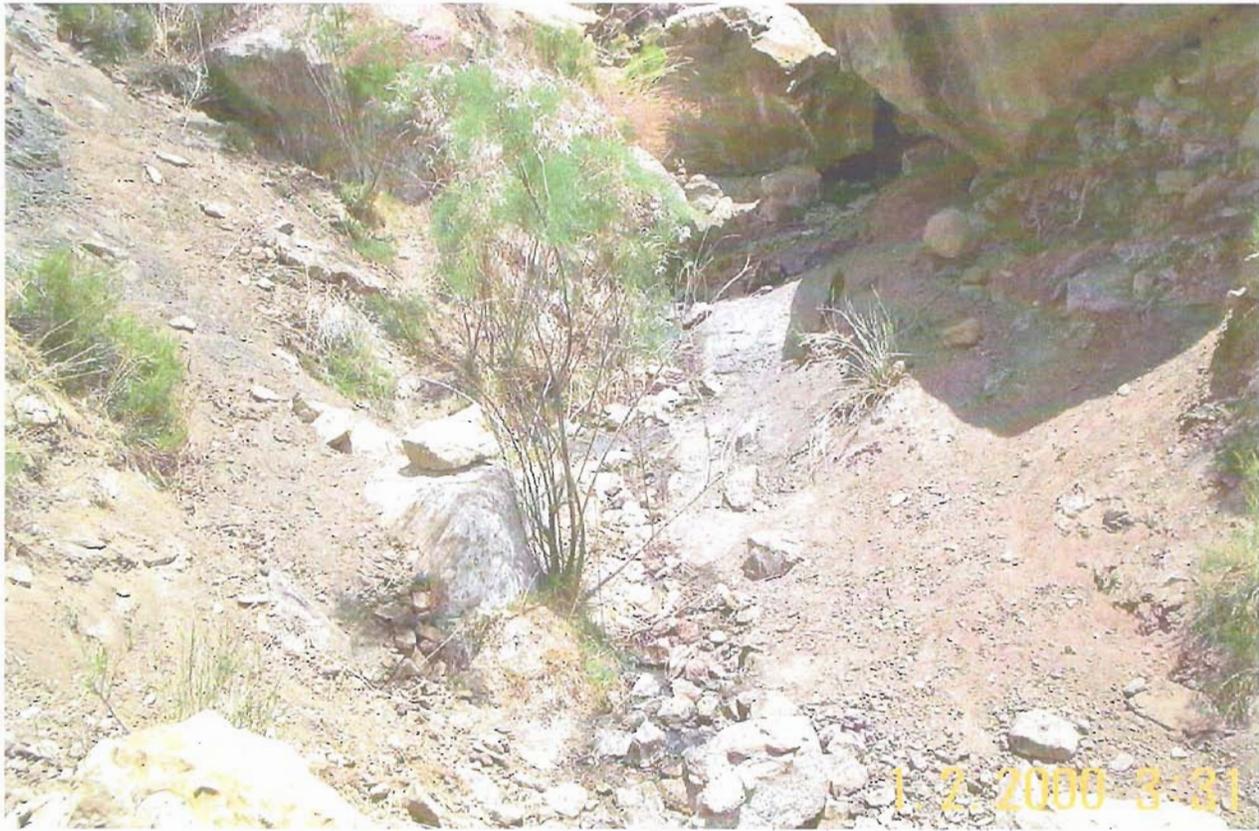
Photograph 42, 43, 50, 52, and 50A, found in Attachment #1, depicts the conditions found in Reach #9C.

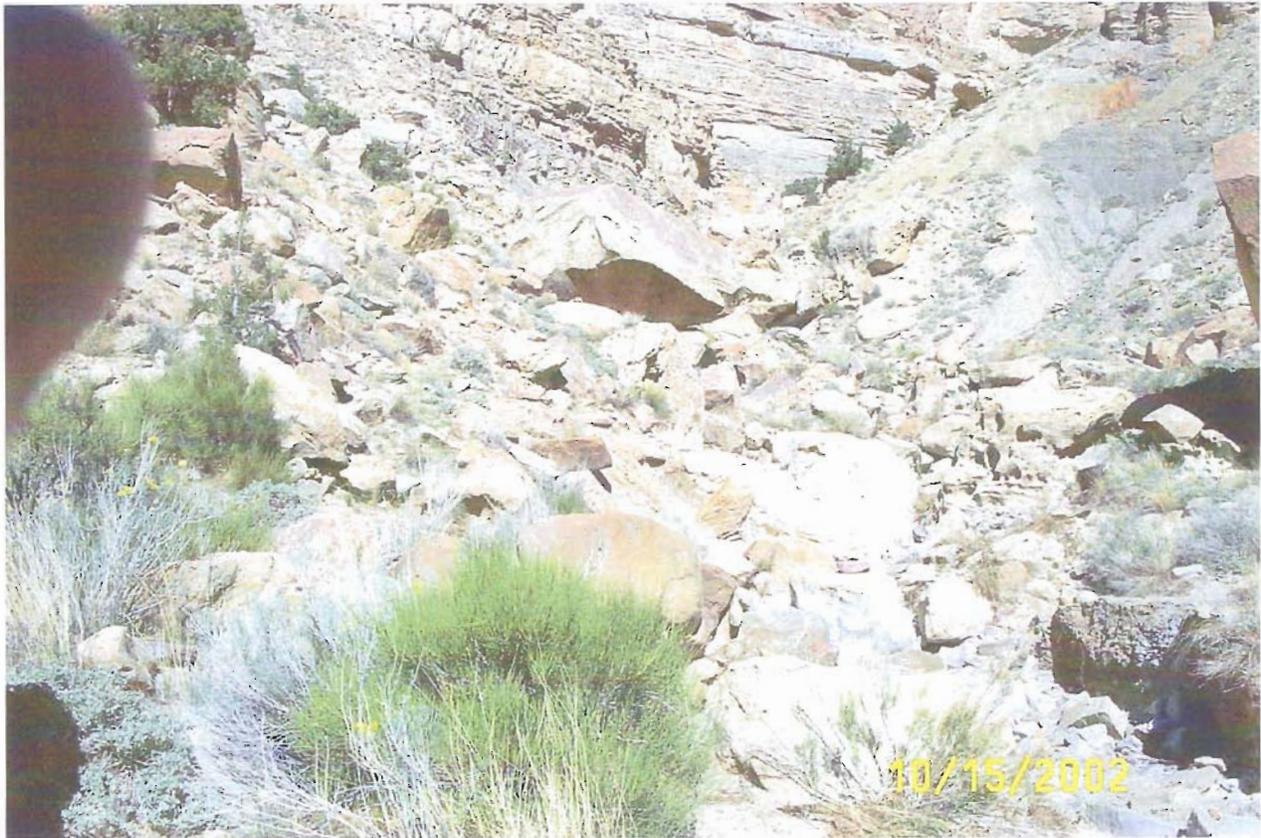
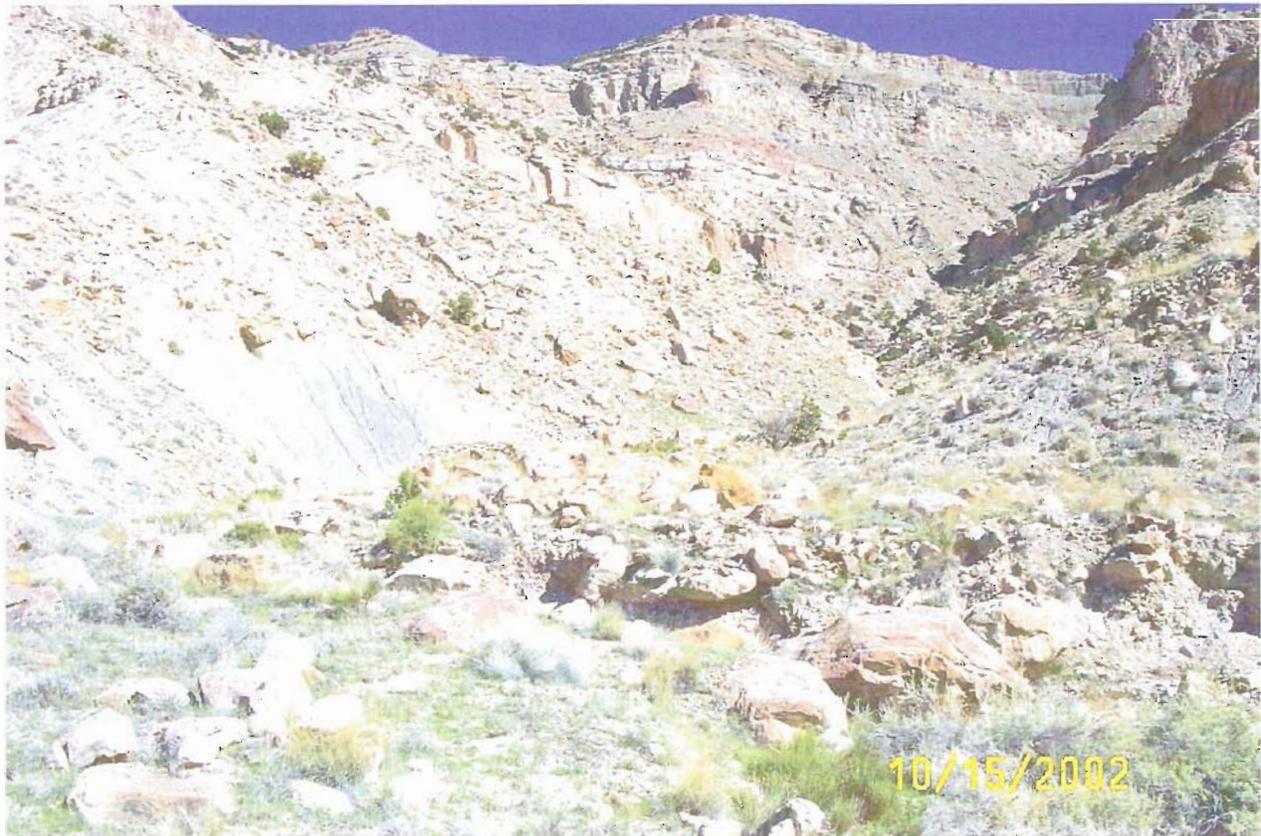
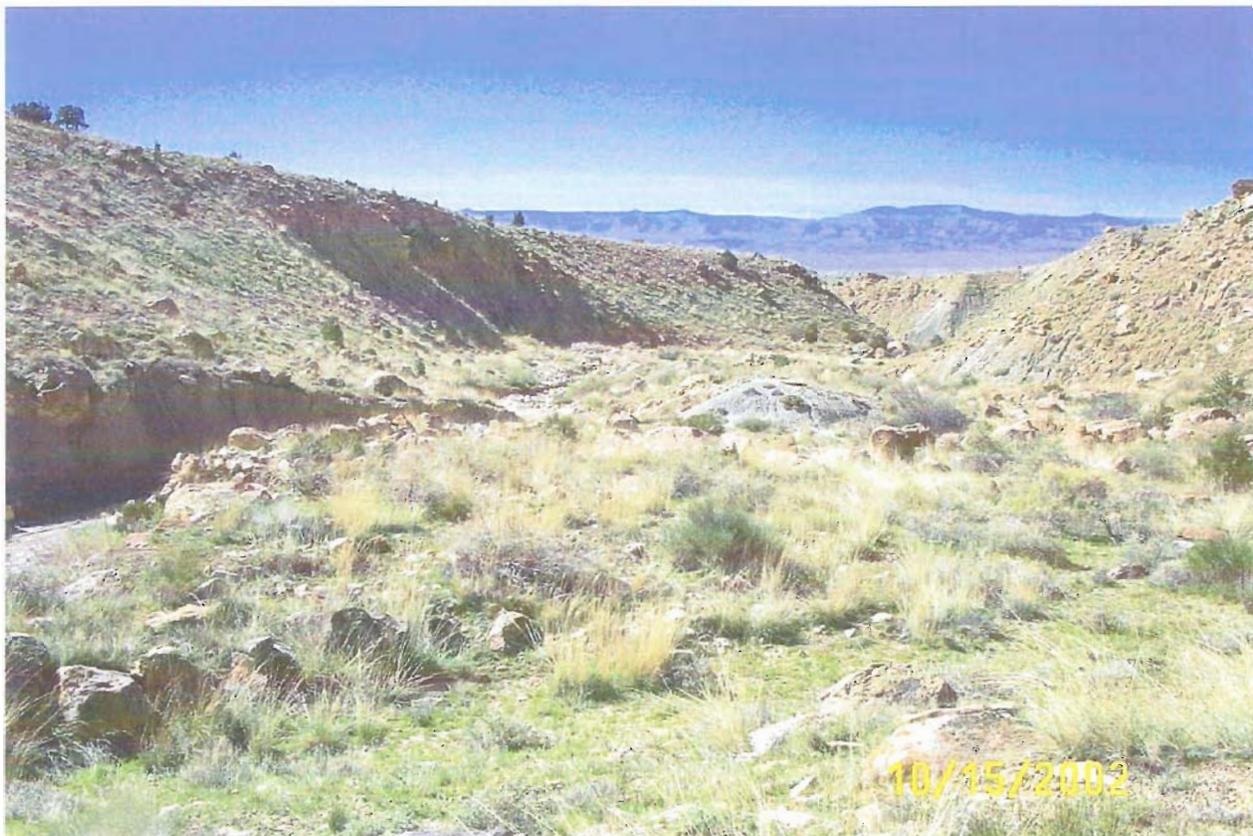
Photograph 72, 75, and 76, found in Attachment #1, depicts the conditions found in Reach #9D.

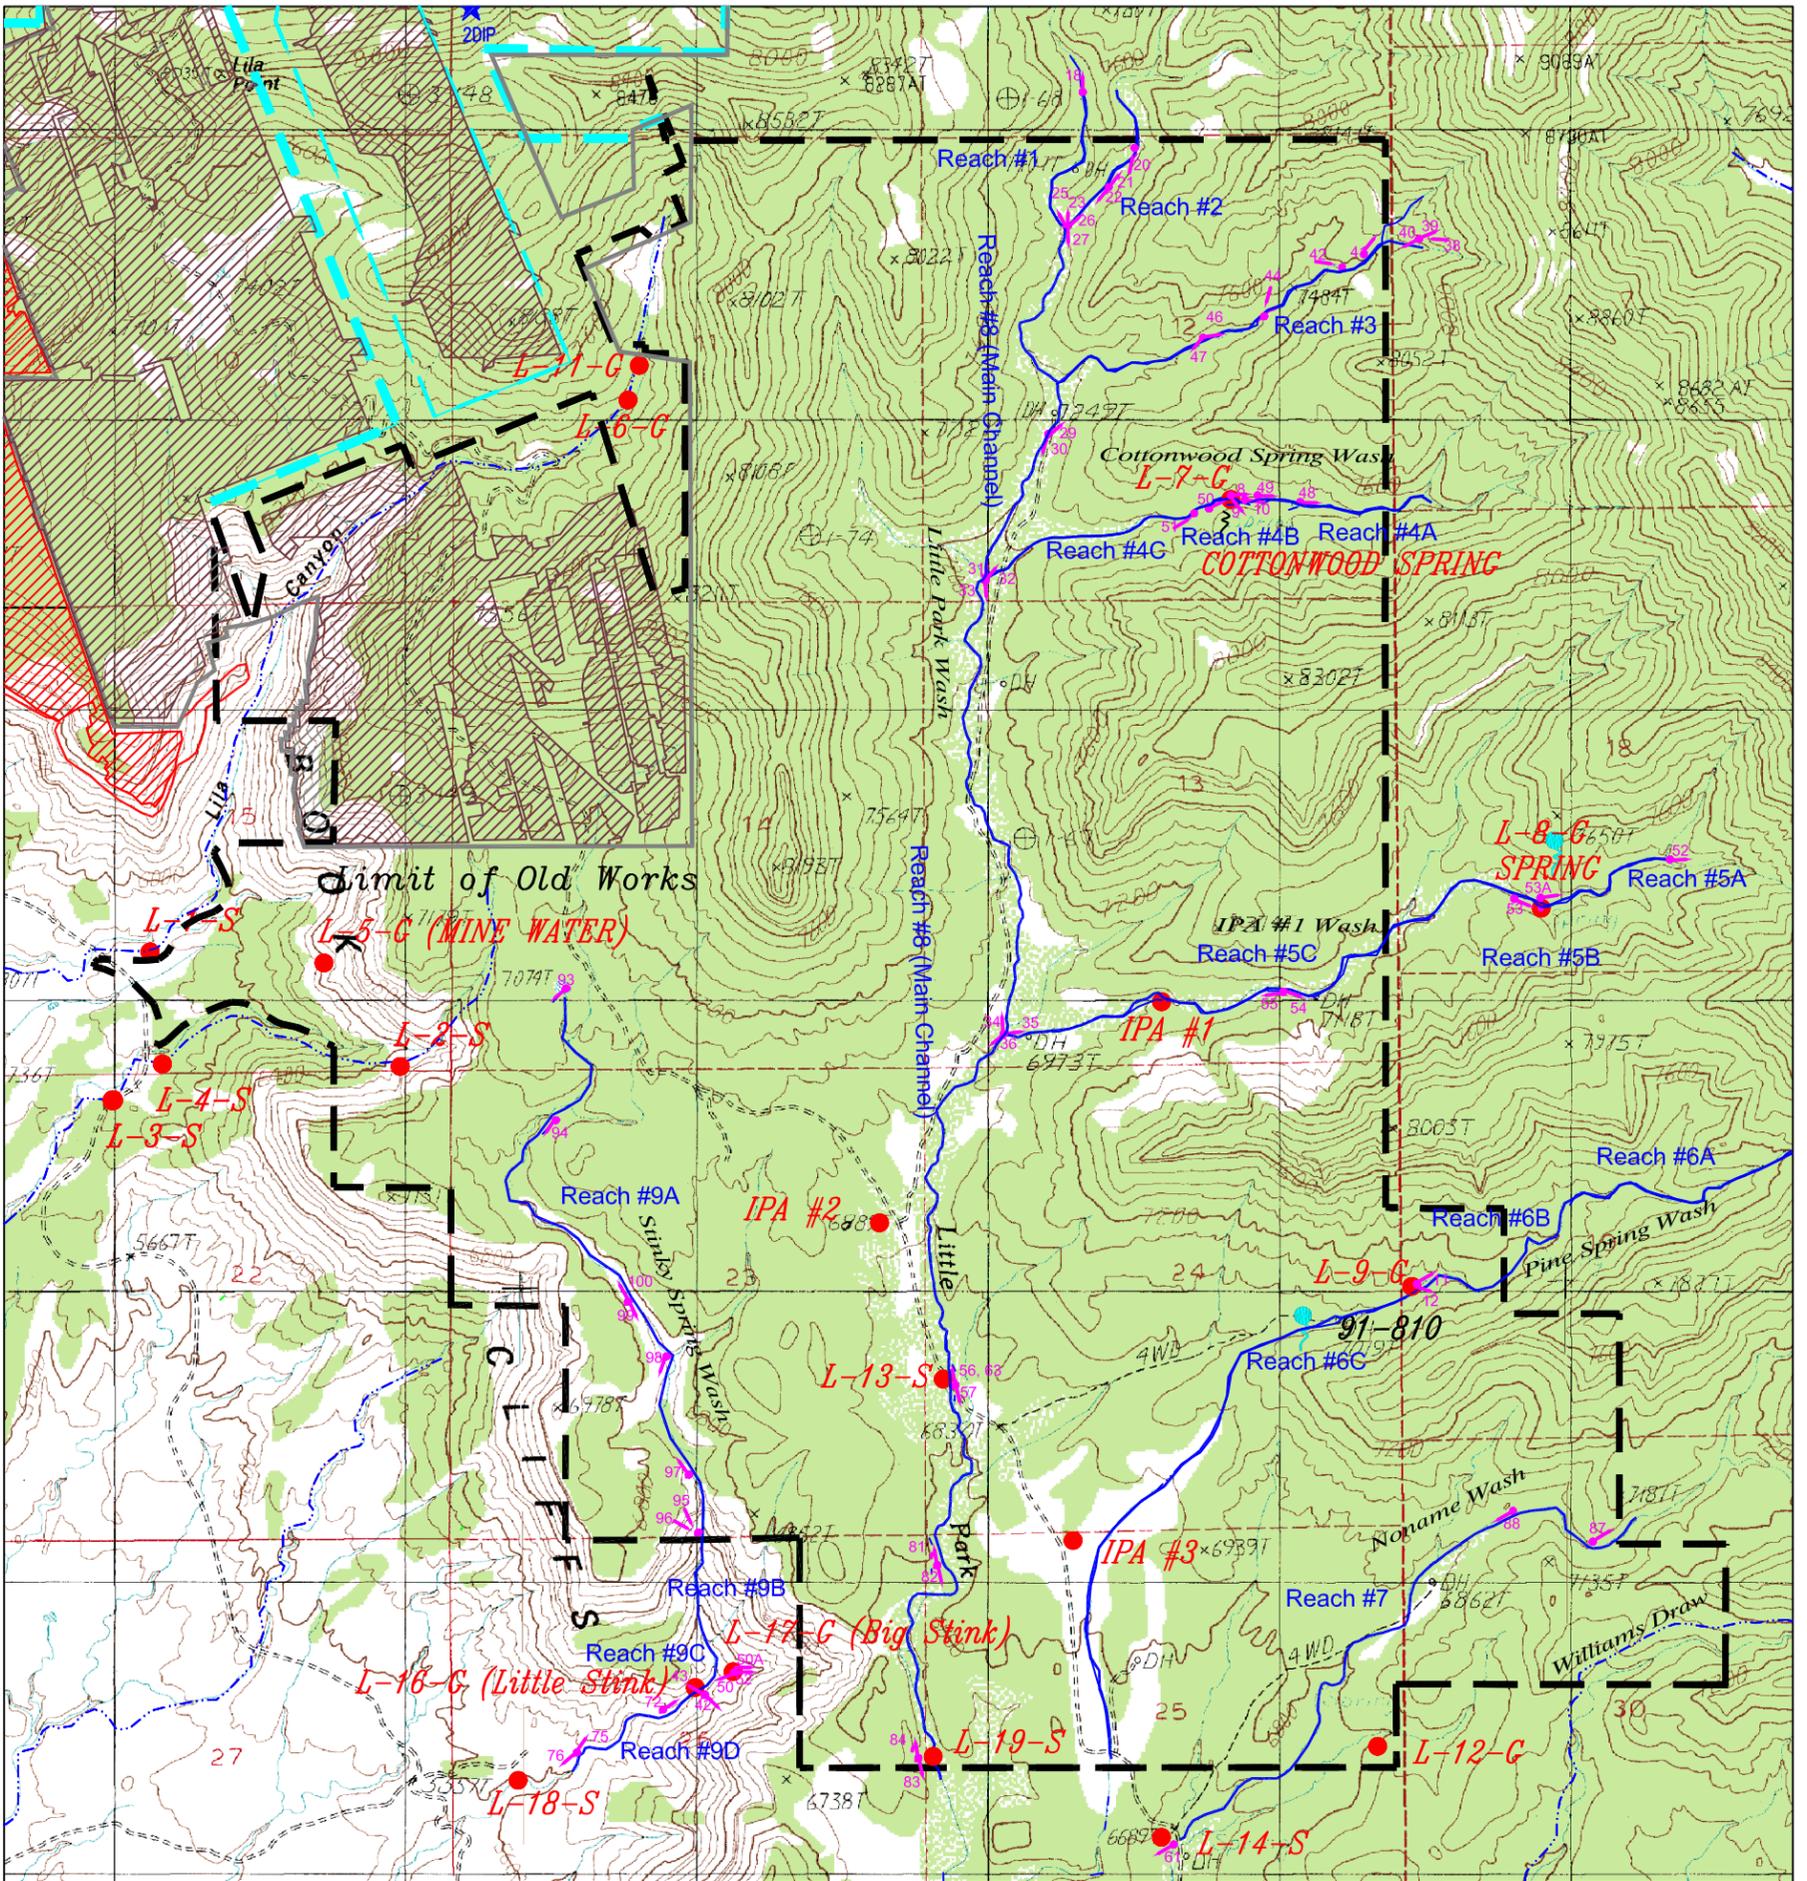
Figure 1

All Stream Reaches

Photo Locations in Magenta
