APPENDIX 7-8

Water Monitoring Location Descriptions

Last updated November 2006

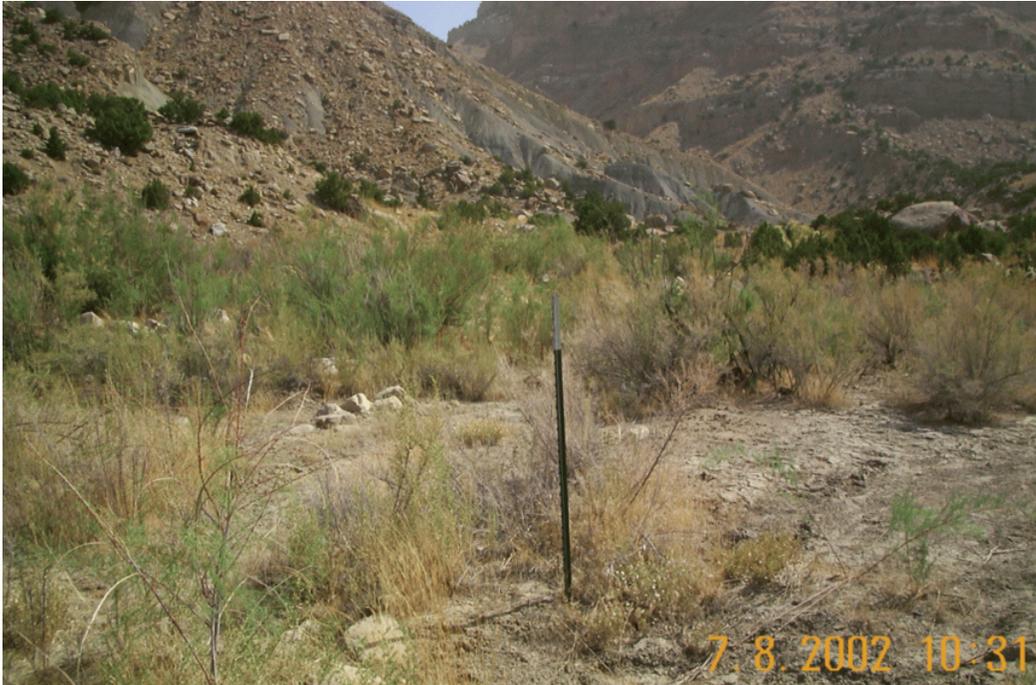
Location: In Lila Canyon wash North of the permit area. Stream reach is intermittent by definition but ephemeral acting (See Appendix 7-7 & Plate 7-4). The wash above and below flows only as a result of spring run-off or storm events. Located in the Mancos Shale at an elevation of 5,830 feet.

General: The Sunnyside coal seam does not exist at this location. Since L-1-S is located off the permit area and subsidence is not a possibility, there is no potential for Lila Canyon Mine to negatively affect this monitoring location. The permittee has never observed amphibians at or near this location.

Vegetation description: Habitat within this Mancos substrate out wash area is predominately a mix of salt desert shrub, greasewood, and invasive tamarisk and cheatgrass.

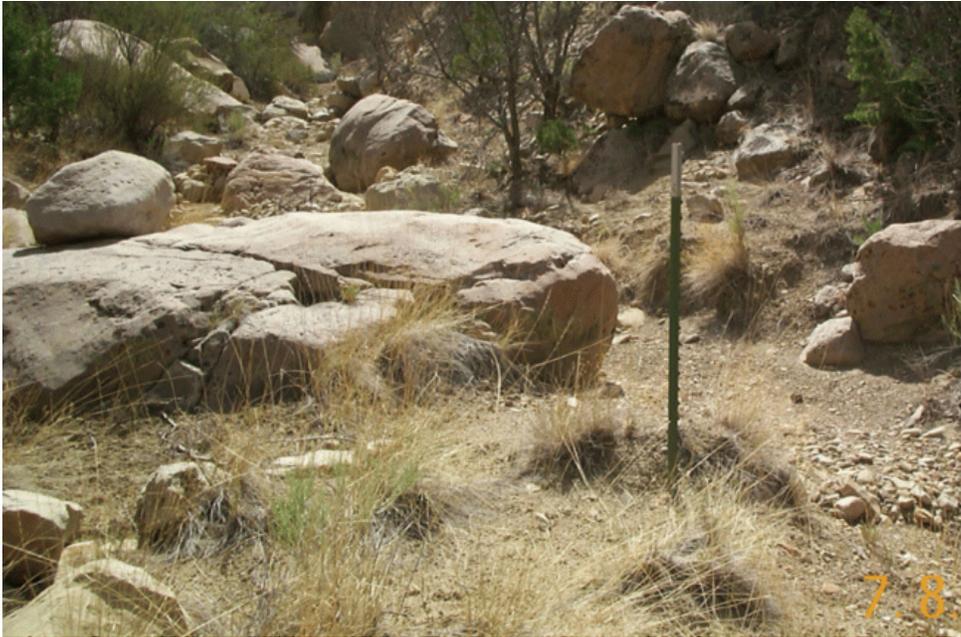
Location: L-2-S is located In the Right Fork of Lila Canyon wash South of and upstream of the permit area. Stream reach is ephemeral by definition (See Appendix 7-7& Plate 7-4). The wash above and below flows only as a result of spring run-off or storm events. Located in the Mancos Shale at an elevation of 5,950 feet.

General: The Sunnyside coal seam does not exist at this location. Since L-2-S is located off the permit area and subsidence is not a possibility, there is no potential for Lila Canyon Mine to negatively affect this monitoring location. The permittee has never observed amphibians at or near this location.

Vegetation description: Habitat overstory adjacent to the dry streambed monitoring location is Pinyon-Juniper, isolated sagebrush, and needle and thread grass.

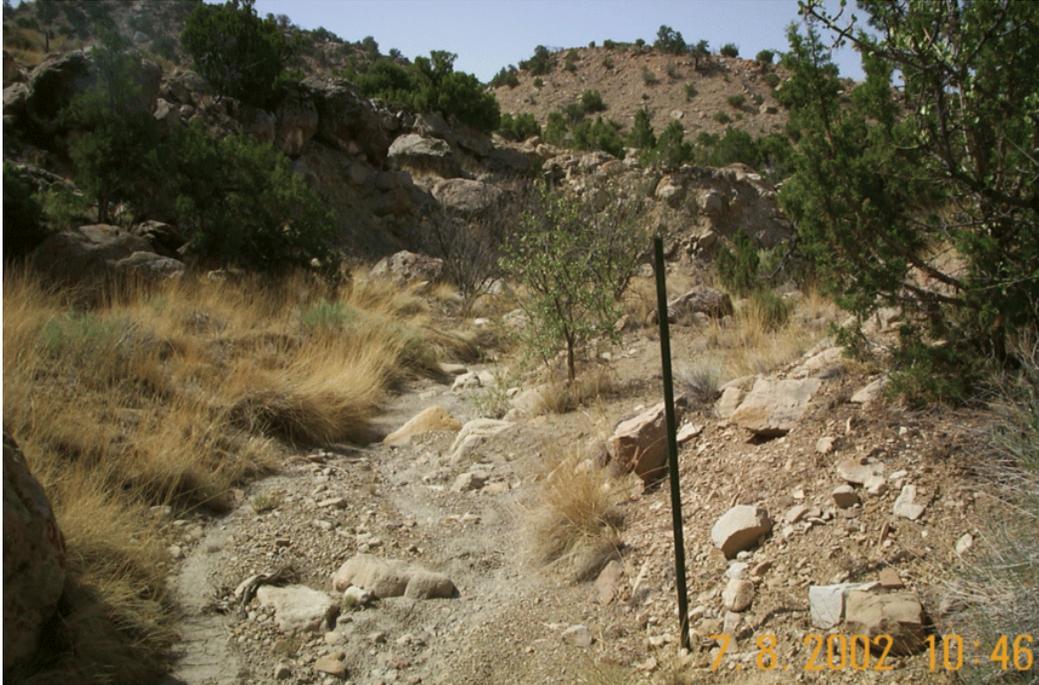
Location: Located in the Right Fork of Lila Canyon wash South of and down stream of the permit area. Stream reach is ephemeral by definition (See Appendix 7-7& Plate 7-4). The wash above and below flows only as a result of spring run-off or storm events. The Sunnyside coal seam does not exist in this location. Located in the Mancos Shale at an elevation of 5,750 feet.

General: Since L-3-S is located off the permit area and subsidence is not a possibility, there is no potential for the Lila Canyon Mine to negatively affect this monitoring location. The permittee has never observed amphibians at or near this location.

Vegetation description: Habitat overstory is a Pinyon-Juniper habitat similar to L-2-S.

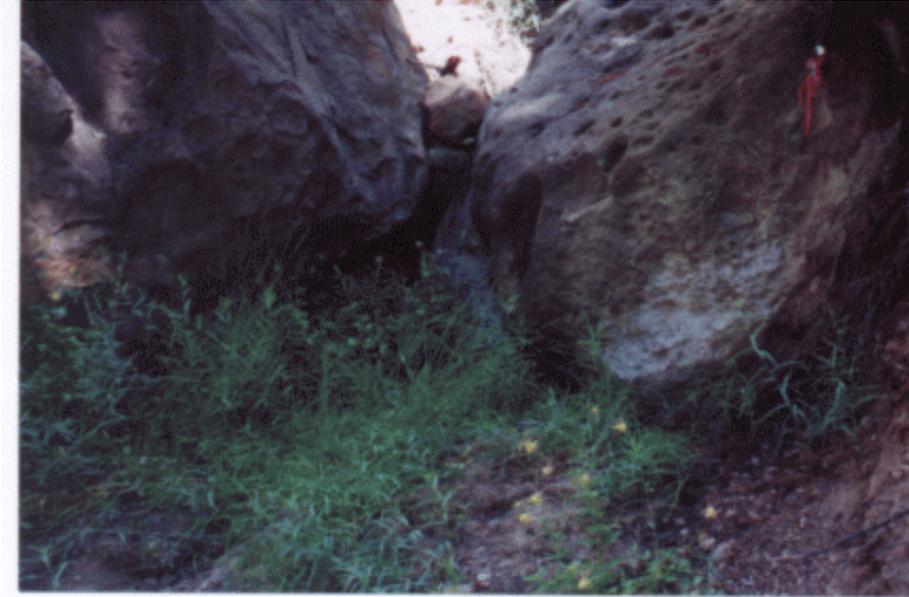
L-6-G
(H-18) Lila Canyon

Location: Located in Lila Canyon within the Permit area. The old Horse Canyon Mine has already undermined this monitoring location with no impact. Stream reach is intermittent by definition but is ephemeral acting (See Appendix 7-7 & Plate 7-4). The wash above and below the spring flows only as a result of spring run-off or storm events. Located in the Upper Price River near the contact of the Flagstaff/ North Horn and the Upper Price River Formations at an elevation of 7280 feet.

General: The coal seam has been previously mined under this location. The spring lies approximately 1,800 feet above the mined out Sunnyside coal seam. There is no potential for Lila Canyon Mine to negatively impact this monitoring location. The permittee has never observed amphibians at or near this location.

Vegetation description: Habitat overstory is Douglas Fir-Mountain Brush association.

Since the operator has never observed flow at this location, and a new location upstream has been determined to be more suitable for monitoring, this site will be terminated. L-11-G has been established to replace L-6-G as a monitoring location.

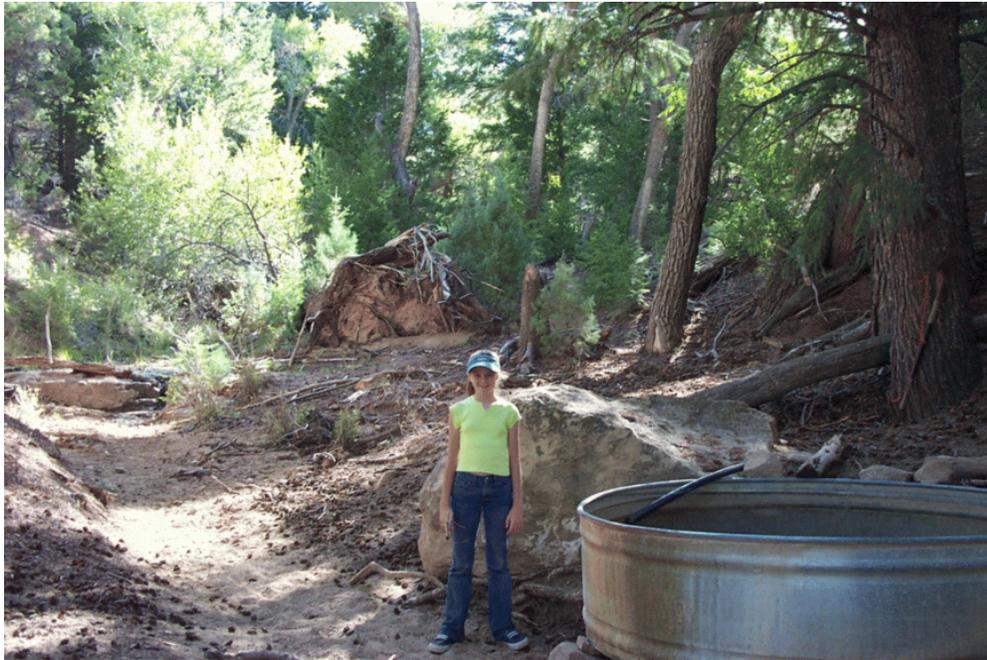
L-7-G Cottonwood Spring

Location: Located in Cottonwood Canyon approximately .5 miles from the intersection of Cottonwood Canyon with Little Park Wash. This spring is located approximately .25 miles inside the permit area. Located in the Flagstaff/North Horn Formation at an elevation of 7360 feet. Stream reach is intermittent by definition but is ephemeral acting (See Appendix 7-7 & Plate 7-4). Flow from the spring flows approximately 200 feet down stream where it evaporates or is absorbed. The drainage above and below Cottonwood spring flows only as a result of spring run-off or storm events.

General: The coal seam at this location lies approximately 2,500 feet below the spring. Due to the depth of the coal and the tendency for the overlying formations to swell and seal, there is little potential for Lila Canyon Mine to negatively impact this spring or recharge sources. The permittee has never observed amphibians at or near this location.

Vegetation description: Habitat overstory is Douglas fir-mountain brush association.

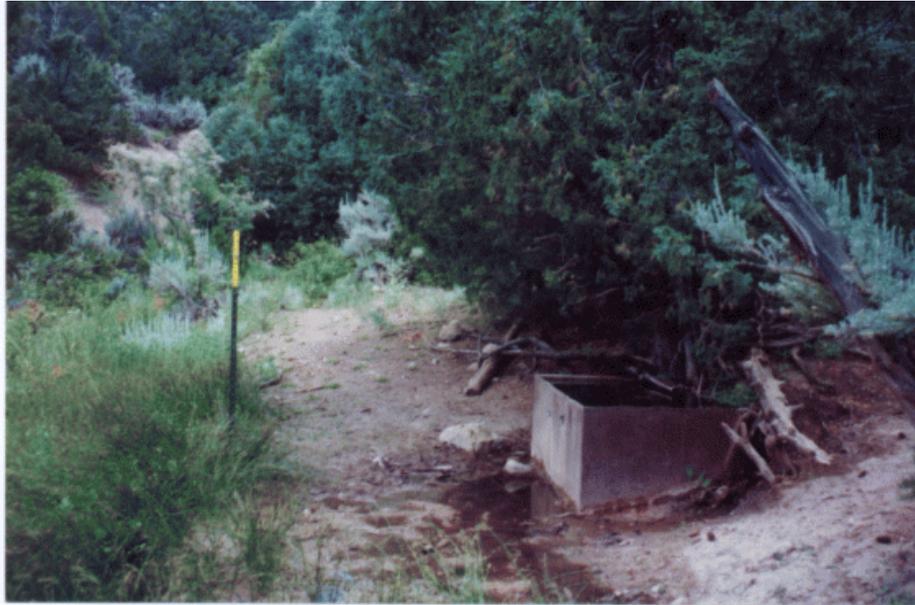
L-8-G
Above IPA #1

- Location:** L-8-G is located in an unnamed canyon that the operator refers to as IPA #1, approximately 1 mile above Piezometer IPA #1. Located in the Flagstaff/ North Horn Formation at an elevation of 7360 feet. Stream reach is intermittent by definition but is ephemeral acting (See Appendix 7-7 & Plate 7-4). Flow from the spring flows approximately 200 feet down stream where it evaporates or is absorbed. The drainage above and below this spring flows only as a result of spring run-off or storm events.

- General:** The coal seam at this location lies approximately 2,400 feet below the spring. The spring is located .5 miles to the East and off of, the permit area. Due to its location, .5 miles outside of the limit of subsidence, depth of the coal, and the tendency for the overlying formations to swell and seal, there is no potential for Lila Canyon Mine to negatively impact this spring or recharge sources. The permittee has never observed amphibians at or near this location.

- Vegetation description:** Habitat is predominantly Pinyon - Juniper and sagebrush grass associations.

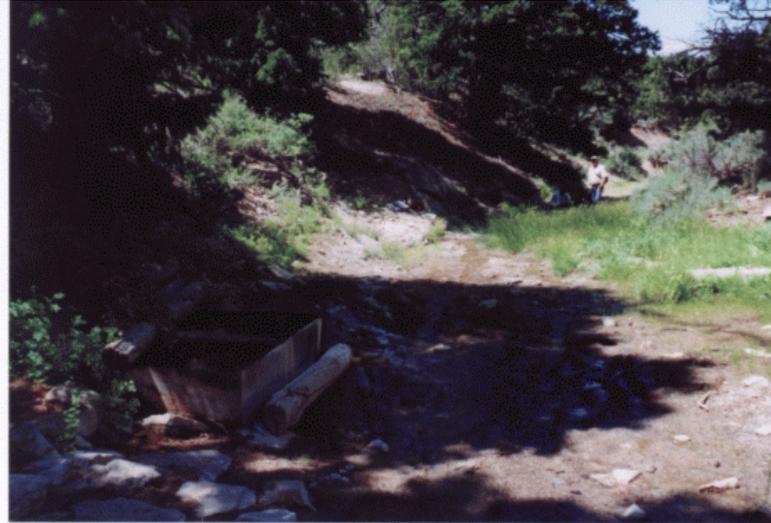
L-9-G Pine Spring

Location: L-9-G is located in an unnamed side canyon approximately 1.25 miles from Little Park Wash. Located in the Flagstaff/ North Horn Formation at an elevation of 7200 feet. Stream reach is intermittent by definition but is ephemeral acting (See Appendix 7-7 & Plate 7-4). Flow from the spring flows approximately 400 feet down stream where it evaporates or is absorbed. The drainage above and below this spring flows only as a result of spring run-off or storm events.

General: The coal seam at this location lies approximately 2,300 feet below the spring. The spring is located along the channel and just inside of the permit area. Due to its location, thickness of the overburden, and the tendency for the overlying formations to swell and seal, there is no potential for Lila Canyon Mine to negatively impact this spring or recharge sources. The permittee has never observed amphibians at or near this location.

Vegetation description: A wet meadow habitat is present within the area of the monitoring site. An overstory of Pinyon-Juniper and sagebrush grass lies immediately adjacent along each side of this site. The wet meadow habitat was washed out or covered with sand and gravel as a result of storm events in Aug 2003. Indications of localized riparian habitat exists. Moss, sedge, willow, columbine observed.

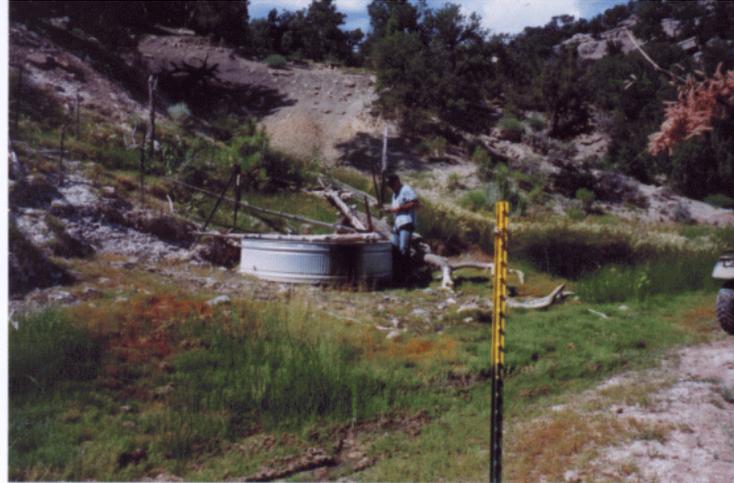
L-10-G Williams Draw Spring

Location: L-10-G is located in Williams Draw approximately 1.25 miles South and East of the permit area. Located in the Upper Price River near the contact of the Flagstaff/ North Horn and the Upper Price River Formations at an elevation of 6720 feet. Stream reach is intermittent by definition but is ephemeral acting (See Appendix 7-7 & Plate 7-4). Flow from the spring flows approximately 200 feet down stream where it evaporates or is absorbed. The drainage above and below this spring flows only as a result of spring run-off or storm events.

General: The coal seam at this location lies approximately 1250 feet below the spring. The spring is located over a mile outside of the limit of subsidence. Due to its location, outside the limit of subsidence, depth of the coal, and the tendency for the overlying formations to swell and seal, there is no potential for Lila Canyon Mine to negatively impact this spring or recharge sources. The permittee has never observed amphibians at or near this location.

Vegetation description: A wet meadow habitat is present within the area of the monitoring site. An overstory of Pinyon-Juniper and sagebrush grass lies immediately adjacent along each side of this site.

Since this spring location is so far off the permit area a better site was identified where the information gathered would be more valuable. This site will be replaced by L-12-G.

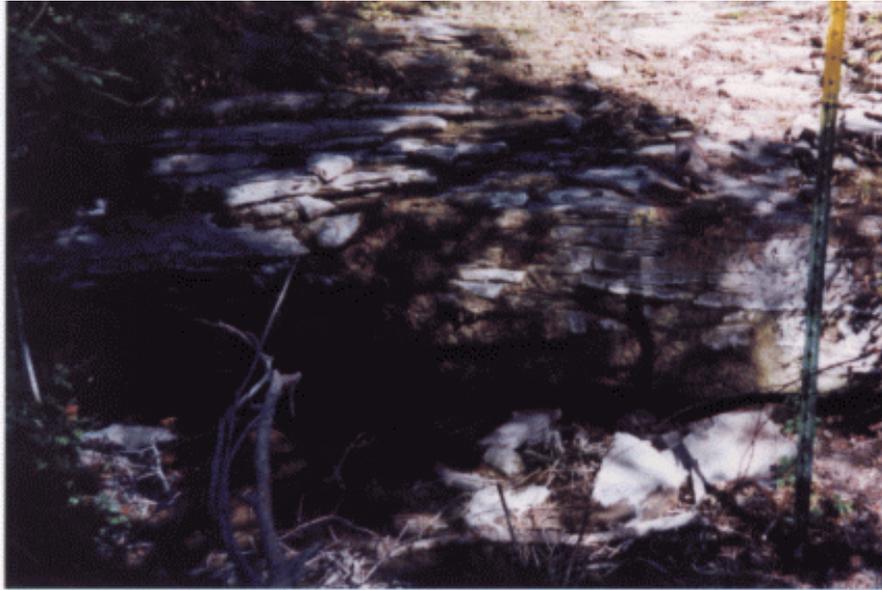
L-11-G
Mont/Leslie Springs Area
Will Replace L-6-G

Location: L-11-G is located in Lila Canyon within the Permit area. Located in the Upper Price River near the contact of the Flagstaff/ North Horn and the Upper Price River Formations at an elevation of 7360 feet. The old Horse Canyon Mine has already undermined this monitoring location with no impact. The spring flows for approximately 50 feet where it either evaporates or is absorbed. Stream reach is intermittent by definition but is ephemeral acting (See Appendix 7-7 & Plate 7-4). The wash flows only as a result of spring run-off or storm events.

General: The coal seam has been previously mined at this location. The spring lies approximately 1,900 feet above the mined out Sunnyside coal seam. There is no potential for Lila Canyon Mine to negatively impact this monitoring location. The permittee has never observed amphibians at or near this location.

Vegetation description: Habitat overstory is Douglas fir-mountain brush association.

This monitoring location will replace L-6-G.

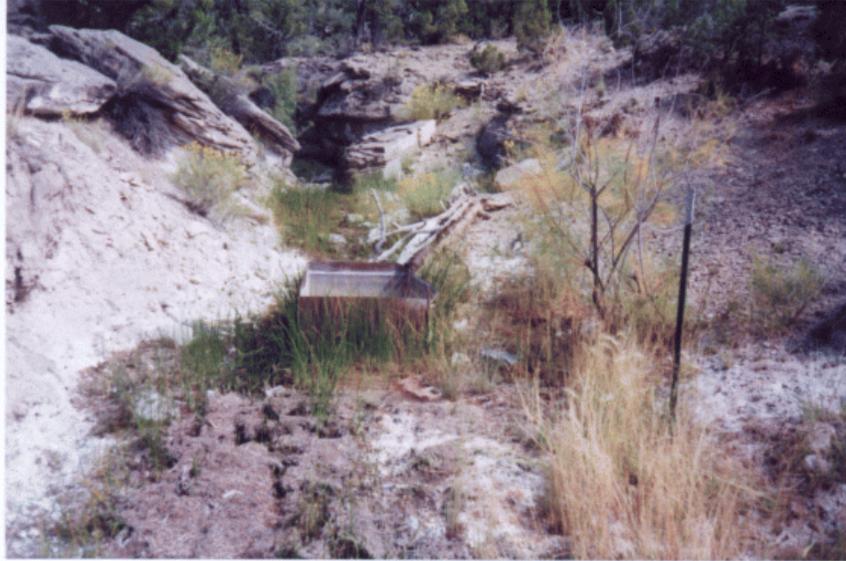
L-12-G
Will Replace L-10-G

- Location:** L-12-G is located in an unnamed drainage on the south end of the permit area. Located in the Upper Price River at an elevation of 6800 feet. Stream reach is intermittent by definition but is ephemeral acting (See Appendix 7-7 & Plate 7-4). Flow from the spring flows approximately 100 feet down stream where it evaporates or is absorbed. The drainage above and below this spring flows only as a result of spring run-off or storm events.

- General:** The coal seam at this location lies approximately 1100 feet below the spring. The spring is located just outside of the limit of subsidence. Due to its location, outside the limit of subsidence, depth of the coal, and the tendency for the overlying formations to swell and seal, there is no potential for Lila Canyon Mine to negatively impact this spring or recharge sources. The permittee has never observed amphibians at or near this location.

- Vegetation description:** A small wet meadow habitat is present within the area of the monitoring site. An overstory of Pinyon-Juniper and sagebrush grass lies immediately adjacent along each side of this site.

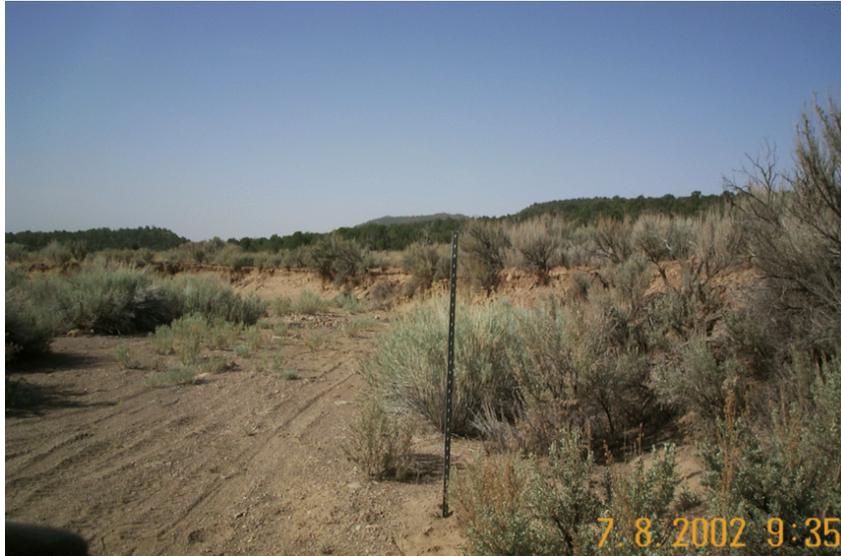
L-13-S Little Park Wash

Location: L-13-S is located in Little Park Wash at the road intersection. Located in Alluvium adjacent to the Upper Price River Formation at an elevation of 6840 feet. Stream reach is intermittent by definition but is ephemeral acting (See Appendix 7-7 & Plate 7-4). The drainage above and below this monitoring location flows only as a result of spring run-off or storm events.

General: The coal seam at this location lies approximately 1400 feet below the monitoring location. Due to its location, depth of the coal, and the tendency for the overlying formations to swell and seal, there is no potential for Lila Canyon Mine to negatively impact this monitoring location. The permittee has never observed amphibians at or near this location.

Vegetation description: The area surrounding the dry wash monitoring site consists primarily of mature sagebrush habitat.

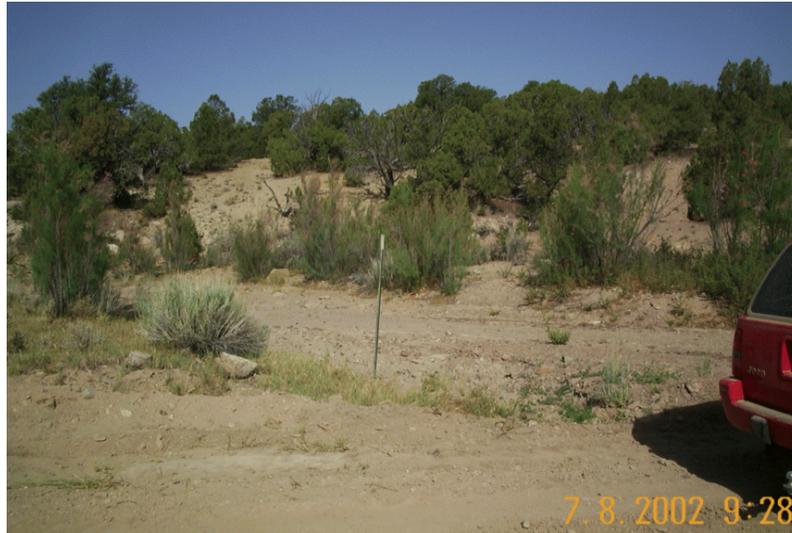
L-14-S Wash Below L-12-G

Location: L-14-S is located at the road intersection of the unnamed drainage below L-12-G. Located in the Upper Price River Formation at an elevation of 6690 feet. Stream reach is intermittent by definition but is ephemeral acting (See Appendix 7-7 & Plate 7-4). The drainage above and below this monitoring location flows only as a result of spring run-off or storm events.

General: The coal seam at this location lies approximately 1000 feet below the monitoring location. Due to the faulting this monitoring location is outside the mine projections and the projected limit of subsidence. As a result of its location, depth of the coal, and the tendency for the overlying formations to swell and seal, there is no potential for Lila Canyon Mine to negatively impact this monitoring location. The permittee has never observed amphibians at or near this location.

Vegetation description: The area surrounding the dry wash monitoring site consists primarily of mature sagebrush habitat with a bordering overstory of Pinyon-Juniper and invasive tamarisk..

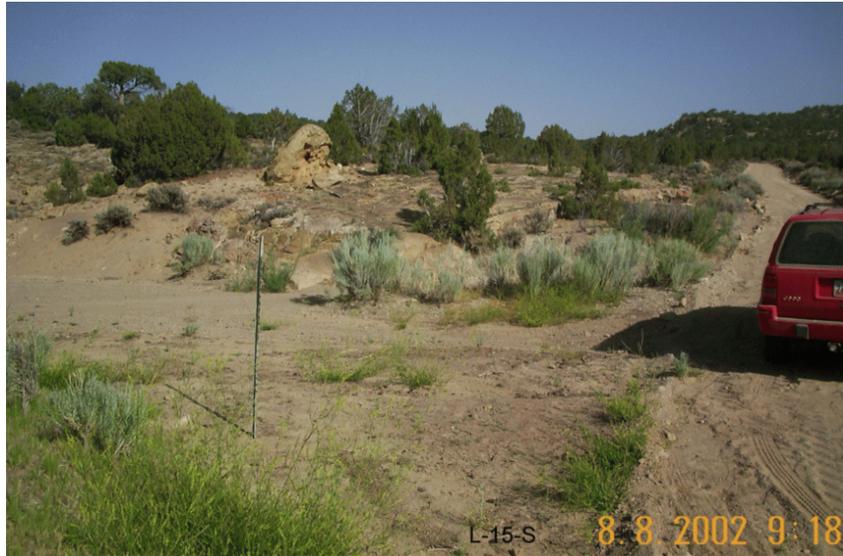
Location: L-15-S is located at the road intersection of Williams Draw. Located in Alluvium adjacent to the Upper Price River Formation at an elevation of 6560 feet. The stream reach is intermittent by definition but is ephemeral acting (See Appendix 7-7 & Plate 7-4). The drainage above and below this monitoring location flows only as a result of spring run-off or storm events.

General: The coal seam at this location lies approximately 900 feet below the monitoring location. This site is located 1.25 miles South of the permit boundary. As a result of its location, there is no potential for Lila Canyon Mine to negatively impact this monitoring location. The permittee has never observed amphibians at or near this location.

Vegetation description: The area surrounding the dry wash monitoring site consists primarily of mature sagebrush and Pinyon-Juniper habitat.

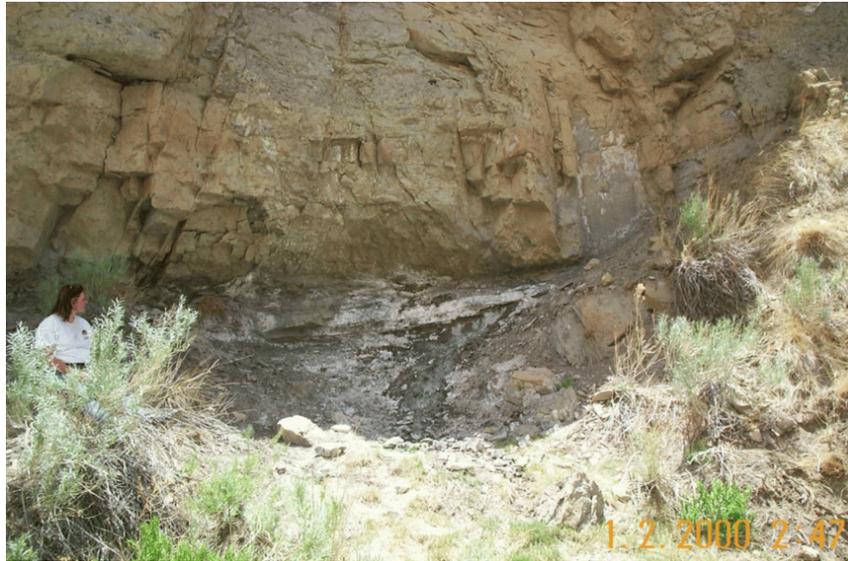
L-16-G Little Stink

Location: Located in what has recently been named Stinky Spring Canyon by the Operator. The seep is located approximately 0.25 miles to the West of the permit area and within the Central Graben. The seep is located at the top of the Mancos Shale approximately 600 feet below the coal seam in a highly faulted area at an elevation of 5840 feet. The stream reach is intermittent by definition but is ephemeral acting (See Appendix 7-7 & Plate 7-4). The drainage above and below this monitoring location flows only as a result of spring run-off or storm events.

General: Due to its location, outside the permit area, outside the limit of subsidence, within the Central Graben, and being 600 feet below the coal seam, there is no potential for Lila Canyon Mine to negatively impact this spring or recharge sources. This location is used by Rocky Mountain Bighorn Sheep; however, no evidence of the sheep using the poor quality water has been documented. The permittee has never observed amphibians at or near this location.

Vegetation description: Habitat immediately below this wet seep monitoring site is a mix of grasses and salt desert shrub habitat.

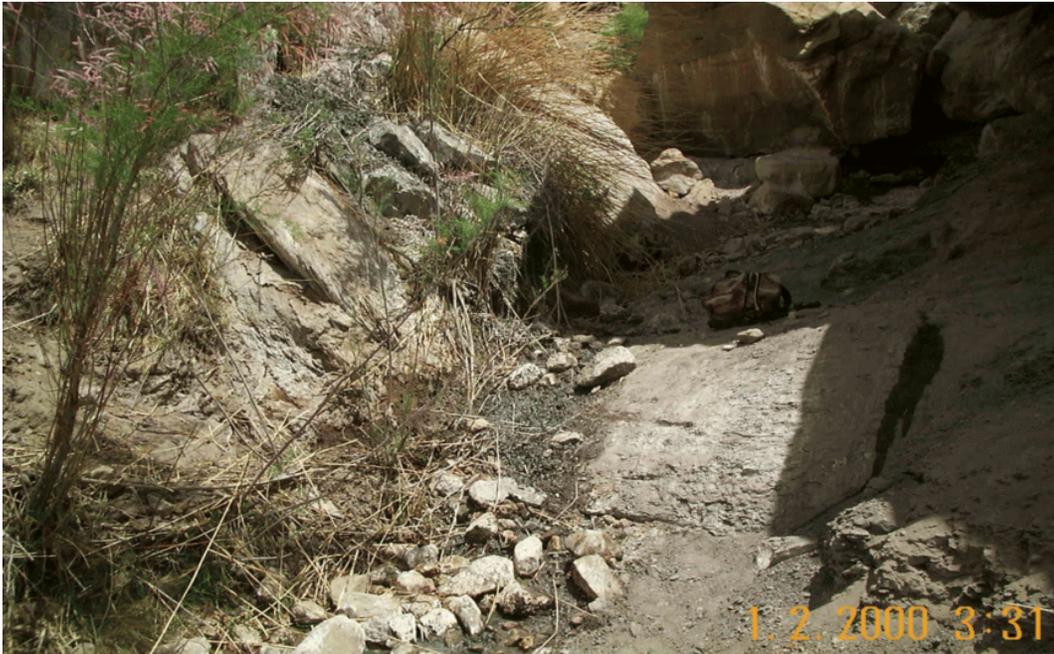
L-17-G Big Stink

Location: Located in what has recently been named Stinky Spring Canyon. The seep is located approximately 0.25 miles to the West of the permit area, 0.1 mile above L-16-S, and within the Central Graben. The seep is located at the top of the Mancos Shale approximately 500 feet below the coal seam in a highly faulted area at an elevation of 5920 feet. The stream reach is intermittent by definition but is ephemeral acting (See Appendix 7-7 & Plate 7-4). The drainage above and below this monitoring location flows only as a result of spring run-off or storm events.

General: Due to its location, outside the permit area, outside the limit of subsidence, and being 500 feet below the coal seam, there is no potential for Lila Canyon Mine to negatively impact this stream reach. This location is used by Rocky Mountain Bighorn Sheep; however, no evidence of the sheep drinking the poor quality water has been documented. The permittee has never observed amphibians at or near this location.

Vegetation description: Habitat immediately below this wet seep monitoring site is a mix of grasses and salt desert shrub habitat and invasive tamarisk.

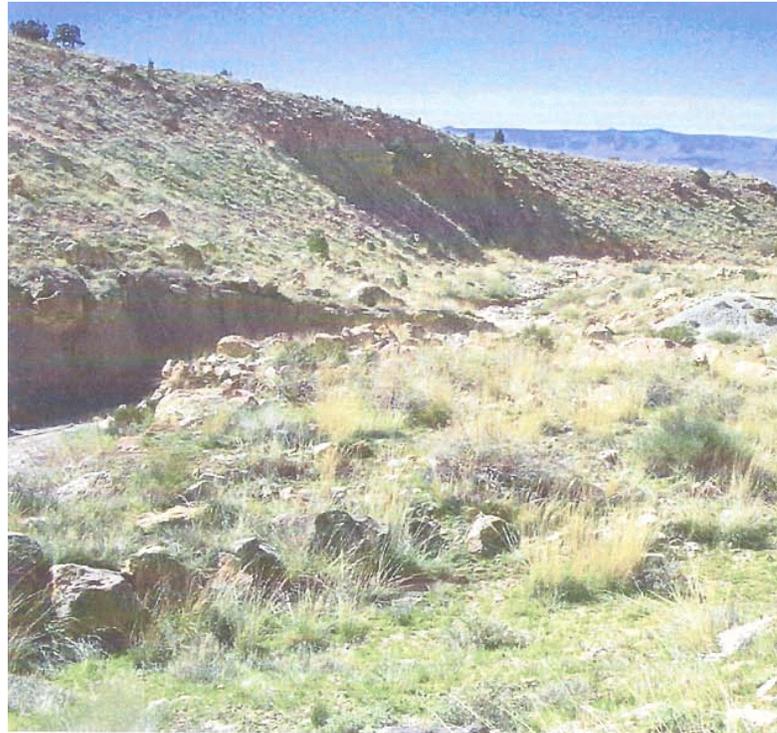
L-18-S Stinky Spring Wash

Location: Loca ted in what has recently been named Stinky Spring Canyon. The stream reach is intermittent by definition but is ephemeral acting (See Appendix 7-7 & Plate 7-4). The drainage above and below this monitoring location flows only as a result of spring run-off or storm events.

General: Due to its location, outside the permit area, outside the limit of subsidence, and being 500 feet below the coal seam, there is no potential for Lila Canyon Mine to negatively impact this spring or recharge sources. This location is used by Rocky Mountain Bighorn Sheep; however, no evidence of the sheep drinking the poor quality water has been documented. The permittee has never observed amphibians at or near this location.

Vegetation description: The area surrounding the dry wash monitoring site consists primarily of mature sagebrush and Pinyon-Juniper habitat.

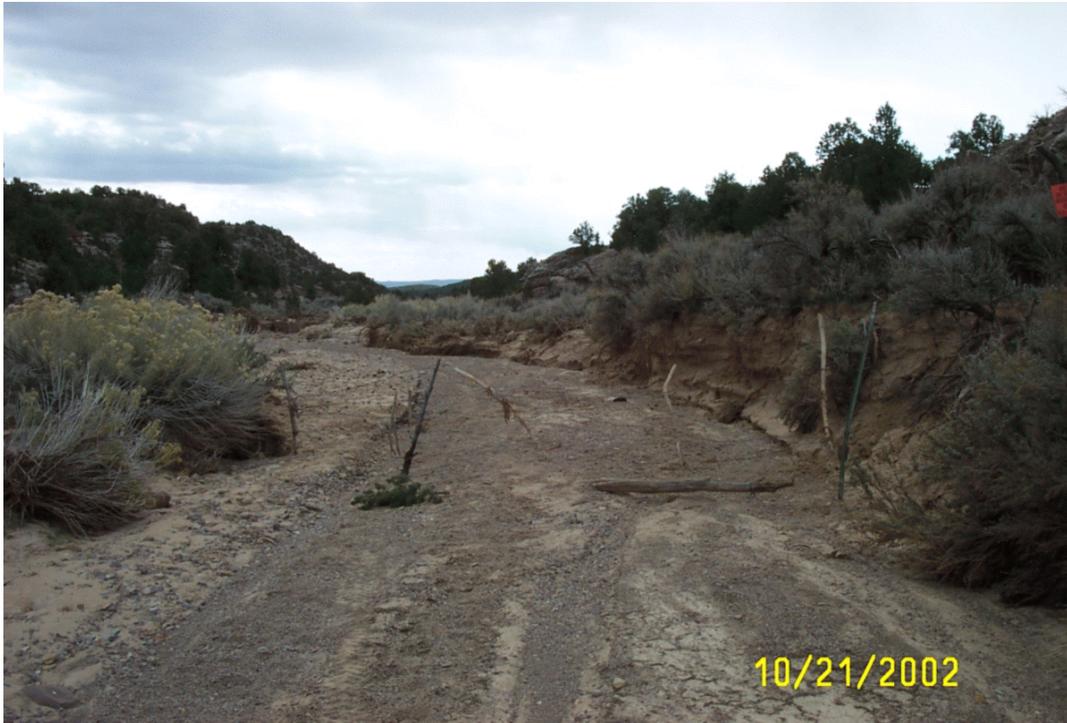
L-19-S Little Park Wash

L-19-S is located in Little Park Wash at the permit boundary. The flow at this site is nearly the same as for L-13-S. There are no contributing sources between the two sites other than overland flow. Essentially, the data already recorded for site L-13-S is representative of the new site. Located in Alluvium adjacent to the Upper Price River Formation at an elevation of 6725 feet. Stream reach is intermittent by definition but is ephemeral acting (See Appendix 7-7 & Plate 7-4). The drainage above and below this monitoring location flows only as a result of spring run-off or storm events.

General: The coal seam at this location lies approximately 1400 feet below the monitoring location. Due to its location outside of the subsidence area, depth of the coal, and the tendency for the overlying formations to swell and seal, there is no potential for Lila Canyon Mine to negatively impact this monitoring location. The permittee has never observed amphibians at or near this location.

Vegetation description: The area surrounding the dry wash monitoring site consists primarily of mature sagebrush habitat.

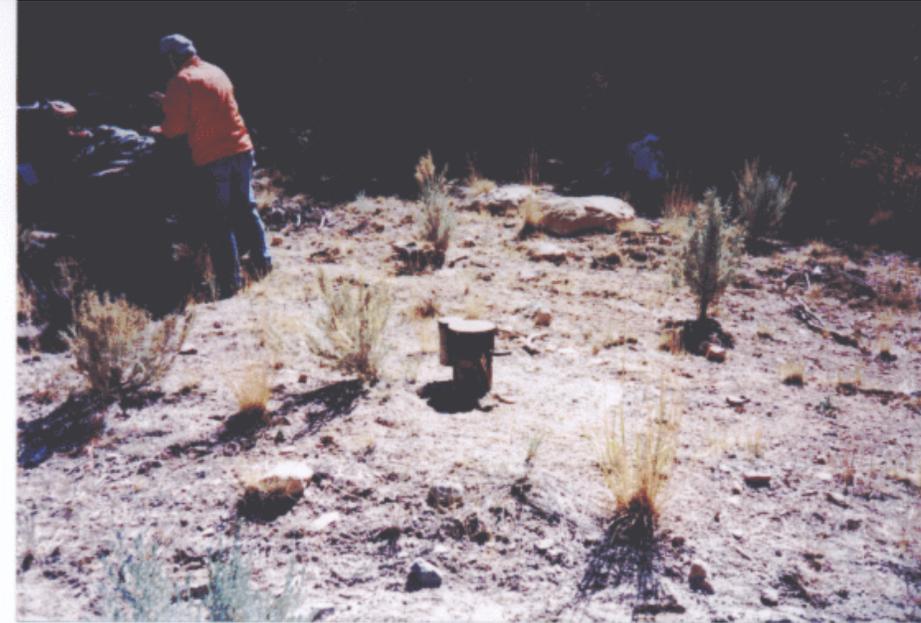
**IPA #1
Piezometer**

Location: Located in an unnamed canyon that is a branch of Little Park Wash. Located in the Upper Price River Formation at an elevation of 7034 feet. See Plate 7-4 for location.

General: This site is used as a Piezometer measuring location only. The depth of water is measured quarterly.

Vegetation description: Habitat surrounding this Piezometer site is sagebrush-grass.

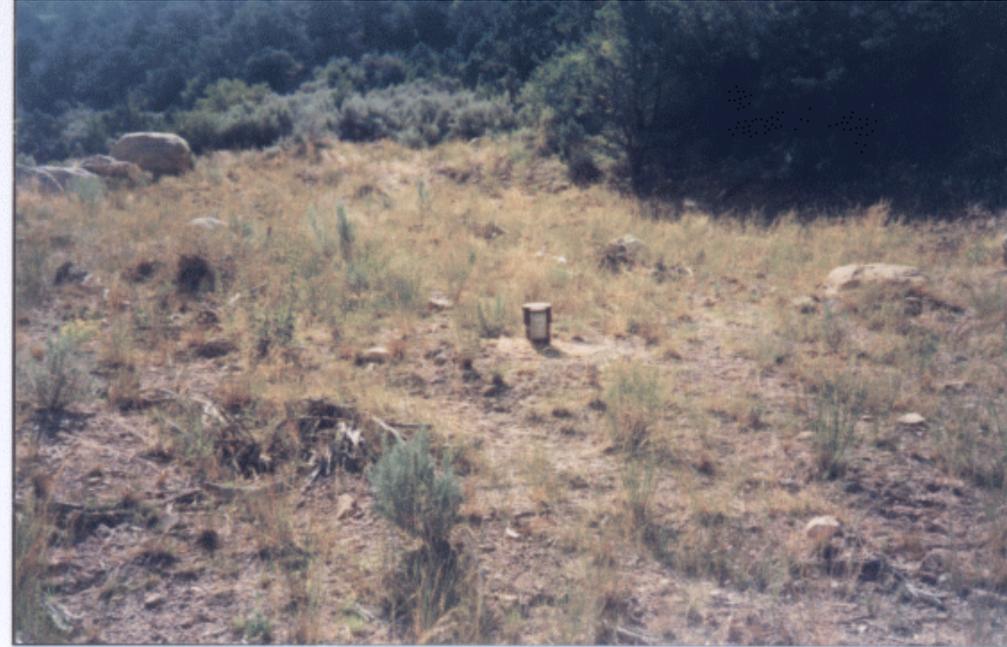
IPA #2
Piezometer

Location: Located on the Little Park Wash road near the Little Park Wash crossing. See Plate 7-4 for location. Located in the Upper Price River Formation at an elevation of 6865 feet.

General: This site is used as a Piezometer measuring location only. The depth of water is measured quarterly.

Vegetation description: Habitat surrounding this Piezometer site is sagebrush-grass.

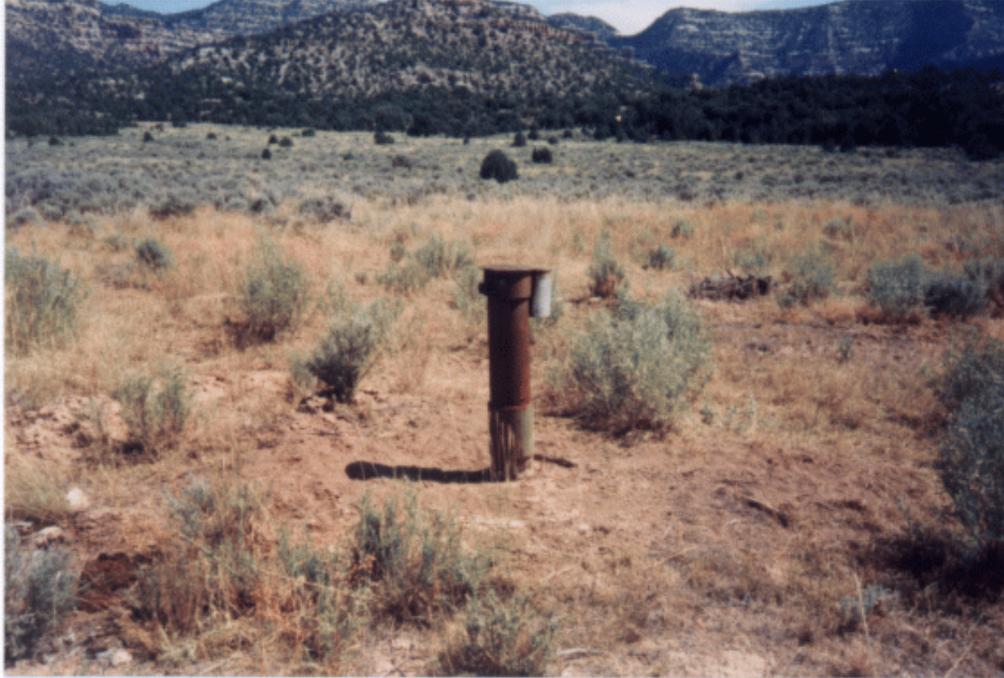
**IPA #3
Piezometer**

Location: Located on the Little Park Wash road. See Plate 7-4 for location. Located in the Upper Price River Formation at an elevation of 6810 feet.

General: This site is used as a Piezometer measuring location only. The depth of water is measured quarterly.

Vegetation description: Habitat surrounding this Piezometer site is sagebrush-grass.

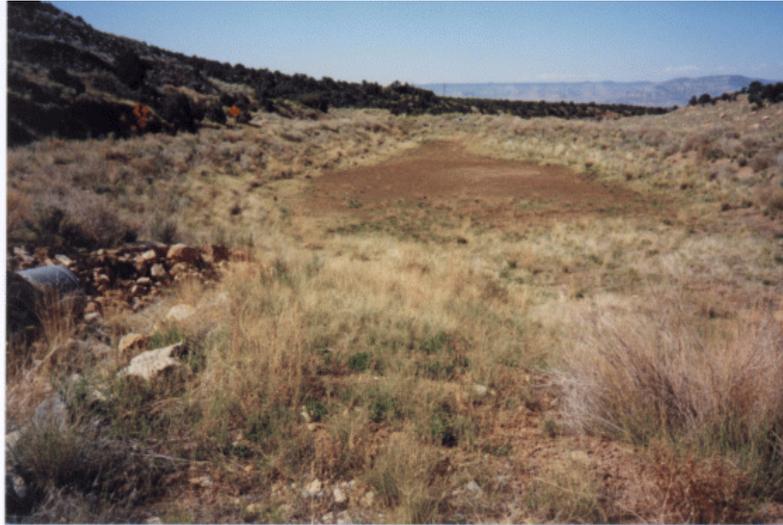
**Horse Canyon
Sediment Pond #2
UPDES #002A**

Location: Located in Horse Canyon above and to the North of the bridge on County highway 124. Located in an alluvial fan on the Mancos Shale at an elevation of 6190 feet.

General: This is UPDES site #002A of the Horse Canyon UPDES permit. The Sunnyside coal seam does not exist in this location. There is no potential for Lila Canyon Mine to negatively affect this monitoring site. The permittee has never observed amphibians at or near this location.

Vegetation description: This reseeded sediment pond is covered by a reclamation vegetation cover consistent with a sagebrush-grass habitat.

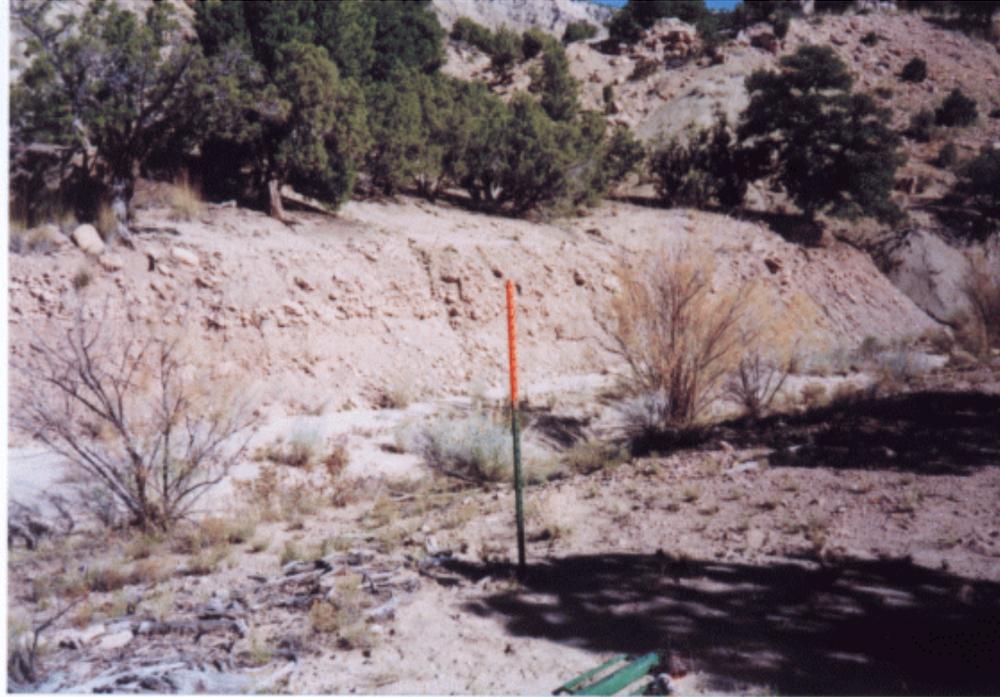
HC-2 (B-1)

Location: HC-2 is located in Horse Canyon Wash West and downstream of the permit area. Located in an alluvial fan on the Mancos Shale at an elevation of approximately 6100 feet. Stream reach is ephemeral by definition (See Appendix 7-7& Plate 7-4). The wash above and below flows only as a result of spring run-off or storm events.

General: The Sunnyside coal seam does not exist in this location. Since this site is located off the permit area and subsidence is not a possibility, there is no potential for Lila Canyon Mine to negatively affect this monitoring location. The permittee has never observed amphibians at or near this location.

Vegetation description: This dry channel monitoring location is surrounded by a Pinyon-Juniper overstory. Vegetation within the ephemeral acting channel is a mix of sagebrush, salt desert shrub and invasive tamarisk habitats.

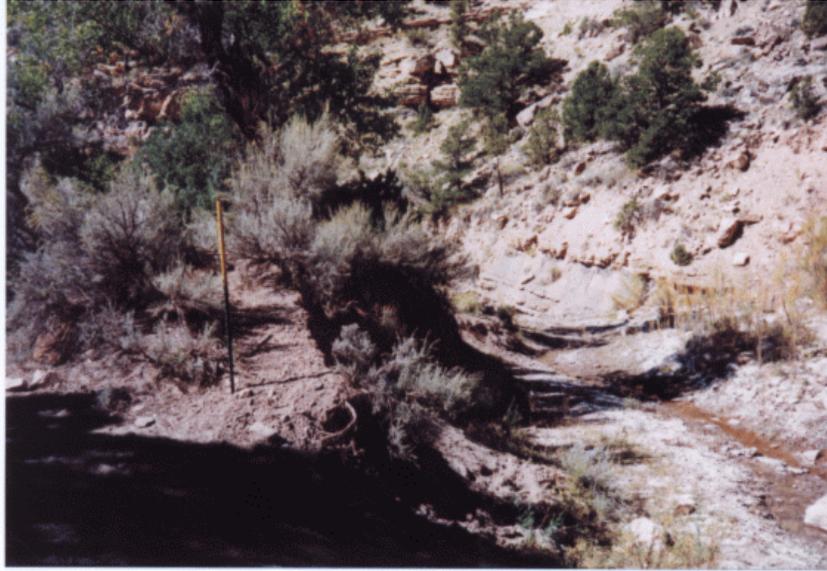
HC-1 Horse Canyon Above Permit Area

- Location:** HC-1 is located in Horse Canyon Wash within the permit area, near the Carbon Emery county lines. Located in the Upper Price River Formation at an elevation of 6480 feet. Flow appears to be perennial due to spring inflow in the immediate area. Stream reach below this monitoring point is intermittent by definition but exhibits ephemeral flow patterns. The wash above and below flows only as a result of spring run-off or storm events.

- General:** The coal seam has been previously mined at this location. The monitoring location lies approximately 300 feet above the mined out Sunnyside coal seam. There is no potential for Lila Canyon Mine to negatively impact this monitoring location. The permittee has never observed amphibians at or near this location.

- Vegetation description:** This wet channel monitoring location is surrounded by mature sagebrush and Pinyon-Juniper habitats. Invasive tamarisk is present within the channel.

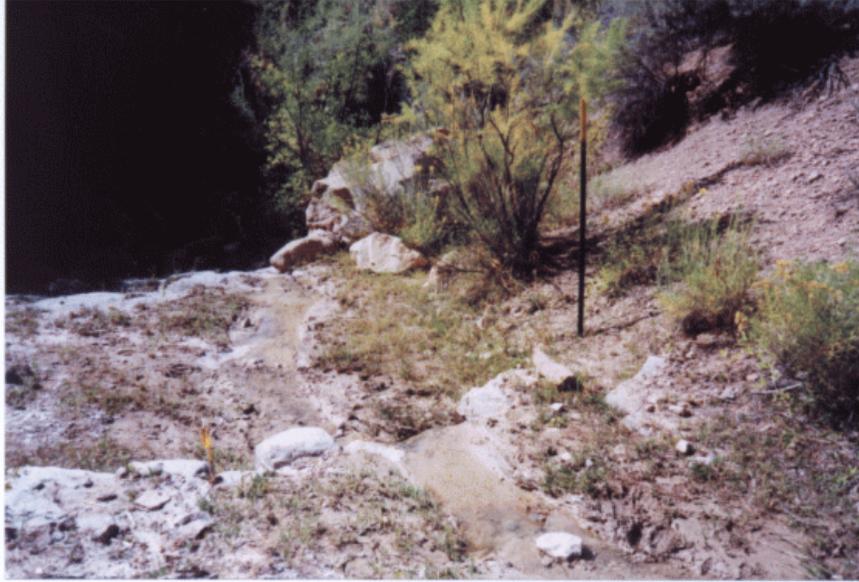
RF-1 Right Fork

Location: RF-1 is located in the right fork of Horse Canyon Wash near the road forks but within the permit area. Located in the Upper Price River Formation at an elevation of 6480 feet. Flow appears to be perennial due to Redden Spring inflow. Flow continues for approximately 300 feet below the monitoring location where the stream reach becomes ephemeral. The wash 700 feet below flows only as a result of spring run-off or storm events.

General: The coal seam has been previously mined at this location. The monitoring location lies approximately 300 feet above the mined out Sunnyside coal seam. There is no potential for Lila Canyon Mine to negatively impact this monitoring location. The permittee has never observed amphibians at or near this location.

Vegetation description: This wet channel monitoring location is surrounded by mature sagebrush and Pinyon-Juniper habitats. Invasive tamarisk is present within the channel.

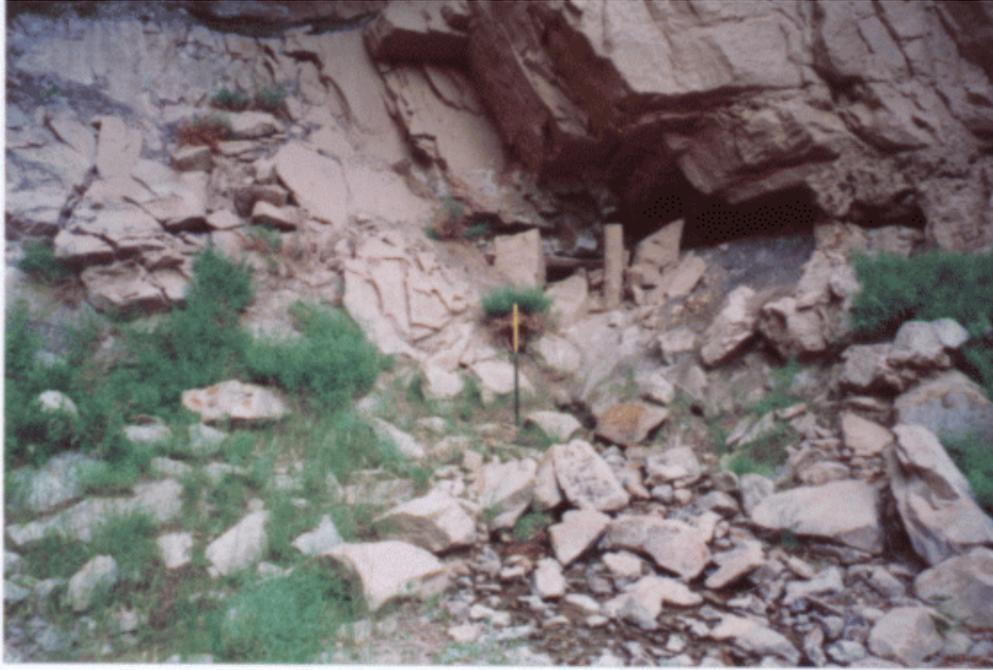
RS-2 Redden Spring

- Location:** Redden Spring is located in the right fork of Horse Canyon Wash near the road forks but within the permit area. Located at the base of the Flagstaff/North Horn Formation at an elevation of 6592 feet. The wash above flows only as a result of spring run-off or storm events.
- General:** The coal seam has been previously mined at this location. The monitoring location lies approximately 800 feet above the mined out Sunnyside coal seam. There is no potential for Lila Canyon Mine to negatively impact this monitoring location. The permittee has never observed amphibians at or near this location.
- Vegetation description:** Habitat immediately below this wet seep monitoring site is a mix of grasses and salt desert shrub habitat.
