## Inspection Report

Permit Number:	C0070013
Inspection Type:	TECHNICAL
Inspection Date:	Thursday, January 03, 2008
Start Date/Time:	1/3/2008 9:45:00 AM
End Date/Time:	1/3/2008 2:00:00 PM
Last Inspection:	Friday, December 28, 2007

Permittee: **UTAHAMERICAN ENERGY INC**  
 Operator: **UTAHAMERICAN ENERGY INC**  
 Site: **HORSE CANYON MINE**  
 Address: **PO BOX 986, PRICE UT 84501**  
 County: **CARBON**  
 Permit Type: **PERMANENT COAL PROGRAM**  
 Permit Status: **ACTIVE**

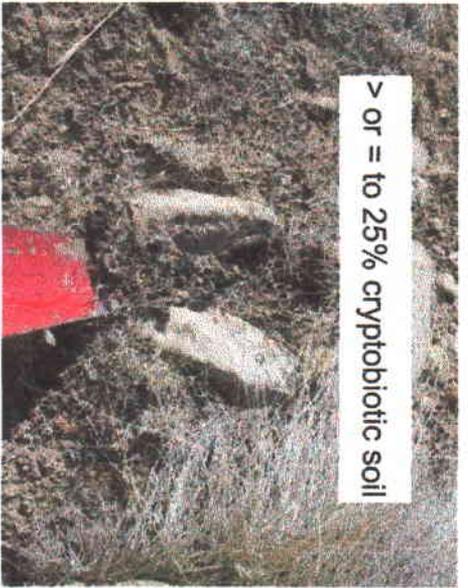
> or = to 25% cryptobiotic soil

Next, we collected 8, 5 gallon buckets of cryptobiotic soil from locations immediately north and south of the jeep trail shown on the PSE surface facilities map. The location was chosen for the ease of access and little snow cover. The approximate location was marked on Plate 2-3 Soil Salvage Map. Plate 2-3 identifies the soil as Rubbleland-Strych-Gerst (RBL) soil, where 8 inches of topsoil salvage is expected. The collected soil was from areas that had greater than or equal to 25% cover of cryptograms (Schoeneberger, P.J., et al, 1998. Field Book for Describing and Sampling Soils was used as a reference for this estimation.) A shovel of the surface soil from 0 - 2 inches deep was scooped into the buckets. The soil was not screened as described in Section 232.100, since only a very small screen was available. A field decision was made that the soil will be screened before use. The eight buckets were covered during transportation to a cool, dry and dark location (the crawl space beneath the West Ridge office). In storage, the bucket lids were left ajar, to allow moisture in the soil to evaporate. The cryptobiotic soil will be applied to the topsoil stockpiles as described in Section 234.230.

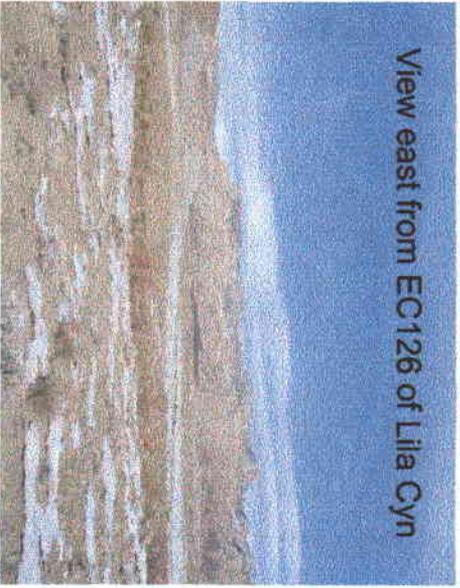
View east from EC126 of Lila Cyn

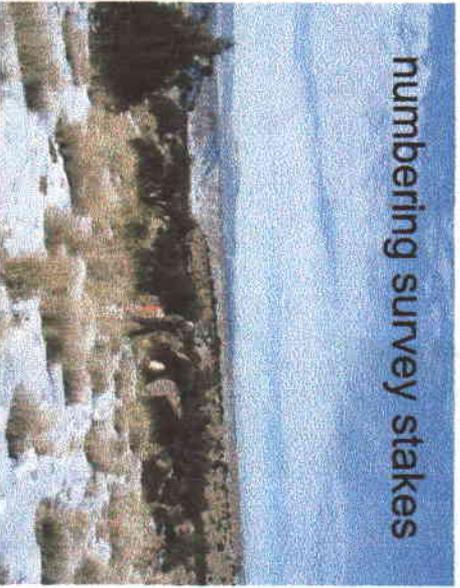
numbering survey stakes

Using a site facilities map created by Precision Services Engineering (PSE map), we walked 37 survey points that had been installed to demarcate the area that would be grubbed in the coming week. The area of grubbing includes the office, parking, topsoil, and sediment pond, that is, the lower portion of the proposed site. Survey points #8 - 11 were close to the disturbed area boundary on the Lila Canyon wash side and would be moved inward to ensure that the disturbed area drains to the sediment pond. Grubbing was started with a D6 dozer and by January 9, a backhoe was also being employed. According to Mr. Marshall, on January 9, approximately 30% of the lower portion of the site had been grubbed.
