# Inspection Report

Permit Number:	<b>C0070013</b>
Inspection Type:	COMPLETE
Inspection Date:	Monday, August 17, 2020
Start Date/Time:	8/17/2020 9:30:00 AM
End Date/Time:	8/17/2020 1:00:00 PM
Last Inspection:	Tuesday, July 28, 2020

Permittee: **UTAHAMERICAN ENERGY INC**  
 Operator: **UTAHAMERICAN ENERGY INC**  
 Site: **HORSE CANYON MINE**  
 Address: **PO BOX 910, EAST CARBON UT 84520-0910**  
 County: **CARBON**  
 Permit Type: **PERMANENT COAL PROGRAM**  
 Permit Status: **ACTIVE**

**ATTACHMENT A – Photos Lila Canyon August 17, 2020 site visit**

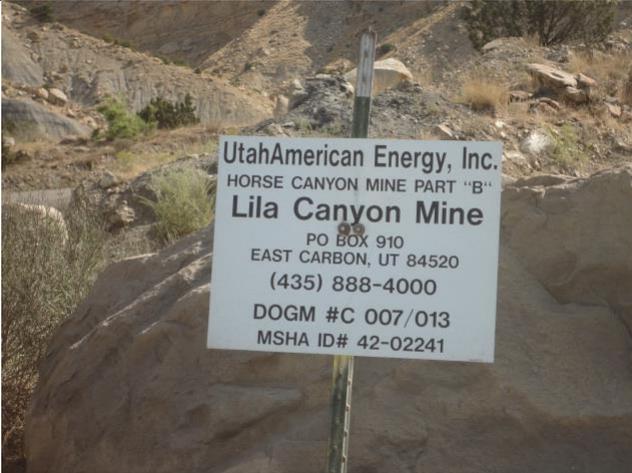
**PHOTO 1**

There is one mine identification sign associated with this site. The sign is posted at the access point from the county road into the mining permit area.

Regulations require that certain information be posted on the identification sign. These requirements are the name, address, phone number and permit number. All of these items were posted on the identification sign for Utah American Energy, Lila Canyon Mine.

The sign is in compliance.

Lila Canyon Identification Sign  
(Vegetation Removed From In Front Of Sign)

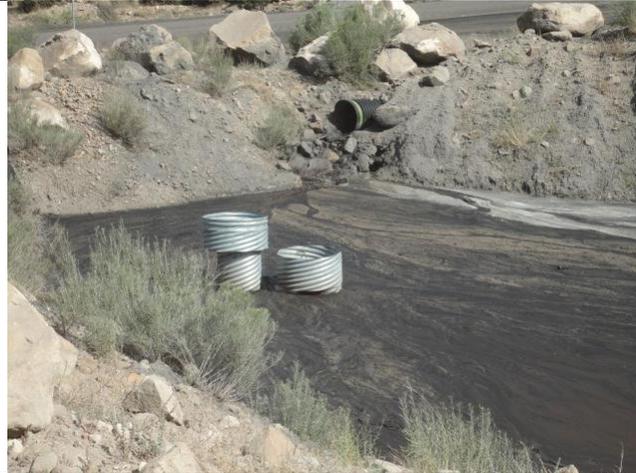
**PHOTO 2**

Sediment pond #2 the smaller sediment pond near the mine identification sign needs to be cleaned. According to the last sediment pond inspection the pond is scheduled to be cleaned this construction season. This cleaning should occur as soon as possible as the sediment level is near to the discharge stand pipe. Retention time for any storm events has been greatly diminished.

Sediment Pond #1 60% elevation 5843.6'. Existing sediment elevation 5838.1'.  
Sediment Pond #2 60% elevation 5847.0'. Existing Sediment elevation 5848.0'.  
(Pond Scheduled to be Cleaned).

Lila Canyon Sediment Pond #2  
(Small Pond Needs to be Cleaned)

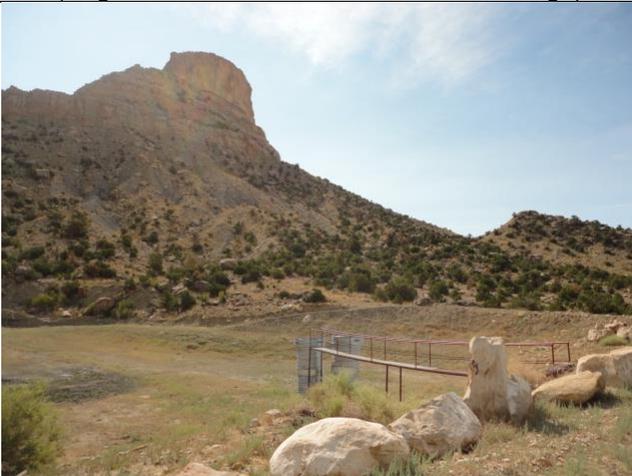
**PHOTO 3**

Lila Canyon Sediment Pond #1  
(Large Pond)

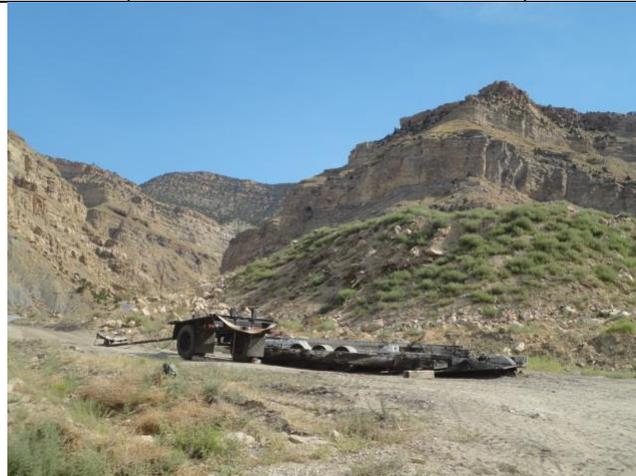
**PHOTO 4**

The topsoil storage pile was evaluated. Protection for this pile is provide by vegetative cover and supplemented by an earthen berm. Material from newly planned construction was placed on the pile late 2019 and was seeded early 2020. Pictures of the pile were taken and are attached in Attachment A of the PDF version of this inspection report.

Lila Canyon Topsoil Pile

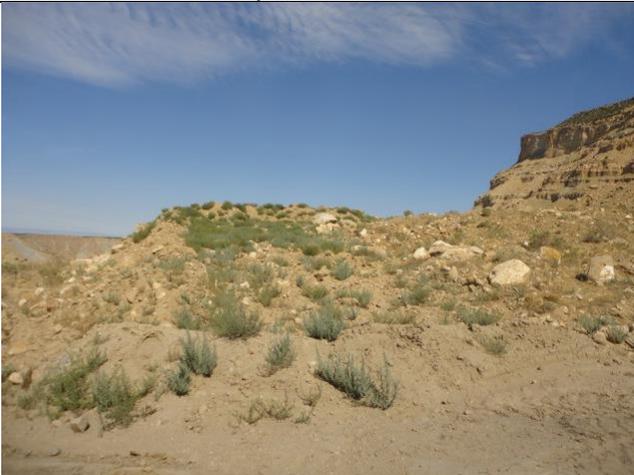
**PHOTO 7**

Lila Canyon Topsoil Pile  
(Most Recently Placed Soils)

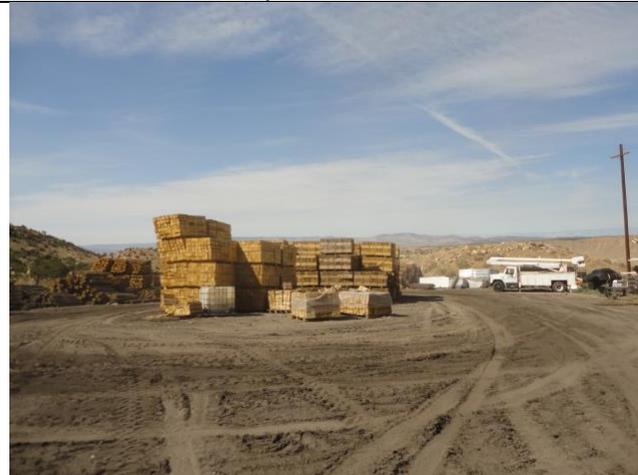
**PHOTO 8**

The mine is going through a Longwall move. Some equipment was stored near the base of the topsoil pile along a pad subsequent to a roadway.

Lila Canyon Storage Yard

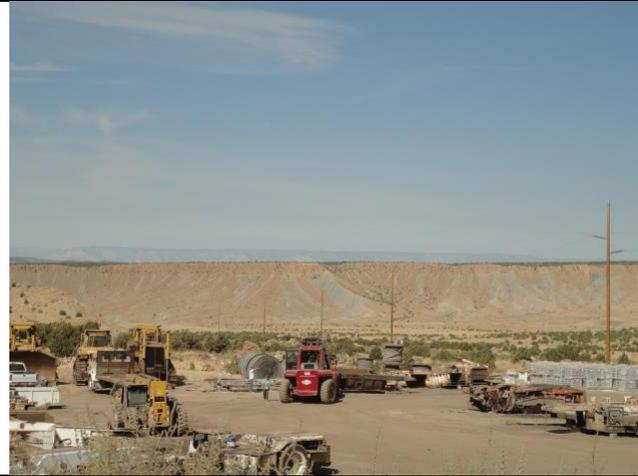
**PHOTO 10**

Construction on the new warehouse that was approved in 2019 still has not taken place. A pad area was built and soils savaged. No structure has been erected. The pad is currently being used to store equipment.

Lila Canyon New Warehouse Pad

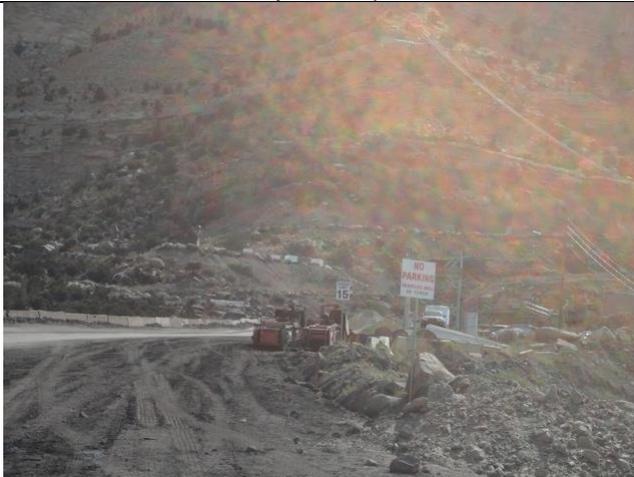
**PHOTO 11**

The road diversion near the bath house had the cable and wood removed from it's interior. This item was noted of the July inspection.

Lila Canyon Road Diversion by Bath House  
(Cleaned After 07/28/2020 Inspection)

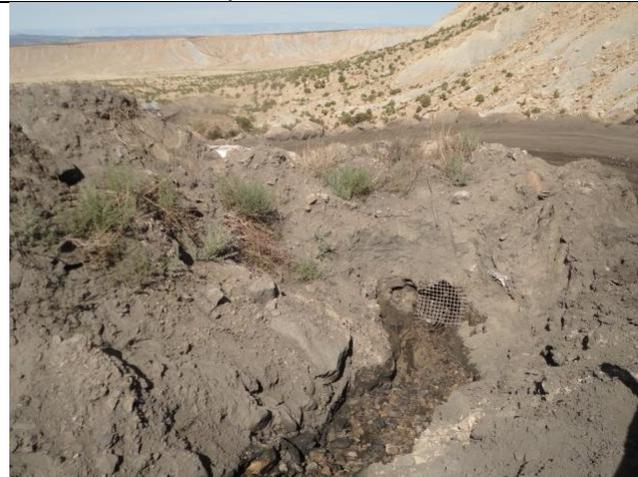
**PHOTO 12**

Diversions and inlets noted in the partial inspection done in July had been addressed. (DC-1, DC-4 & DD-2) Pictures of this work done in these ;locations were taken and are attached to the PDF version of this inspection report in Attachment A.

Lila Canyon DC-4  
(Cleaned After 07/28/2020 Inspection)

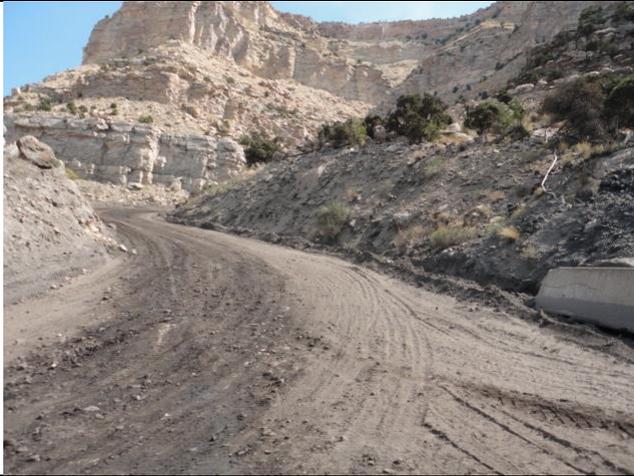
**PHOTO 13**

Lila Canyon DD-2  
(Cleaned After 07/28/2020 Inspection)

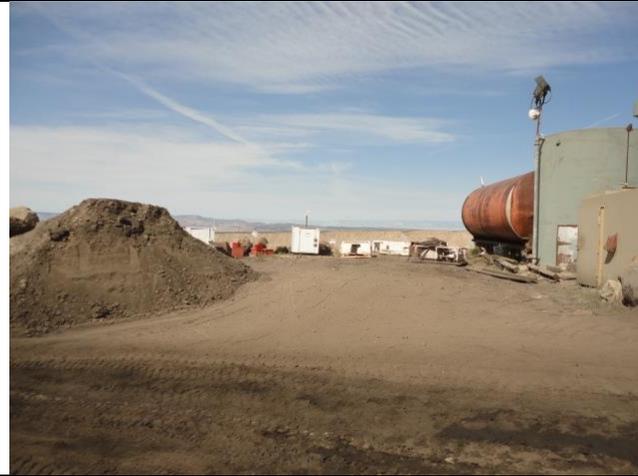
**PHOTO 14**

As part of the complete inspection the explosive storage area was checked. The powder and cap magazines are separated form each other. The magazines are grounded against a lighting strike. Signs are placed in accordance with the directions given in the regulations.

Lila Canyon Explosive Storage Pad

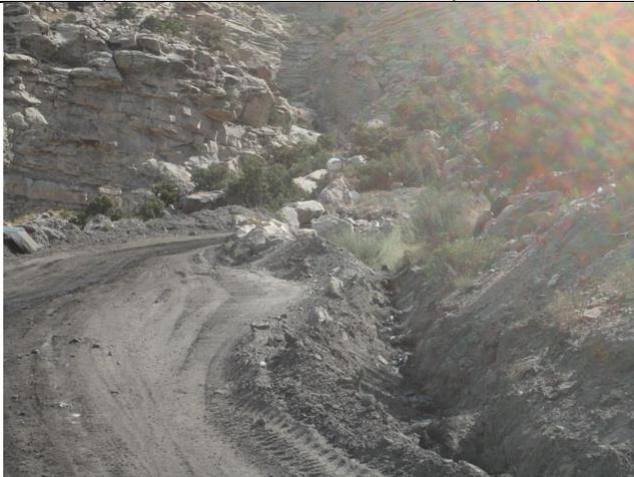
**PHOTO 15**

Lila Canyon DD-2  
(Cleaned After 07/28/2020 Inspection)

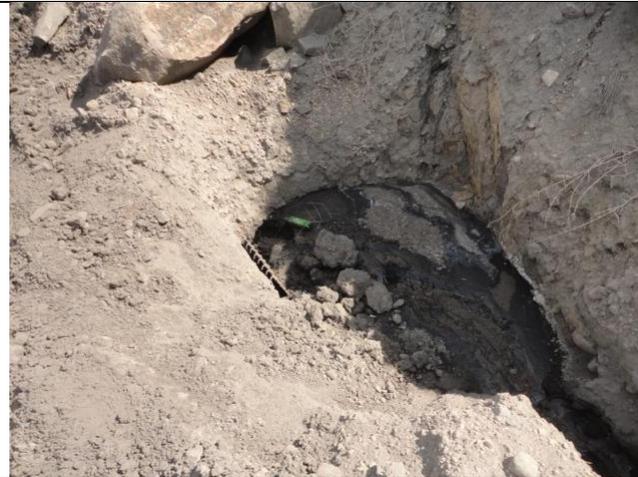
**PHOTO 16**

One culvert inlet at the first switch back down from the portal (DC-1) is building with sediment again and is about half full. This inlet need to be cleaned.

Lila Canyon DC-1  
(Partially Plugged Needs to be Cleaned)
