## February 2021 Inspection Report

# Inspection Report

Permit Number:	C0070013
Inspection Type:	PARTIAL
Inspection Date:	Wednesday, February 10, 2021
Start Date/Time:	2/10/2021 8:00:00 AM
End Date/Time:	2/10/2021 2:00:00 PM
Last Inspection:	Wednesday, January 13, 2021

Permittee: **UTAHAMERICAN ENERGY INC**  
 Operator: **UTAHAMERICAN ENERGY INC**  
 Site: **HORSE CANYON MINE**  
 Address: **PO BOX 910, EAST CARBON UT 84520-0910**  
 County: **CARBON**  
 Permit Type: **PERMANENT COAL PROGRAM**  
 Permit Status: **ACTIVE**

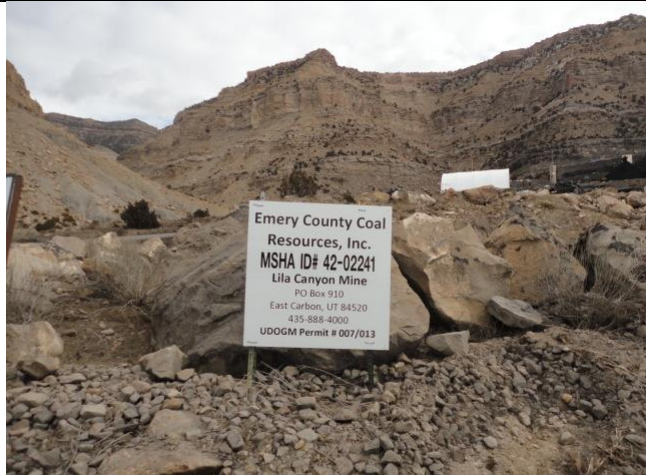
**PHOTO 1**

The identification sign is posted at the entrance leading into the permit area.

The sign is placed along the county access road on the out slope of the small sediment pond.

The law requires that the name, address, phone number and permit number be displayed on the identification sign. All of these items are listed on the sign.

The sign is in compliance with the law

Lila Canyon Identification Sign

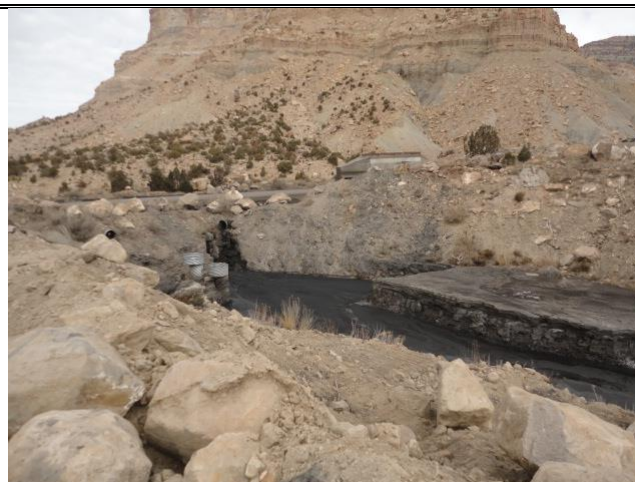
**PHOTO 2**

The first is the small sediment pond (#2). This pond is located near the intersection of two county roadways. The pond was cleaned last year to bring it below the 60% clean elevation. The entire pond was not cleaned do to the reach of the track hoe that was used.

Lila Canyon Small Sediment Pond

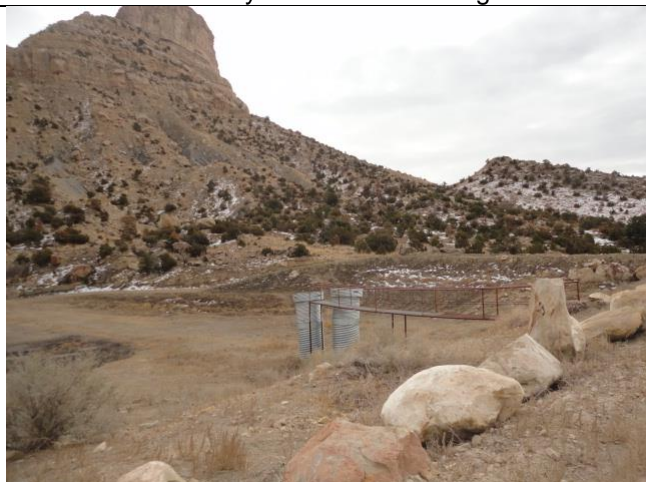
**PHOTO 3**

The second sediment pond is the large sediment pond (#1). This pond is located further down the county road that borders the base of the permit area. This pond was dry and no problems were noted.

Lila Canyon Large Sediment Pond

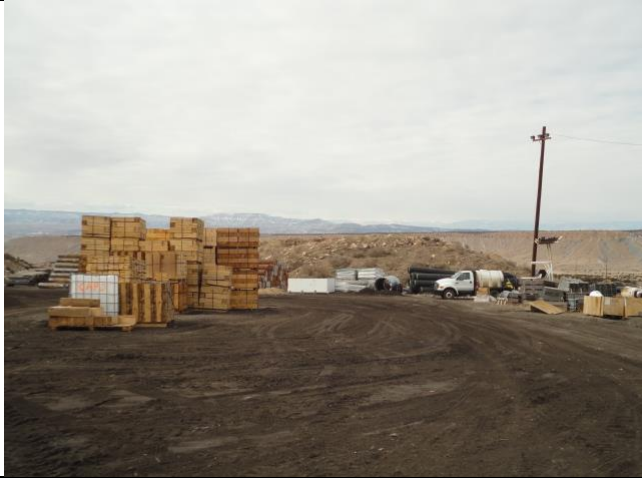
**PHOTO 5**

Lila Canyon Storage Yard

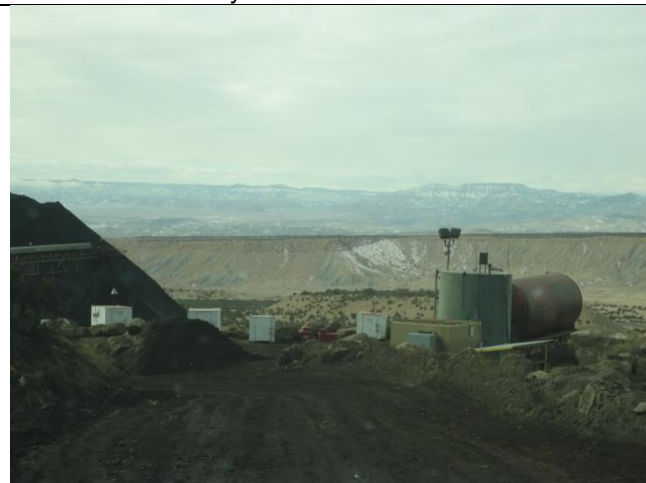
**PHOTO 8**

The explosive storage area is located on a pad to the side of the portal access road and diversion DD-2. The magazines located on this pad are grounded against lighting strikes and have signs to indicate that explosives are contained in the magazines. Two different magazines are on this pad. One for explosives and the other for caps.

Lila Canyon Explosive Storage Area
