AN ARCHEOLOGICAL SURVEY OF
PORTIONS OF FIASCO CANYON, STARPOINT
CANYON AND STRAIGHT CANYON NEAR
PRICE, UTAH

For the
TOWER RESOURCE-AMCA COAL COMPANY
PRICE, UTAH

An archeological survey for Tower Resources--AMCA Coal Company of Price, Utah was completed during May 19 through May 29. The field crew consisted at various times of Bruce Hawkins, Gregory Seward, and Deborah Truell. Under the supervision of Asa S. Nielson the survey work was carried out by the Consulting Services Branch of the Antiquities Section, Division of State History, Salt Lake City, Utah. The project area included portions of Fiasco Canyon, the Starpoint Fork of Deadman Canyon and Straight Canyon (U.S.G.S. Deadman Canyon Quadrangle 7.5 minute series) (Figure 1). The specific survey

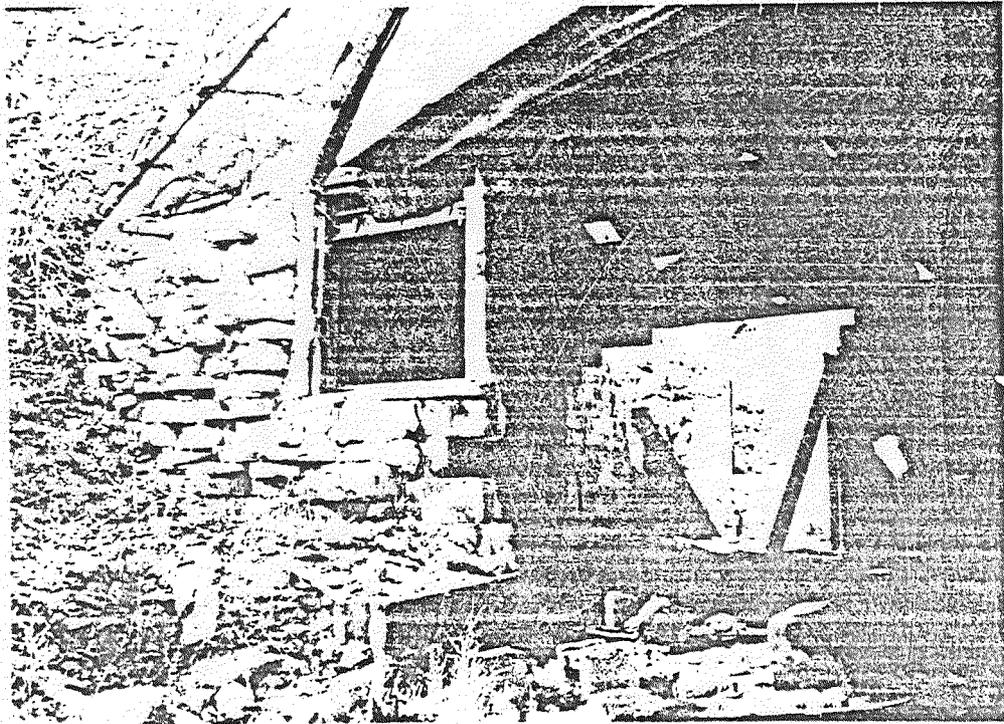
Figure 5. 42Cb177. Structure 1. Note stone structure with cement block addition.

Structure 1 (Figure 5) is located in the bottom of the canyon. It measures approximately 10 by 10 by 9 feet high. Structure 1 is built on a square plan with an addition. The structure has a gable roof. The walls of structure 1 are constructed of stone. The addition is constructed of concrete block. The roof of structure 1 is constructed of milled lumber

on a truss design and is shingled with asphalt shingles. Structure 1 contains 2 windows. One in the south wall is built into the stone wall. The other windows of wood frame construction is contained in the north wall. Three doorways are contained in Structure 1. One doorway is framed in wood and located in the east wall of the addition. A second doorway is also framed in wood and located in the concrete block wall separating the main structure from the additions. The third doorway is located in the south wall of the structure and opens onto a porch area which is roofed and walled with concrete block. A concrete pad is located on a framework of timbers in the southeast corner of the structure. There is no apparent wood floor. The structure interior contains coal, burnt wood, rusted metal, nails, and broken block. Function of the structure is unknown.

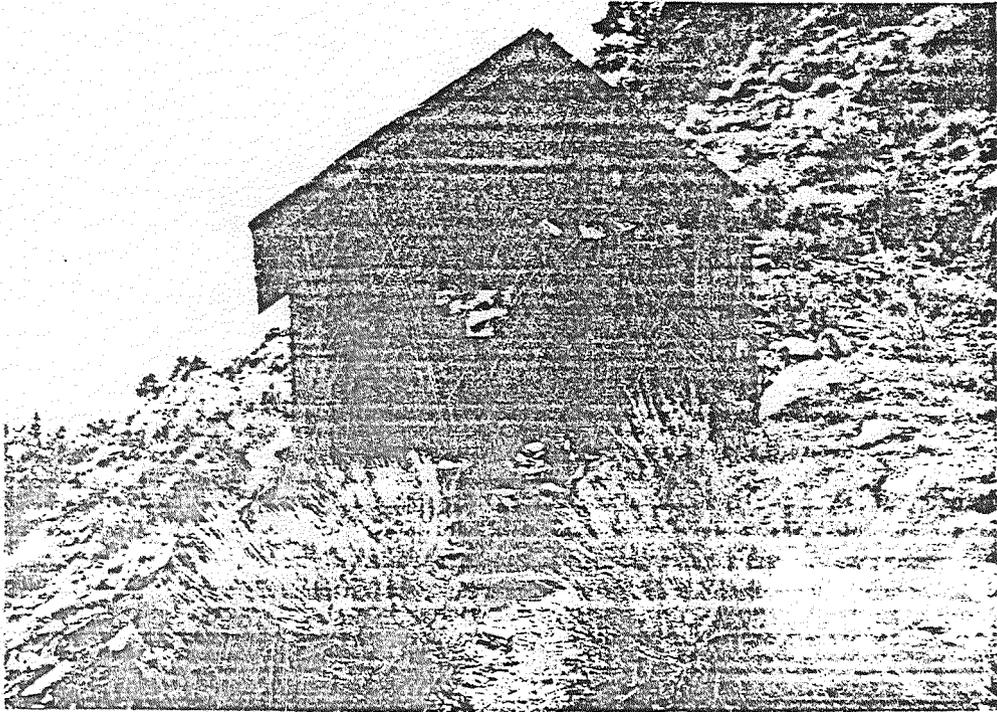
Figure 6. 42Cb177. Structure 2. Wood Frame Concrete Block Construction.

Structure 2 (Figure 6) is located on the west flank and approximately 100 feet above the canyon bottom. Structure 2 measures 15 by 12 by 9 feet high. The structure is constructed on a rectangular plan and has a gable roof. The structure is walled on 3 sides with concrete block and opens to the north. The roof is built on a truss design with 2 by 8, 2 by 6, and 1 by 6 inch limber. Asphalt shingles were observed on the surrounding surface. One window measuring 3 by 3 feet is contained in the east wall of the structure. A concrete pad forms the floor of structure 2. A 3 sided rectangular pit is located in the pad. A concrete footing with embedded bolts runs east-west approximately midway across the pit. Ten by 10

inch timbers, bottle glass (post 1903), gaskets, bolts, sheet metal and cans (post 1915) were found within the structure. Structure 2 probably served as a shop or housed machinery.

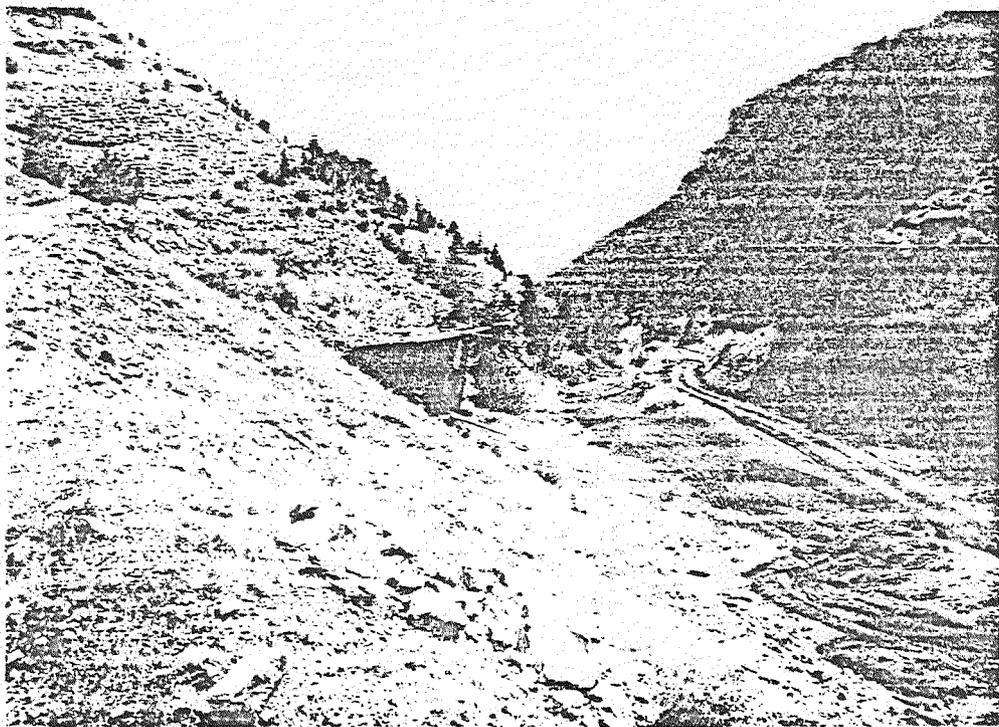
Figure 7. 42Cb177. Structure 3 on West Slope of Canyon Wall.

Structure 3 (Figure 7) is located approximately 80 feet above the canyon bottom on its east flank. Structure 3 measures 12 by 12 by 6 feet high. The structure is built on a square plan. The walls are constructed using 10 by 10 inch wood beams as studs. Two by 12 inch planks and corrugated sheet metal serve as roofing materials. A large rectangular opening in the west wall of the structure functioned as a window. An entranceway is incorporated into the north wall. No artifacts were noted in the structure interior. The function of structure 3 is unknown.

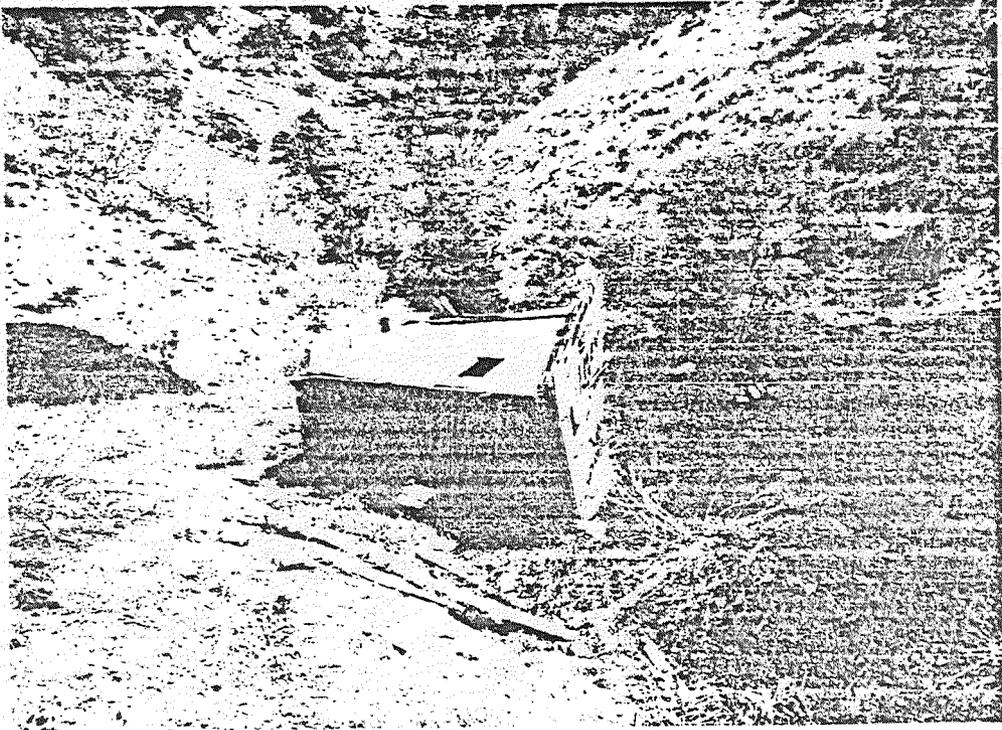
Figure 9. 42Cb177. Outhouse.

The outhouse (Figure 9) is located in the bottom of an east side canyon between structure 3 and the coal loading area. The outhouse is presently disconnected from its pad and resting on

its side. The structure pad is pre-cast. The superstructure measures 4 by 4 by 7 feet high and is constructed of wood stud walls and siding. A window exists in the north wall. A door is contained in the west wall. The superstructure has a slant roof constructed with 1 by 6 inch planks. The coal loading here (Figure 10) consists of a road, coal piles, and the remnants of a frame structure. The loading area is north of the end of the Starlight Canyon road and is oriented east-west. The coal piles measure 2-3 feet high, 12-14 feet wide and approximately 45 feet wide. The road measures 5 feet wide. The structure remnants consist of a stud wall, made of 2 by 4 inch wood studs and 1 by 6 inch planks.

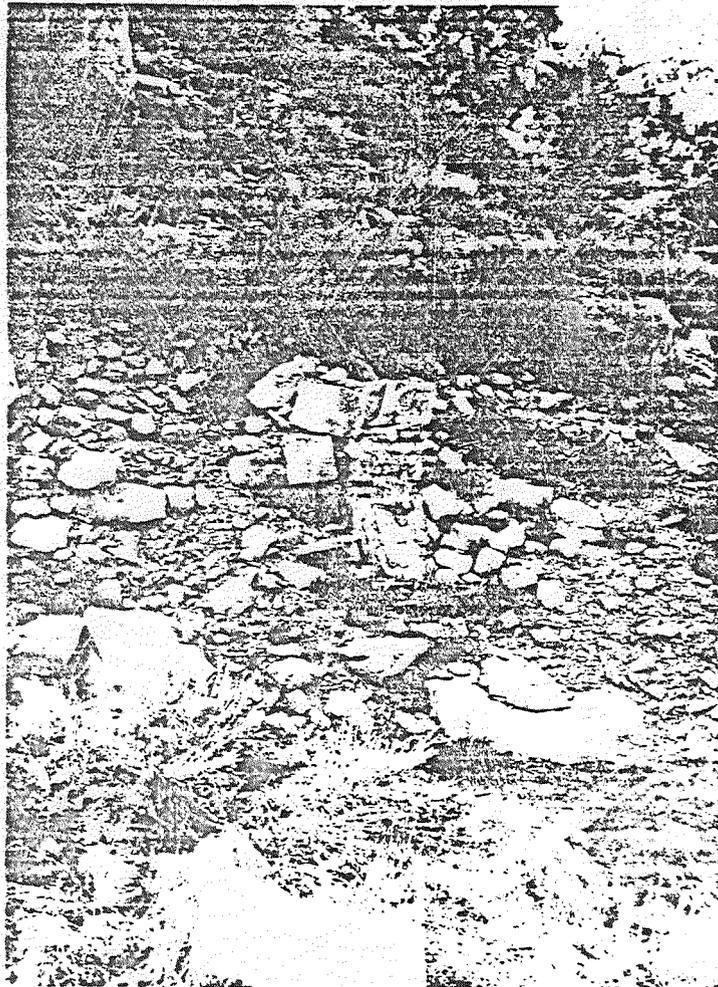
Figure 11. 42Cb177. Ventilator Foundation Looking Northwest.

The ventilator foundation (Figure 11) is located west of the coal bin, across the road. It is constructed of stone and concrete and probably contained the ventilating fan located to the northeast (Figure 12). The foundation may have also supported a building superstructure.

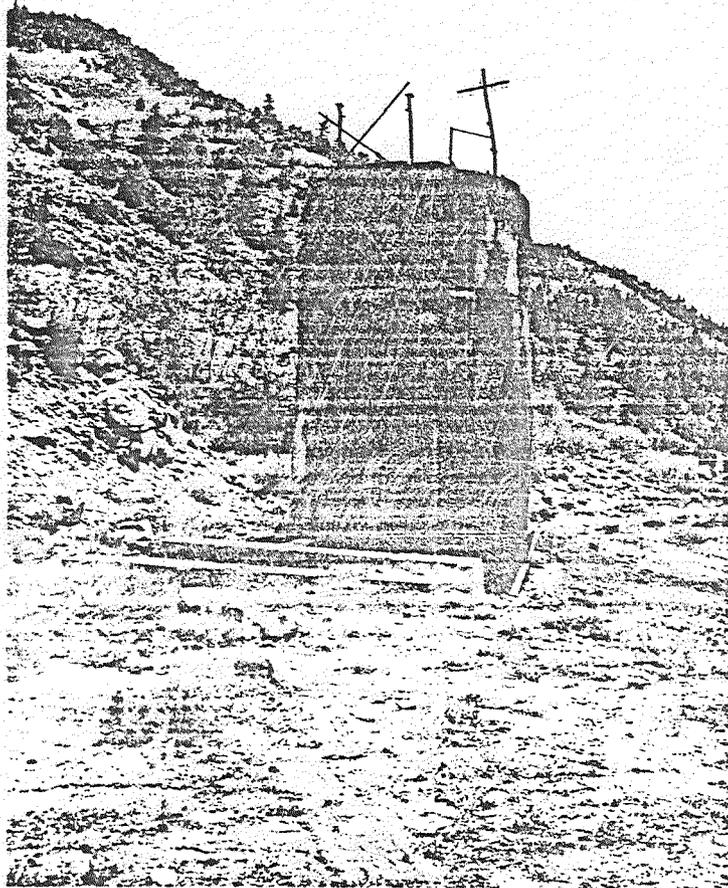
Figure 16. 42Cb178. Concrete Footings and Steel Tower.

A series of concrete footings (Figure 16) presently support a steel tower which was used to store coal. Two footings are aligned north-south. The remaining two are aligned east-west. The area covered by the footings measures 30 by 15 feet.

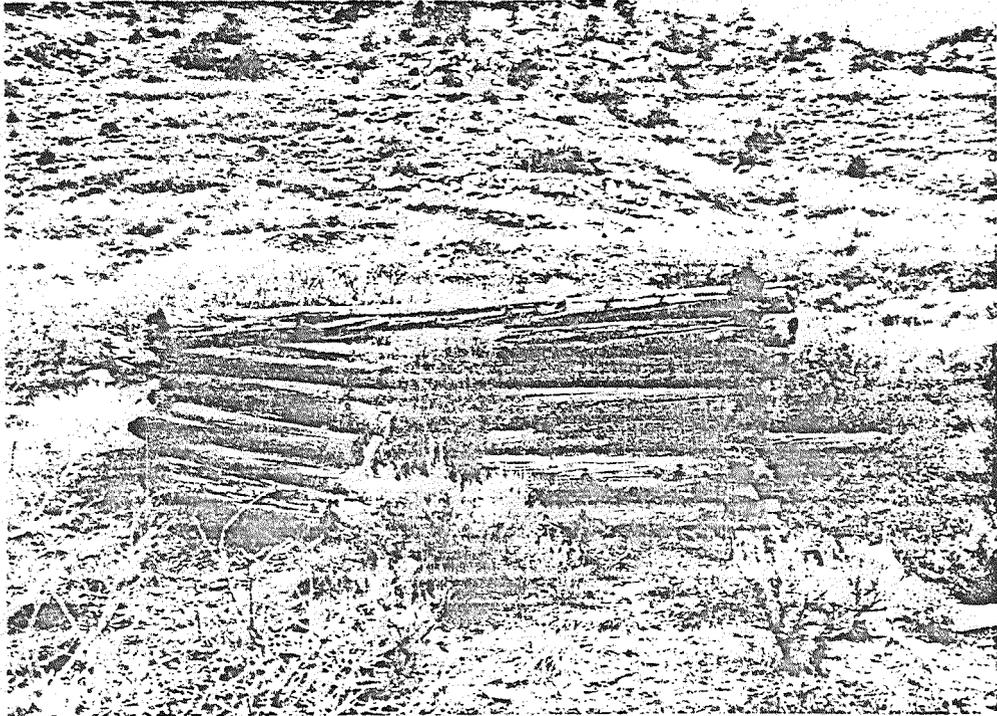
Figure 18. 42Cb180. Cabin.

42Cb180 is a log cabin (Figure 18). The site is located approximately 1 mile into the canyon, 60 feet west of the main canyon road in the SE 1/4 of the SW 1/4, Section 8, Township 13 South, Range 11 East. The cabin measures 10 by 10 by 6 feet high and is built on a square plan. The walls are constructed

of saddle notched round logs which have been squared on the interior surface. Saddle notching was done with a saw. A possible ridge pole is suspended across the center of the structure running north-south. No other roofing remains. One window is centered in the west wall and a door is centered in the east wall. A vertical slab is nailed to each side of the entrance to hold the east wall vertical. Each corner of the structure is supported by a stone. The floor appears to be earth with no artifacts other than a bedspring in association. 42Cb181 is a historic petroglyph (Figure 19) pecked on a sandstone boulder at the mouth of Straight Canyon on the east side of the road in the SW 1/4 of the SW 1/4 of the SE 1/4, Section 17, Township 13 South, Range 11 East at an elevation of 6,760 feet. The inscription reads "J.A. Peterson, May 11, 1901."

The occupant and date of construction for this cabin are presently unknown and could potentially qualify the site for the National Register. Avoidance is recommended for this site.

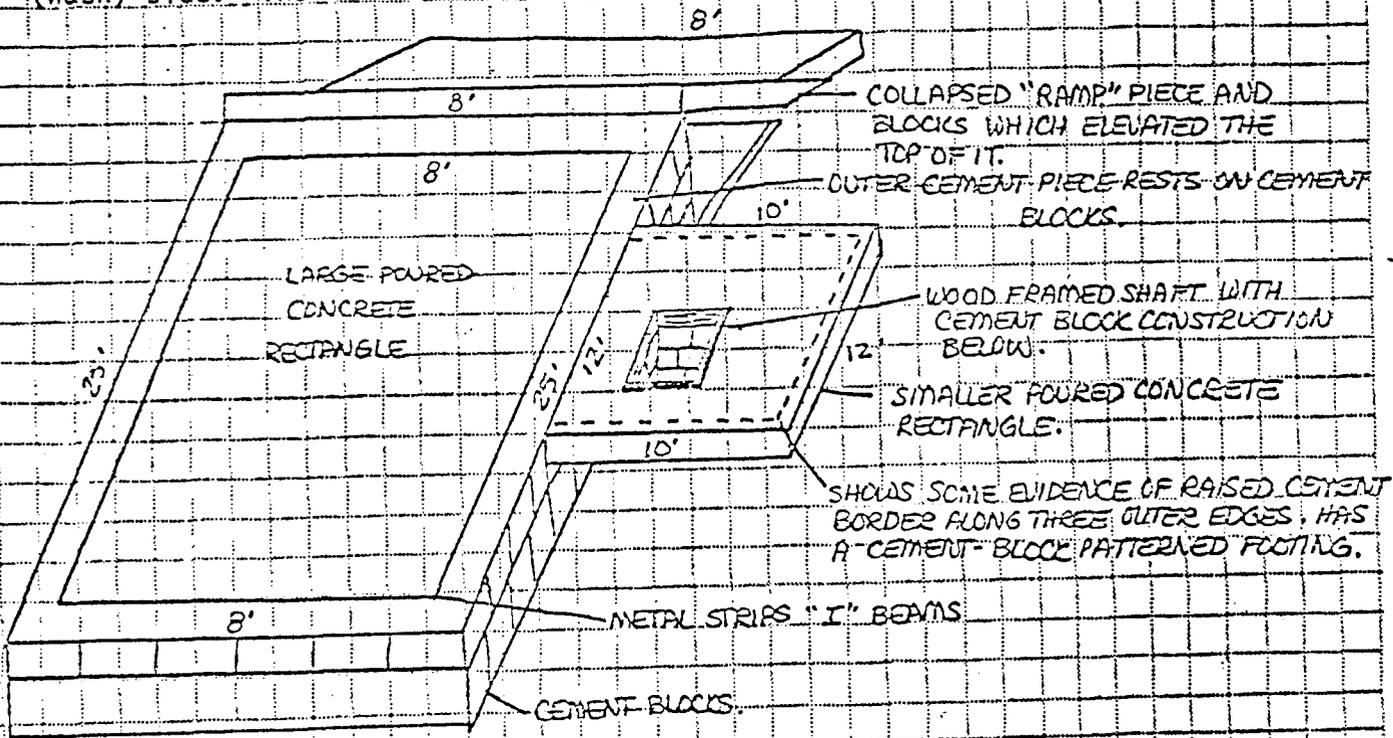
Feature No. F-5

F-5 lies southwest of the silo-type F-2 structure of the Rio Grande mine. It is on the east side of the wash that runs down from Deadman's (right fork) Canyon and just below Fiasco Canyon. It consists of a large "pad" of poured cement. A large rectangular part is closest to the road. To the west (its left facing north) lies a smaller poured cement pad with a wood framed opening (constructed beneath the pad of cement block. This has been filled in for the most part and it is impossible to guess how deep a shaft this may be. The large rectangle has a border of two metal strips, placed about 2 inches apart and rimmed with a layer of cement block topped with poured concrete (see diagram). To the south of this large rectangle in a separate piece is another slab of poured concrete. The northern edge of this (almost touching the large rectangular pad) is elevated by a cement block while the southern edge lies on the ground, forming a rough ramp. (The concrete has cracked and the "ramp" collapsed). A few wooden planks with nails lie around the area particularly on the west (wash) side. There is a metal and wood frame underneath.

LARGER RECTANGLE: 25' x 8'
 SMALLER RECTANGLE: 10' x 12'
 SHAFT: 1' x 1'
 RAMP: 8' x 6'
 RAMP HEIGHT AT APEX: 1'

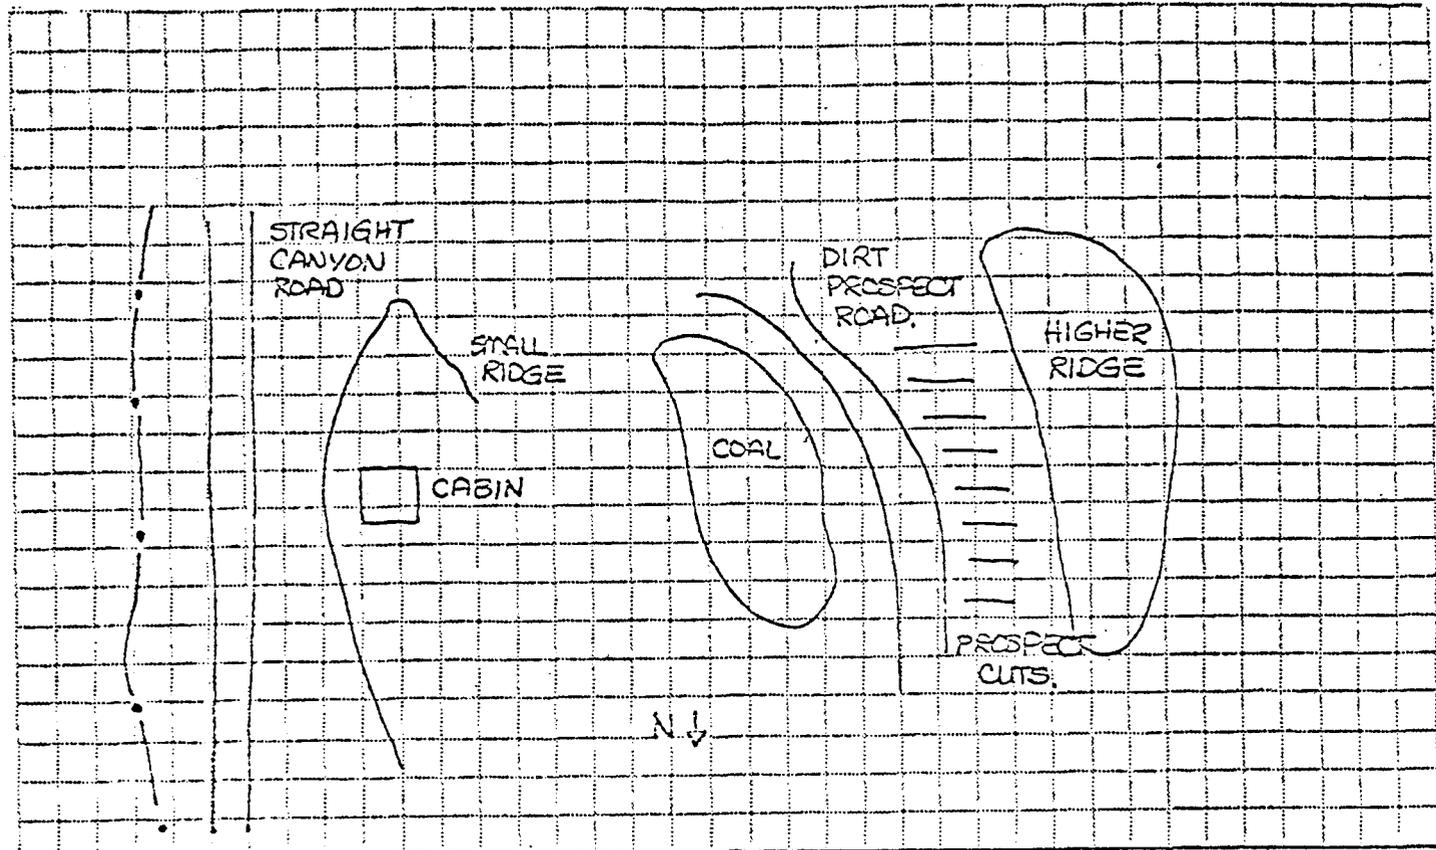
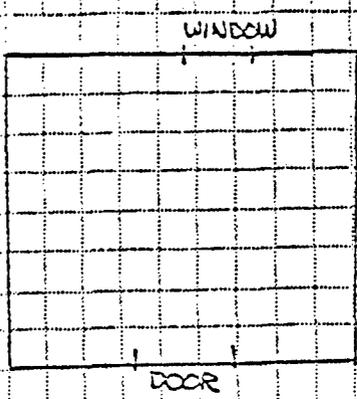
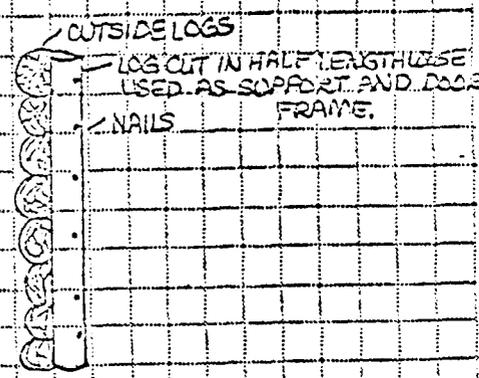
CROSS-SECTION OF CABIN WALL AT DOORWAY.

STRUCTURE MAY HAVE BEEN FLAT-ROOFED WITH LOGS.

ARTIFACTS: A RUSTED MATTRESS SPRINGBOARD HAD BEEN DISCARDED INSIDE.

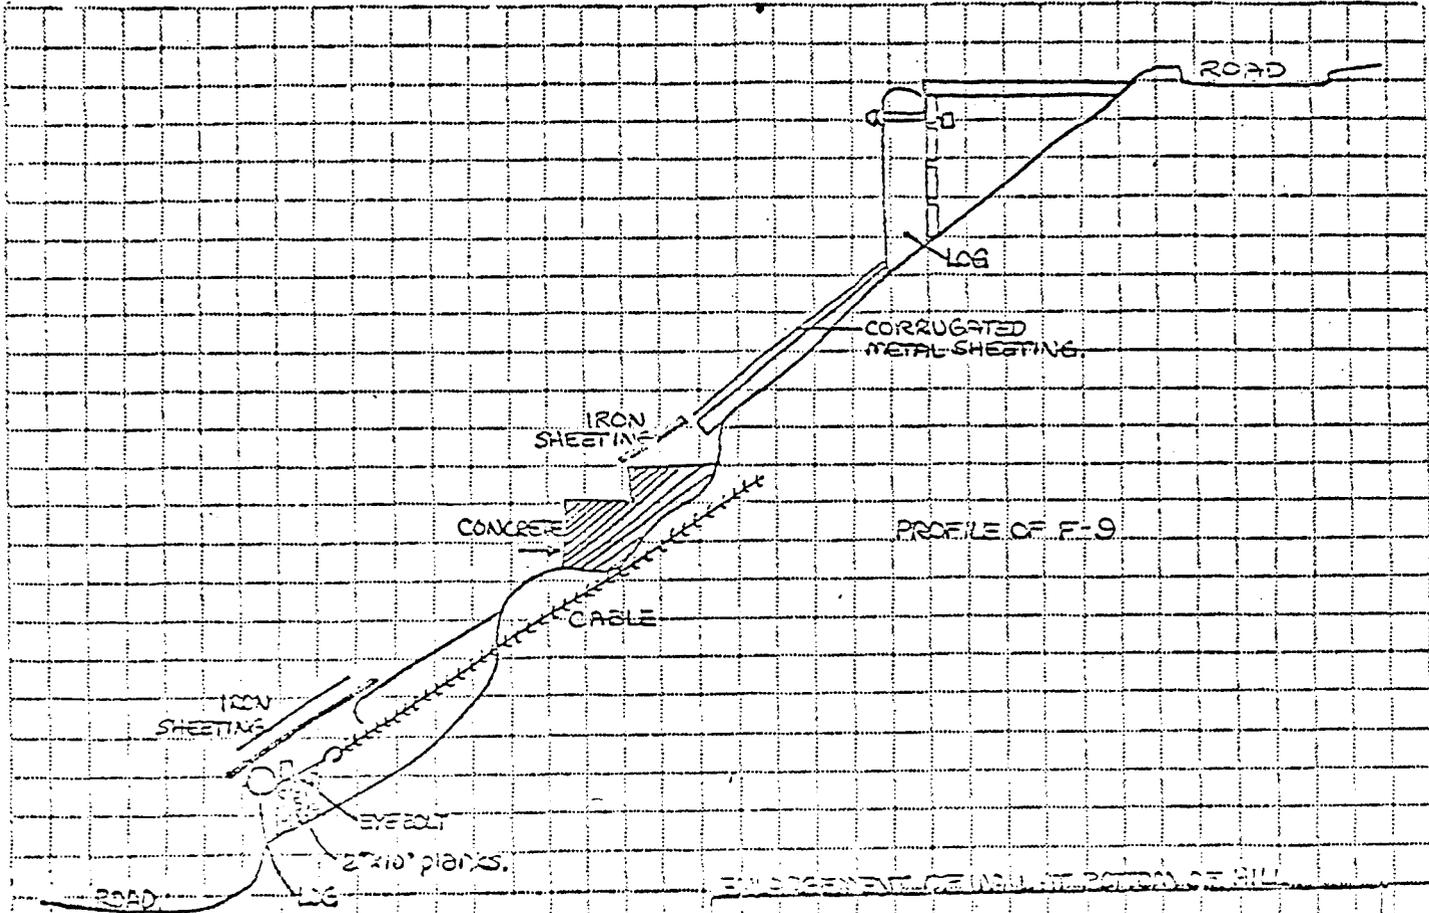
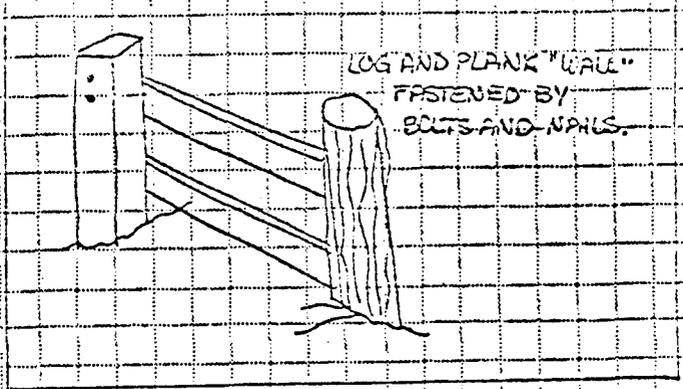
ENGINEER'S RECONSTRUCTION OF WALL

ASSOCIATED ARTIFACTS:
 MACHINE RUBBERIZED BOLTS, GLASS,
 MISCELLANEOUS METAL PARTS, COAL,
 RUBBER VEHICLE TIRE PARTS.

INTERPRETATION: COAL STORAGE BIN AND TIPPLE CIRCA 1920
 W 50' x 80'

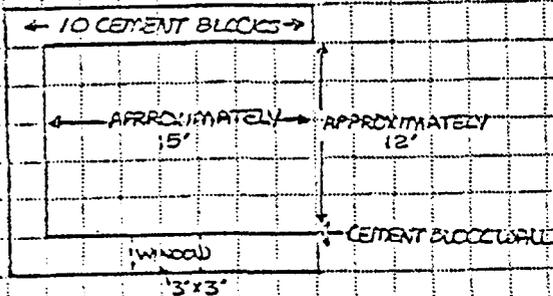
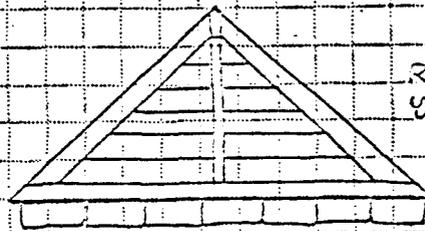
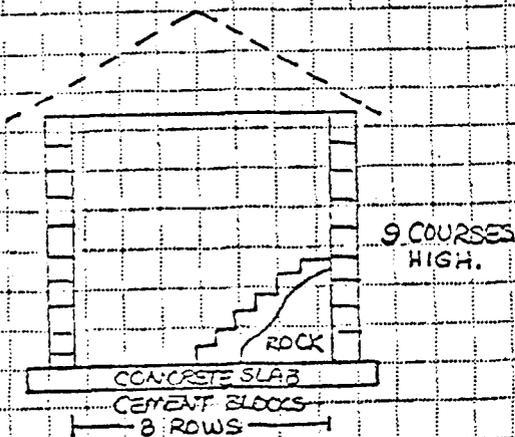
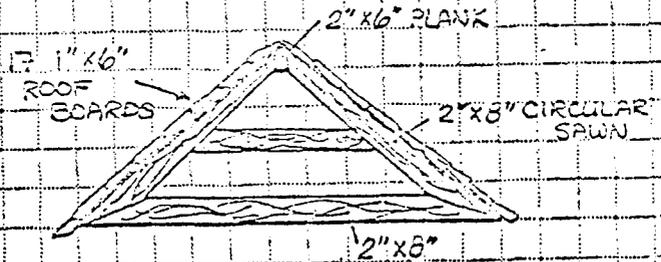
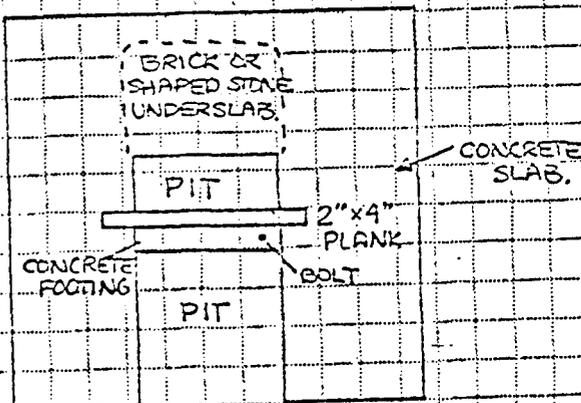
INTERPRETATION: 1920-30's structure skidded to location and jacked up under dry laid rock foundation, probably used as a shop. Structure probably skidded to area formerly occupied by Feature Remnants of which are piled on the hill below.

PLAN VIEW

GABLE END DETAIL

INTERIOR PLAN

TRUSS CONSTRUCTION

SURFACE INTERIOR ARTIFACTS: GASKETS, BOLTS, BROWN AND GREEN BOTTLE GLASS, (AUTOMATIC BOTTLE MACHINE), POST-1915 CANS, SHEET METAL FOR STOVE PIPE OPENING, RUBBER HOSE

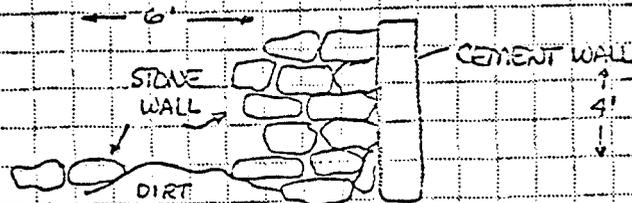
F-13 is a cement wall of cement blocks about 4 high. It is the corner of some kind of structure, the major exposed part running north/south and disappearing into the slope to the west under caved-in debris. It appears to have been an underground shaft or casement. The cut is 20 feet high, 20 feet long into a coal vein. Cable, standard and narrow guage rail, concrete, concrete blocks, stone rubble, iron sheathing, and sawn logs are concentrated into a rubble pile at the mouth of the cut.

Interpretation: possible mine adit - completely covered over by rubble slide debris
