2004 ANNUAL REPORT

ANDALEX RESOURCES, INC.
CENTENNIAL MINESITE
C/007/019

**ANDALEX RESOURCES, INC.
2004 ANNUAL POND INSPECTION REPORT**

**VEGETATION MONITORING
ON THE
SUBSTITUTE TOPSOIL TEST PLOTS**

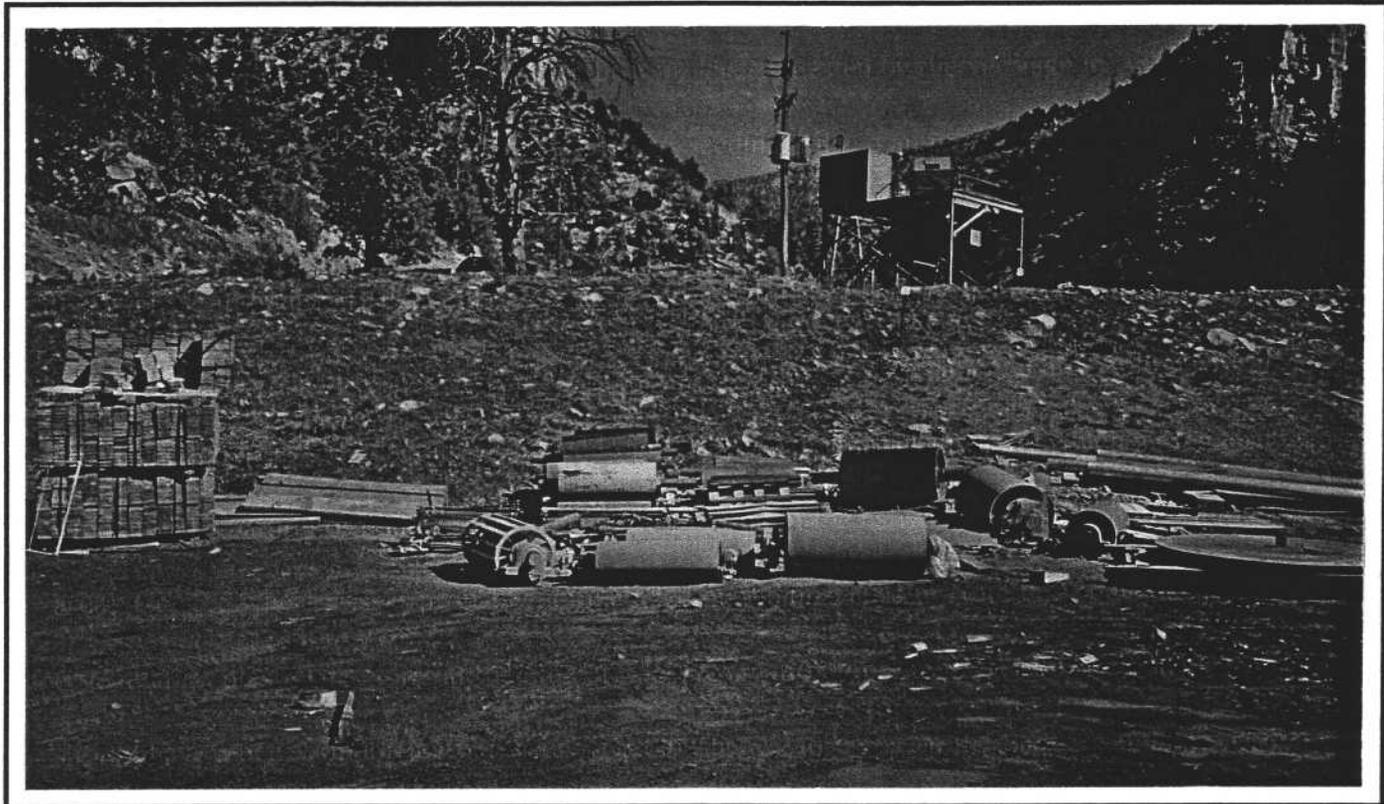
Total living cover of the North Warehouse Slope at the time of sampling was 30.50% (Table 1-

A). Shrub species were not present in the quadrats, whereas forbs represented 40.61% of the total cover and grasses 59.39% (Table 1-B).

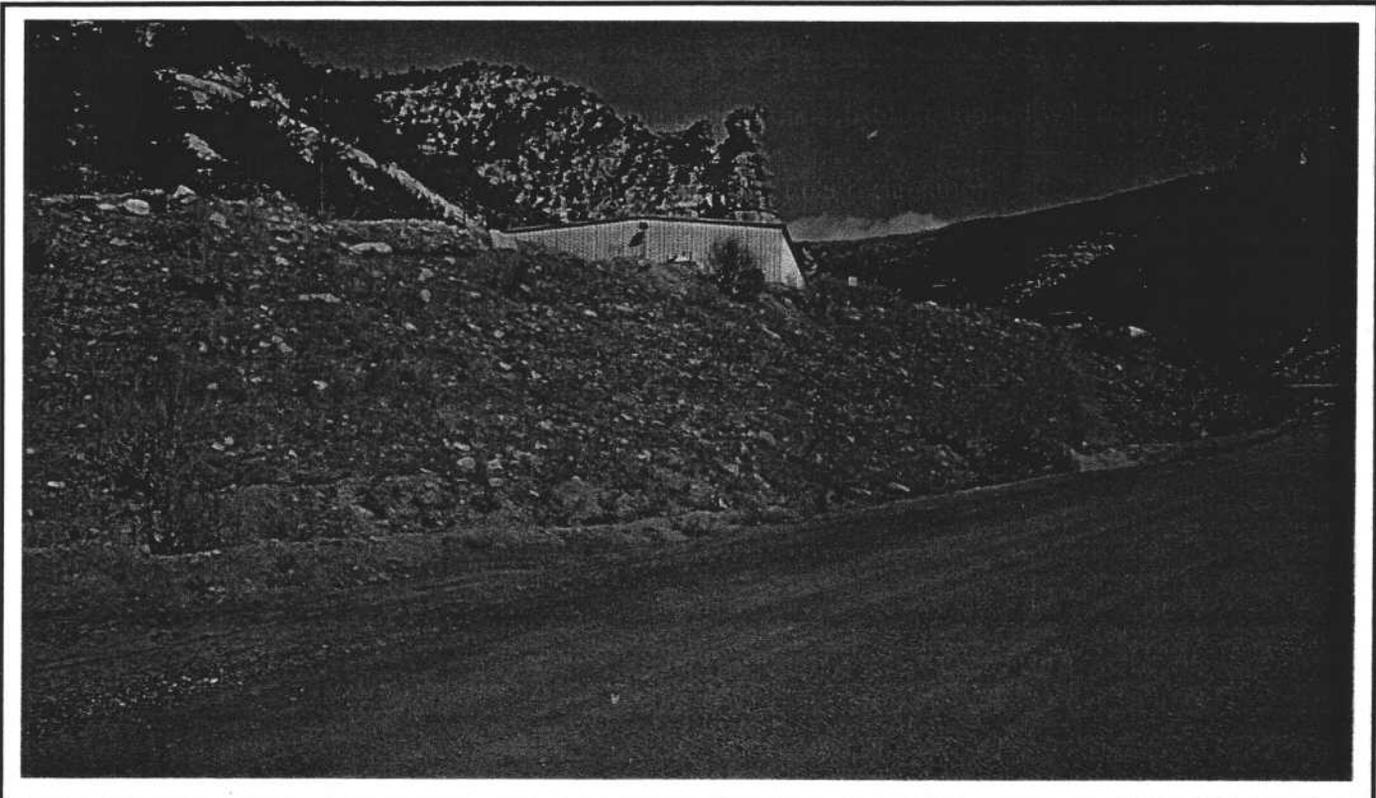
The total living cover of the South Warehouse Slope was estimated at 37.00% (Table 3-A). Grasses made up 66.78%, forbs 23.22% and shrubs 10.00% of the living cover (Table 3-B).
