Inspection Report

Permit Number:	C0070019
Inspection Type:	COURTESY
Inspection Date:	Tuesday, September 19, 2006
Start Date/Time:	9/19/2006 1:00:00 PM
End Date/Time:	9/19/2006 3:00:00 PM
Last Inspection:	Friday, September 08, 2006

Inspector: Priscilla Burton, Environmental Scientist IIIWeather: sun, 70'sInspectionID Report Number: 1079Accepted by: whedberg
9/29/2006 *OK*Permittee: **ANDALEX RESOURCES INC TOWER DIVISION**Operator: **ANDALEX RESOURCES INC TOWER DIVISION**Site: **CENTENNIAL MINE**Address: **6750 AIRPORT RD, PO BOX 902 PRICE UT 84501**County: **CARBON**Permit Type: **PERMANENT COAL PROGRAM**Permit Status: **ACTIVE**

UEI's Andalex Centennial mine proposes to construct a new office/bathhouse facility. The location for the facility was observed and the disposal of the mine waste to be encountered during construction was discussed.

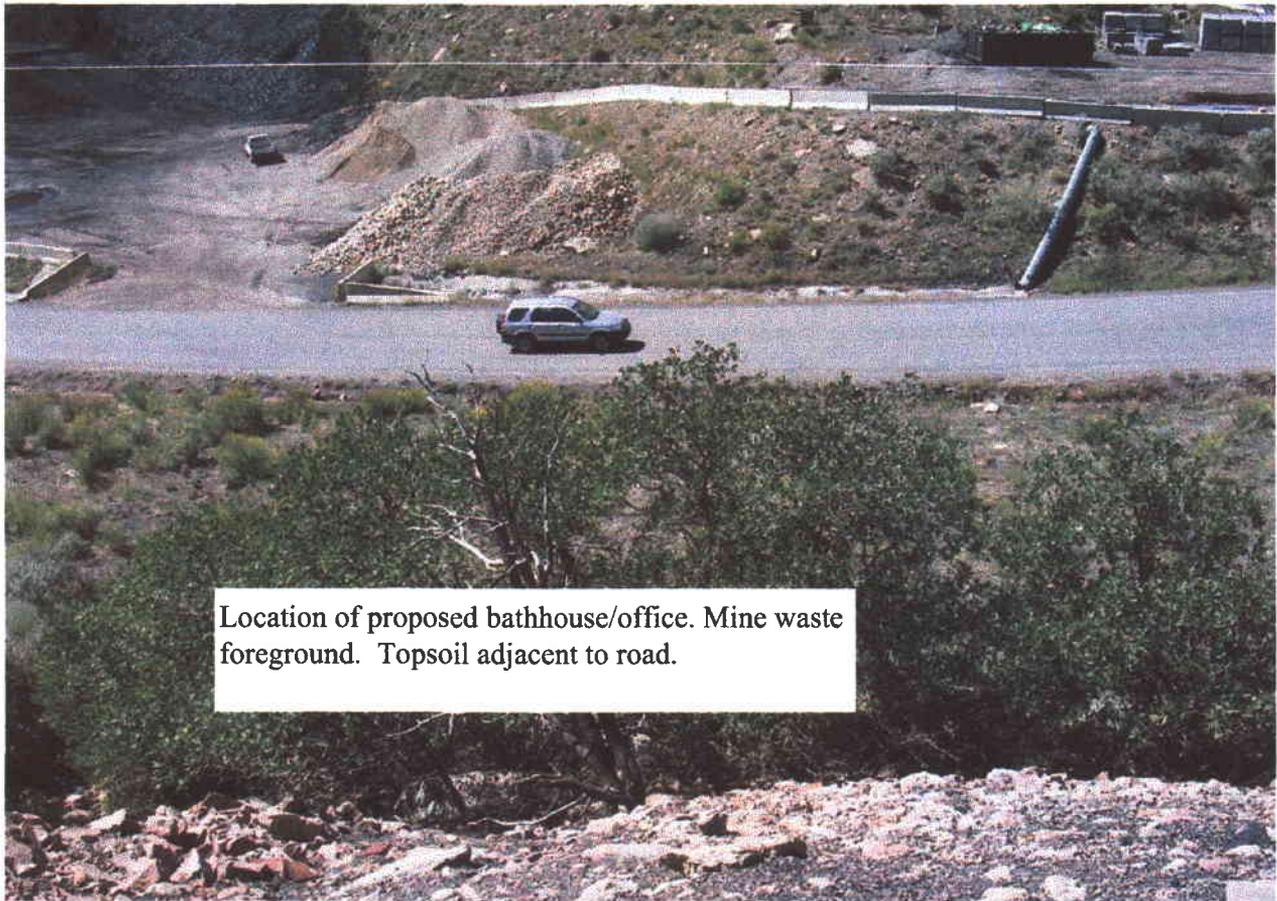
The location for the proposed office/bathhouse is a former mine dump adjacent to the existing office building. The mine waste looks red, like burnt coal. The waste would be removed and used to fill catch basin B shown on Plate 6 (Surface Facilities Map) with excess being used to fill the excavation adjacent to topsoil storage pile G, immediately north of sediment pond C. Photos attached. Volume of waste and volume of ponds was not available at the time of the inspection. In addition to the mine waste on the office pad slope, there is mine waste piled at the north end of the disturbed area that will be placed either in catch basin B or adjacent to Topsoil pile G.

Location of proposed bathhouse/office. Mine waste foreground. Topsoil adjacent to road.

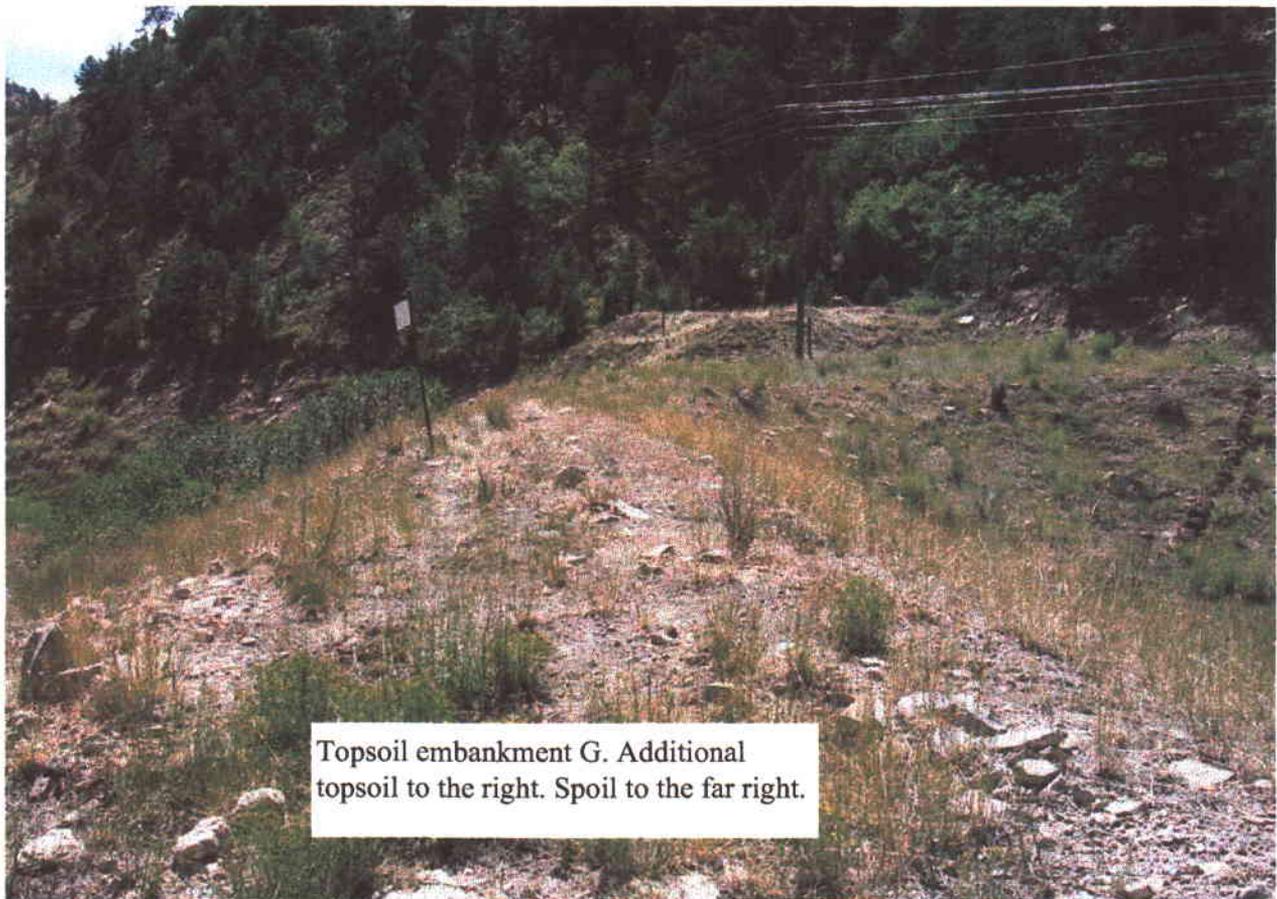
Topsoil removed from the construction site will be added to topsoil pile G which is the embankment of an excavation site. The removal of topsoil pile C to the same storage area was discussed. Photos attached.

Topsoil embankment G. Additional topsoil to the right. Spoil to the far right.

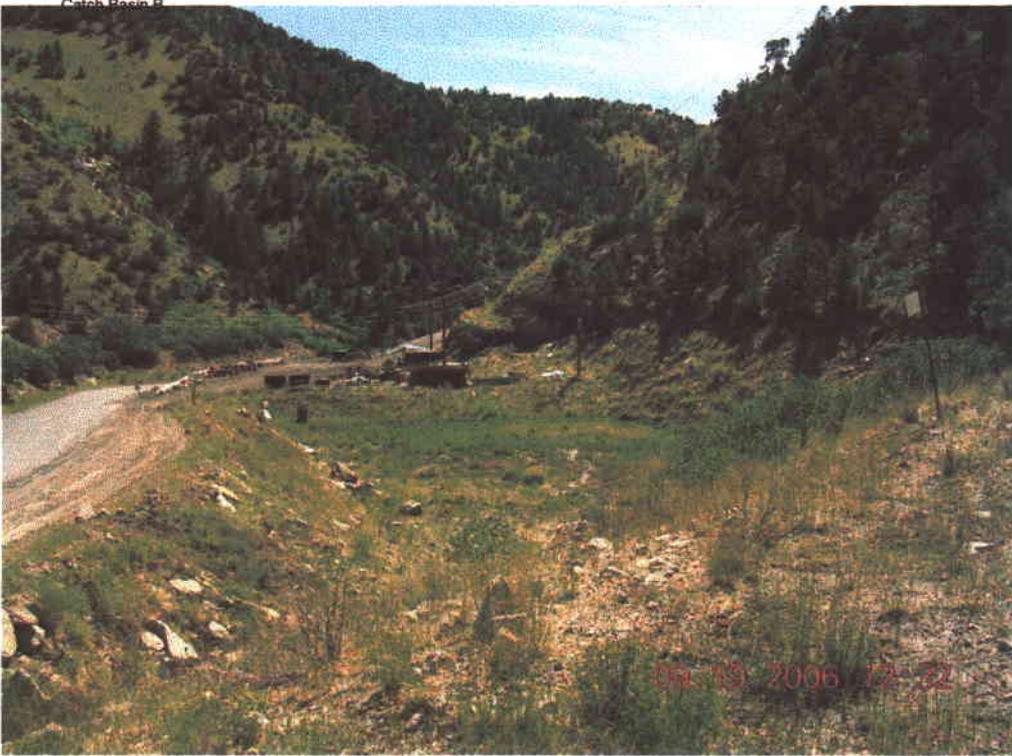
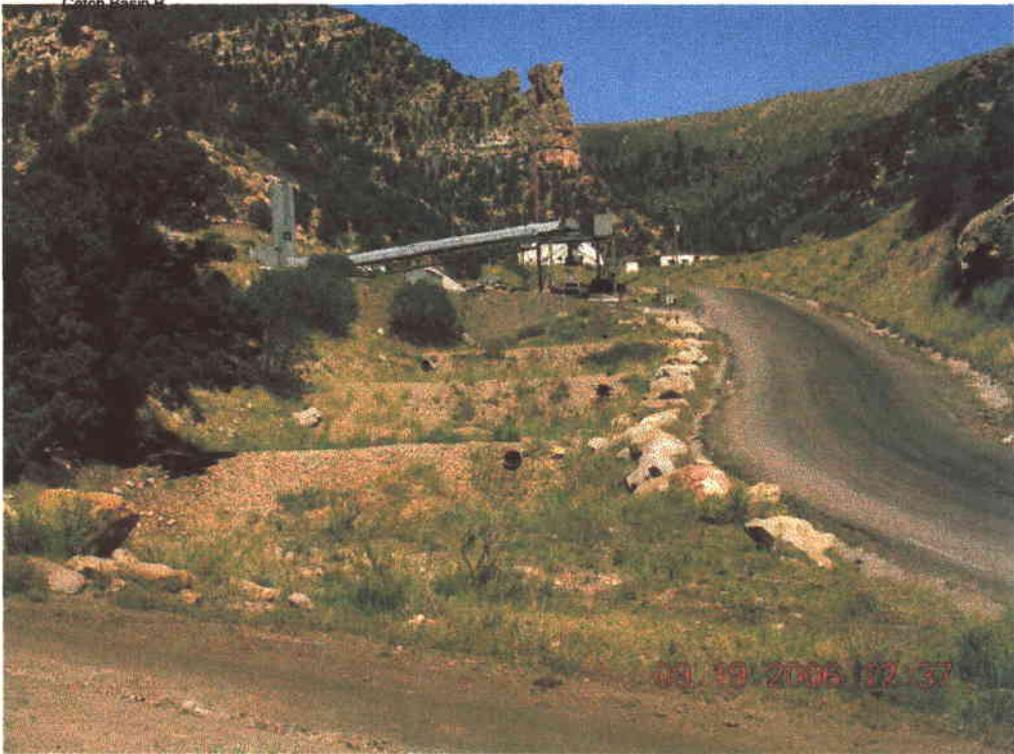
Dave Shaver (representative of the Centennial Mine) has submitted a proposal to fill catch basin B and divert the discharge the basin currently impounds and route it to catch basin C. Mr. Shaver stated at the time of the field inspection that catch basin B was the proposed location of a new parking facility needed to accommodate the addition of approximately 82 workers recently reassigned to the Centennial Mine from the Genwal facility. Catch basin C has been designed for a 6-hour 100 year storm event. Mr. Shaver contends that the volume of catch basin C has the capacity to satisfy both storm discharge and sediment containment requirements as prescribed by state law. Catch basin B consists of 4 separate detention cells, numbering 1-4. At the time of inspection, cell 1 was observed to be essentially filled with sediment. Sediment had accumulated to the invert elevation of the 18" CMP outlet culvert. Cell 2 was observed to be approximately 3/4 full with sediment at the time of the inspection. Further hydrologic analysis will be required in order to determine if catch basin C has the capacity to accept the storm runoff currently directed to catch basin B. Photos of Catch basin attached.
