# Inspection Report

Permit Number:	C0070020
Inspection Type:	PARTIAL
Inspection Date:	Wednesday, May 21, 2014
Start Date/Time:	5/21/2014 2:00:00 PM
End Date/Time:	5/21/2014 3:00:00 PM
Last Inspection:	Thursday, May 08, 2014

Site: **HORIZON MINE**

An inspection took place at the Horizon Mine on May 21, 2014. On site from OGM were Daron Haddock, Amanda Daniels and Pete Hess. During the inspection, overall site maintenance was evaluated. Corresponding pictures are attached. See NOV's 10140, 10141, and 10142.

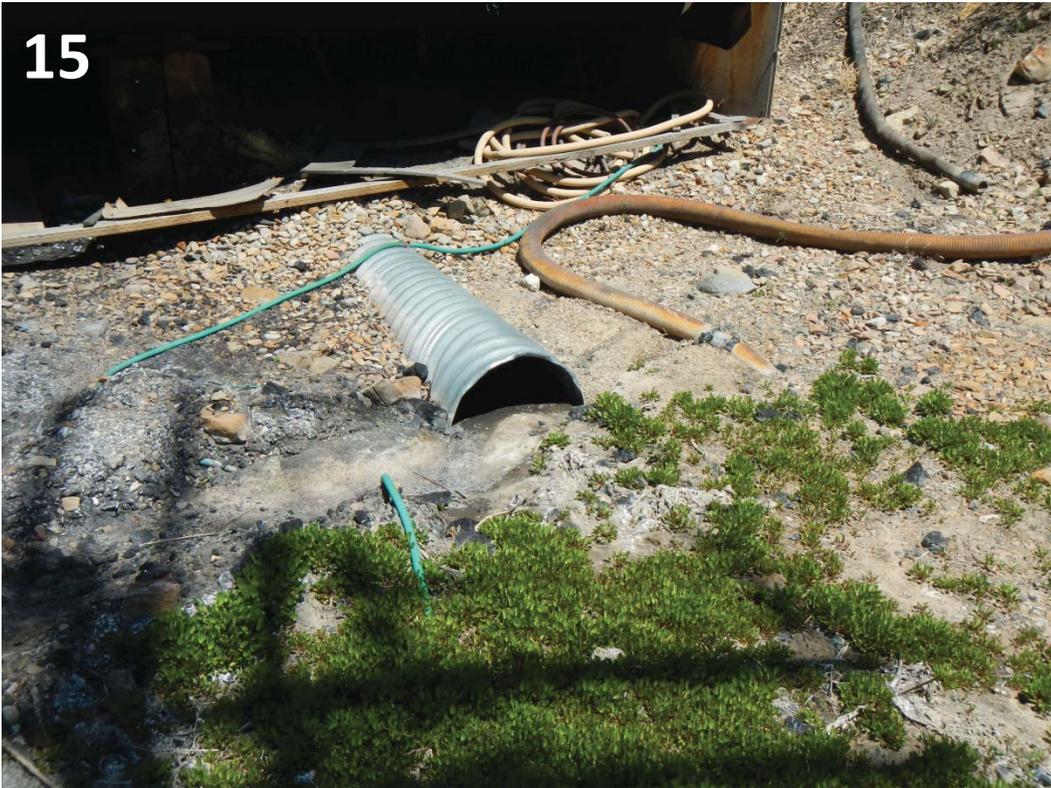
15

Undisturbed drainage culverts UC-2 (picture 20) and UC-3 (pictures 11 and 12) are both partially blocked by debris and waste. The outlet of UC-1 (picture 6) is almost completely plugged and should be cleaned immediately. Culvert DC-1 (picture 15) is also partially blocked. All drainage ditches throughout the facility need maintenance, but currently DD-6 (picture 1) and DD-1 (pictures 21, 22, and 23) do not have the ability to effectively transmit water. See NOV 10140.

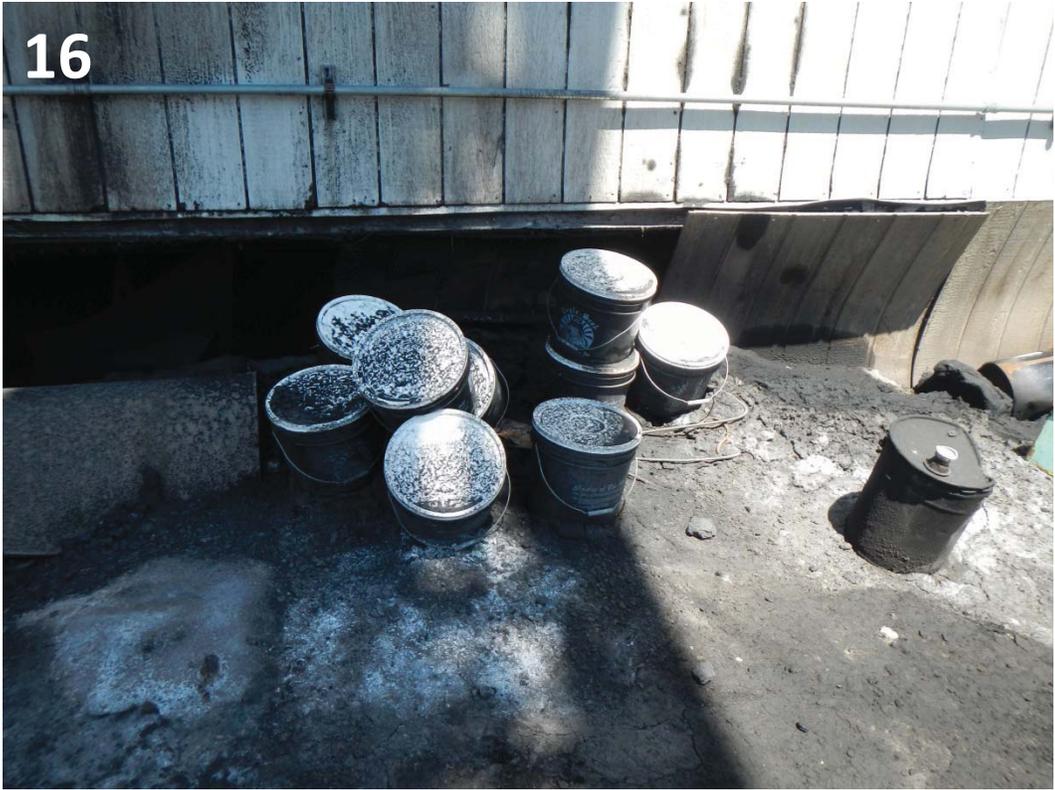
Waste is located throughout the site and should be cleaned up. One of the oil barrels have fallen into Jewkes Creek and sits at the inlet of UC-3 (picture 12). It is unclear if this barrel is empty. Other waste located throughout the site is documented in picture 16 and almost all of the other attached pictures. See NOV 10142.

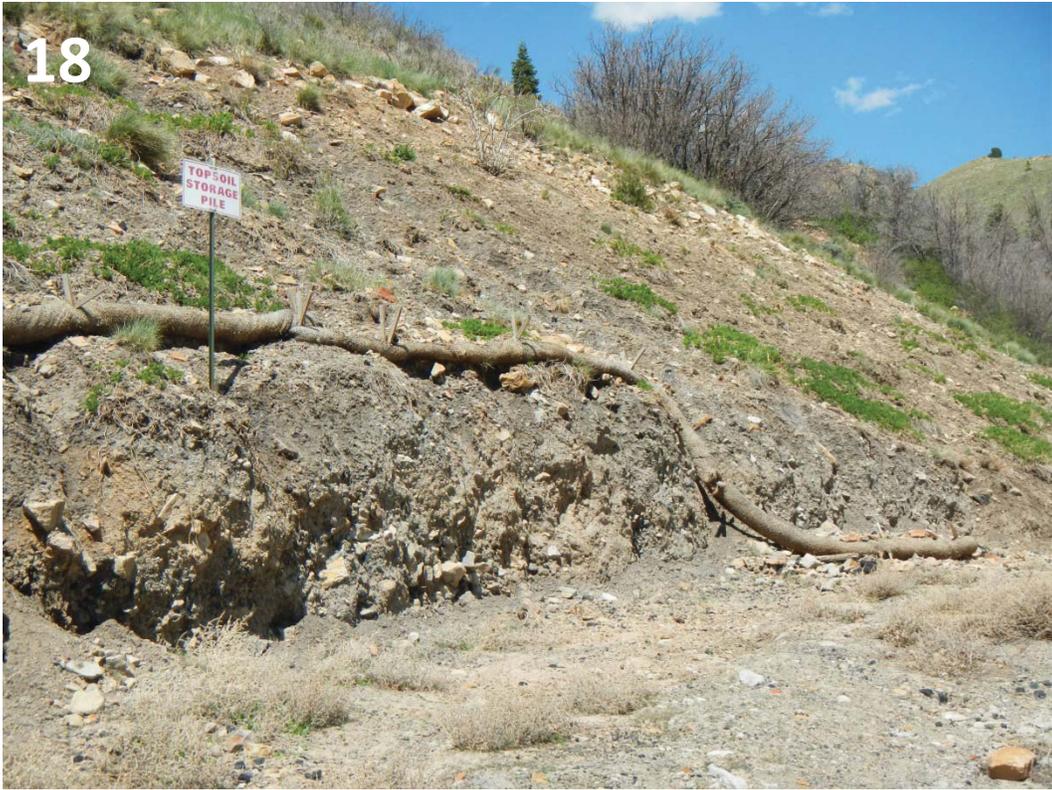
Excelsior logs along the toe of the topsoil piles, on the North side of the facility, are in need of maintenance. See pictures 18 and 19.

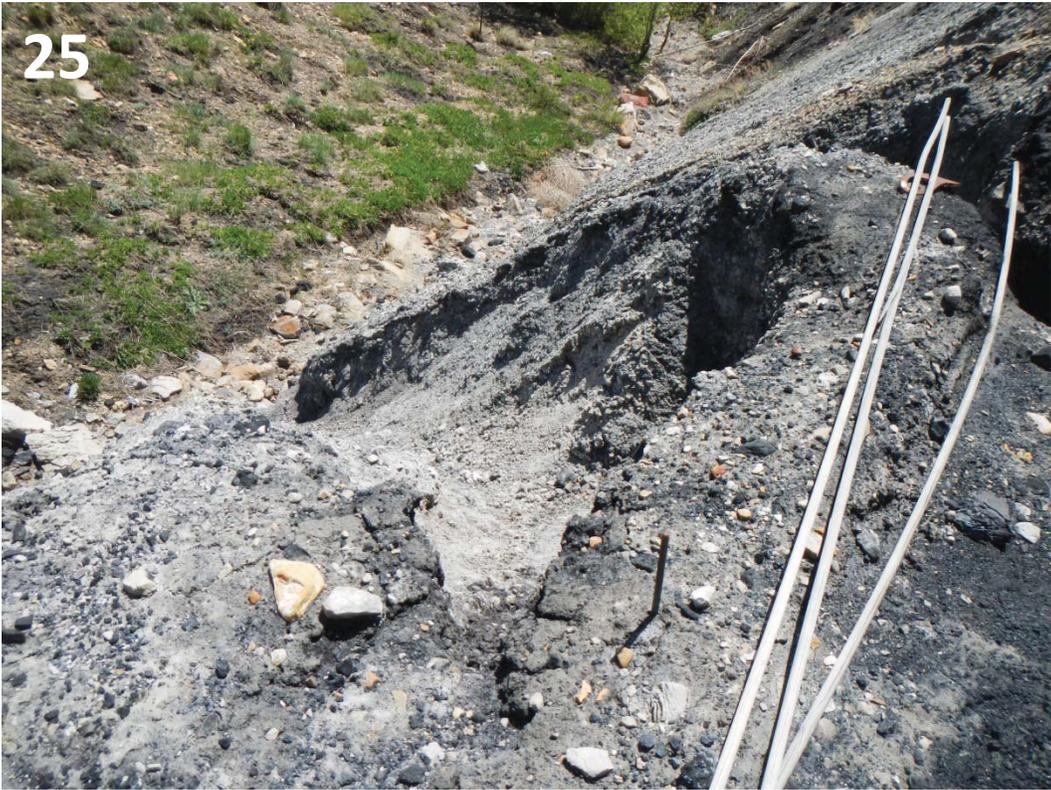
25

Slopes above the pond and above ditches DD-1H and DD-1I (pictures 25, 26, and 27) are eroding and should be maintained.
