# Inspection Report

Permit Number:	<b>C0070020</b>
Inspection Type:	COMPLETE
Inspection Date:	Thursday, March 16, 2017
Start Date/Time:	3/16/2017 1:50:00 PM
End Date/Time:	3/16/2017 2:40:00 PM
Last Inspection:

Permittee: **HIDDEN SPLENDOR RESOURCES**  
 Operator: **HIDDEN SPLENDOR RESOURCES**  
 Site: **HORIZON MINE**  
 Address: **57 WEST 200 SOUTH, SUITE 400, SALT LAKE CITY UT 84101**  
 County: **CARBON**  
 Permit Type: **PERMANENT COAL PROGRAM**  
 Permit Status: **ACTIVE**

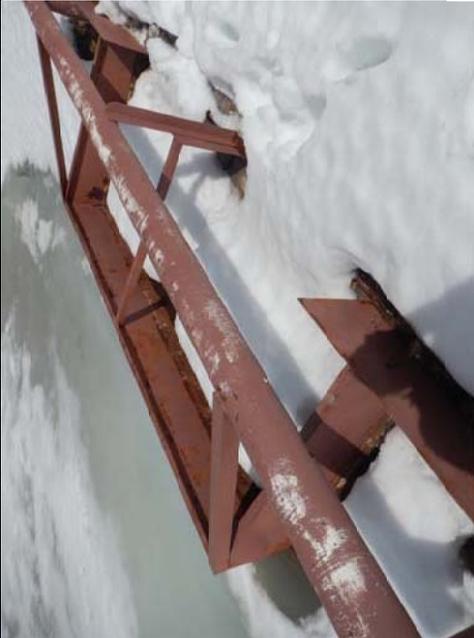
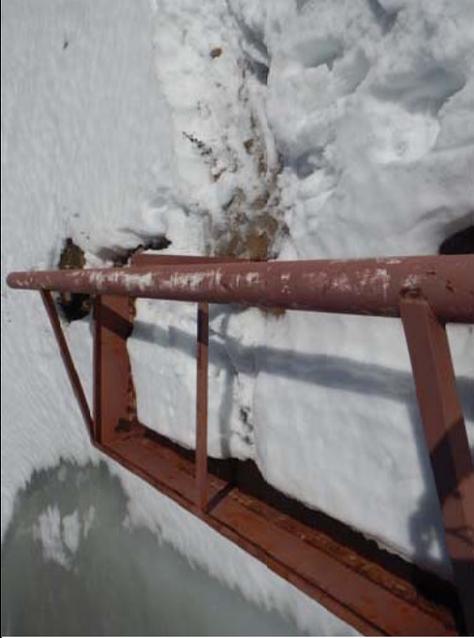
The Horizon mine was covered by a couple feet of snow. The sediment pond was discharging. Due to neglect, discharging water no longer flows over the open channel spillway. Snow cover prevented the Division inspector from locating the area where water now discharges from the sediment pond (Photos 1, 2).

<p><b>PHOTO 1</b> Non-functioning spillway covered with snow. March 16, 2017</p>	<p><b>PHOTO 2</b> Non-functioning spillway covered with snow. March 16, 2017</p>

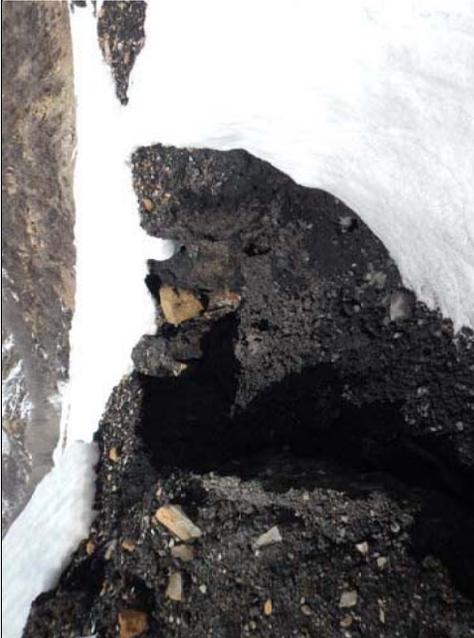
Runoff passes over the coal waste on the lower landing and flows to the sediment pond (Photo 3).

<p><b>PHOTO 3</b> Runoff from lower landing pad. March 16, 2017</p>	<p><b>PHOTO 4</b> Subsidence holes above and inby the southern portal. March 16, 2017</p>

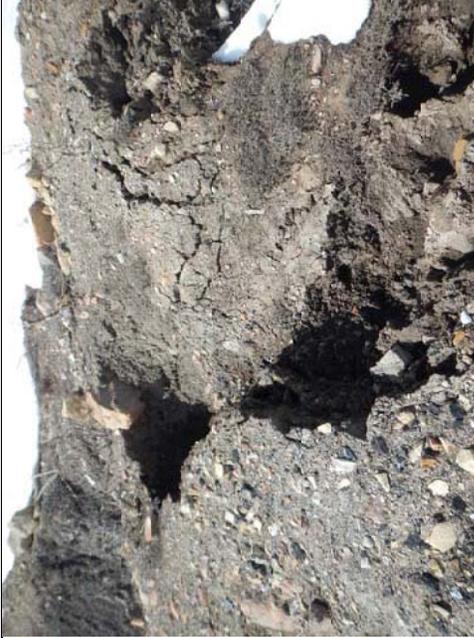
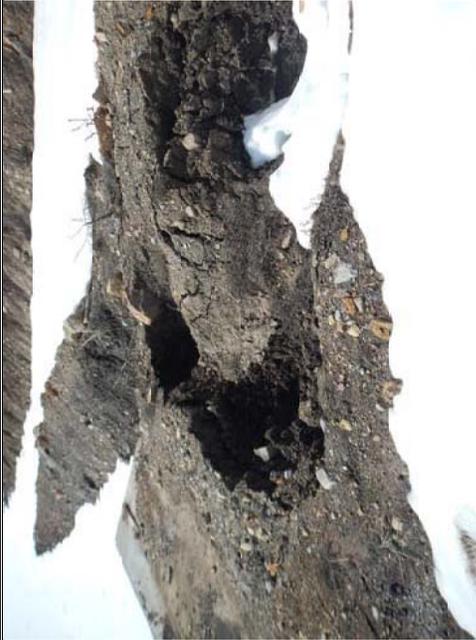
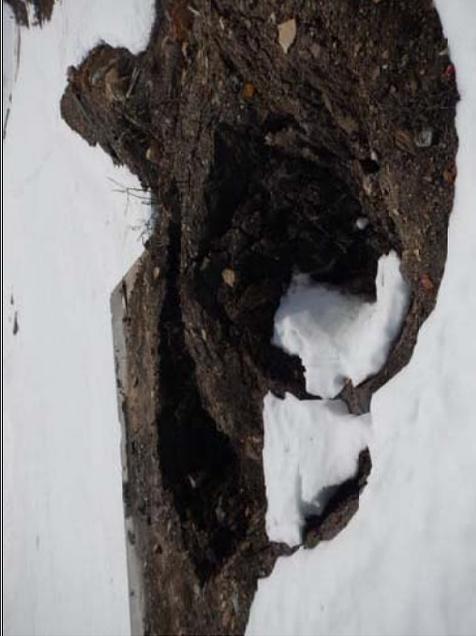
The inby roof of the southern portal is collapsing. This is causing subsidence holes to open at the surface (Photos 4-6). These subsidence holes will be fenced as soon as the snow melts and it is possible to access the portals by vehicle

<p><b>PHOTO 5</b> Subsidence holes above and inby the southern portal. March 16, 2017</p>	<p><b>PHOTO 6</b> Subsidence holes above and inby the southern portal. March 16, 2017</p>

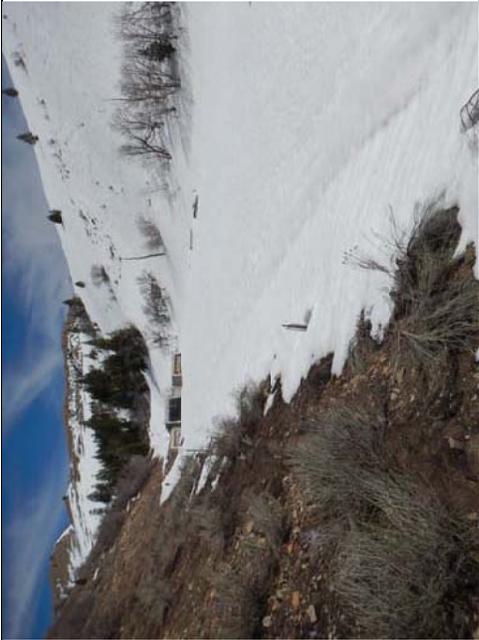
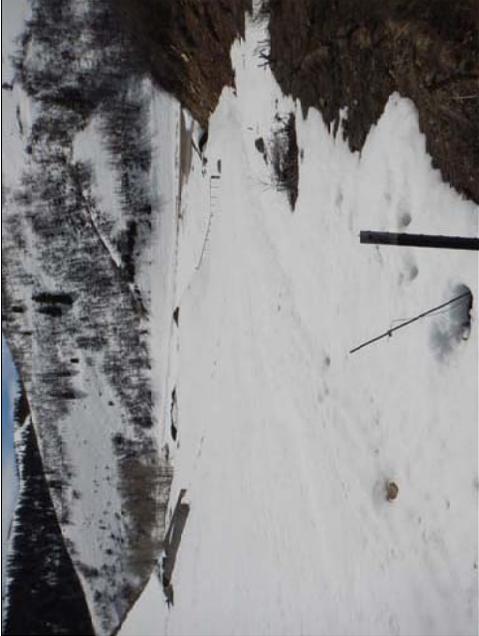
<p><b>PHOTO 7</b> Site covered in snow. March 16, 2017</p>	<p><b>PHOTO 8</b> Site covered in snow. March 16, 2017</p>

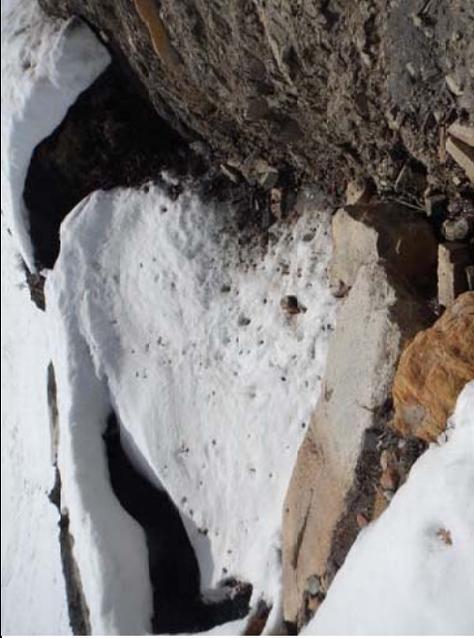
**PHOTO 9**

Inlet to disturbed drainage culvert.  
March 16, 2017

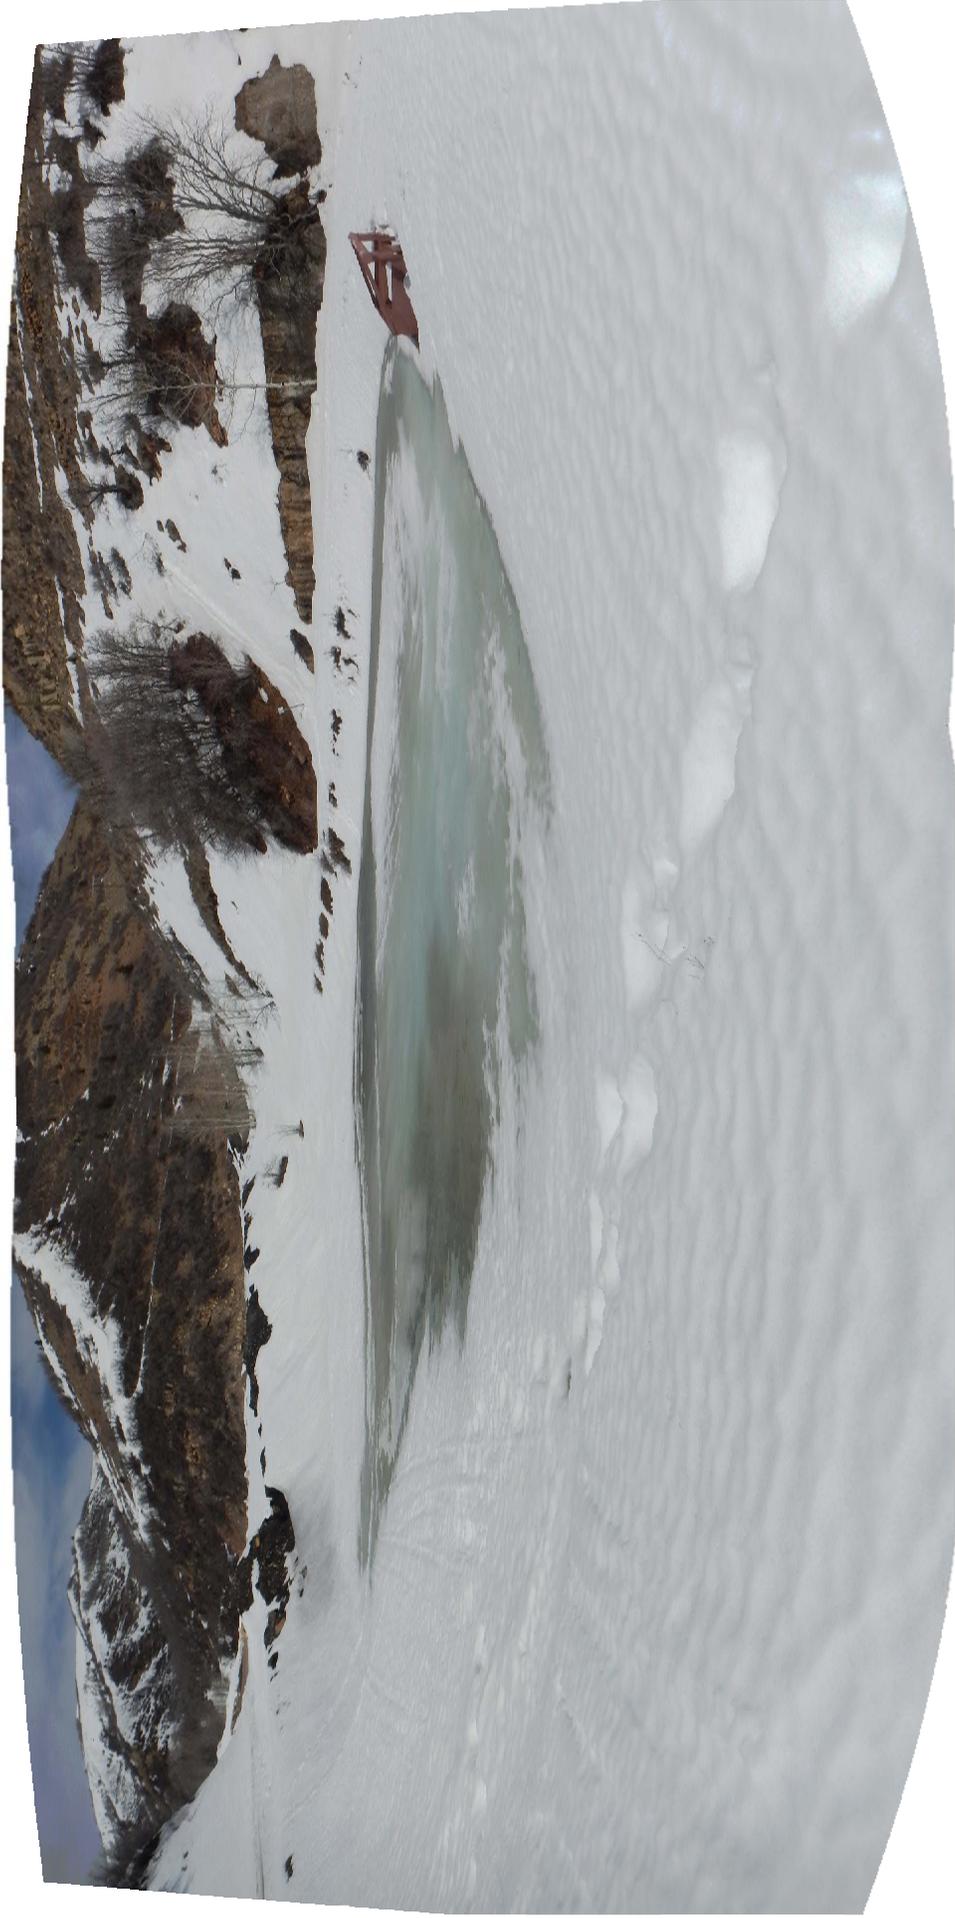
**PANORAMA 1**

Sediment pond covered by a couple feet of snow. The pond was full of water was discharging at the time the photo was taken.  
March 16, 2017
