# Inspection Report

Permit Number:	C0070020
Inspection Type:	PARTIAL
Inspection Date:	Friday, April 28, 2017
Start Date/Time:	4/28/2017 1:30:00 PM
End Date/Time:	4/28/2017 3:00:00 PM
Last Inspection:

Permittee: **HIDDEN SPLENDOR RESOURCES**  
 Operator: **HIDDEN SPLENDOR RESOURCES**  
 Site: **HORIZON MINE**  
 Address: **57 WEST 200 SOUTH, SUITE 400, SALT LAKE CITY UT 84101**  
 County: **CARBON**  
 Permit Type: **PERMANENT COAL PROGRAM**  
 Permit Status: **ACTIVE**

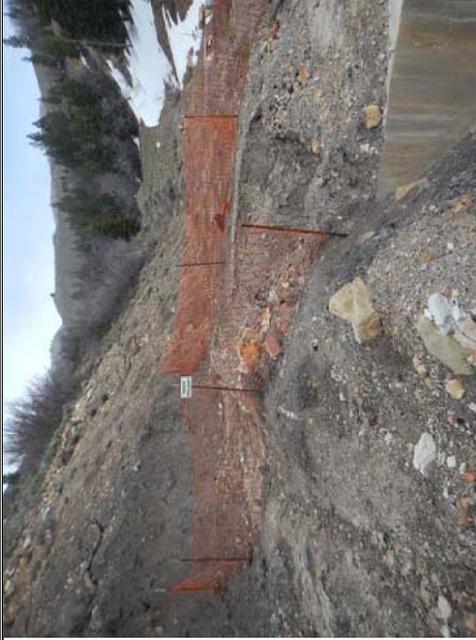
The Division installed a safety barrier fence on the surface above the collapsing inby entry of the southern portal (Photos 1-6). A sign was posted to prevent the public from entering into the fenced area.

<p><b>PHOTO 1</b> Collapsing portal entry fenced with safety barrier and posted 'Danger Open Shaft' April 28, 2017</p>	<p><b>PHOTO 2</b> Collapsing portal entry fenced with safety barrier and posted 'Danger Open Shaft' April 28, 2017</p>

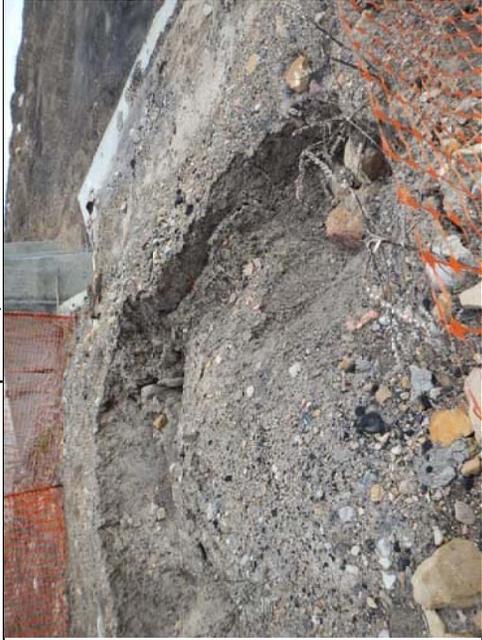
<p><b>PHOTO 3</b> Collapsing portal entry April 28, 2017</p>	<p><b>PHOTO 4</b> Collapsing portal entry fenced with safety barrier and posted 'Danger Open Shaft' April 28, 2017</p>

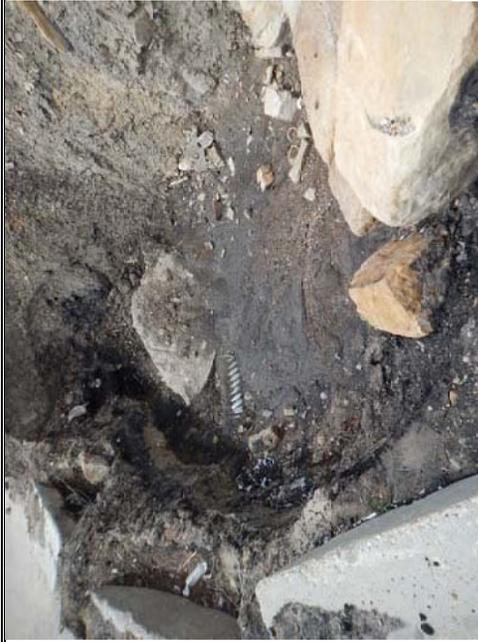
The disturbed area culvert appeared to be blocked at its inlet. The inlet to the culvert was not impounding water, so water must be able to slowly seep into the disturbed culvert (Photos 9, 10).

**PHOTO 9**  
Disturbed culvert blocked.  
April 28, 2017

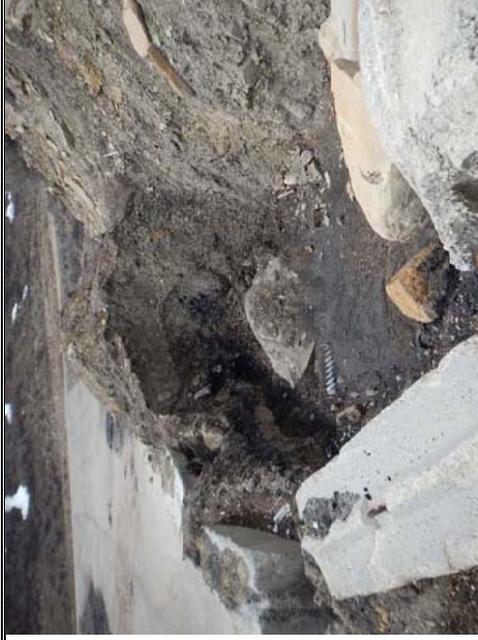
**PHOTO 10**  
Disturbed culvert blocked.  
April 28, 2017

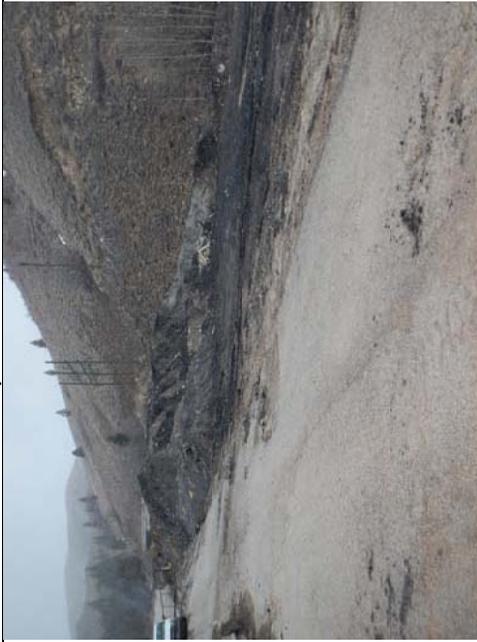
Multiple piles of coal waste and non coal waste are scattered across the loadout (Photos 11, 12).

**PHOTO 11**  
Waste piles on the loadout.  
April 28, 2017

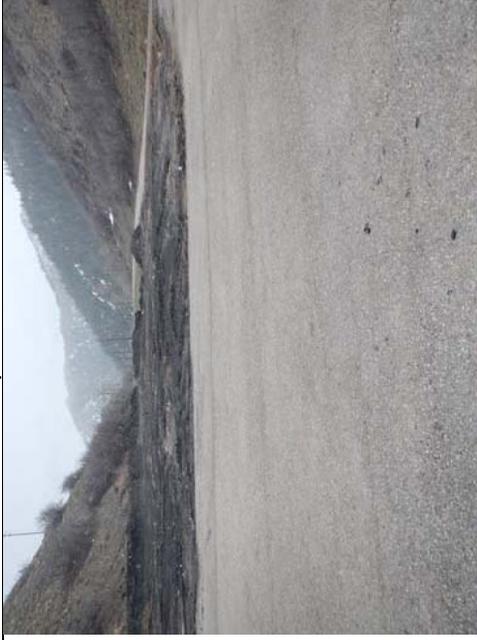
**PHOTO 12**  
Coal waste on loadout.  
April 28, 2017

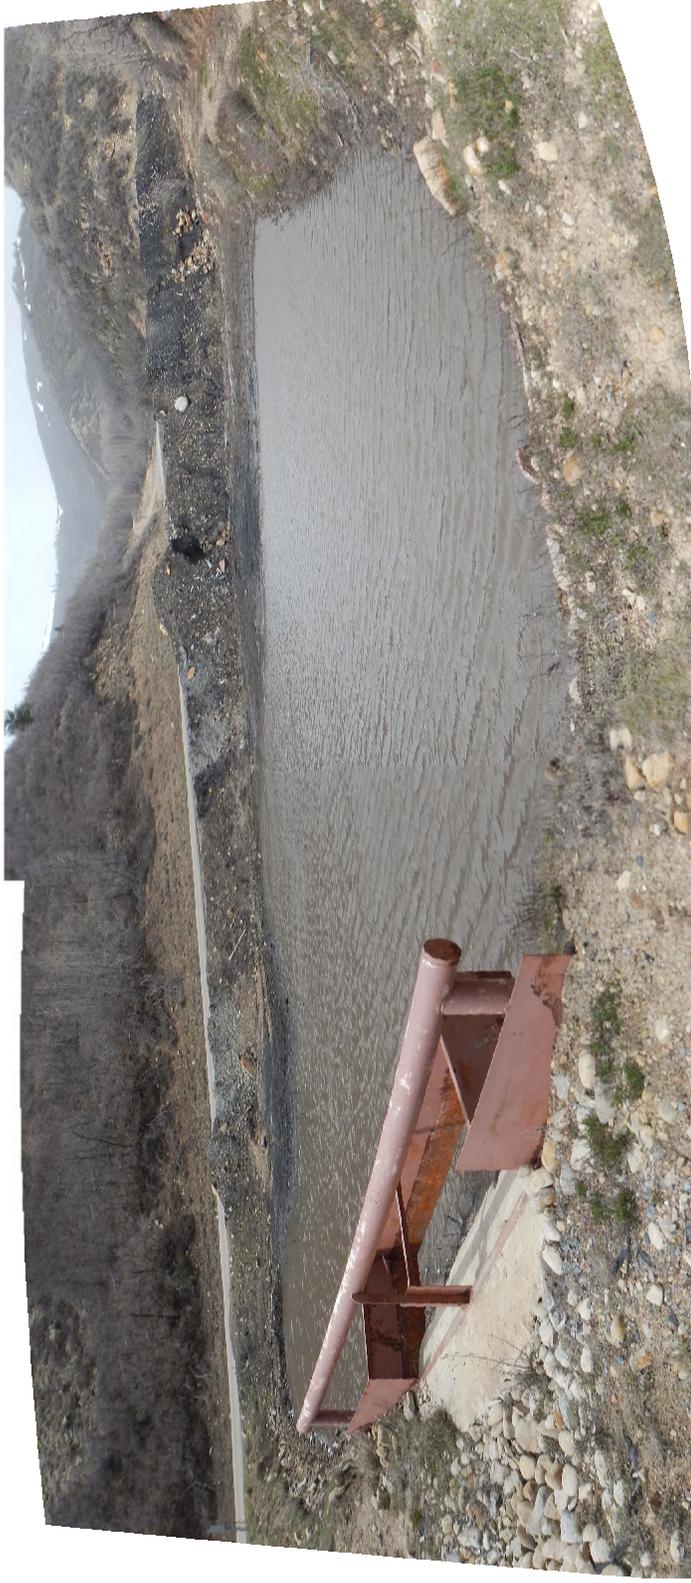
**PANORAMA 1**

The sediment pond was not discharging at the time of the inspection (Photo 8, Panorama 1).

Sediment pond impounding water.  
April 28, 2017
