DOGM, Daily Construction Progress Report

Horizon Mine Reclamation

C/007/020

ATTACHMENT A – Photos September 17, 2018

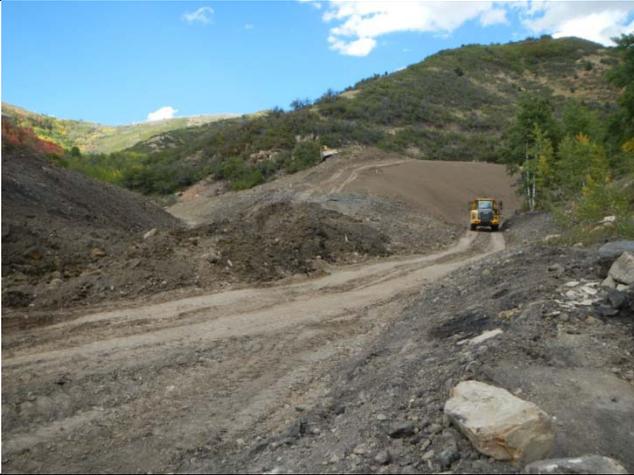
PHOTO 1

Looking West at the peninsula between Jewkes and Portal Cyn. The excavator is on the South facing slope. The articulated truck is hauling topsoil. Note pile of overburden blocking confluence.

Steve was in the excavator moving topsoil and fill on the South face of the peninsula between Portal and Jewkes Creeks. The reconstructed slope flattens out a bit as it ties in with the undisturbed ground. This looks nice and breaks the slope.

Dal was hauling topsoil in the articulated truck from the portal canyon topsoil stockpile down the drainage. Two stockpiles of topsoil are being stored on the lower topsoil pile, One topsoil stockpile is on the slope above the upper reach of Jewkes Creek. About all the portal cyn topsoil, to be moved, has been moved. The rest will stay in Portal Cyn.

*Jewkes Creek culvert was also removed from both ends. Jewkes channel is completed in all but the reach with the confluence. At present, a pile of cut material blocks Jewkes Creek before the confluence with Portal Cyn. This will be moved to the slope along the road. **Slopes above Jewkes Creek appear steeper than 3h:1v. There is an opportunity to improve the South side,** but the North is set by the location of the Jewkes channel. The channel cut is presently 2 ft above the stream at the upstream end and 2 ft below the stream at its down stream end. At the upstream end, it will be 4 ft*

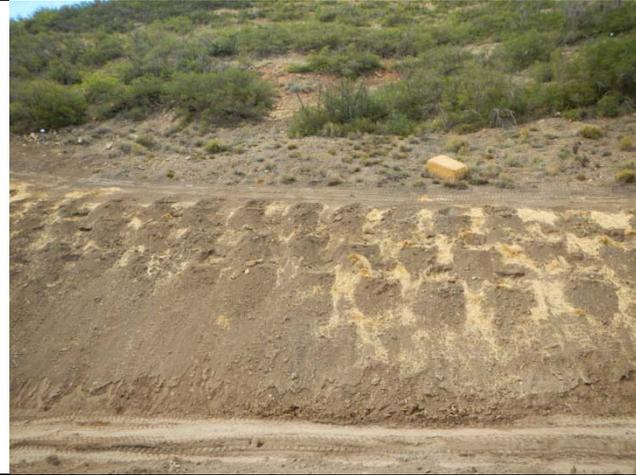
PHOTO 2

Pocking on the East facing slope of Portal Cyn was interrupted. The next operator will use a smaller bucket and get better hay scatter and incorporation.

One bale of hay was distributed across the West side (East facing slope) of portal canyon. It was poked in, but the work was stopped by Steve for quality control reasons. Steve will restart the work himself using the smaller bucket.

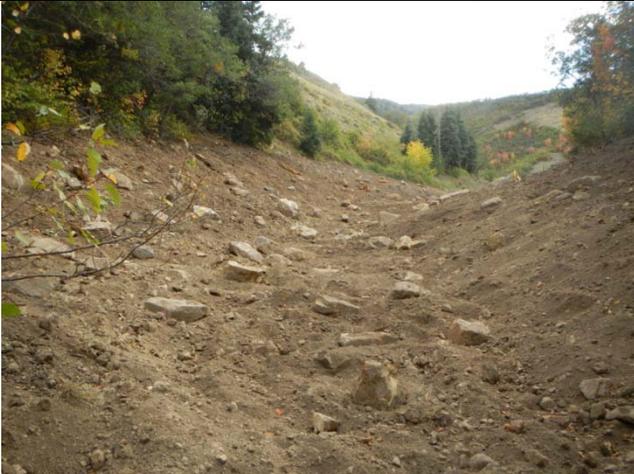
PHOTO 3

Looking downstream at the upper reach of reconstructed Portal Cyn.

*Drew was in the Komatsu 220 constructing the upper Portal canyon drainage. He has created a natural look. The reconstructed reach of Portal canyon drainage is formed of loose soil and rock. Drew has scattered rock on the slopes to look natural. He placed a layer of topsoil on the surface of shale fragments that were exposed in topsoil removal. Drew removed a portion of the by pass culvert at the Portal Cyn inlet and the remaining culvert was crushed and bent backwards on itself. **A portion of the by pass culvert remains to be removed at the location of the portals. That will be done tomorrow.** Through the topsoil area, the remaining culvert is above the portal drainage in elevation.*

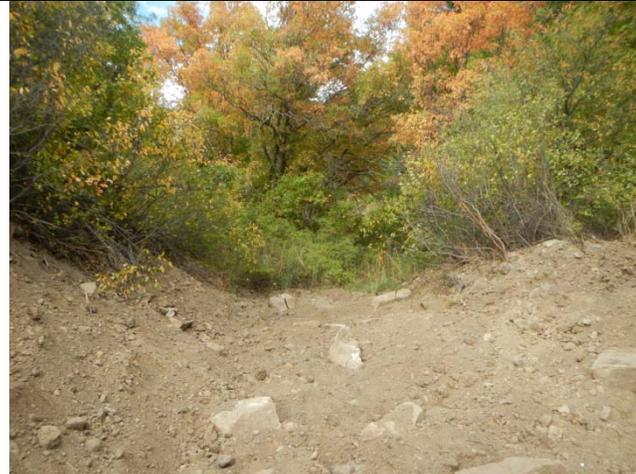
PHOTO 4

Portal Cyn looking upstream at undisturbed area.

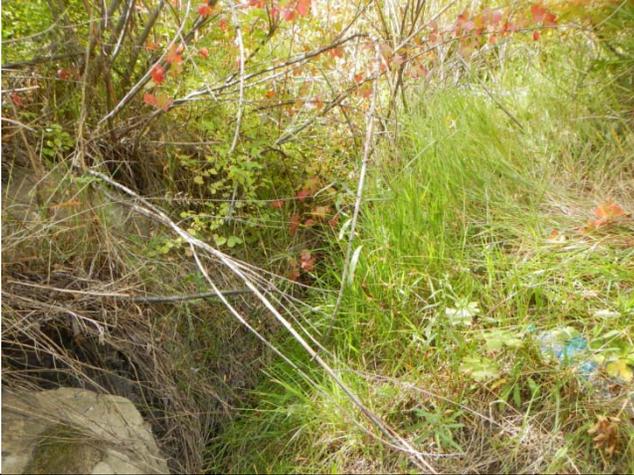
PHOTO 5

Thalweg in Jewkes just before disturbed area

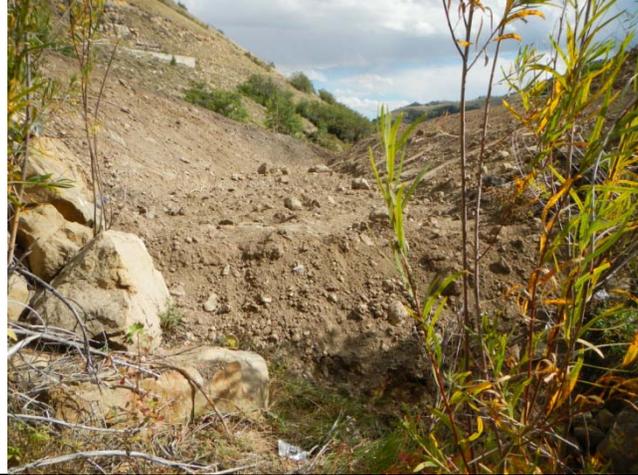
PHOTO 6

Looking downstream at reconstructed channel from thalweg.

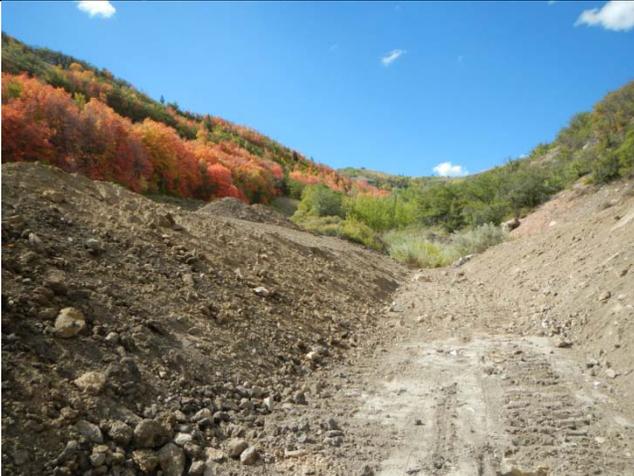
PHOTO 7

Looking upstream at reconstructed Jewkes Creek.

above the existing channel when channel rock is placed and the face of the reconstructed channel will be hardened with rock. At its downstream end, the final configuration will meet with well vegetated grassy sward and cut its own path.

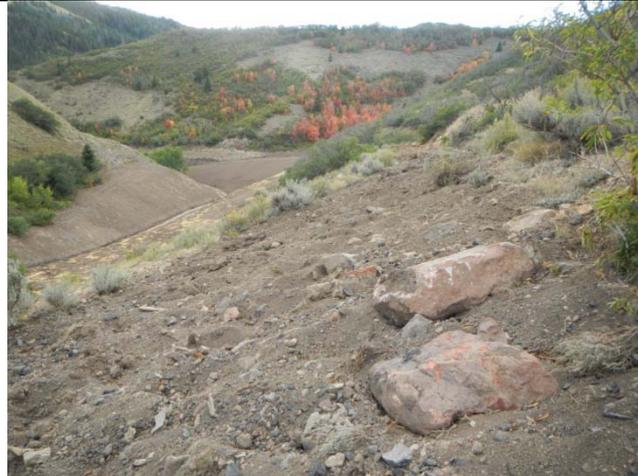
PHOTO 8

Looking South at reclamation with the shaft reclamation foreground.

The shaft has been capped with concrete. Soil has been placed over top and the area has been pocked all the way down the access road to the site.
