Horizon Daily Report -- Tuesday, 9182018

DOGM, Daily Construction Progress Report

Horizon Mine Reclamation

ATTACHMENT A –Sept 18, 2018 site visit

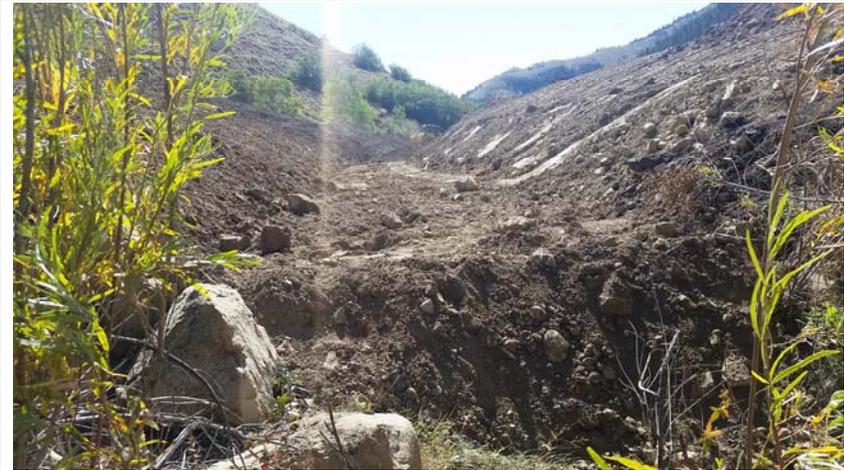
PHOTO 2

View looking east from the undisturbed thalweg in the upstream end of Jewkes Creek. This view illustrates the offset at the head of Jewkes.

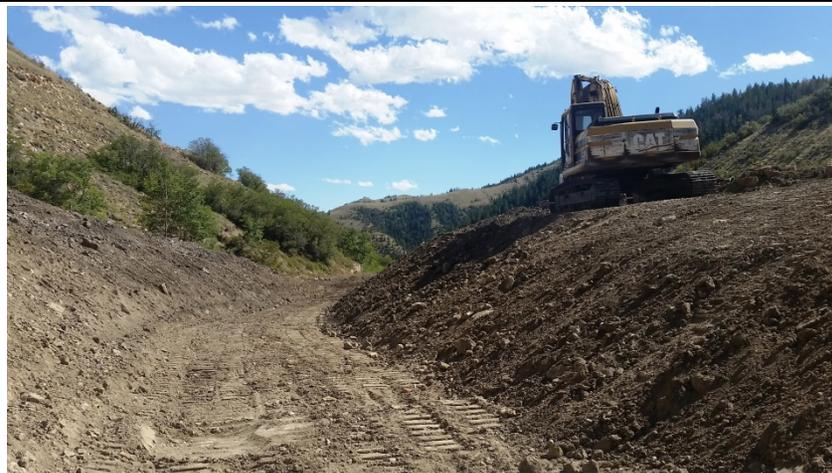
PHOTO 3

View looking east from the middle of Jewkes Creek channel.

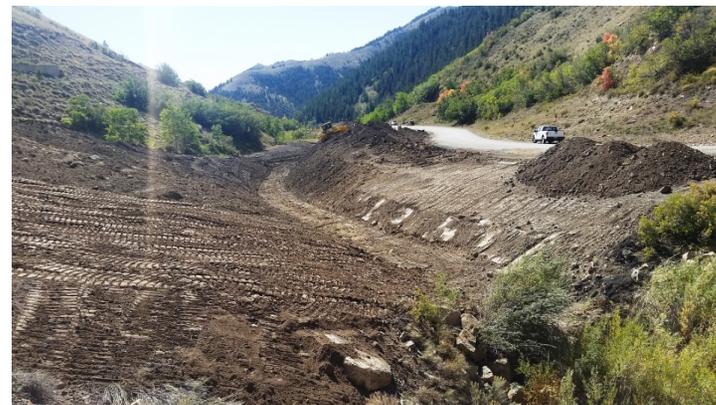
PHOTO 4

Overview of entire Jewkes Creek channel.

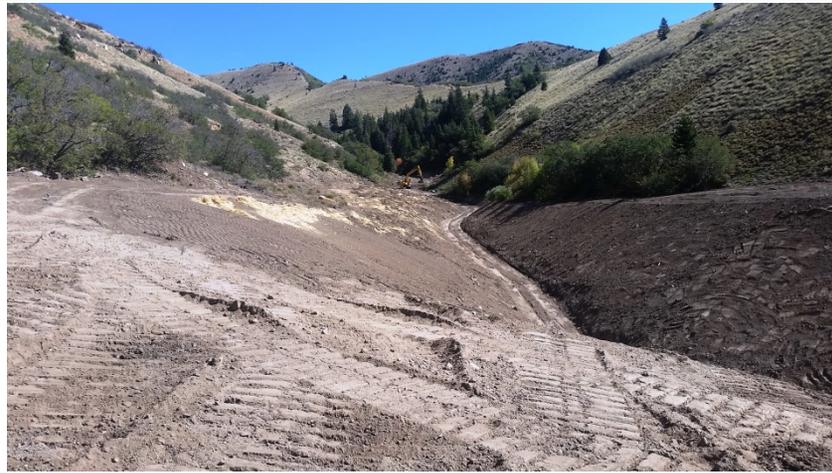
PHOTO 5

Looking north overlooking Portal Canyon. Excavator access road (foreground) will be reclaimed during the final pass.

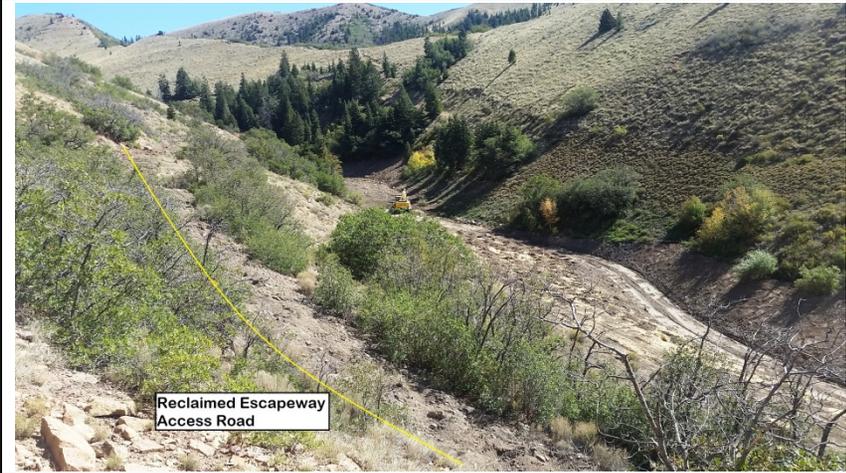
PHOTO 6

Reclaimed Escapeway Access Road

The yellow line highlights the reclaimed escapeway access road. It has been pocked, but no mulch yet.

There is a section of slopes on the west side of Portal Canyon that has been pocked and mulched with hay, although the mulch is spotty and the pock spacing needs to be tightened as the individual cups are a little too widely spaced. The road to the reclaimed escapeway shaft has been pocked as well, but so far no mulch.

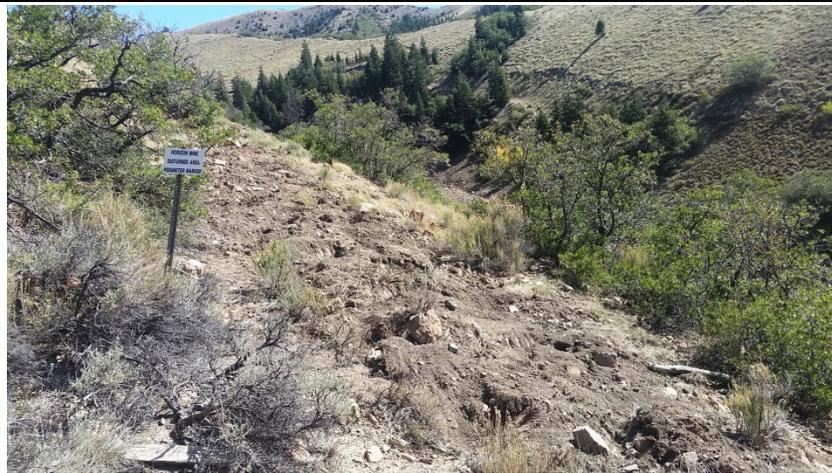
PHOTO 7

Another view of reclaimed escapeway access road. The pocking could be a little tighter.

I discussed tightening up the pocking with Drew yesterday. He said he would try to be more diligent and mentioned that Steve would likely attempt to repair or redo the pocking already done on the upper west slopes of Portal Canyon. Possibly with a mini-ex or something with a smaller bucket.

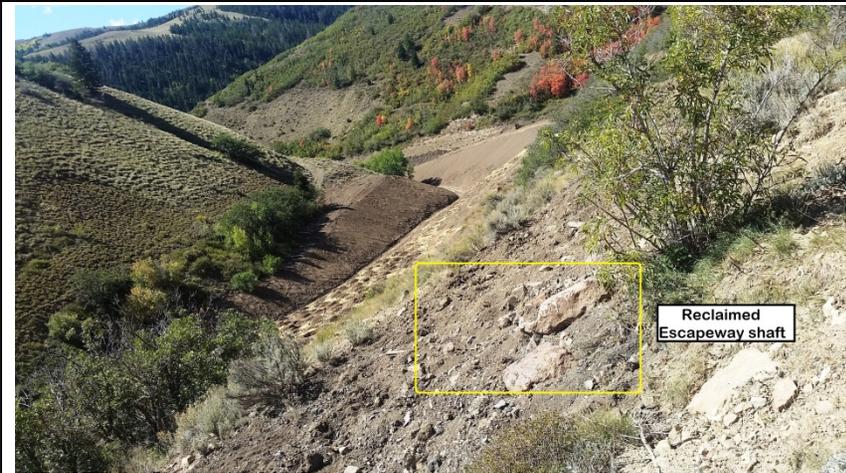
PHOTO 8

Reclaimed Escapeway shaft

The yellow square depicts where the old escapeway shaft used to reside.

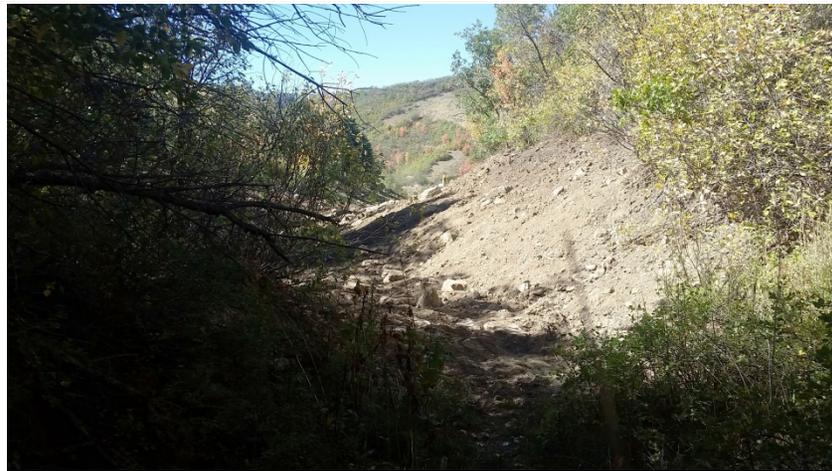
PHOTO 9

Upper portion of reconstructed Portal Canyon as viewed from undisturbed thalweg. The UD culvert was located here.

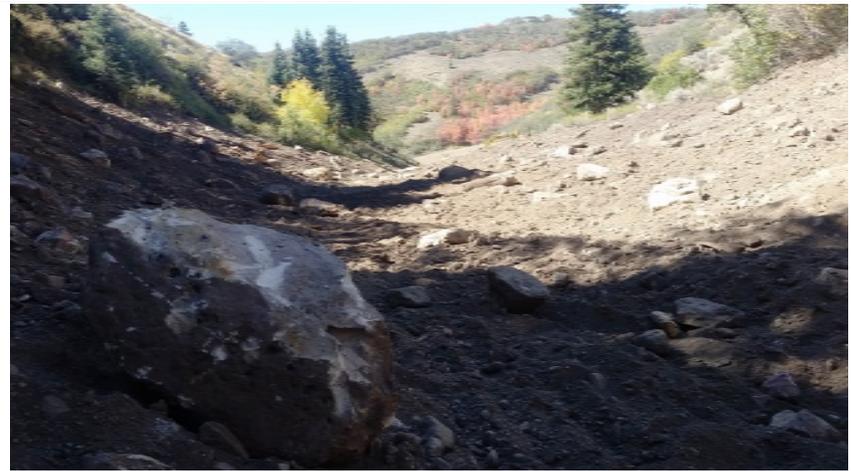
PHOTO 10

Another view of reconstructed Portal Canyon channel. Rocks and woody debris scattered to create a natural look.

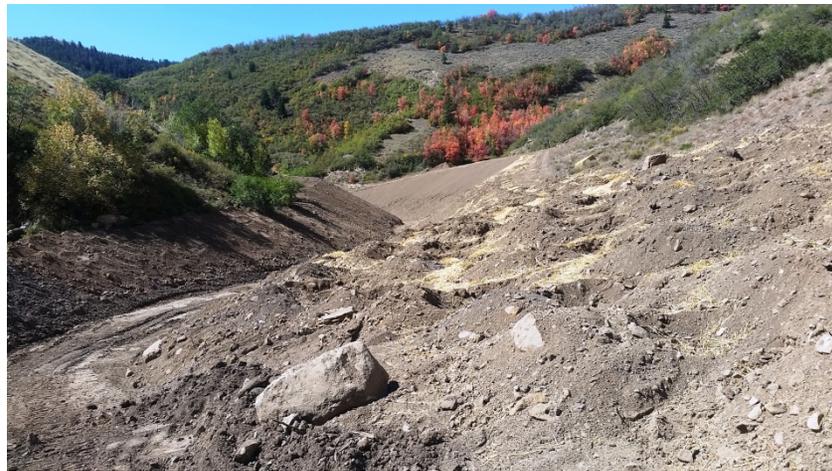
PHOTO 11

These mulched/pocked slopes reside over where the concrete portals used to be located.

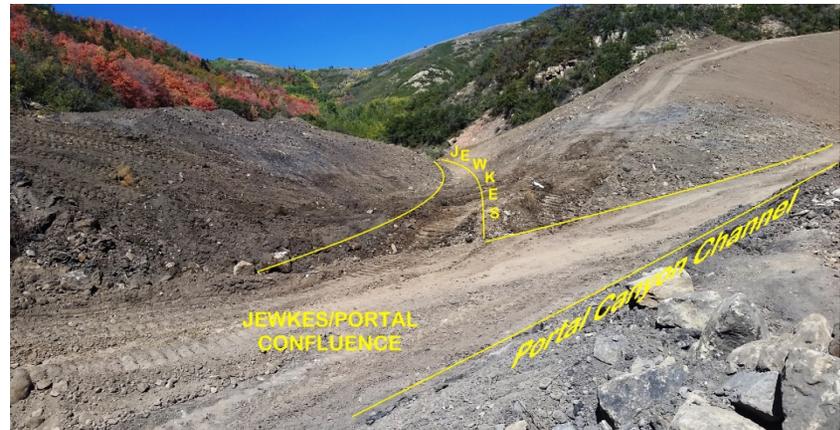
PHOTO 12

Yellow lines illustrate the confluence of Portal and Jewkes Canyon channels.

Excavation of the Jewkes Creek channel has been dug to final grade, and the confluence with Portal Canyon established. Just downstream from the confluence the channel is routed directly through where the sediment pond used to reside. The fortunate lack of precipitation in recent weeks has enabled construction crews to excavate the fines from the sediment pond and establish the main channel. Final grade for the main channel through the old sediment pond has been achieved, and is currently awaiting placement of gravel and riprap. Dal was occupied for much of the day with placing topsoil on the newly contoured slopes in Jewkes Canyon. Drew was working on tying in the graded slopes in upper Portal Canyon with the main channel just beneath where the portals used to be. There was some vegetation in the channel that he was trying to preserve as he brought the slopes in to final grade.

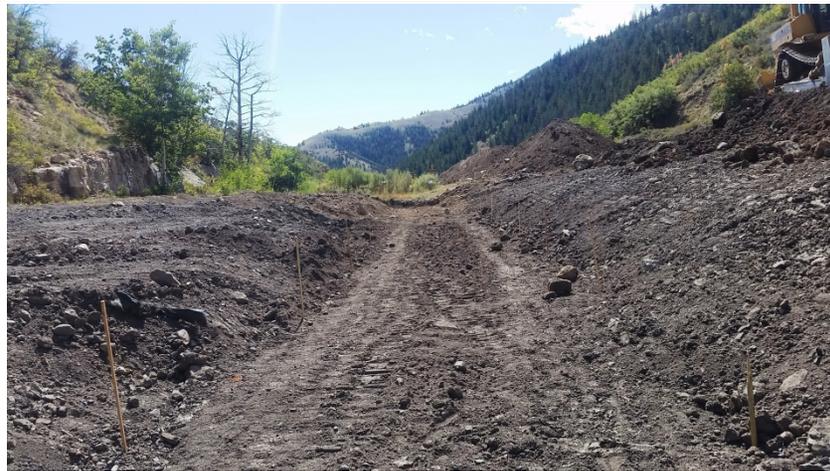
PHOTO 13

Standing at the confluence looking east at the channel cut through the sediment pond.

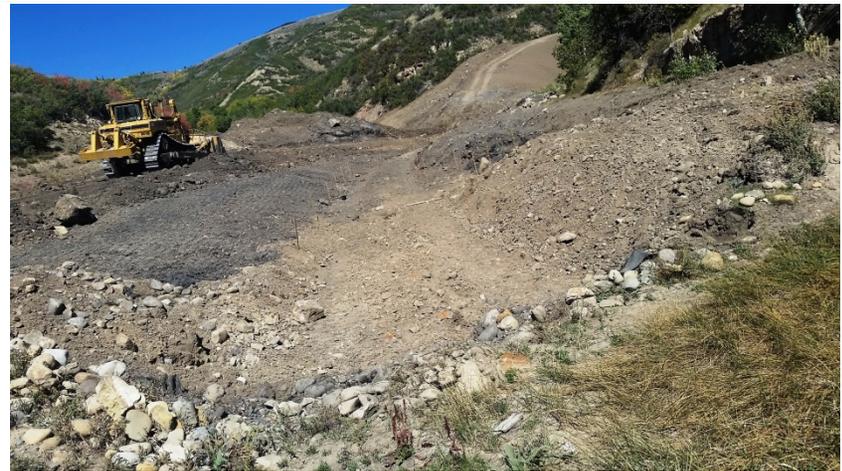
PHOTO 14

Looking west at channel through sediment pond from grassy sward.

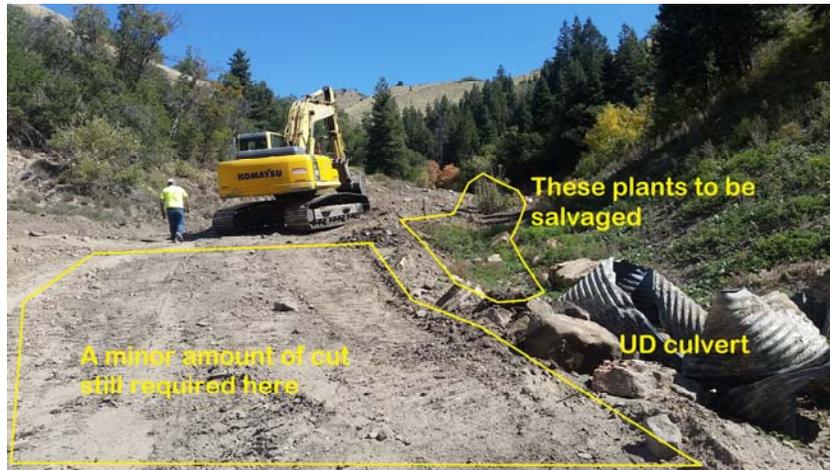
PHOTO 17 – PORTAL CANYON (11:45am)

Drew mentioned that he would have to gently “paint” his way around these plants as he continues reconstruction of Portal Canyon.

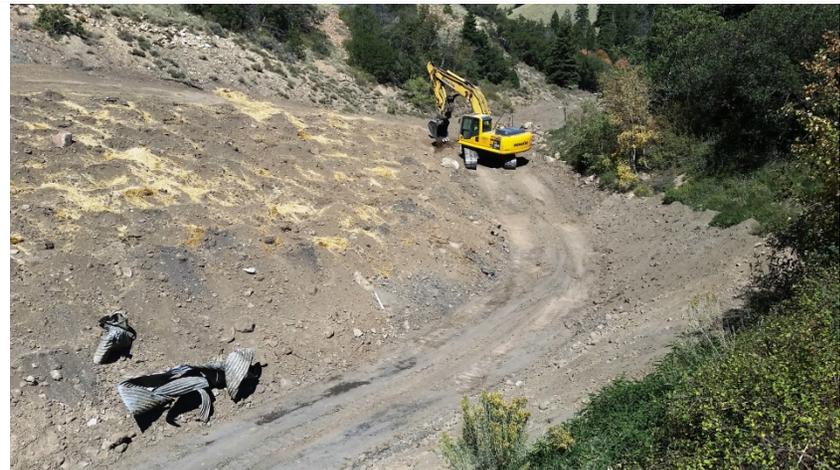
PHOTO 18 – PORTAL CANYON (3:45pm)

Drew in the Komatsu 220 Excavator creating a gentle transition from reconstructed Portal Canyon to main channel.

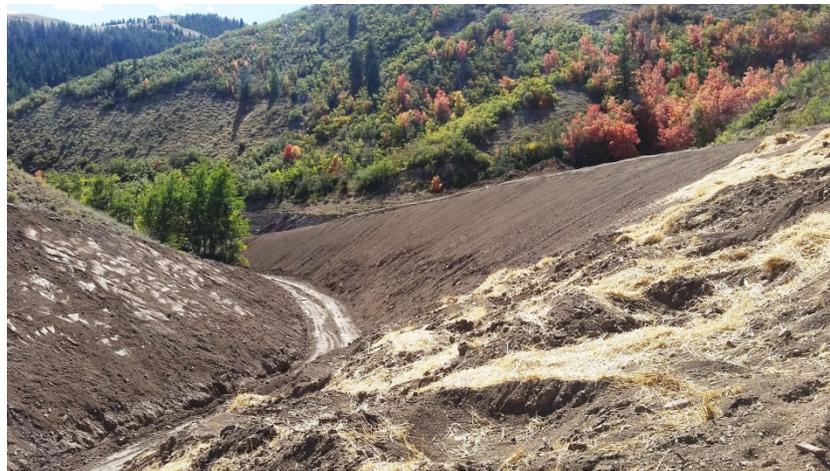
PHOTO 19

The western slopes in Portal Canyon looking east. Slopes in background have yet to be pocked/mulched .

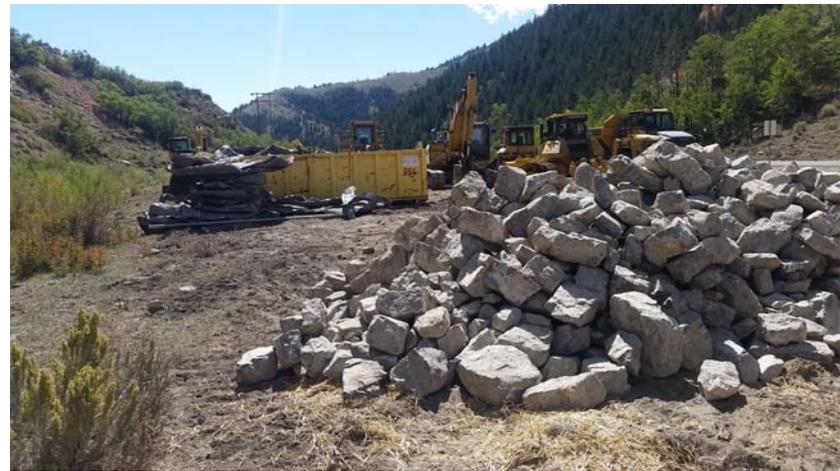
PHOTO 20

These rocks will be used to build/enhance engineered log jams in the newly constructed channels.
