DOGM, Daily Construction Progress Report

Horizon Mine Reclamation

C/007/020

ATTACHMENT A – Photos Date site visit

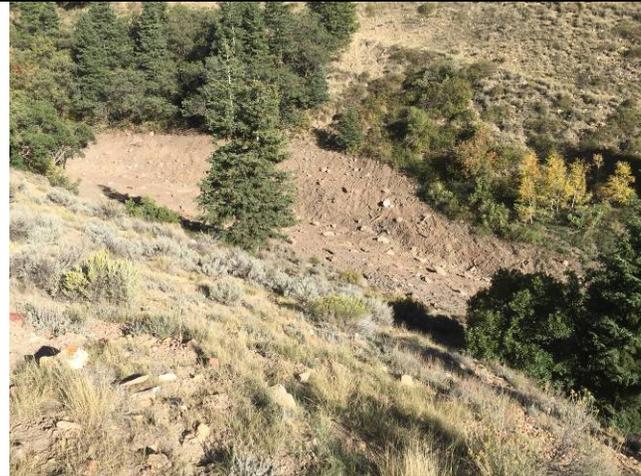
PHOTO 2
Natural channel at head of Portal canyon

Portal canyon topsoil pile has been completely excavated and hauled down to the lower topsoil pile. The natural channel has been reestablished through the canyon bottom. The large rocks within the pile have been scattered across the slopes in a random distribution.

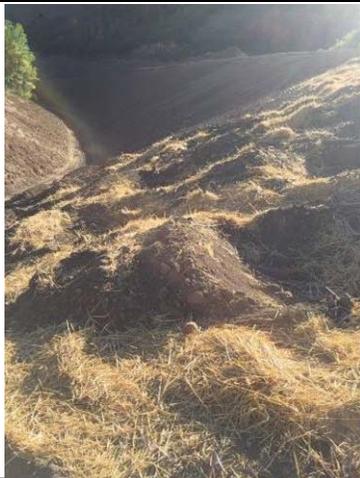
PHOTO 3
Pocked Portal canyon slopes

Steve is mulching and pocking the slopes of Portal canyon. He's laying down the straw and working it into the slope as he pocks. I discussed with him the pattern I'm looking for with pocking. The pocks need to be directly adjacent to each other so there are no flat areas between pocks and the pock features need to be deep enough to capture rainfall and runoff.

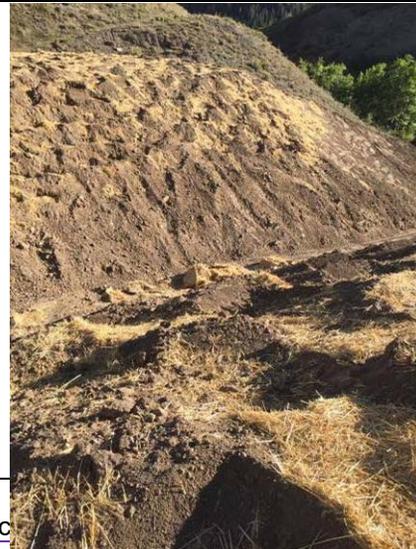
Pock
slopes

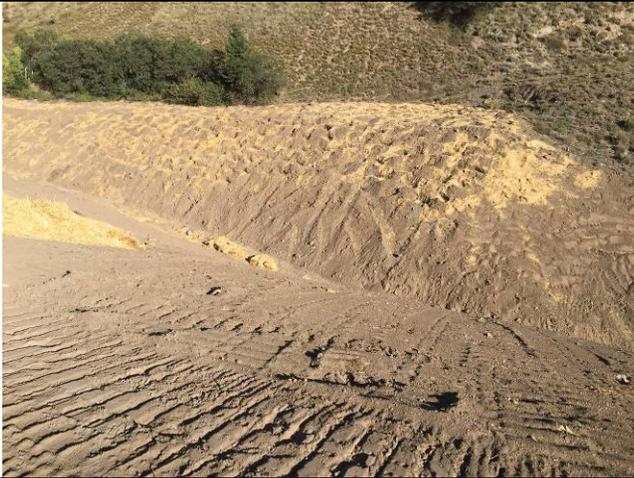
PHOTO 5

Pocked and mulched slopes in Portal canyon

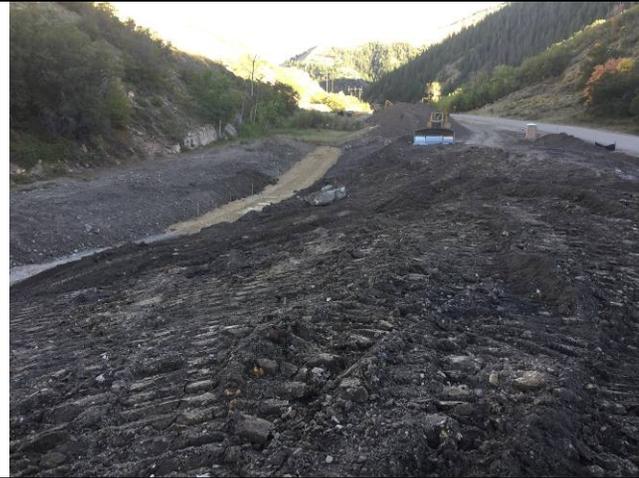
PHOTO 6

The first load of gravel filter has been laid into the channel. The gravel filter has been compacted with the sheeps foot.

Gravel filter laid near outlet of reclaimed channel

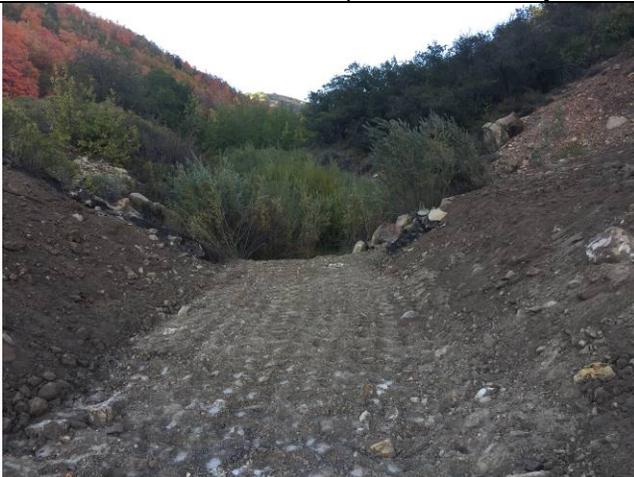
PHOTO 7

Drew is working at the outlet of Jewkes channel. From the outlet of the bypass CMP, it has been excavated upchannel 15 feet and removed. The rest of the bypass CMP where it ran along the sediment pond will be abandoned as outlined in the Scope of Work.

Inlet of Jewkes channel

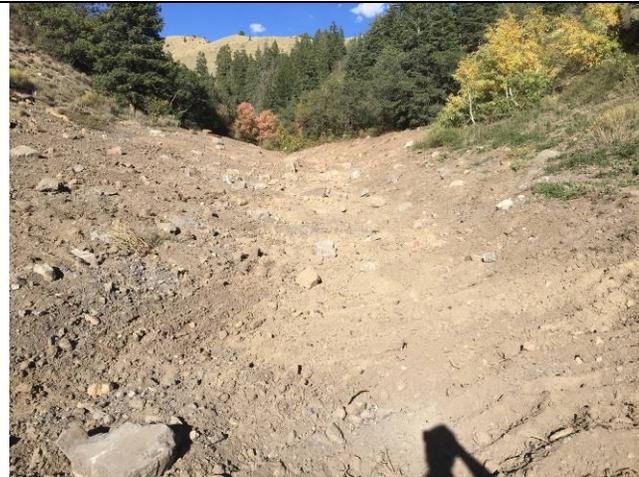
PHOTO 8

Natural channel at head of Portal canyon where topsoil pile sat
